This footrot sample collection kit instruction is a guide for the collection of samples for the isolation of *Dichelobacter nodosus* from footrot lesions.

Sample Collection Kit

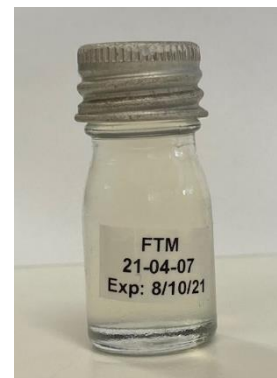
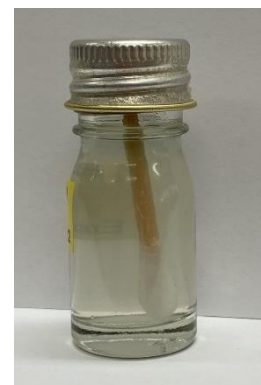
1. Check each bottle of transport media. The FTM should be opaque and colourless (Figure 1). **Do not use the bottle if the indicator in the medium has turned blue or if the bottle is not full.**
2. Using the cotton tipped sterile swab provided, collect sample material from the active area of a lesion.
3. Remove the lid and push the swab deep into the FTM, break the swab off level with lip of the bottle and replace the lid firmly to create an airtight seal. Use one swab per bottle of FTM (Figure 2).
4. Refer to the Foot Scoring Details table included in the Specimen Advice Form to label bottles to identify the animal sampled. Record the details on the lid and adhesive label on the bottle with a water-proof permanent marker.
5. Transport medium should be returned to EMAI as soon as possible and kept cool during transit.

N.B. Store unused media at 4°C. **The transport media will remain satisfactory providing the indicator in the medium has not turned blue and the bottle is full** and should be used before the expiry date on the bottle. Care is required with transport of unused transport media during hot weather. It is preferable to keep the media chilled. **Please return expired transport media to EMAI.**
