Dairy Farmer Response to Storm and Floods 2021/22

Investing in shelter and refuge

“Williams Dairy”: Providing a refuge for extreme weather

“Kenarie Jerseys”: Response to extreme loss of machinery and animals due to flood water heights

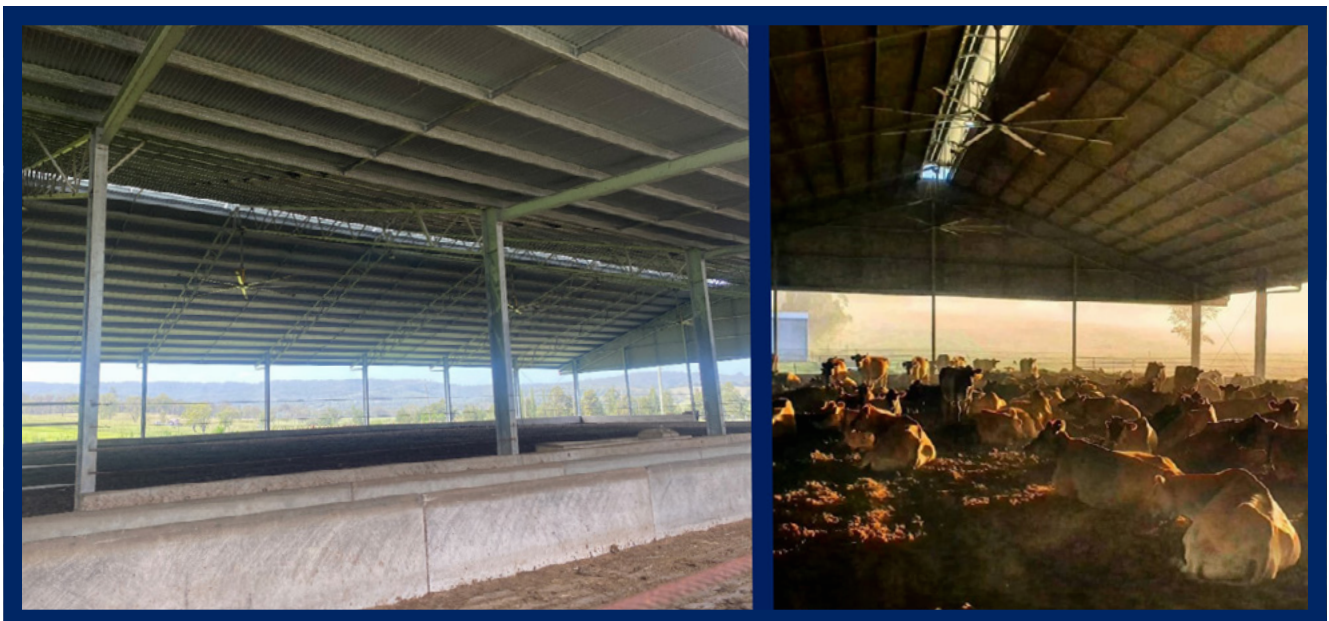
The loafing barn feed bunk and compost bedded pack

To do this, the Williams's invested in an **all-weather loafing barn**. Before commencement of construction, David and Peter visited other barns for design ideas. Settling on a “stock standard” barn, they were able to reduce costs by doing their own land levelling and concreting the feed pad area. Contractors then erected the barn and an electrical system for lighting and fans. With support and co-operation of both council and neighbours, the construction process went smoothly. With a total cost of \$750,000, the loafing barn was completed in 2019 and now provides shelter and the ability to feed the herd during the heat of summer while also protecting the cows and the paddocks from extended wet periods and floods. The compost bedded pack area is 100m x 40m and can fit up to 350 cows with 11 m²/cow,

but the Williams family cap their stocking at 340 cows to optimise animal well-being and keep the compost drier. To maintain the compost, they till the compost every 12 hours when in use and only top up the pack when it appears “sticky”.

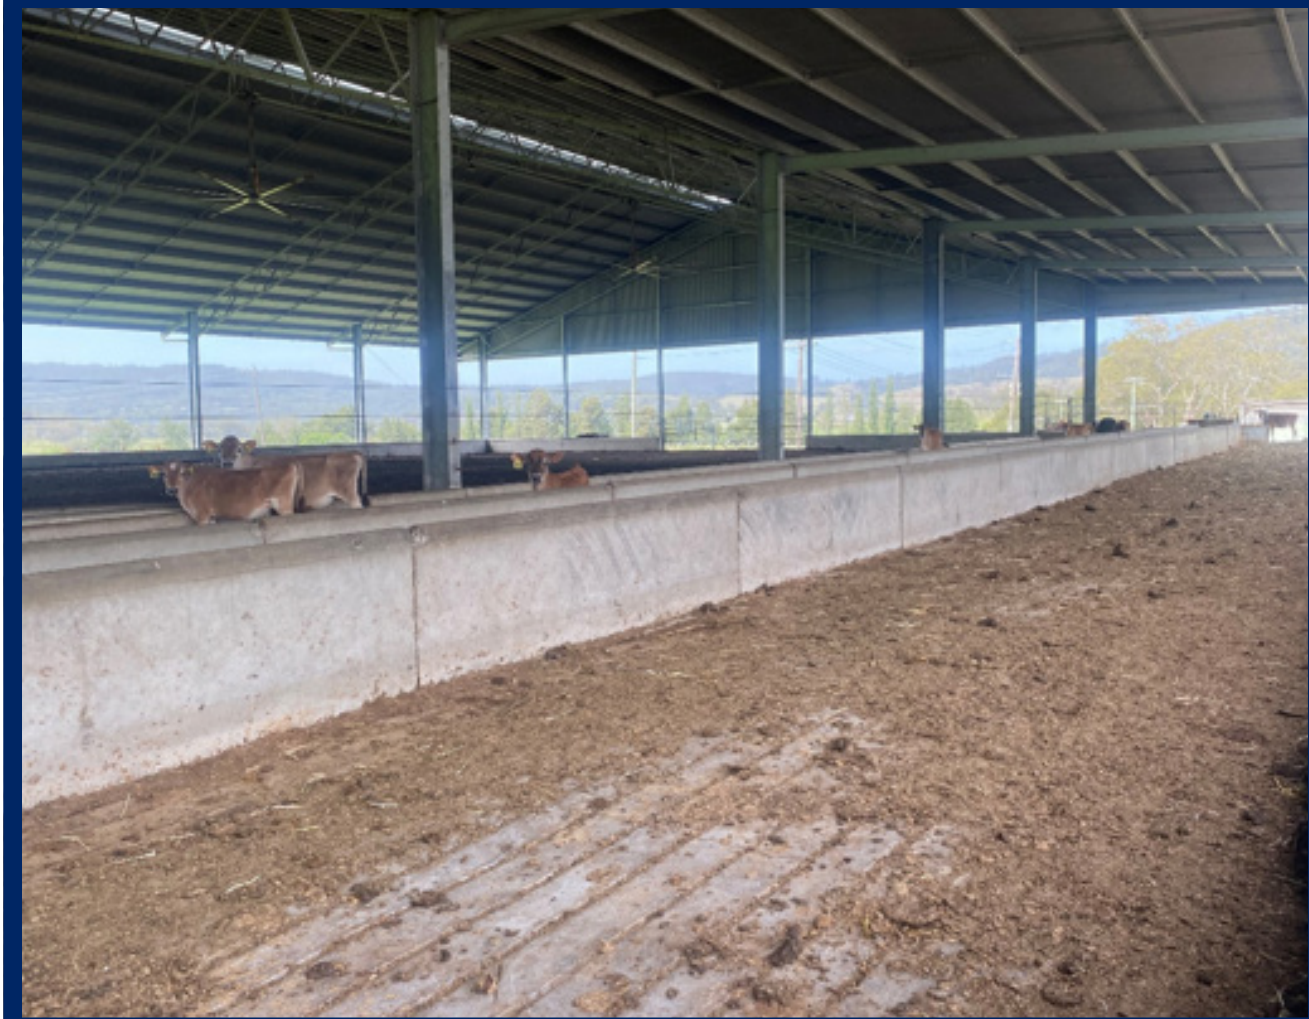
Heifers accessing the laneway of the loafing barn for shade.

The shed is also occasionally used for weaned heifers for shade in the summer and refuge from wet weather. It also provides safety from wild dogs which can be a problem in the area at times.

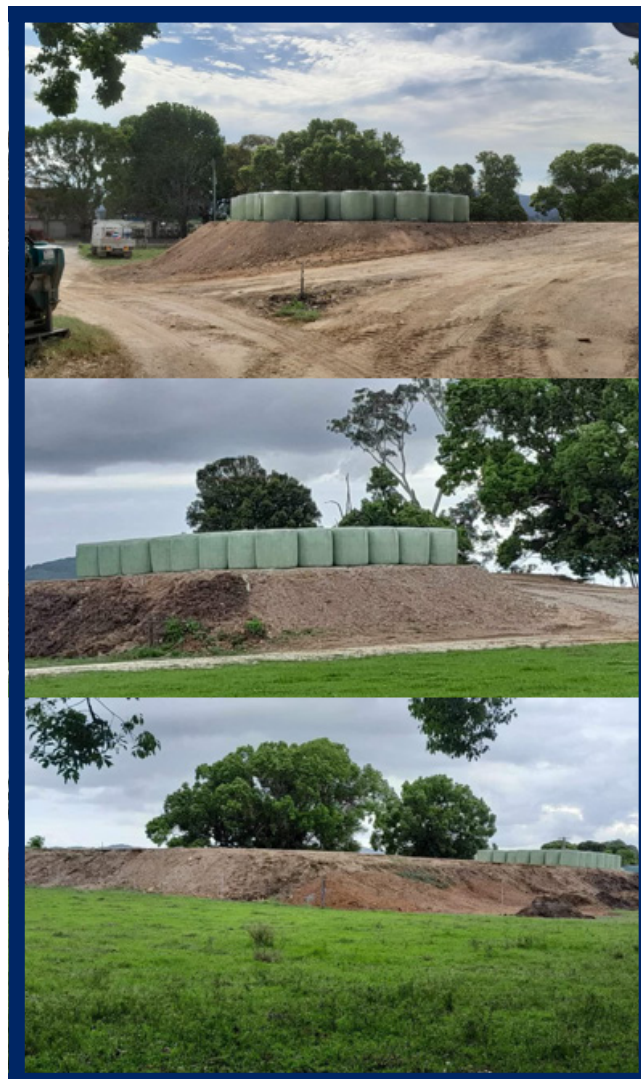
Flood mound from several angles showing the access point for cows and machinery.

and **constructing a large “flood mound”** creating a temporary refuge for animals, machinery, and feed.

The McDonald’s selected an area away from normal heavy “water flow zones” where waters tend to backup. Jen explains that “the flood mound location was selected to allow for easy access of machinery and animals.”

To allow construction to commence, they applied for a “disposal of fill” permit from Tweed Shire Council. Once approved, council and other private contractors began to deliver fill from another regional riverbank reconstruction project. Some of the fill was also used to restore laneways. After 18 months and with over 1000 loads of fill arriving, a 30M x 30M refuge eventually rose to stand 3-4m high from the plain. With Jen spending over 80 hours spreading and leveling, the total cost of the project including fuel, leveling and earthworks was over \$25,000.

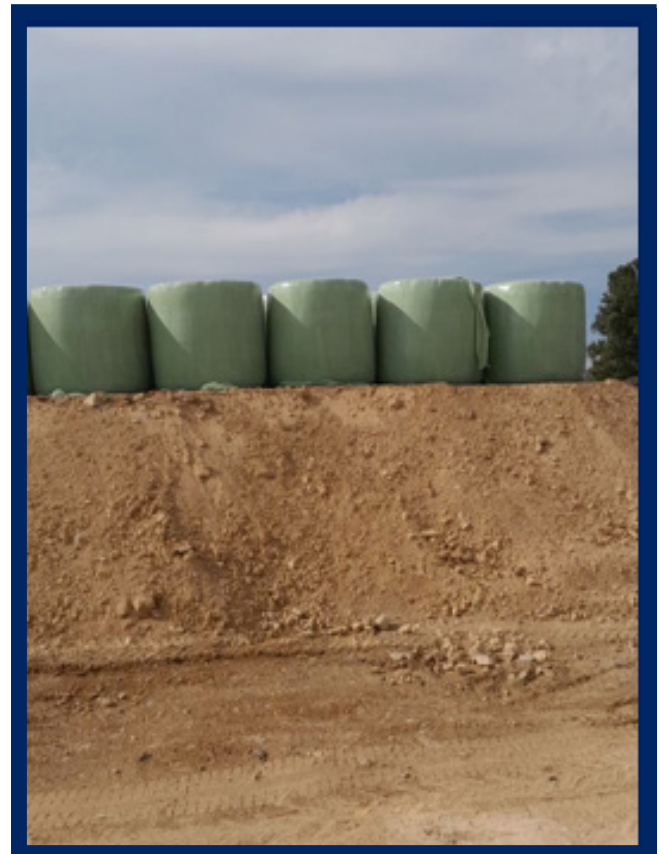
The current angle of the base with plans to widen it with a gentler incline.

The mound is yet to be tested in a major flood and there are some finishing touches still to be applied. There are plans to widen the base with a gentler angle to decrease erosion. An additional \$5,000-\$10,000 needs to be spent on yard fencing that will safely contain all stock groups. Water trough access will be added to each yard. When funds allow, a cover to protect feed and machinery will be added, and Jen would love to add some concrete areas for
