Bank stabilisation works

Wilson River protection and re-snagging

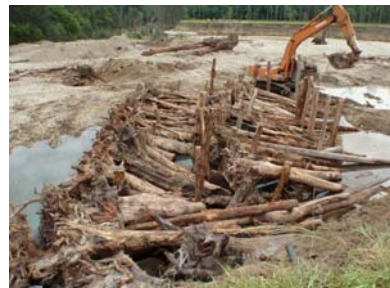
Native hardwood deflector groynes were pinned in place to promote longevity. Photo PMHC

Following recommendations provided in a report on the Wilson River the project partners undertook a remediation project at the site. A suite of initiatives was implemented to reduce erosion and protect the banks, including the construction of 7 large woody debris deflector groynes. Engineered and reinforced with cabling, these groynes were dug into the gravel bed to ensure their longevity. Riparian fencing to control cattle access and extensive revegetation were conducted at the site to provide long-term protection, stability and habitat benefits.

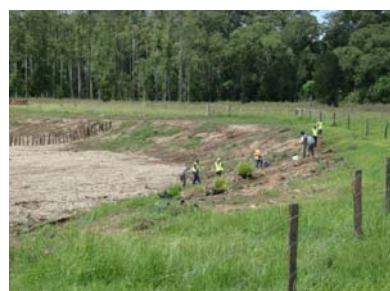
Reshaped banks were planted with endemic riparian species to ensure long-term stability. Photo PMHC
