**REDUCING THE IMPACT OF ROAD CROSSINGS  
ON AQUATIC HABITAT IN COASTAL WATERWAYS –  
HUNTER/CENTRAL RIVERS, NSW**

*REPORT TO THE NEW SOUTH WALES ENVIRONMENTAL TRUST*

**NSW DEPARTMENT OF  
PRIMARY INDUSTRIES**

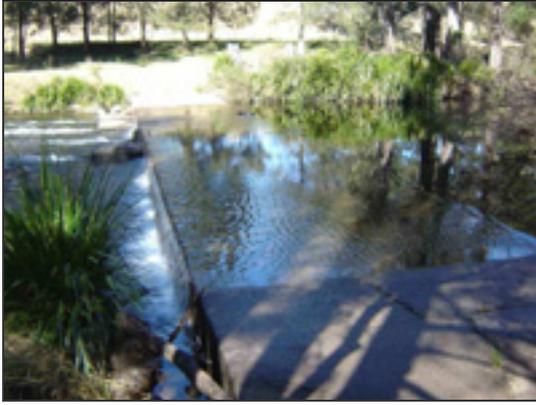
**Photo 1.** Causeway with high invert (headloss) and shallow water depth (Manning River, Lower North Coast subregion)

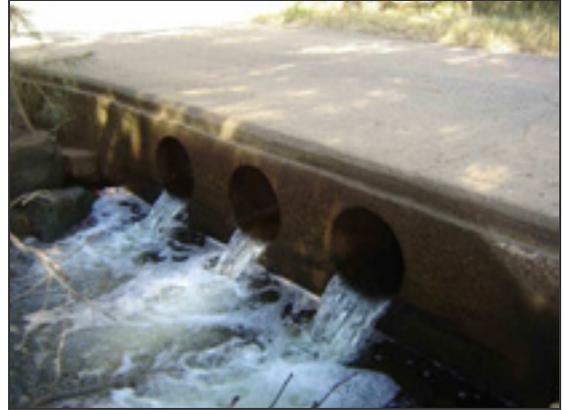
**Photo 2.** Pipe culvert with high invert (headloss) (Black Ck, Hunter subregion)

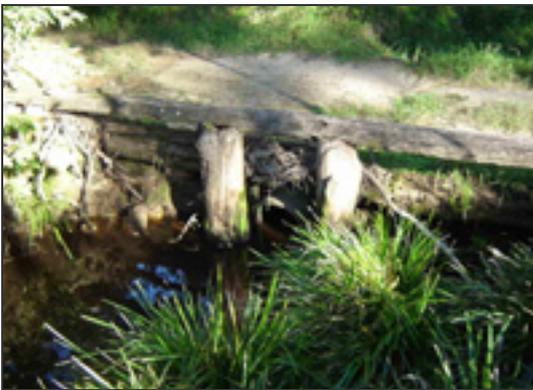
**Photo 3.** Piped crossing with inadequate sized pipes, and high invert (headloss) (Morans Ck, Central Coast subregion)

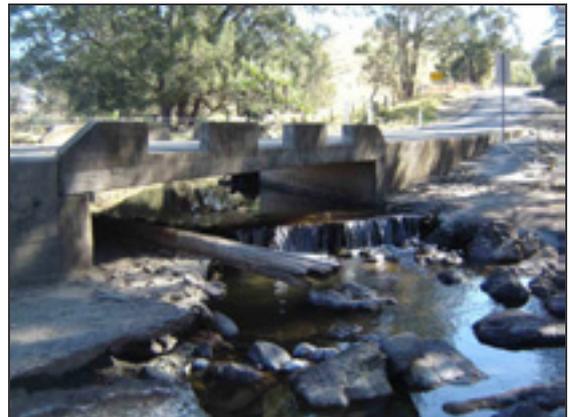
**Photo 4.** Bridge with scouring on downstream side creating headloss (Berrico Ck, Lower North Coast subregion)

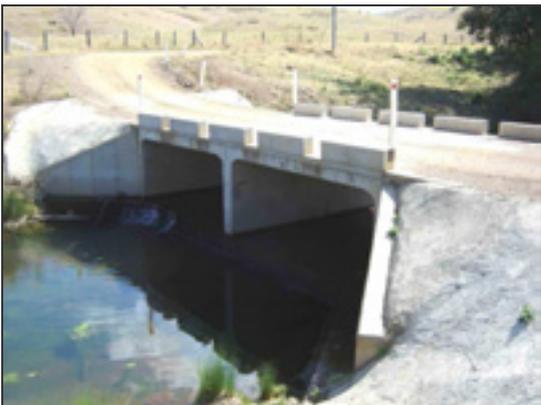
**Photo 5.** Box culvert with high invert (headloss) and shallow water depth (Kerriki Ck, Lower North Coast subregion)

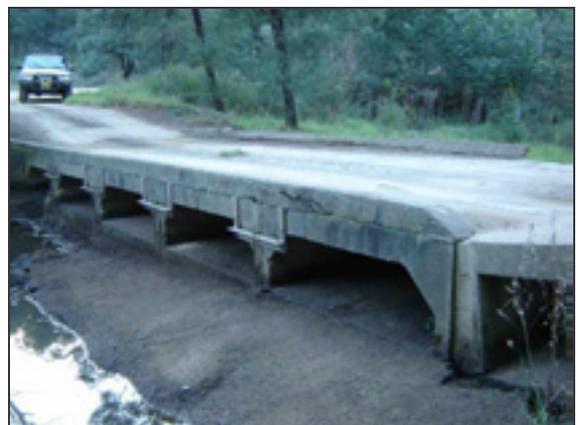
**Photo 6.** Low box culvert with steep apron (Wollombi Ck, Hunter subregion)

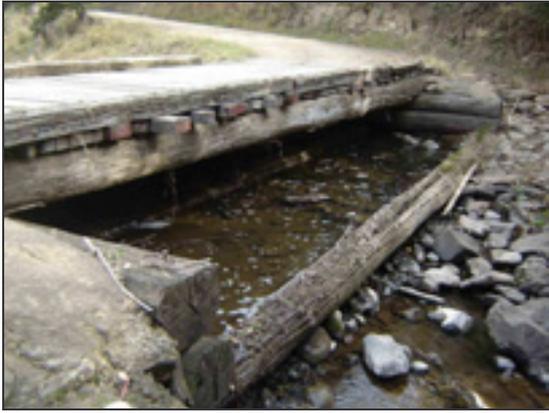
**Photo 7.** Combination structure (causeway used as low bridge base), high invert (headloss) and shallow water depth (Firefly Ck, Lower North Coast subregion)

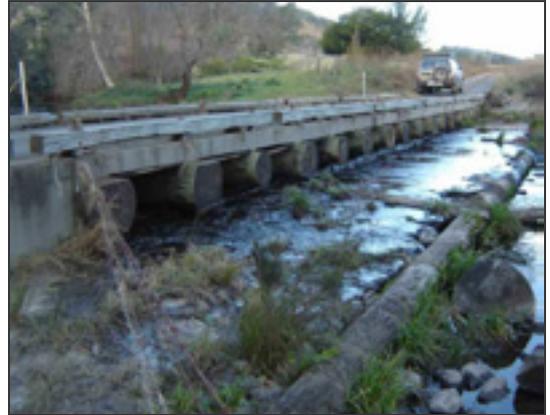
**Photo 8.** Combination structure (causeway used as low bridge base), high invert (headloss) and shallow water depth (Belbora Ck, Lower North Coast subregion)

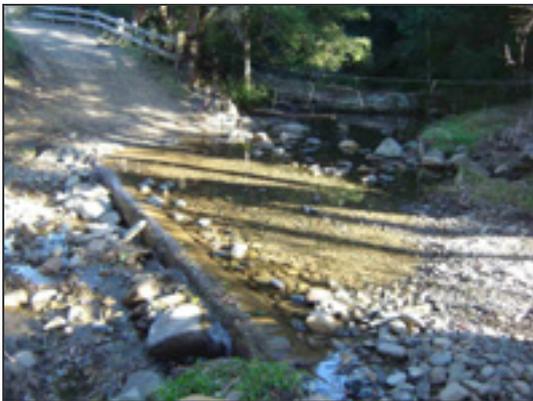
**Photo 9.** Ford with high invert (headloss) (Berrico Ck, Lower North Coast subregion)

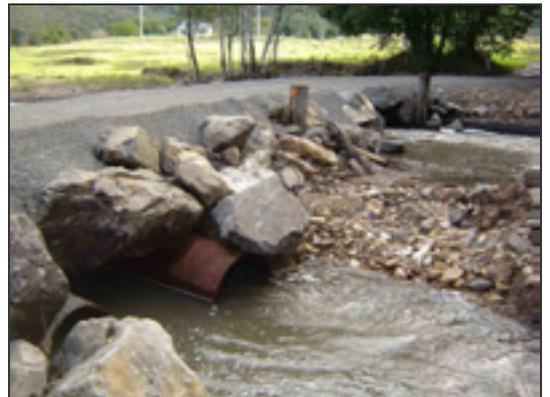
**Photo 10.** Pipe culvert with high water velocities (Crawford R, Hunter subregion)

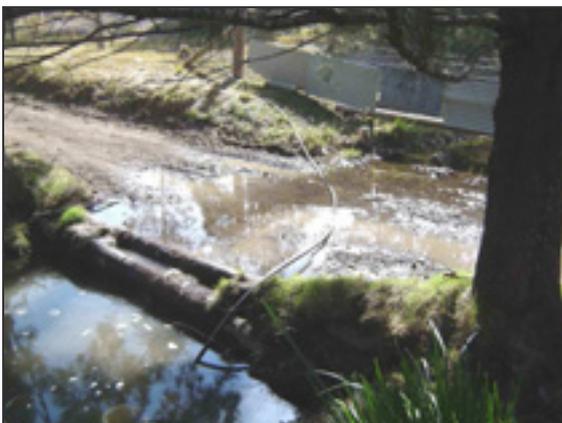
**Photo 11.** Ford crossing with high invert (headloss) and increased sediment loading (Bullen Bullen Ck, Lower North Coast subregion)

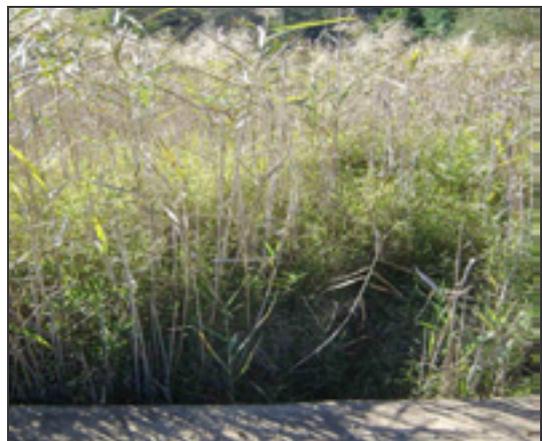
**Photo 12.** Pipe culvert with excessive reed growth (Wollumbi Ck, Hunter subregion)

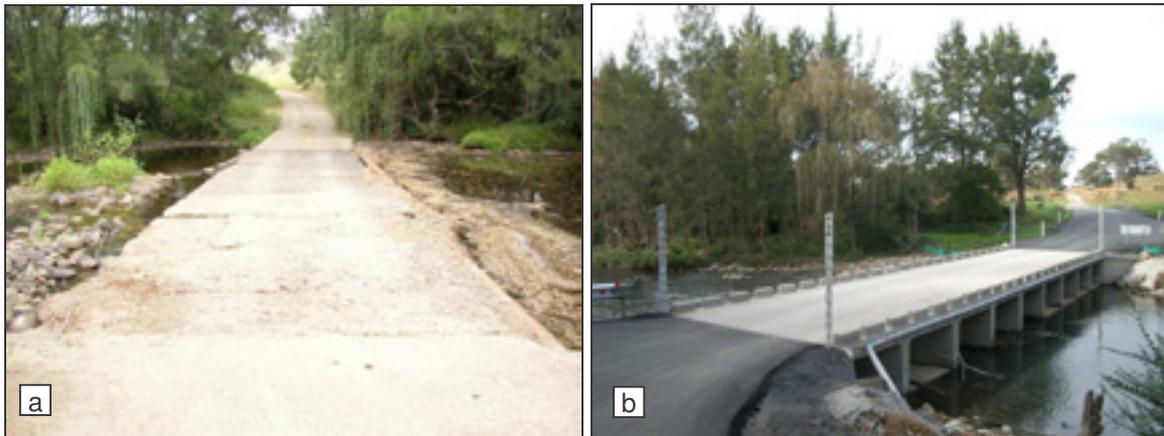
**Figure 4.** Dixons Crossing causeway (Karuah River) prior to (a), and following (b) remediation – note three central low flow cells.

Alternative technologies can also be employed to provide fish passage where traditional methods are unfeasible (e.g. due to funding restrictions). Several causeway crossings on the Gloucester River have been remediated by Gloucester Shire Council through the construction of modified partial width rock ramp fishways adjacent the crossings (Figure 5 and Appendix E). These modified fishways run along the downstream edge of the causeway and have their upstream exit at a low flow point on the causeway structure itself (low flow depression in the causeway capping). This means that fish must still negotiate a shallower section of water across the top of the causeway.

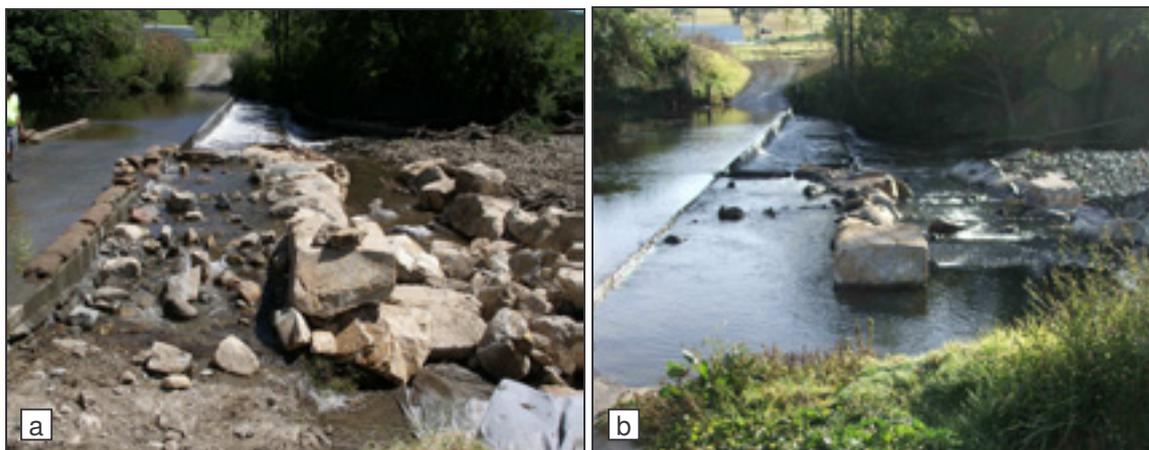
**Figure 5.** Faulkland Road Crossing modified partial width rock ramp fishway (a) during construction, (b) completed work.

In the Gloucester Shire Council LGA (Hunter/Central Rivers CMA), modified versions of the partial width rock ramp fishway have been employed at causeway road crossings, with the upstream exit of the fishway meeting the downstream edge of the road cap at a depression in the road surface. This modified fishway provides a means for fish to reach the road surface, but fish passage remains limited to rising flows when water depth across the road surface is increased.
