The Assessment & Modification of Barriers to Fish Passage in the Namoi Catchment

NSW Department of Primary Industries (2006). *The Assessment and Modification of Barriers to Fish Passage in the Namoi Catchment*. Report to the Namoi Catchment Management Authority. Department of Primary Industries (Aquatic Habitat Rehabilitation Unit), Tamworth.

As a result of funding from the Namoi Catchment Management Authority, NSW Department of Primary Industries undertook a project entitled *“The Assessment and Modification of Barriers to Fish Passage in the Namoi Catchment”*.

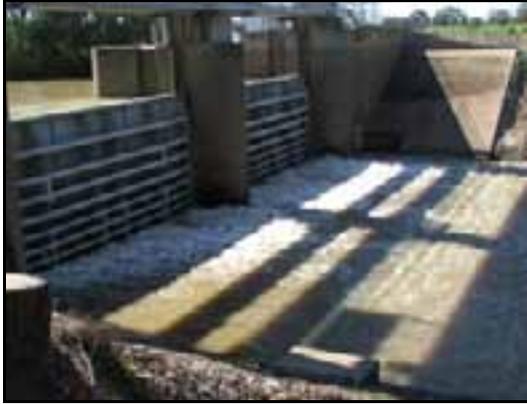
Plate 1: Gunidgera Weir, Namoi River, Narrabri LGA (Code: 419/970000/B0104).

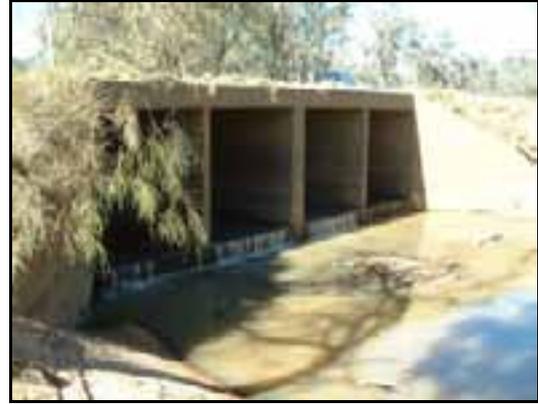
Plate 2: Box culvert, Gunidgera Creek Narrabri LGA (Code: UPN6).

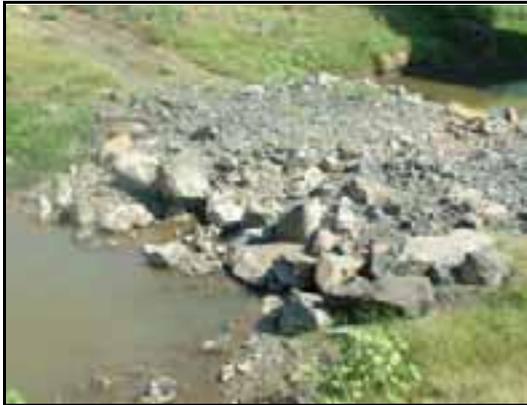
Plate 3: Causeway, Mooki River, Gunnedah LGA (Code: MIA).

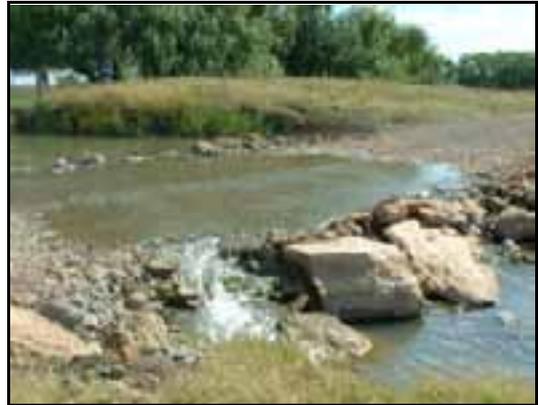
Plate 4: Ford, Mooki River, Tamworth LGA (Code: PCA).

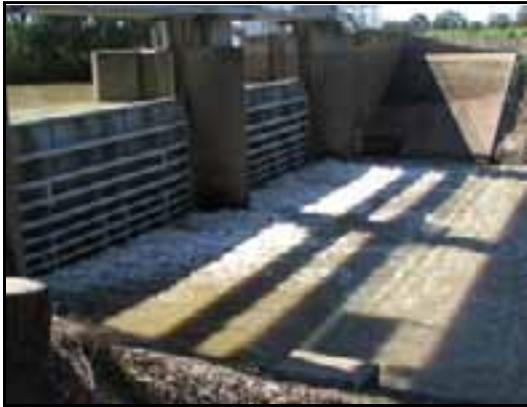
Plate 7: Gunidgera Weir (419/970000/B0104)

Gunidgera Weir (Plate 7) is located in the lower end of the catchment on the Namoi River, approximately 3km north of Wee Waa. The weir is approximately 5m in height and 50m across the length of the crest. Gunidgera Weir is a regulating structure that acts as a barrier to fish passage throughout the majority of flow conditions, except during high flow events. When flows are low however, the weir restricts fish passage due to excessive headloss and increased turbulence across the face of the structure. There is currently an ineffective fishway at this site.

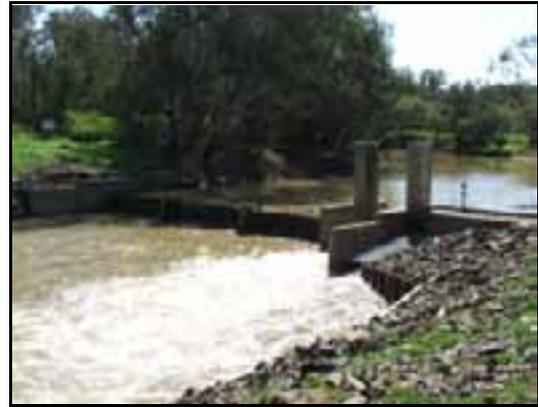
Plate 8: Weeta Weir (419/970000/B0106)

Weeta Weir (Plate 8) is located in the lower end of the catchment on the Namoi River, approximately 40km southwest of Wee Waa. The weir is approximately 2m in height and 45m across the length of the crest. Weeta Weir is a regulating structure that currently has an ineffective submerged orifice fishway. The weir acts as a barrier to fish passage during low flows due to excessive headloss and increased turbulence across the face of the structure.

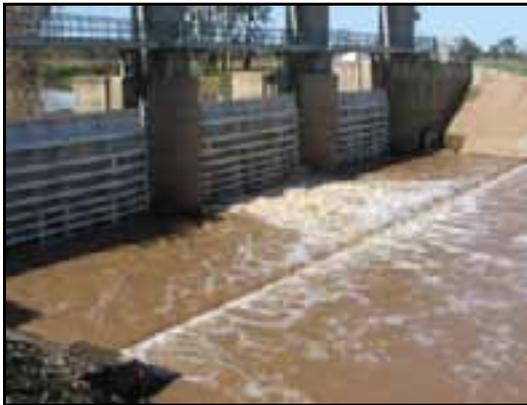
Mollee Weir (Plate 9) is situated on the Namoi River in the lower end of the catchment and is located approximately 20km west of Narrabri. The weir is approximately 5m in height and 60m across the length of the crest. Mollee Weir is a regulating structure that acts as a barrier to fish passage throughout the year except during high flow conditions. When flows are less than this, the weir restricts fish passage due to excessive headloss and increased turbulence across the face of the structure. There is currently an ineffective submerged orifice fishway associated with this structure.

Plate 9: Mollee Weir (419/970000/B0103)

Recommended management options at this site include the installation of a Deelder fishlock, replacing the existing submerged orifice fishway. Management of the vertical lift gates is also essential at this site to limit the potential effects on fish larvae and the natural flow regime. Through implementing these management strategies approximately 220km of waterway will be reinstated.

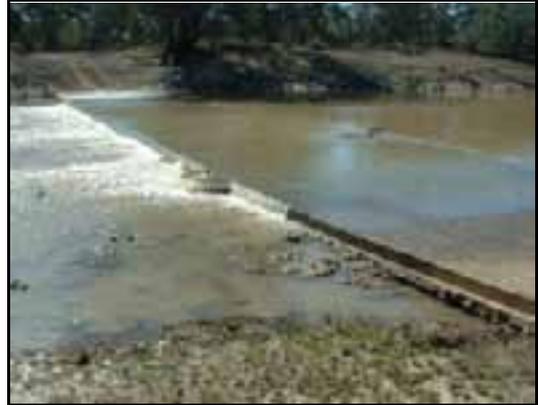
Plate 10: Stoney Crossing (BE21)

The Stoney Crossing (Plate 10) Causeway is located in the lower end of the catchment on the Namoi River, near the town of Pilliga. The structure is approximately 0.5m high and 30m in length and is built directly on the bed, slightly above the natural channel level. This construction has resulted in the causeway acting as a barrier to fish passage due to the excessive headloss of approximately 0.5m, as well as the associated increase in velocities over the crossing.

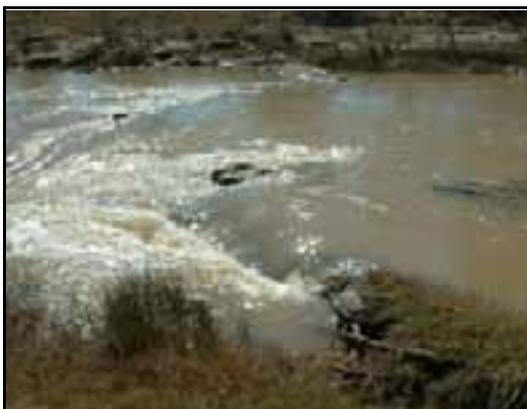
Plate 11: Bugilbone water gauge (WGS4)

The Bugilbone gauging structure (Plate 11) is situated on the Namoi River in the lower end of the catchment. The structure is constructed of both natural bedrock and concrete, and is approximately 15m in length across the channel. The concrete section of this structure is approximately 0.5m high and 1.5m in length. However, it is located directly in the low-flow channel of the system, creating a barrier to fish passage due to excessive headloss and increased turbulence, especially in the low-flow channel of the waterway.

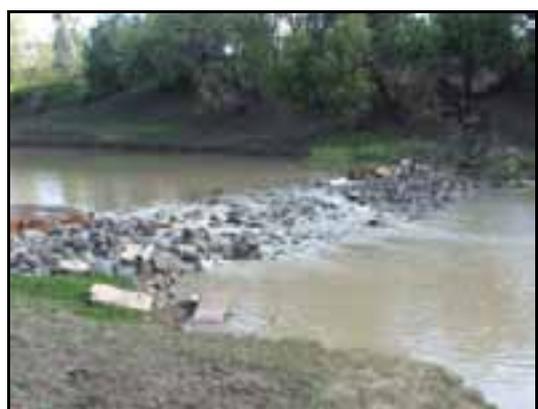
Plate 12: Walgett Weir (419/970000/B0068)

The Walgett Shire Council Weir (Plate 12) is located in the lower end of the Namoi catchment on the Namoi River, just within the town limits of Walgett. The weir is located 4km upstream of the Namoi River and Barwon River junction, and is approximately 1.8m in height and 30m across the length of the crest. Walgett Shire Council Weir is a fixed crest structure with no regulating infrastructure associated with it and is used for town water supply. The weir acts as a barrier to fish passage during flows less than approximately 1500 ML/day, with flows below this resulting in excessive headloss, as well as increased turbulence and velocity across the face of the structure.

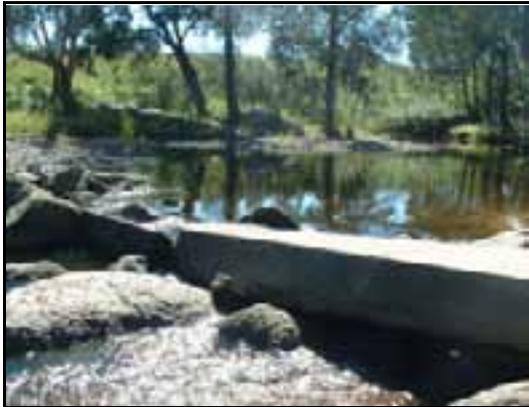
Plate 13: Macdonald River Ford (UNRB)

This ford crossing (Plate 13) occurs on the Macdonald River in the upper section of the Namoi catchment, near the town of Kingstown. The crossing is approximately 15m long and uses natural river rock as its base, however the structure also incorporates concrete blocks on the downstream side. This aspect of the crossing has resulted in excessive headloss of approximately 0.3m, impacting on the passage of fish at this site.

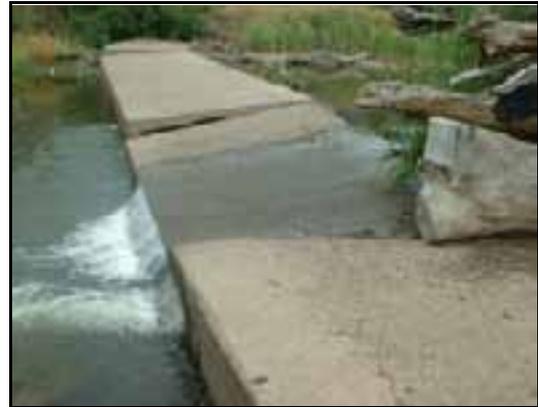
The Jewry Street Causeway (Plate 14) crossing is located on the Peel River within the town limits of Tamworth. The disused crossing is located approximately 50km upstream of the junction of the Namoi and Peel Rivers and is approximately 1.2m in height and 10m across the length of the crest. The causeway acts as a barrier to fish passage during flows less than approximately 1200 ML/day due to excessive headloss and increased turbulence across the face of the structure.

Plate 14: Jewry Street Causeway (LPRA)

The complete removal of the structure would provide the greatest benefit to the aquatic environment of the Peel River and provide significant improvements in the availability of aquatic and riparian habitat. When investigating this recommendation it is essential to take into account the potential erosion impacts that may jeopardise the structural integrity of the upstream bridge. This may result in the additional construction of a bed control structure at the site with appropriate fish passage infrastructure. Addressing the fish passage issue at this site would complement recommended fish passage works at the upstream concrete capped pipeline, significantly benefiting the aquatic environment by reconnecting over 230km of waterway.

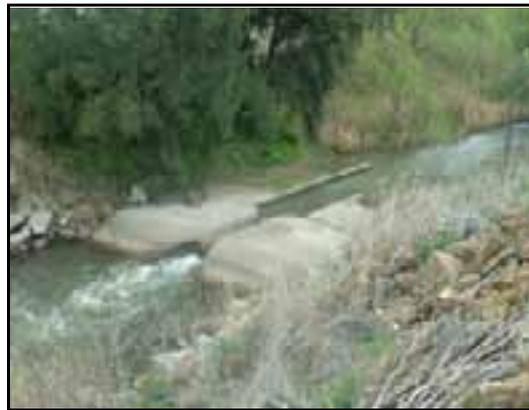
The Peel River water gauge structure (Plate 20) is located on the Peel River in the middle section of the Namoi Catchment. The structure is situated in the eastern suburb of Calala, approximately 200m upstream of the Tamworth Water Treatment Station. The water gauge is a fixed weir structure that is composed of a vertical flume "San Dimas Weir", and is approximately 1.2m in height and 10m across the length of the crest. The structure acts as a barrier to fish passage during flows less than approximately 350 ML/day, restricting fish passage due to excessive headloss, as well as increased velocity and turbulence through the vertical flume. There is also a temporary sandbag weir that occurs downstream to secure town water supplies during periods of low flow.

Plate 20: Peel River water gauge (WGS13)

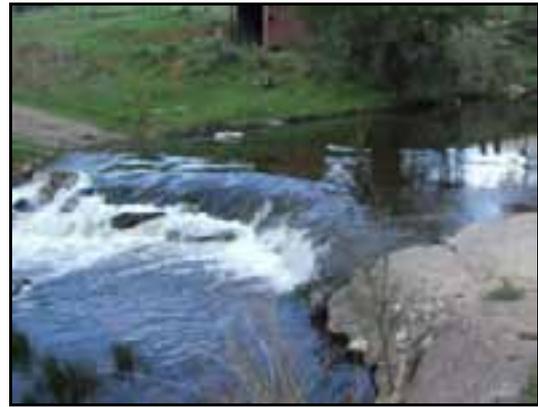
This private road crossing (Plate 24) is located on Mulla Creek, a major tributary of the Cockburn River, and is situated in the middle of the catchment near the small town of Limbri. The crossing is approximately 1m in height and 18m long and is constructed of concrete, with the downstream side of the causeway experiencing erosion effects from high flows resulting in a plunge pool and bank erosion. The presence of the instream crossing significantly impacts on fish passage due to excessive headloss, as well as an associated increase in turbulence.

Plate 24: Mulla Creek Causeway (CR24)

It is recommended that the causeway be replaced by a train carriage bridge design. This option recycles old train carriages, using them as road crossings by removing the sides to allow for effective water flow. Complementing this remediation action, it is also suggested that bank stabilisation efforts and riparian management also be considered at this site. The modification of the causeway has the potential to reinstate approximately 12km of aquatic and riparian habitat.

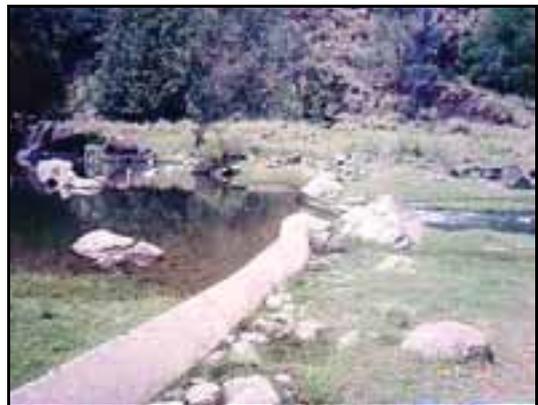
Plate 30: Manilla River gauge (WGS6)

The Manilla River gauging structure (Plate 30) is located immediately downstream of Split Rock Dam between the towns of Manilla and Barraba in the Tamworth Regional LGA. The fixed crest structure is constructed of concrete and is approximately 0.5m high and 30m long. The structure acts as a barrier to fish passage due to excessive headloss, as well as increased turbulence and velocity across the face of the structure.

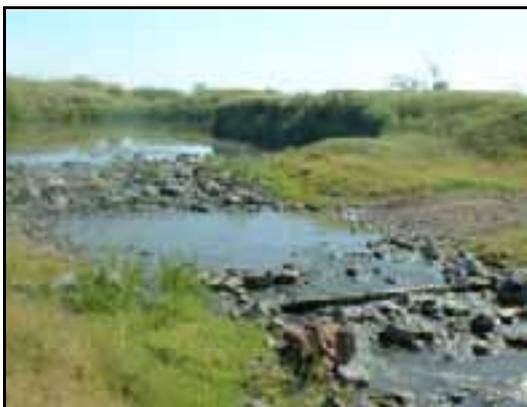
Plate 31: Mooki River Ford (MI10)

This private road crossing (Plate 31) is located on the Mooki River and is situated in the lower section of the catchment near the town of Breeza. The crossing is approximately 0.2m high and 5m long and uses natural river rock as its base, however the structure also incorporates the use of large rocks on both the upstream and downstream side of the crossing to pool water upstream. This aspect of the crossing has resulted in excessive headloss of approximately 0.2m, impacting on fish passage at this site.

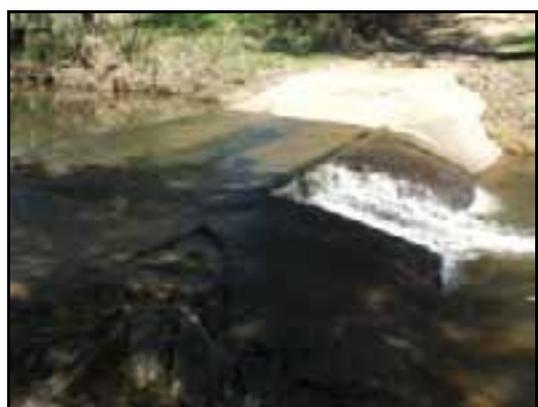
Plate 32: Ingalba Flat Causeway (CR56)

The concrete causeway (Plate 32) is located on Swamp Oak Creek, a major tributary of the Cockburn River, in the upper section of the catchment near the town of Weabonga. The crossing is approximately 1m in height and 12m long, with no associated low-flow infrastructure and the downstream side of the causeway experiencing erosion effects from high flows. The presence of the instream crossing significantly impacts on fish passage due to excessive headloss, as well as an associated increase in turbulence across the face of the structure.

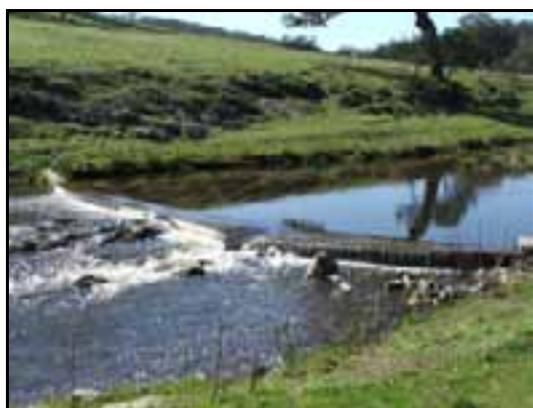
Plate 33: Swamp Oak Creek water gauge (WGS7)

This water gauge (Plate 33) is located on Swamp Oak Creek, a major tributary of the Cockburn River, in the middle section of the Namoi Catchment near the town of Limbri. The instream barrier is a fixed v-notch weir structure that is constructed of concrete and is approximately 0.5m in height and 22m across the length of the crest. The structure acts as a barrier to fish passage during low flows, restricting fish passage due to excessive headloss, as well as increased velocity and turbulence through the vertical flume.

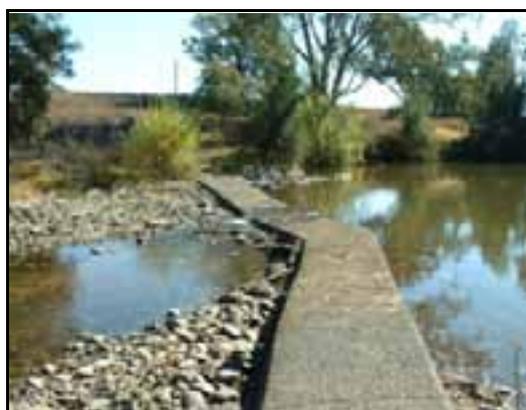
The Namoi River water gauging station (Plate 34) is located on the Namoi River on the "North Cuerindi" property near the town of Manilla. The gauge is a fixed weir structure that is constructed of concrete, and is approximately 0.3m in height and 10m across the length of the crest. The structure acts as a barrier to fish passage during low flows, restricting fish passage due to excessive headloss, as well as increased velocity and turbulence across the face of the gauge.

Plate 34: Namoi River water gauge (WGS1)

The complete removal of the structure is the recommended remediation option for this site. When investigating this option it is important to consider alternative gauging technology that may replace the current gauge. If alternative stream gauging innovations cannot be pursued, the structure will have to remain in place and fishway options further investigated, with a partial width rock ramp being a feasible option for this site. By implementing the suggested strategies at this site over 70km of waterway would be reinstated on the main stem of the Namoi River.
