REDUCING THE IMPACT OF WEIRS ON AQUATIC HABITAT

NSW DETAILED WEIR REVIEW

LOWER MURRAY DARLING CMA REGION

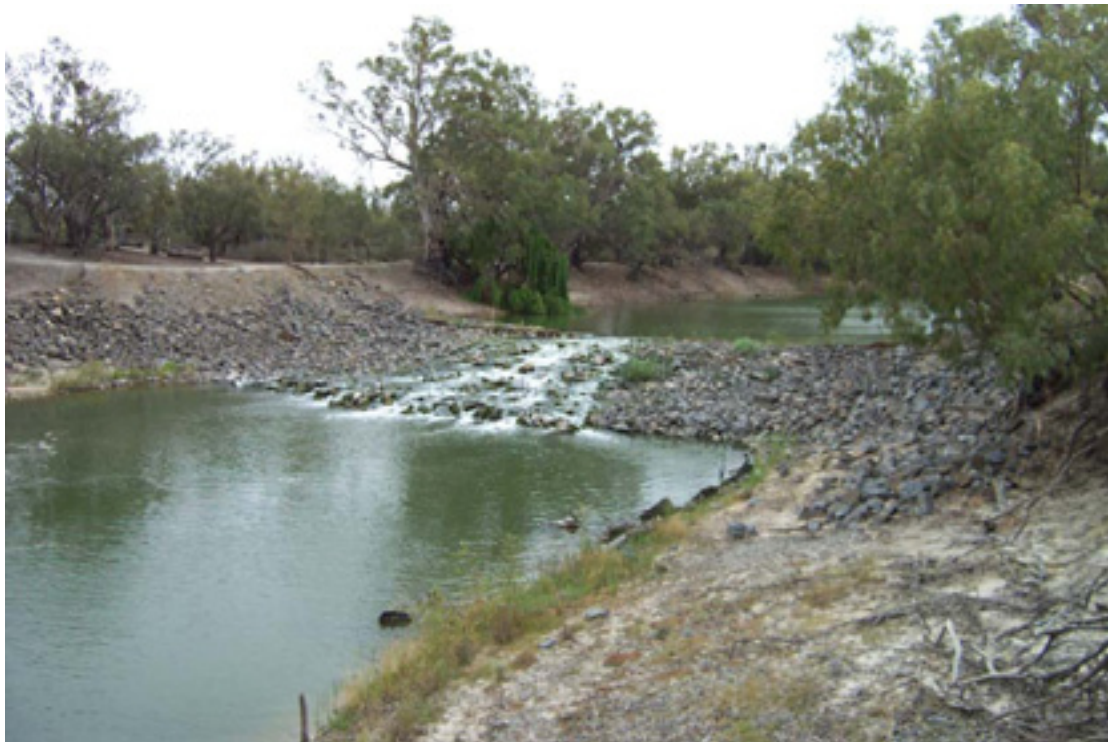
Figure 1. Weir 32 looking upstream, Darling River.

Weir 32 is on the mainstem Darling River was constructed in 1958, is owned and managed by State Water, and is included in the portfolio of structures associated within the Menindee Lakes Storages. The weir is located approximately 39km downstream of Menindee Main Weir on the Darling River and consists of extensive sheet piling and rock fill with a drop-board system that has failed and is now filled with rock. Weir 32 provides a pumping pool for Australian Inland (providers of Broken Hill and Menindee town water supplies) and other permanent planting crops in the Menindee area. The capacity of the weir pool is approximately 3,700ML. Weir 32

Due to the nature of Weir 32 and the information available, it can be determined that passage for a range of species and size classes of fish would be feasible at discharges above 4,000ML/day. At 4,000ML/day the weir has not reached drown-out point (occurring at 7,000ML/day), however flow condition at these volumes is predicted to result in velocity and depth conditions that would permit the passage of a wide range of fish species and size classes.

The removal of Weir 32 is likely to impact upon the security of the water extraction that occurs in the weir pool. The weir pool is relatively short in length, and the proposal would require the relocation of off-take and irrigation infrastructure to the weir pool of Menindee Main Weir (Lake Wetherill). The Broken Hill water supply can alternatively be taken from Copi Hollow (Menindee Lakes system), however this is currently installed as an auxiliary alternative during drought conditions. The security of water in Copi Hollow may be higher than that of the Weir 32 pool, although water quality issues have been encountered during drought conditions and low/empty storage status of Menindee Lakes. The removal of Weir 32 would also cause unmeasured impacts on the indigenous community that currently utilise the facility.

This would decrease the required discharge levels for fish passage and coincide with necessary repairs and refurbishment work at the site. A reduction in the capital costs and engineering levels for a proposed fishway could also occur if the weir was modified to achieve a lower crest height.

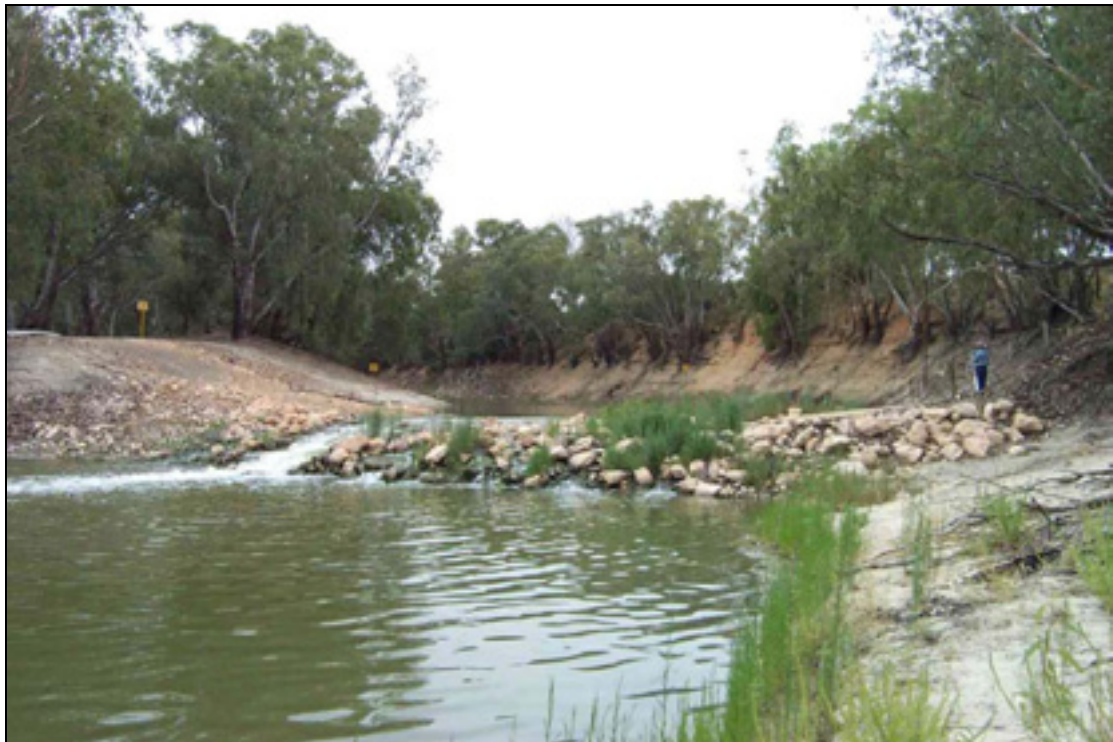
Figure 2. Pooncarie Weir looking upstream, Darling River.

The original construction of Pooncarie Weir in 1969 involved a central concrete wall, iron and limestone placed between rows of reinforced fabric on the downstream face and a grouted rock apron over downstream rock protection. A 300mm diameter pipe through the embankment is no longer evident despite the pipe being included as a condition on the weir license to ensure water passes the structure during low flows. WSC has conducted regular works at the weir, some as recently as January and December 2003. This work involved placement of large quantities of rock material onto the structure.

In 1999 WSC commissioned SMEC Pty Ltd to report on the condition of the weir structure for consideration in future management options. According to the report, the original design of the structure has the following problems:

- Depth of cut-off wall inadequate;
- Location of weir is hydraulically unsound (immediately downstream of a river-bend);
- Re-enforcement fabric is susceptible to rusting;
- The clay fill on the upstream side of the weir requires protection by way of rock pitching placed on a geotextile membrane;

The report determined that the weir has significant structural problems and is beyond repair (SMEC 1999). A short-term solution was recommended that involved the use of rock material.

The construction of a fishway on the existing structure would not be feasible without significant structural repairs being conducted. The regular maintenance required on the weir is testimony to the expiration of the structure. In addition, significant capital investment to provide a fishway would not be economically feasible. Other options that address the issue strategically and consider the imminent issue of the suitability of the structure are deemed more appropriate.

It is acknowledged, however, that Option 3 will cause significant concern to stakeholder groups who historically perceive Pooncarie Weir as essential for maintaining water supply. As previously outlined the security and serviceability of the weir is not sound and a sustainable alternative that meets the ecological, social and economic requirements of stakeholders needs to be employed.

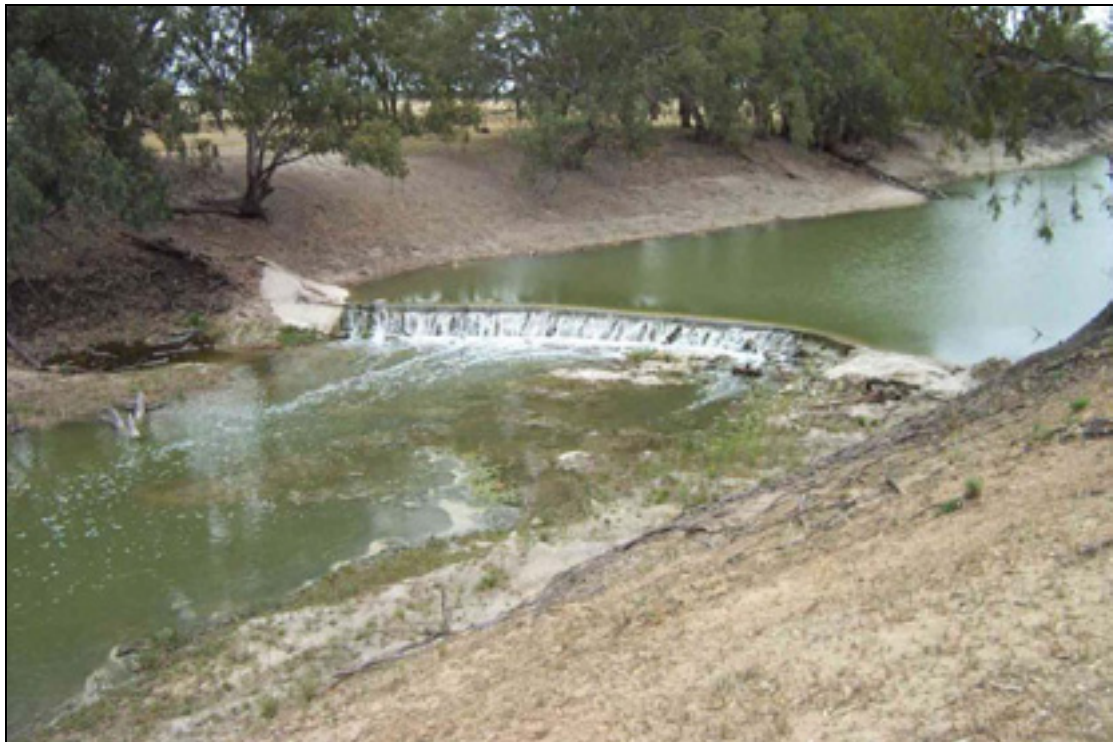
Figure 3. Burtundy Weir looking upstream, Darling River.

The structure consists of a concrete wall with some rock fill on the downstream side. The concrete wall extends into the adjacent banks and has been subject to repair work in 2002. Leaks exist in the side aprons of the weir indicating some degree of structural failure.

The removal of Burtundy Weir would compromise the storage capacity and water supply for existing users. This would not be seen as a suitable option as it would result in significant economic and social impacts. Modification of the weir to lower its vertical height (and therefore reduce the flow volume required to achieve fish passage) would also cause similar impacts. The vertical height and storage capacity of the weir is relatively low.
