CASE STUDY – BRINGING BACK THE FISH: NORTHERN RIVERS

GRADYS CREEK ROAD, GRADYS CREEK, KYOGLE

[An extract from: NSW DPI (2005) *Reducing the impact of road crossing on aquatic habitat in coastal waterways – Northern Rivers, NSW*, Report to the Northern Rivers Catchment Management Authority, NSW DPI, Wollongbar, NSW]

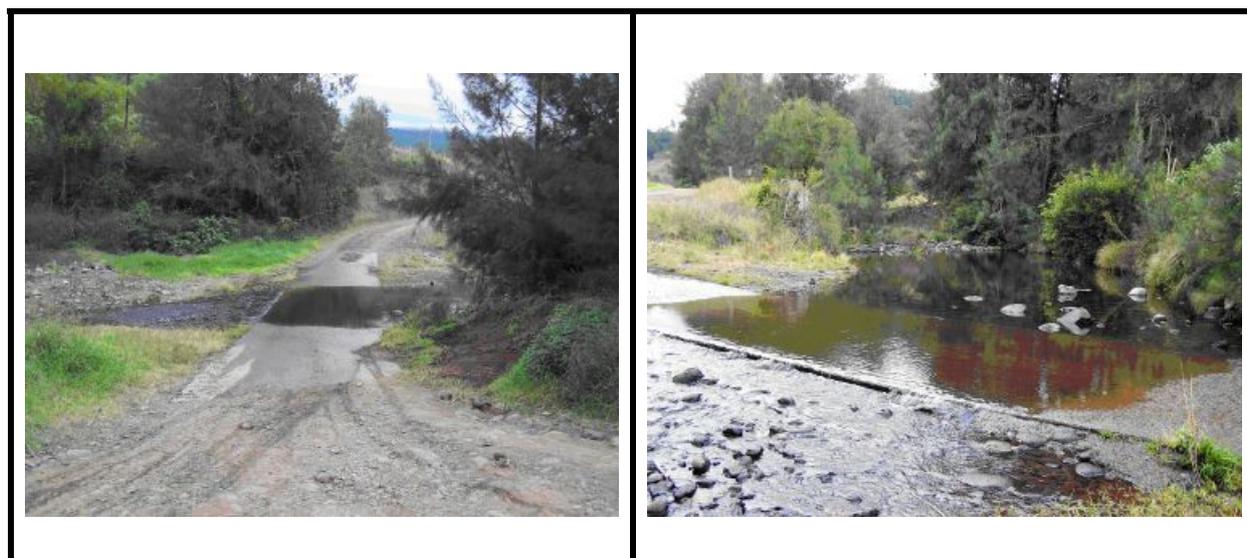
Gradys Creek Road crosses Gradys Creek in the Kyogle Shire local government area. The causeway measured 24 metres in length (from bank to bank) and 4 metres wide, conveying water over the structure in a shallow laminar flow. The crossing prevented fish passage in the upstream direction during low-flow conditions due to shallow flow depths.

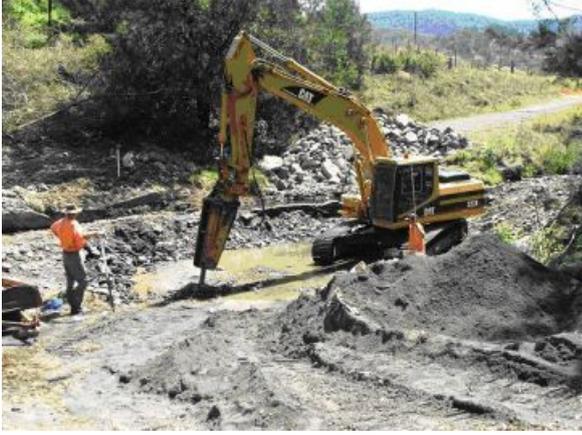
a)

A coffer dam was formed on the upstream side of the causeway to divert water flow through a diversion channel running along the creek's right bank (**Plate a-b**).

The diversion channel was rock protected and underlaid with geotextile fabric to limit bed erosion. The existing causeway, including approaches, was removed using an excavator fitted with a rock hammer (**Plate a**).

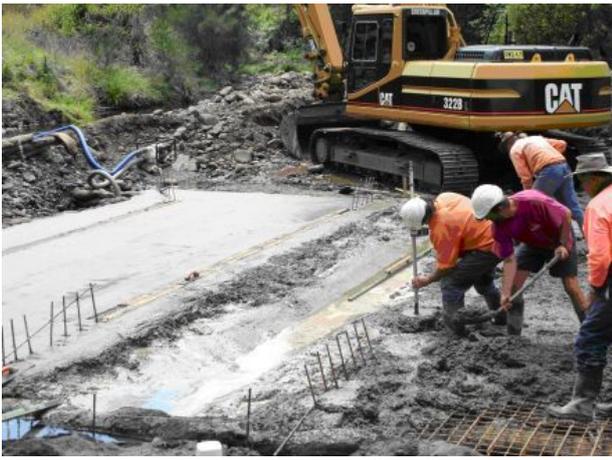
c)

Footings were prepared for the new crossing prior to the insertion of the box culverts, with the middle low-flow channel being formed directly into the concrete slab (**Plate c-d**).

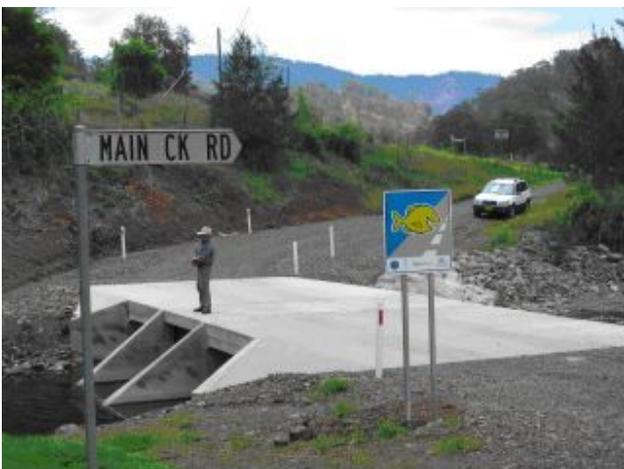
e)

The coffer dam and diversion channel were subsequently removed, allowing stream flow to return through the structure. Approaches for the new road were then graded (**Plate e**), with rock protection being placed on disturbed banks to limit erosion and sedimentation.

were completed over a 6 week period, with Fish-Friendly Road Crossing sings being inserted at the site shortly thereafter (**Plate e-f**).

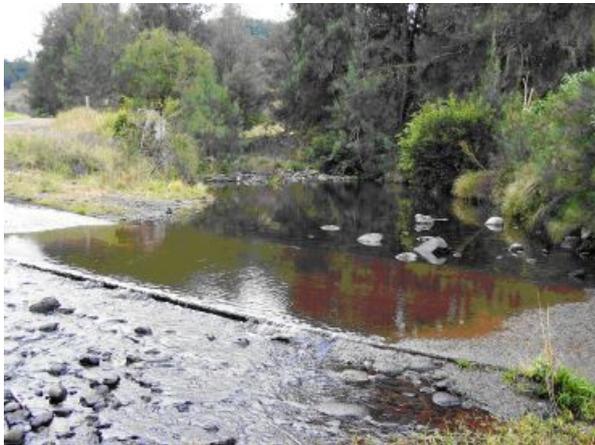
g)

- Improved stream connectivity for native fish species (Plate g-h);
- Education of Kyogle Shire Council of best-practice techniques for the construction of fish-friendly road crossings; and
- Improved safety and reliability of the crossing during minor river rises for ten property owners.
