APPENDIX 6. WETLAND MANAGEMENT STORIES

RICK & JOANNE HISKINS

R & J Hiskins Wetland Management Plan

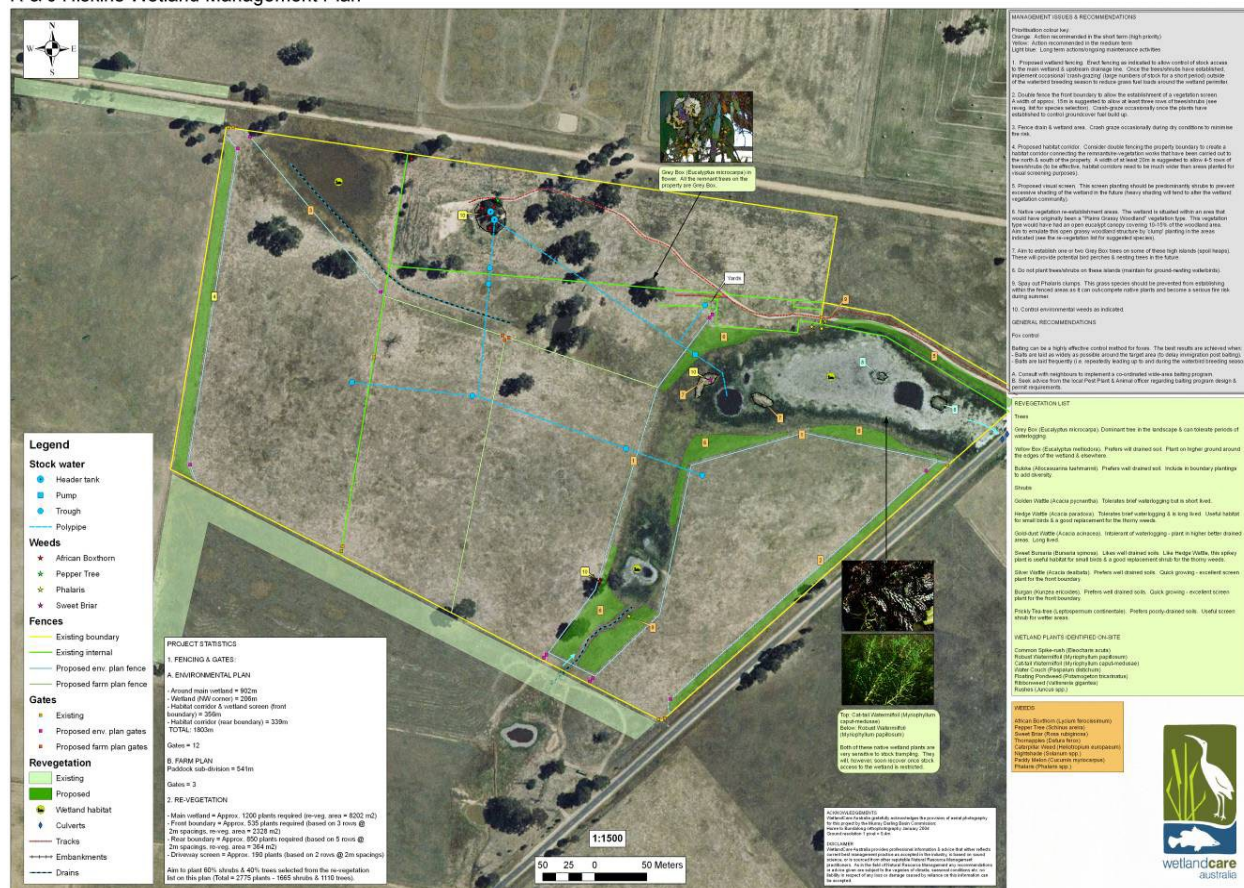
Map 5: Rick & Joanne Hiskins engaged WetlandCare Australia to develop a wetland management plan for their property near Rutherglen.

The works identified on the plan are being implemented in stages over a period of about 18 months and, as of July 2007, are more than half completed. It is always good practice to integrate any environmental rehabilitation plans with the overall vision for the property and this was particularly true in this case as the property is only 27.5 hectares in size. Consequently, the wetland rehabilitation plan involved a review of the entire property, and included consideration of the present and future paddock layout, stock watering points and other desired revegetation works.

The fencing layout was designed to provide a good buffer width around the wetland. As the wetland would have originally been set in an open grassy woodland landscape, the wide buffer allows for some revegetation of native trees and shrubs while maintaining the nutrient and sediment trapping qualities of the grasses. The wide buffers were also considered particularly important as the surrounding paddocks will on occasions be ploughed and re-sown.

- Dense stands of trees will be avoided so that shading of the wetland is minimised (to maintain the current diversity of wetland plants). Particularly wide tree spacing is proposed for the northern side of the wetland for the same reason
- In contrast, the plantings along the boundary facing the road will be tightly packed to form an effective visual screen to minimise the disturbance to waterbirds.

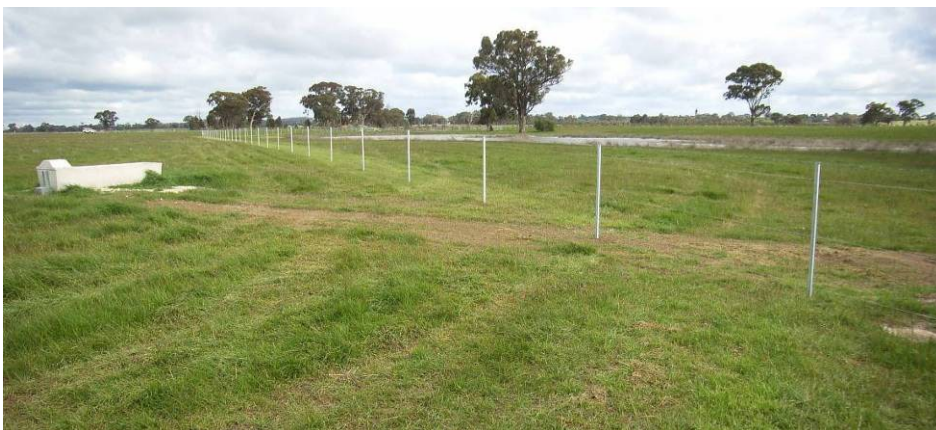
Image 16: Troughs installed and fence under construction, July 2007.

A system of concrete troughs fed from the available town water supply was installed to remove the dependence on the dams within the wetland.
