REDUCING THE IMPACT OF WEIRS ON AQUATIC HABITAT

NSW DETAILED WEIR REVIEW

SOUTHERN RIVERS CMA REGION

5. Southern Rivers CMA - Detailed Weir Review Sites

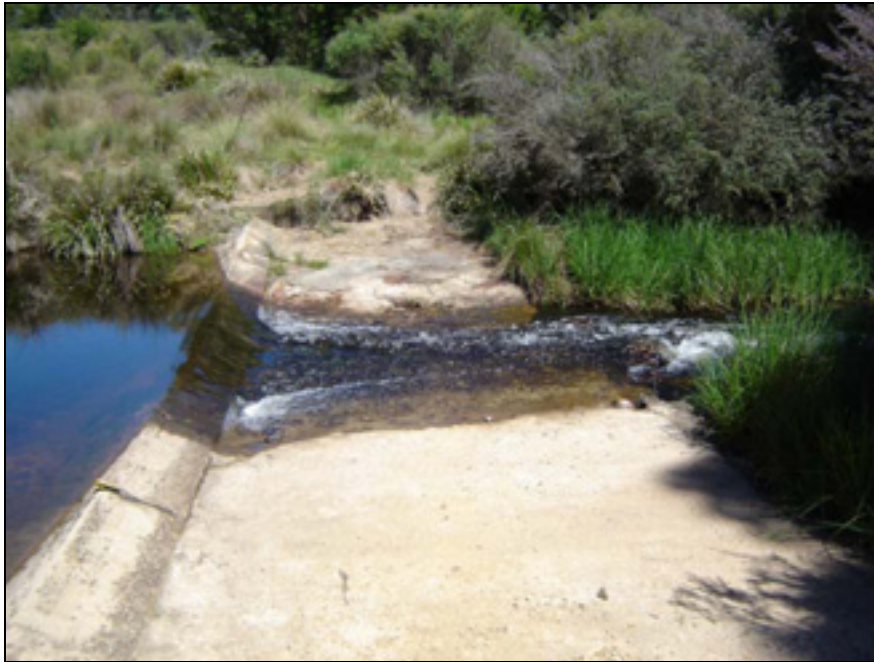
Figure 1. Mongarlowe River Gauging Station, Mongarlowe River (30/3/05, ~34ML/day).

Mongarlowe River Gauging Station (Figure 1) is located in the township of Mongarlowe in the Shoalhaven catchment and is owned by Sydney Catchment Authority. Mongarlowe River is a tributary of the upper Shoalhaven River, the confluence of which is approximately 30km downstream of this site, near the township of Charleyong. The structure is a concrete shallow notched, fixed crest weir, approximately 0.45 metres high and 10 metres across. During low to medium flow conditions the weir restricts fish passage due to excessive head loss (400mm).

Should it be determined that the structure is still required for its original purpose, and/or the effect on upstream extractors is too great, the installation of a partial width rock ramp fishway is the recommended option (Option 1).

Following successful determination that the structure is no longer required and that removal of the structure would not impact on the upstream diverters, the recommended remedial action for this site is removal of the structure (Option 2).

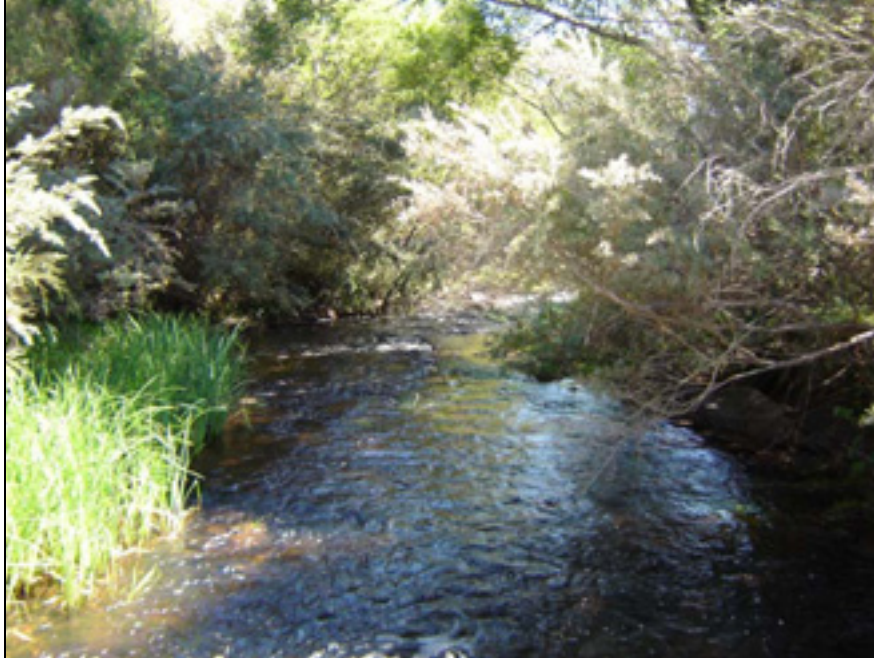
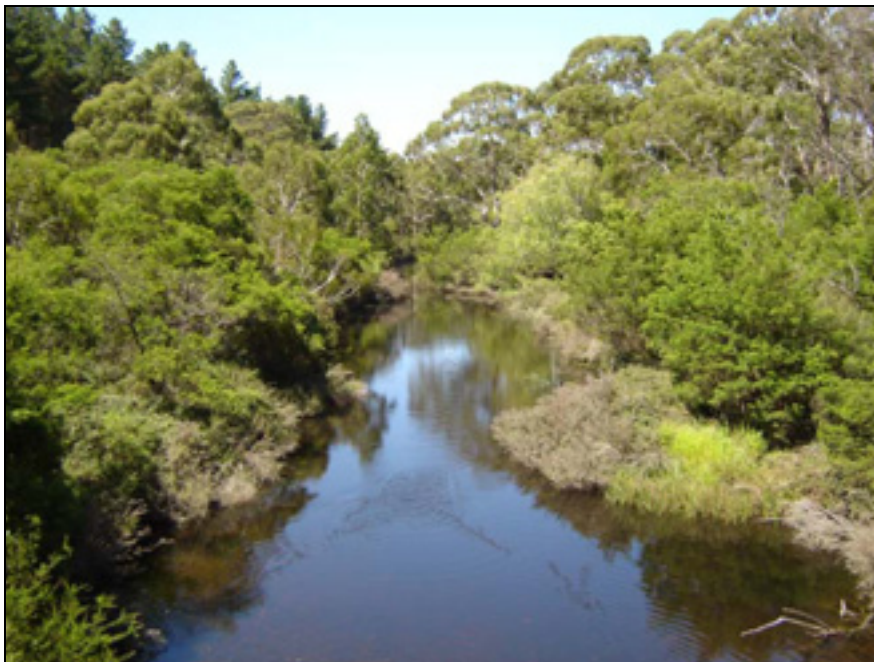
The river contains important fish habitat components including riffles, deep pools, and cobble beds. The site has well vegetated banks with some erosion at fixed points adjacent to structure frequented by user groups. Aquatic vegetation in the weir pool is dominated by *Triglochin* spp., spike rush (*Schoenoplectus* spp.), and another unidentified species. Riparian vegetation is dominated by matt rush, small stands of *Ficus* spp., and eucalypts (Figures 2 and 3).

Figure 2. Mongarlowe River downstream of Mongarlowe River Control Point Structure (30/3/2005, ~34ML/day).

Figure 3. Mongarlowe River upstream of Mongarlowe River Control Point Structure (30/3/2005, ~34ML/day).

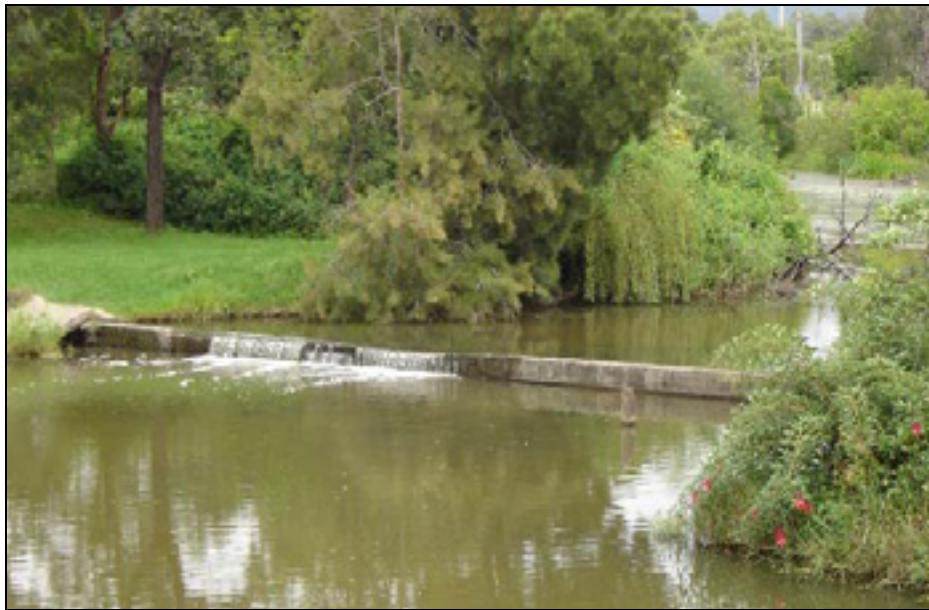
Figure 1. Mullet Creek Weir looking upstream (28/02/05).

Mullet Creek Weir (Figure 1) is located near the township of Kembla Grange on Mullet Creek in the Illawarra catchment. Although the right bank is owned by Wollongong City Council and the left bank is owned and operated by Kembla Grange Golf Club, neither party currently claims ownership of the structure. The weir is constructed of concrete and measures 0.6 metres high by 40 metres wide. The weir pools water over 4km upstream at depths of between 1-2 metres. Water cascades over the crest of the weir, with fish passage restricted due to excessive headloss (500mm) over most flow conditions.

The weir is considered to be in relatively poor condition, with some large cracks allowing water to escape both under and through the weir wall.

Prior to undertaking any removal works at this site, it is recommended that the sediment behind the weir be tested for heavy metals and other contaminants, as these may need to be removed and disposed of as part of the weir removal process.

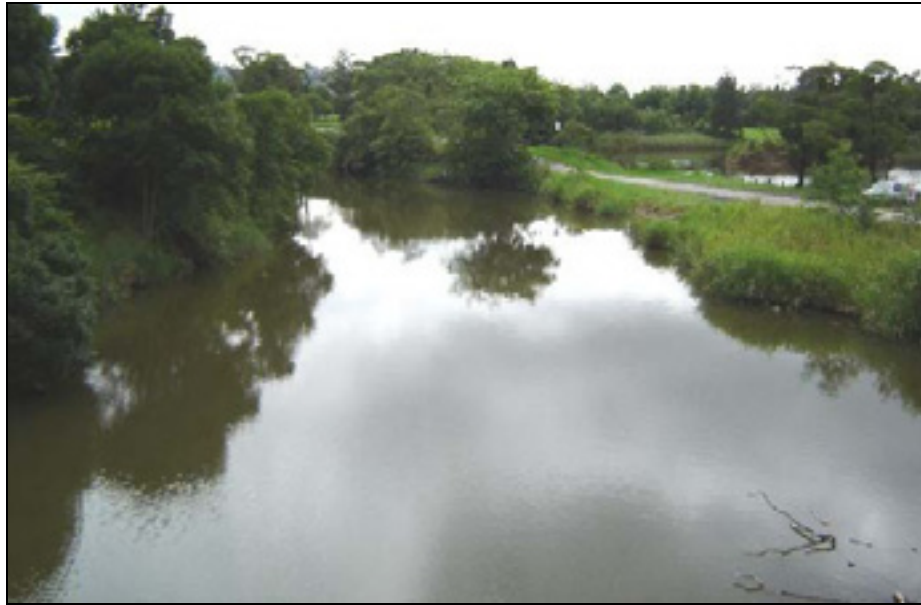
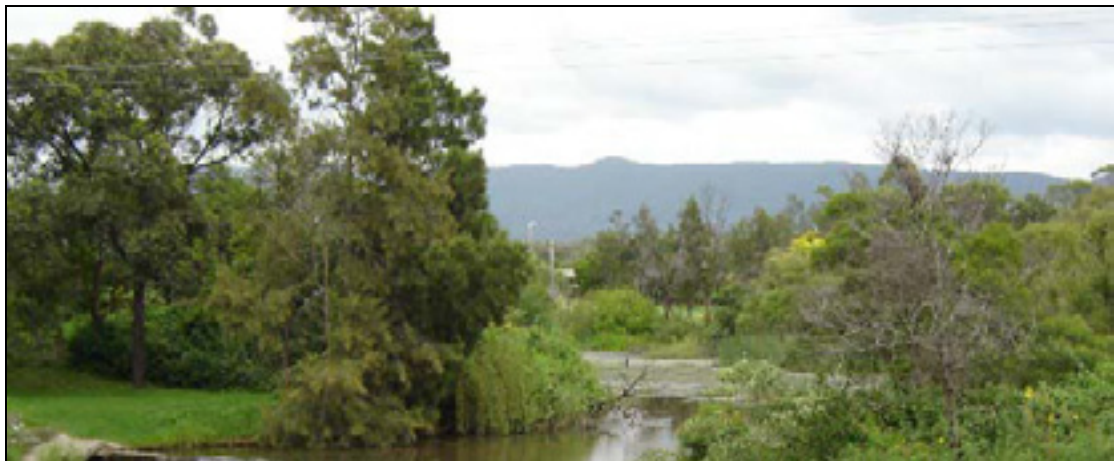
Banks adjacent to the weir wall display moderately to poorly vegetated banks with minor erosion present downstream of the structure - presumably due to recreational fisher and boat access. Riparian vegetation is primarily composed of casuarinas, willows, and a mixture of exotic weed species (Figures 2 and 3). Instream vegetation in the weir pool is dominated by *Cabomba* spp. Siltation is present within the weir pool, with the difference in bed level reported to be approximately 0.5 metres higher on the upstream side of the weir.

Figure 2. Aquatic habitat immediately downstream of Mullet Creek Weir (28/02/05).

Figure 3. View of aquatic habitat upstream of Mullet Creek Weir (28/02/05).

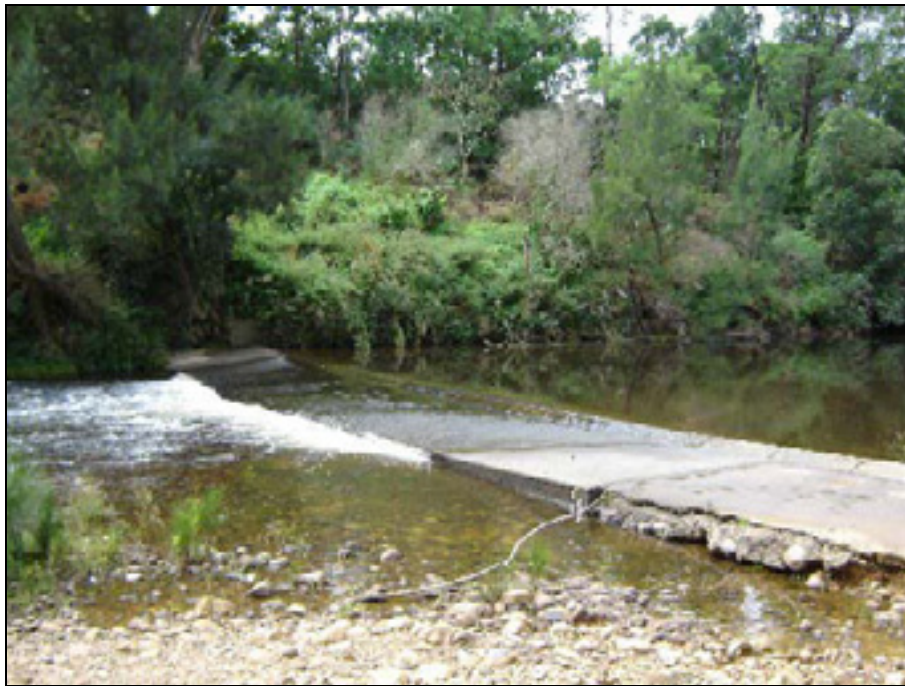
Figure 1. Kangaroo River Gauging Station, Kangaroo River (30/3/05, 150.1ML/day).

Kangaroo River Gauging Station is located in the township of Kangaroo Valley in the Shoalhaven catchment (Figure 1). Kangaroo River is a tributary of the Shoalhaven River, the confluence of which is Lake Yurunga, above Tallowa Dam approximately 40km downstream. The structure is owned by Sydney Catchment Authority, and is a concrete shallow notched, fixed crest weir approximately 0.6 metres high and 22 metres across. During low to medium flow conditions, the weir restricts fish passage due to excessive head loss (500mm).

The gauging station and control point structure were constructed in 1966 for gauging flows in the Kangaroo River, which continues to be its main purpose today. Currently no licensed water extractors draws from the weir pool. At the time of inspection the condition of the gauging station was relatively good.

The Kangaroo River Gauging Station is currently acting as a fish passage barrier at low to medium flows. It is therefore recommended that remedial activities be undertaken at this site to provide for fish passage at these flows.

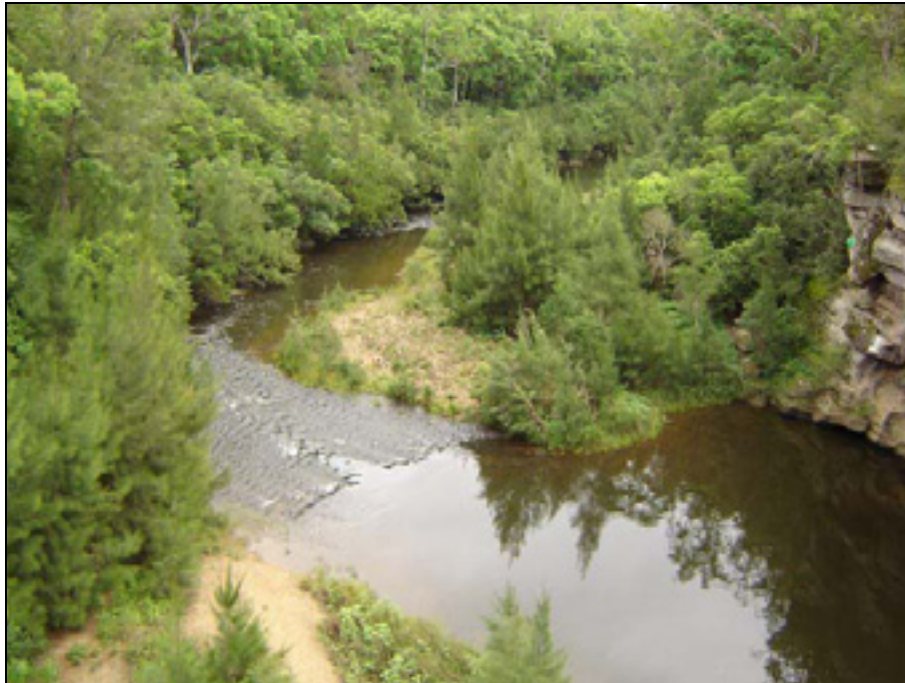
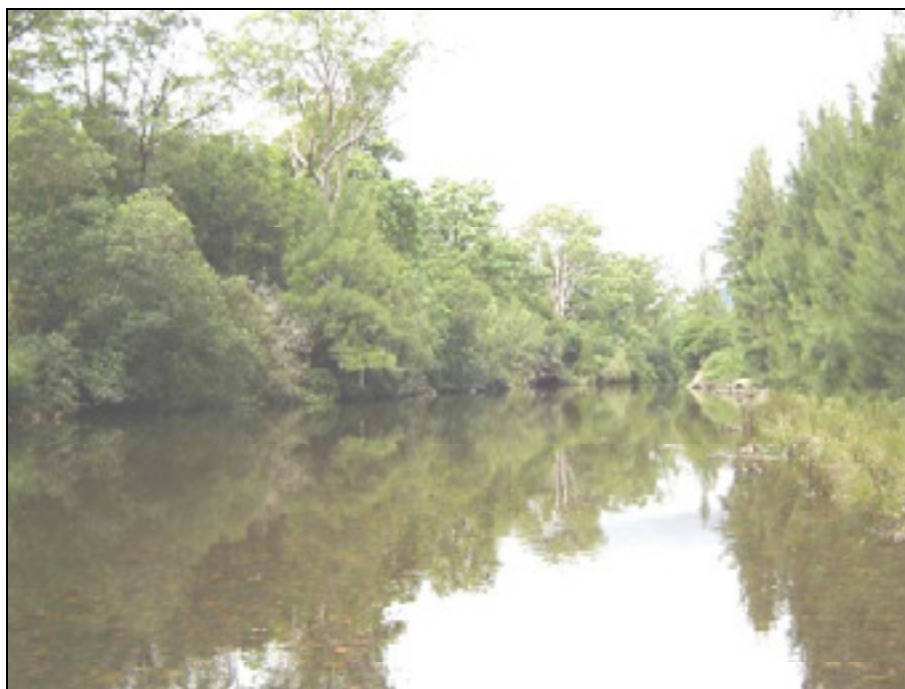
Figure 2. Riffle zone on the Kangaroo River downstream of Kangaroo River Gauging Station (30/3/2005, 150.1ML/day).

Figure 3. Kangaroo River upstream of Kangaroo River Gauging Station (30/3/2005, 150.1ML/day).

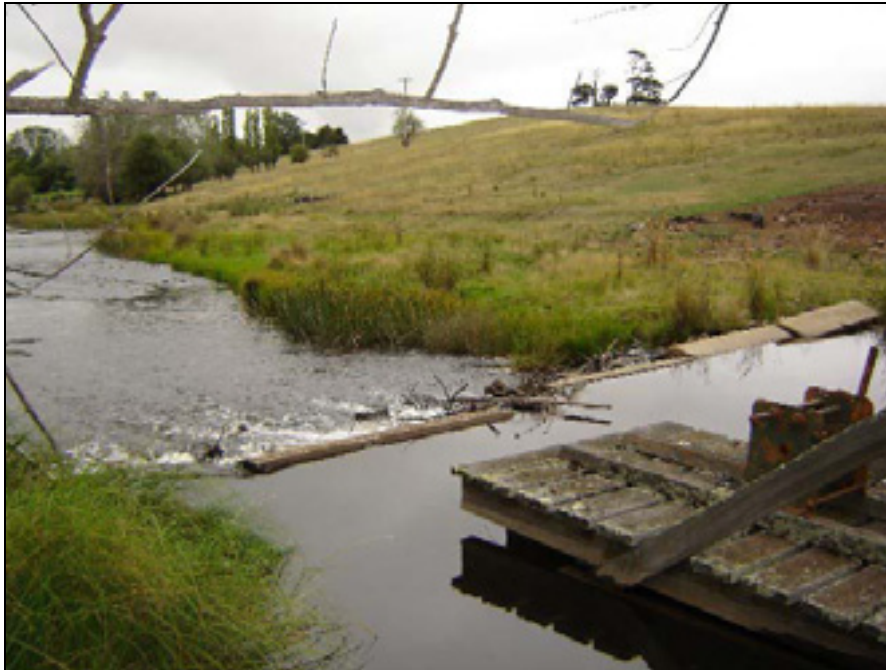
Figure 1. Delegate River Town Water Supply Weir (2/3/05, <122.570ML/day).

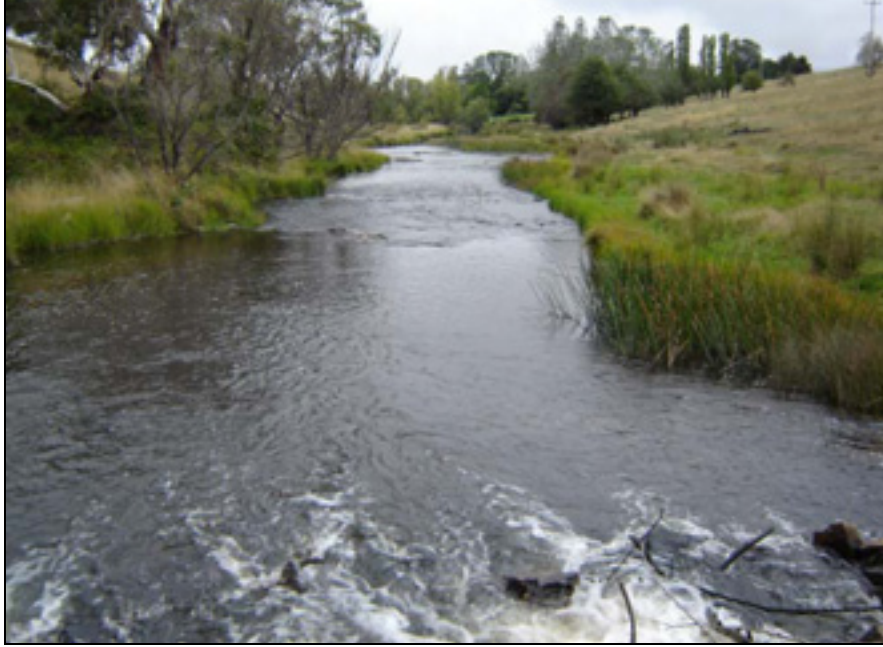
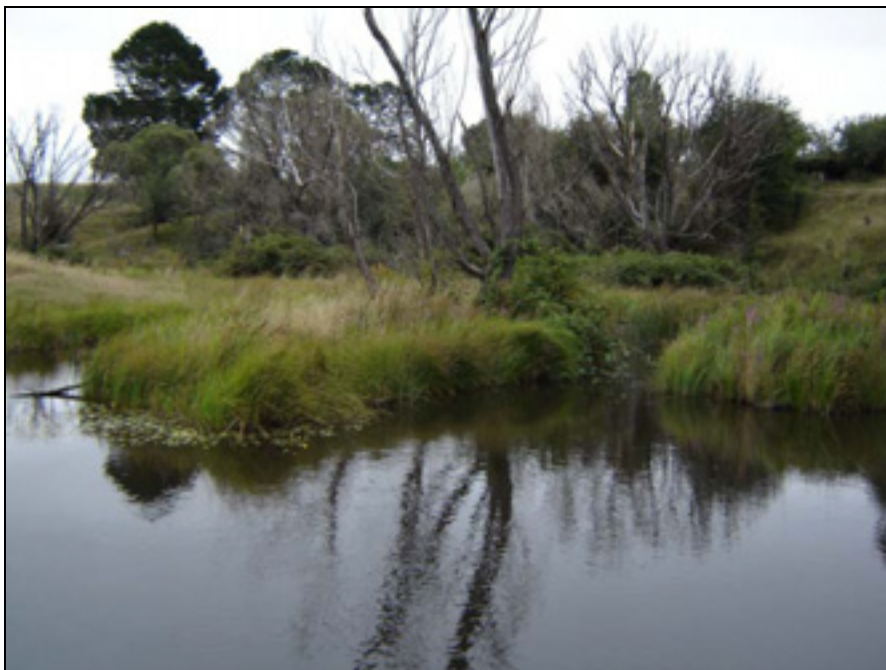
Figure 2. Riparian and instream habitat immediately downstream of Delegate Weir, Delegate River (2/3/05, <122.570ML/day).

Figure 3. Riparian and instream habitat immediately upstream of Delegate Weir, Delegate River (2/3/05, <122.570ML/day).

Water quality at Delegate is described as good, except during drought periods when stagnant pools form. The area surrounding the weir displays moderately to poorly vegetated banks with minor erosion present either side of the structure, presumably due to cattle access. Riparian vegetation is primarily composed of willows and a mixture of native grass species; instream vegetation is primarily composed of spike-rush (*Schoenoplectus* spp.) (Figures 2 and 3).

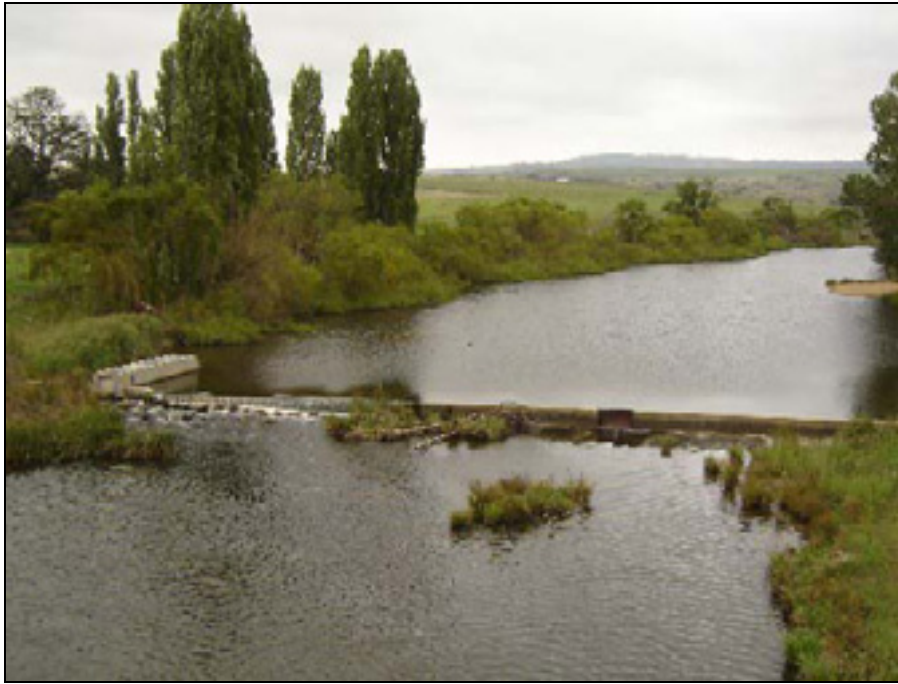
Figure 1. Dalgety Weir and fishway (3/03/05, 98ML/day).

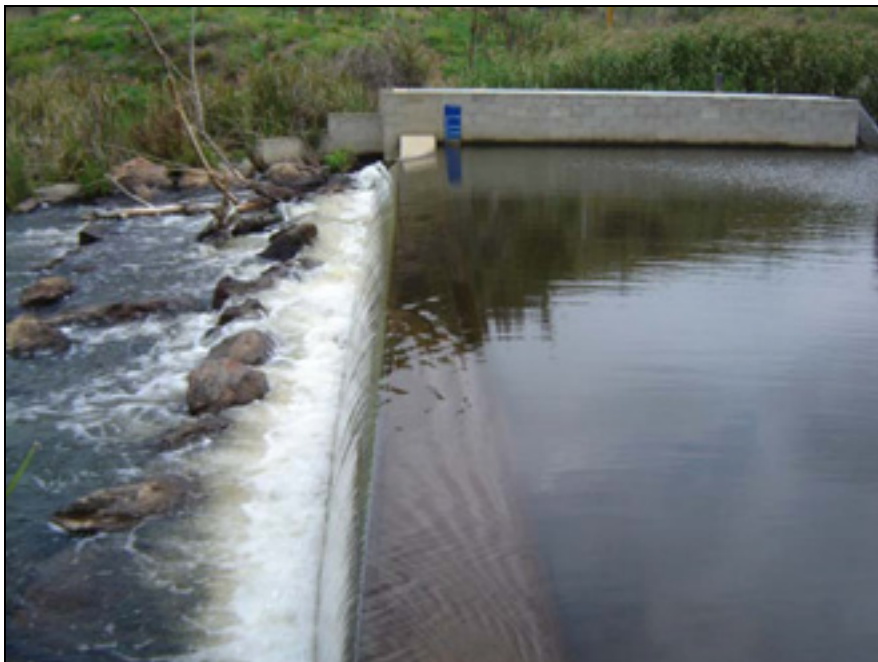
Figure 2. Vertical slot fishway on right abutment of Dalgety Weir. Note wood debris blocking downstream rock ramp fishway approach and vertical slot fishway entrance (3/03/05, 98ML/day).

Currently the weir also provides DNR with a control point from which stream flows can be measured to allow the effective management of the catchment and its associated flow regime. It also provides a weir pool for stock and domestic water supply. Since 1997, a vertical slot fishway, with a partial width rock ramp fishway approach at the downstream end has been in operation providing fish passage past the site for the majority of the time (except when the structure is blocked with debris – refer Figure 2).

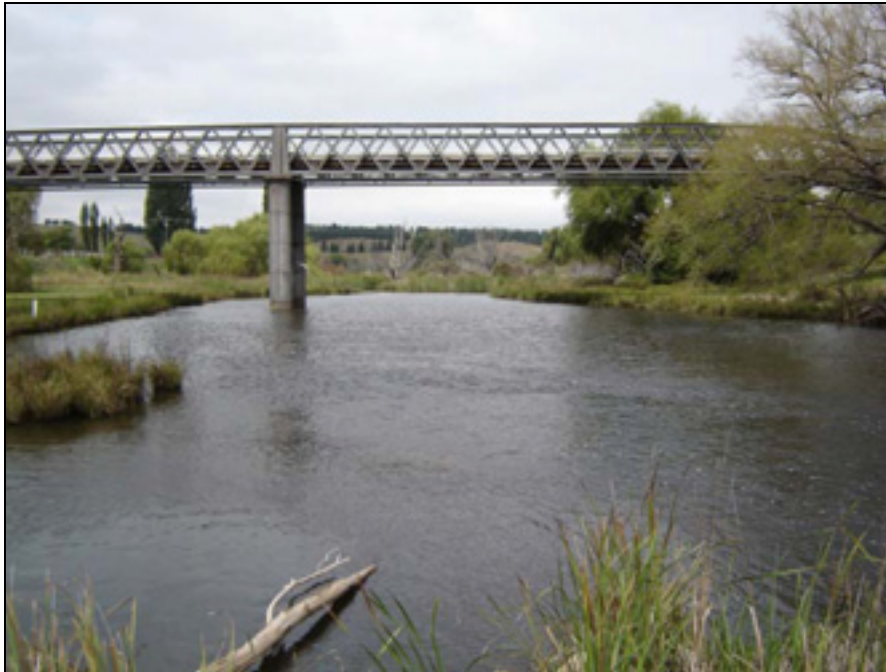
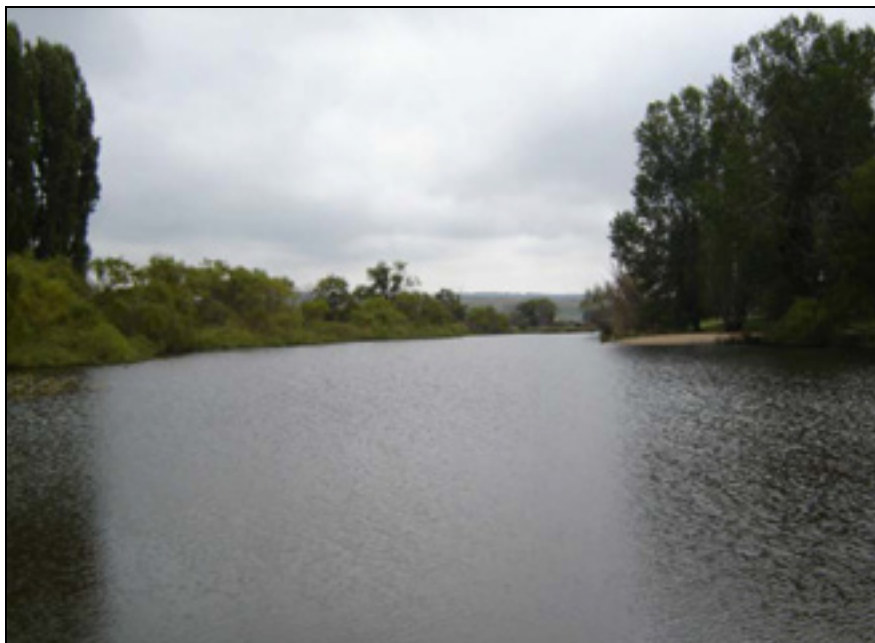
Figure 3. Riparian and instream habitat immediately downstream of Dalgety Weir (3/03/05, 98ML/day).

Figure 4. Riparian and instream habitat immediately upstream of Dalgety Weir (3/03/05, 98ML/day).

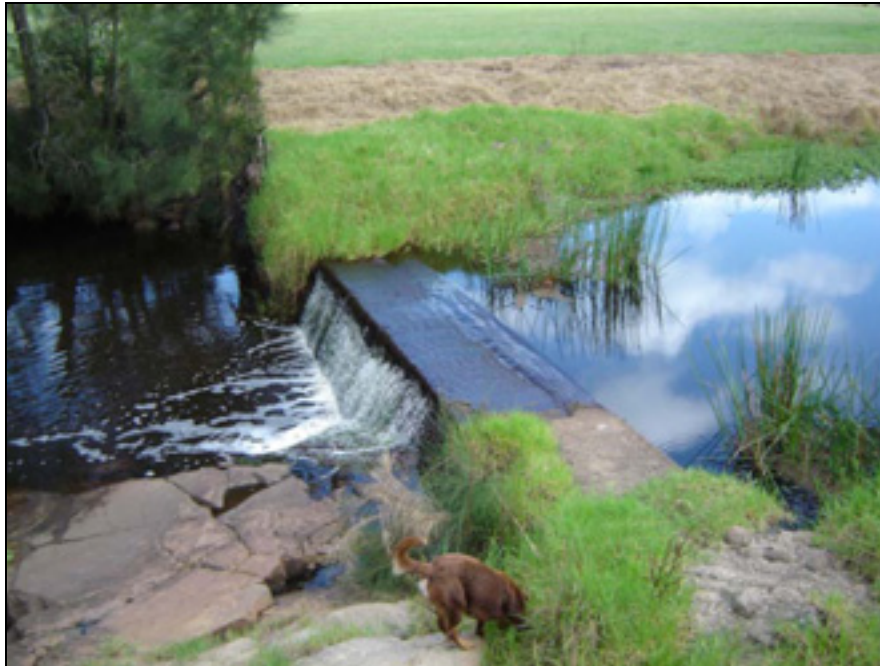
Figure 1. Croobyar Creek Weir No. 6 (28/2/05).

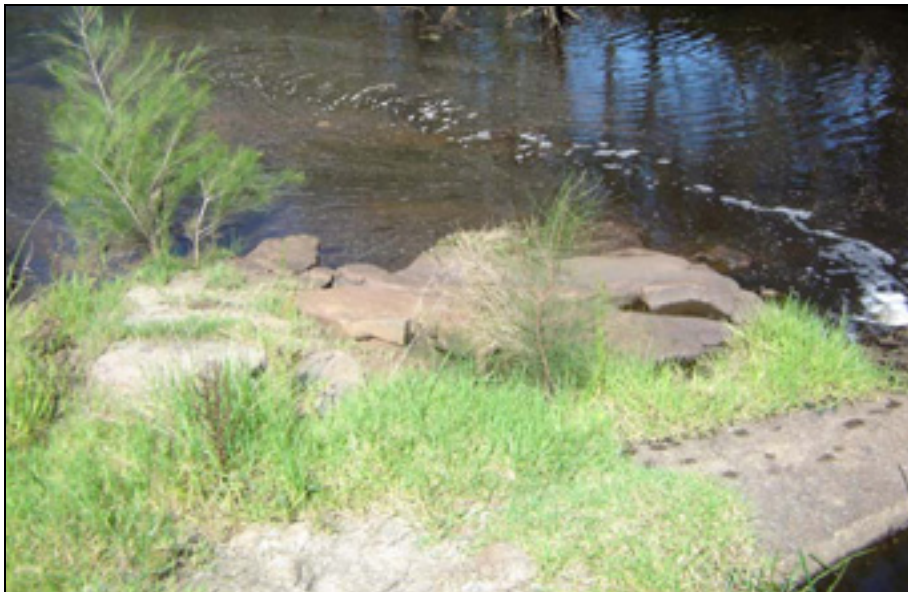
Figure 2. View of rock platform adjacent to Croobyar Creek Weir (28/2/05).

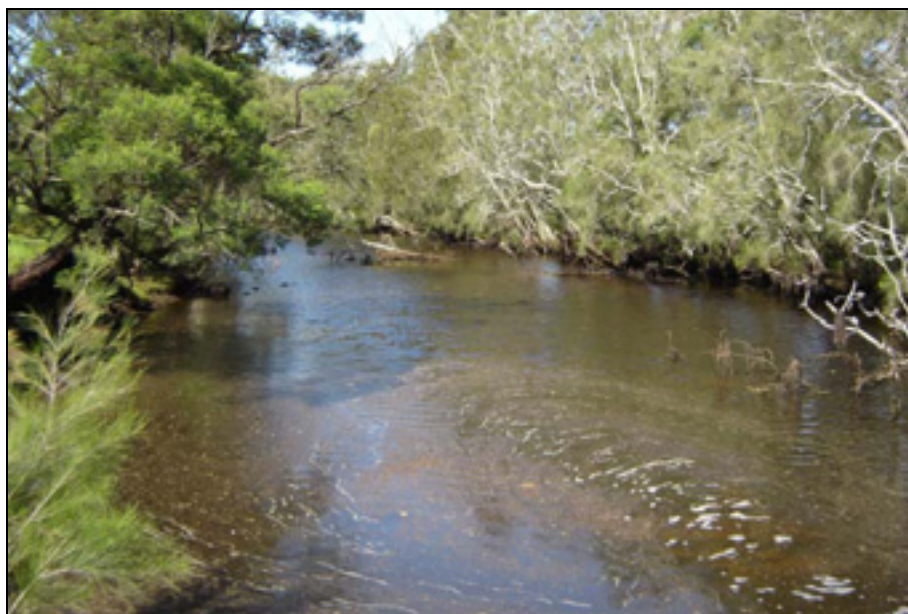
Figure 3. Riparian and instream habitat immediately downstream of Croobyar Creek Weir (28/2/05).

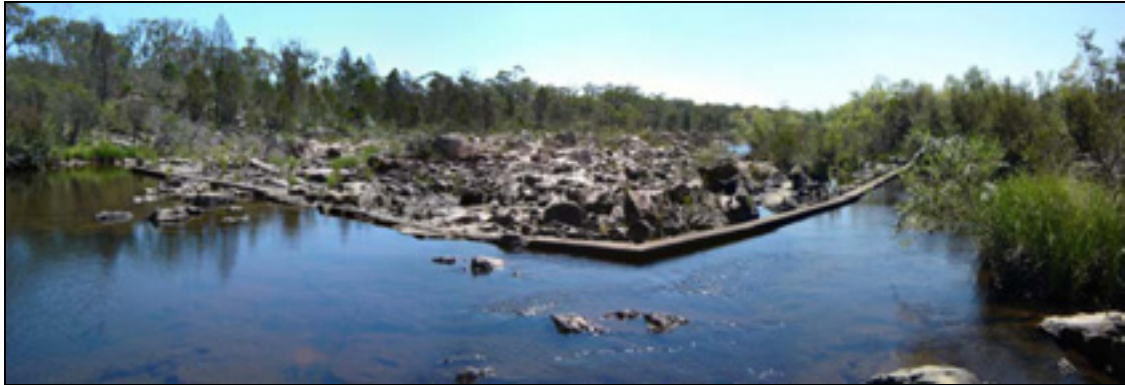
Figure 1. Braidwood Town Water Supply Off-Take Weir, Shoalhaven River
(30/3/05, 53.5ML/day).

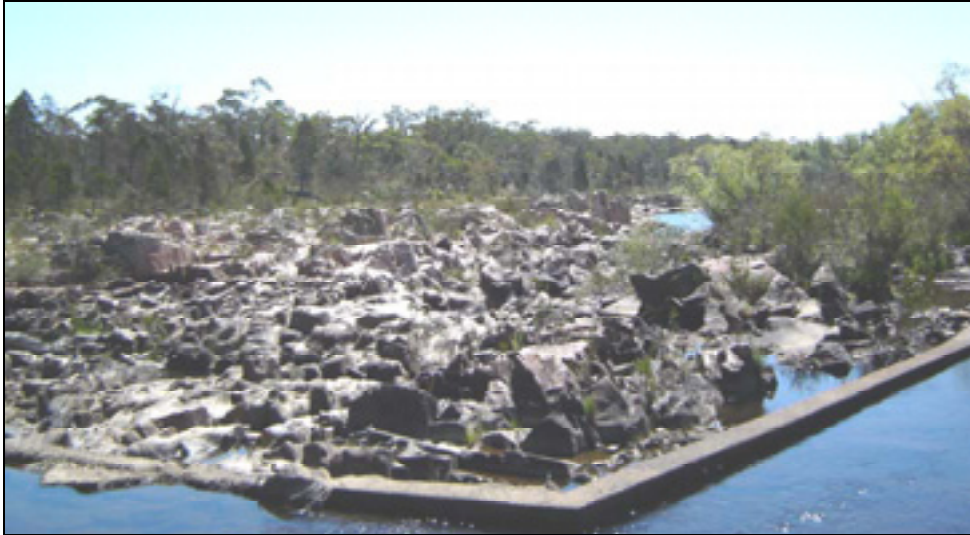
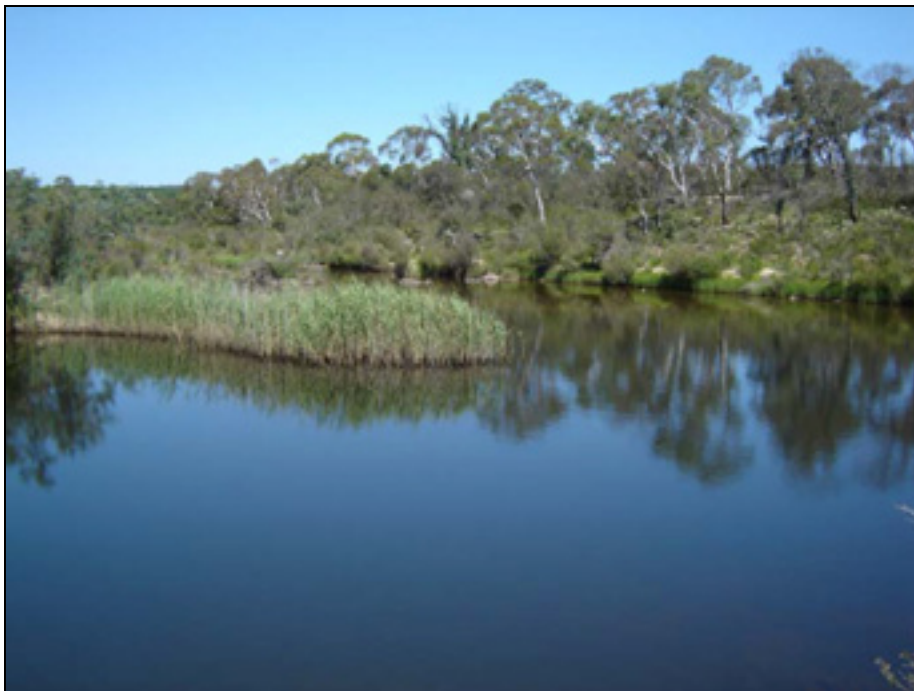
The site has well vegetated banks with some erosion at fixed points upstream and downstream of the structure, presumably from cattle accessing watering points. Aquatic vegetation in the weir pool is dominated by spike rush. Riparian vegetation is dominated by matt rush, with small stands of *Ficus* spp. and eucalypts (Figures 2 and 3).

Figure 2. Shoalhaven River downstream of Braidwood Town Water Supply Weir (30/3/05, 53.5ML/day).

Figure 3. Shoalhaven River upstream of Braidwood Town Water Supply Weir (30/3/05, 53.5ML/day).
