# Marine Aquaculture Research Lease

## Annual Environmental Management Report

October 2018

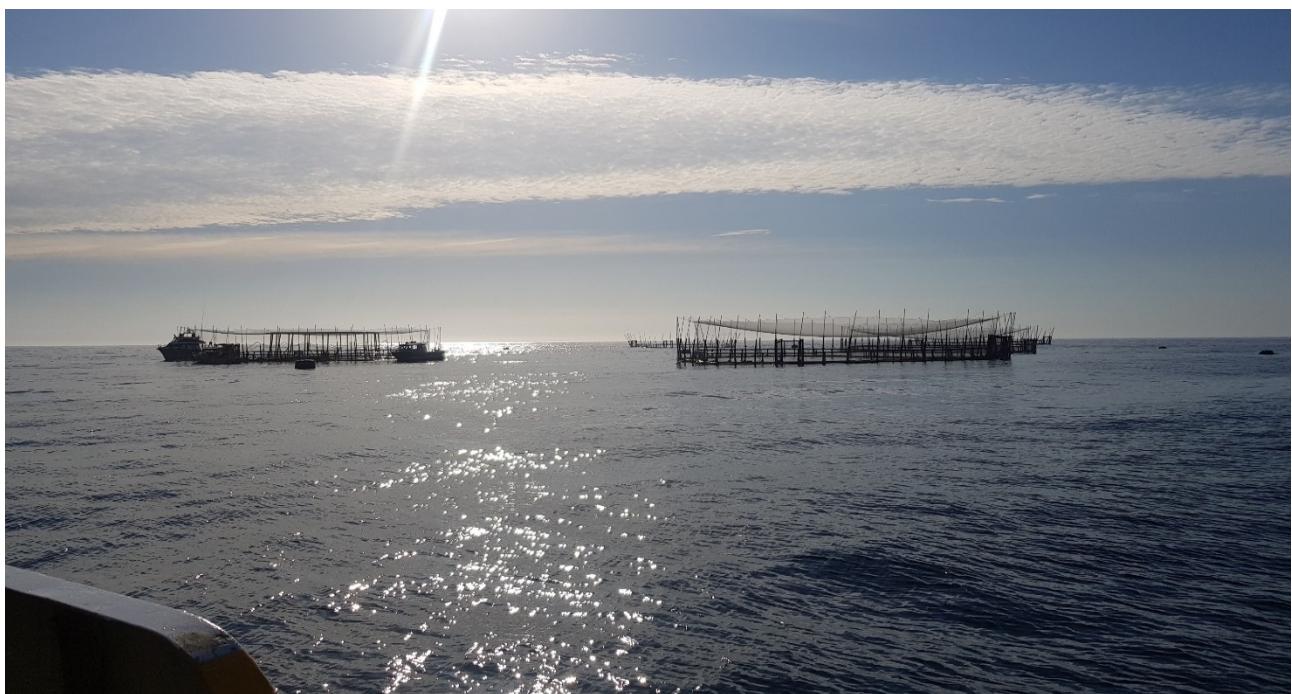
Construction activities for the MARL continued in 2017/2018 with three new sea pens of 38 m diameter manufactured in the Kooragang Industrial Precinct Newcastle Harbour.

Figure 2: Five pens on the MARL (Source: HUON, 2018).

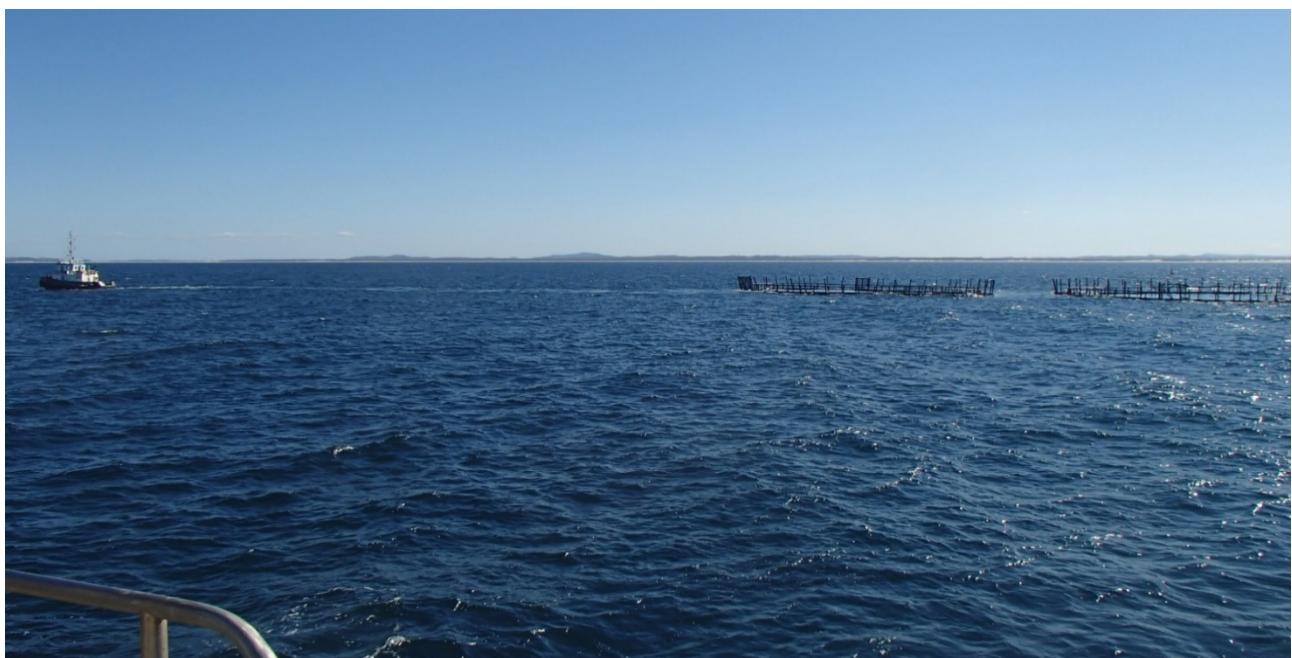
Following two severe storm events in Providence Bay three sea pens were returned to Newcastle for maintenance (April 2018) and to allow refurbishment of the mooring grid. Two sea pens with fish remained on the MARL until the fish were harvested and subsequently those two pens were also removed to Newcastle Harbour in September 2018 for maintenance.

Figure 3: Removal of three sea pens to Newcastle Harbour for maintenance (Source: HUON, 2018).

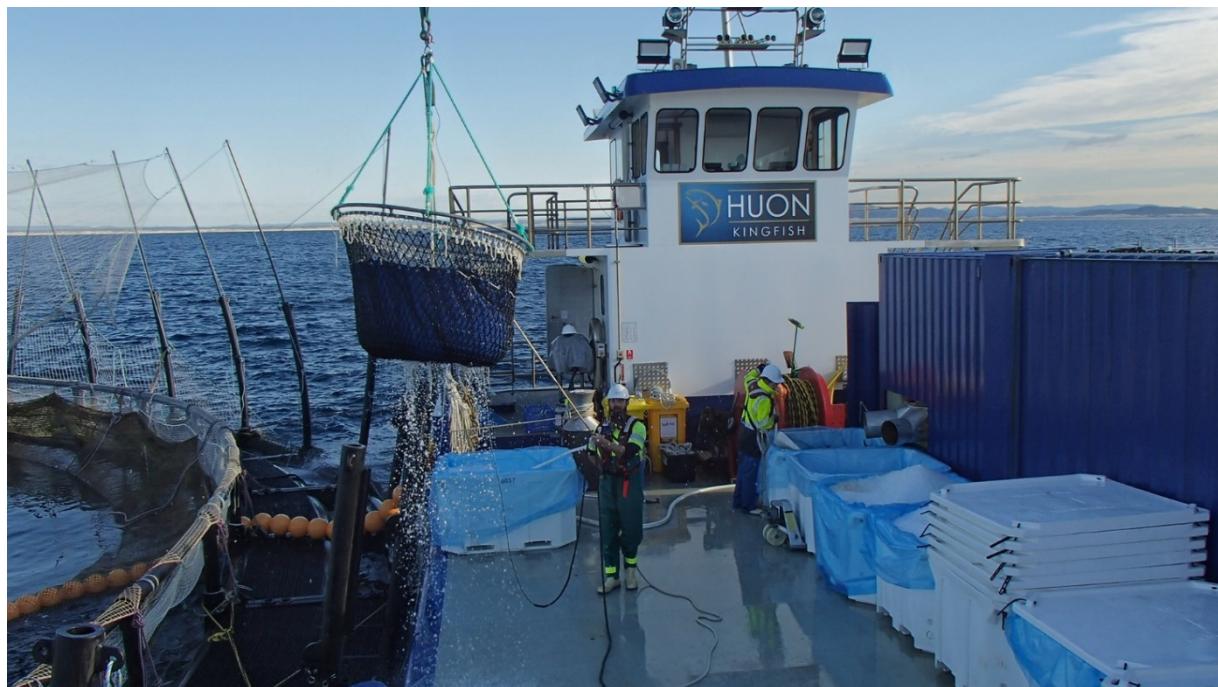
At harvest, the fish are corralled to a small area in the sea pen by net from where they are lifted into a self-contained harvesting unit on the deck of the work vessel *Bulldog*. The harvesting unit was specifically designed to meet a condition of the consent approval to retain all waste water associated with the harvest. The fish were quickly and humanely harvested and loaded into ice slurry in 1,000 litre insulated containers.

Figure 4: Harvest operation on vessel Bulldog (Source: HUON, 2018).

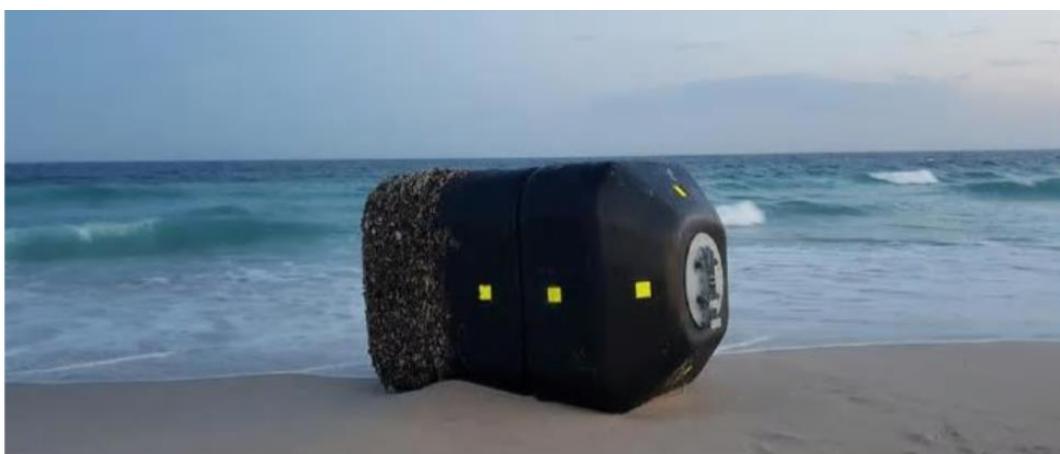
Figure 6: Buoy washed up at The Entrance (Central Coast Gosford Express Advocate, December 2017)

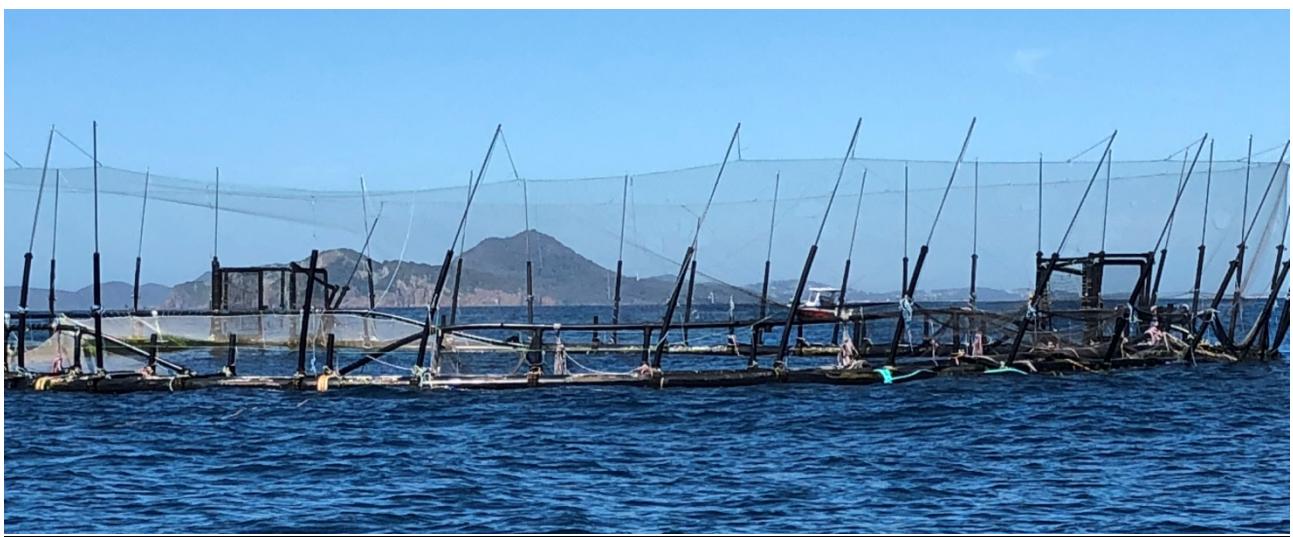
Equipment design was not identified as the lead cause of equipment failure rather, findings indicate the nets detached from the sea pens as a result of biofouling growth. The barnacles, caused damage to a number of ropes, which led to remaining ropes holding the nets becoming overloaded. Excessive weight due to biofouling growth put strain on the net rigging once the initial compromised ropes had been severed. The combination of load transfer resulted in leading to other structural damage including failure of components (snake ropes, water line ties, endless ropes, handrail "T"s and cotton reels) on two sea pens.

In addition, one empty sea pen collar was damaged as a result of the storm. Excessive wear from the mooring ropes attached to the cage, put extra pressure on the collar resulting in the rope wearing through the sea pen collar.

Figure 7: Post storm damage to sea pen 1602 (Huon 2018)

*Management actions:* Secured damaged lease infrastructure. An incident investigation was undertaken by an Independent Investigation Facilitator in conjunction with the NSW DPI/Huon Research Team. An investigation team was assembled to conduct site visits, review the incident background and the processes leading up to and following the incident.

Key recommendations arising from the incident investigation relate to improving the existing management plans for structural integrity monitoring and emergency response/recapture procedures.

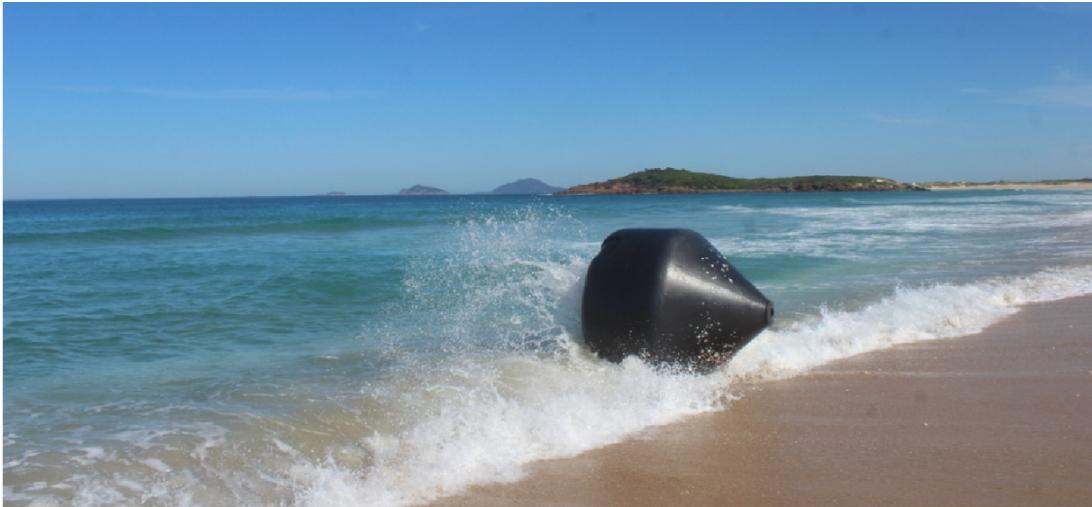
One grid buoy broke free in May 2018 after extreme weather conditions. The buoy and a length of chain washed up at Mungo Brush were located by local residents. The buoy was subsequently destroyed against rocks during storm action.

Figure 8: Buoy washed up at Mungo Brush (Local resident: May 2018)

- Investigate the malfunction/s with the product manufacturer, use of alternative manufacturers and replaced shackles;
- The ability to fit grid buoys with GPS transponders;
- Alternative harvest methods to avoid the need for the tubing;
- Refurbishment of sea pen mooring infrastructure based on new wave data;
- Reduce hardware components associated with the current mooring arrangement where possible to prevent re-occurrence;
- Next mooring installation will have a further reduction of hardware components;
- The sea pens are undergoing repairs and refurbishment; and
- New technology-based systems relating to net cleaning, moorings inspection and maintenance schedules.

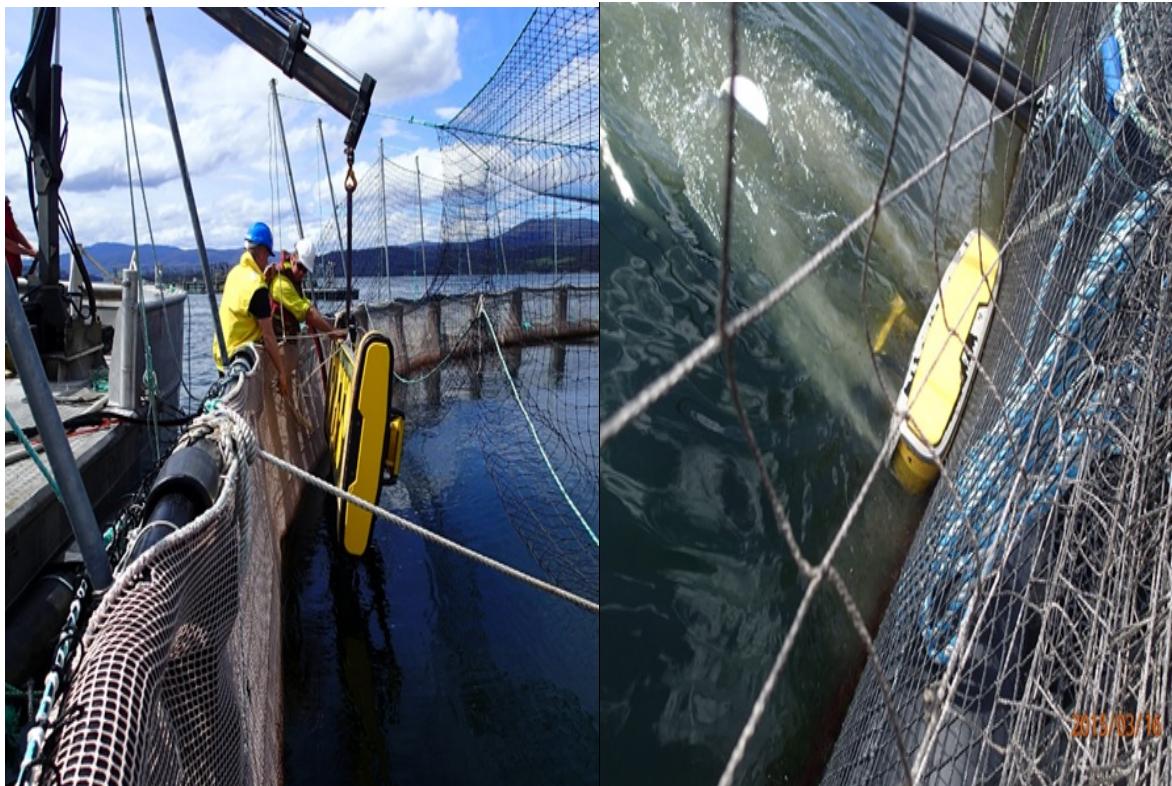
The submersible cleaning robots are in the process of being upgraded to more powerful models to enable routine cleaning of the predator and culture nets (Figure 8 and 9). These new net cleaners only recently became available and have been trialled extensively at Huon's operations in Tasmania. Huon is confident that they will allow for more efficient cleaning of the nets, particularly the predator nets at the MARL.

Figure 9: Picture showing deployment of the current robotic cleaner - remote operator net cleaner (Source: Huon, 2015).

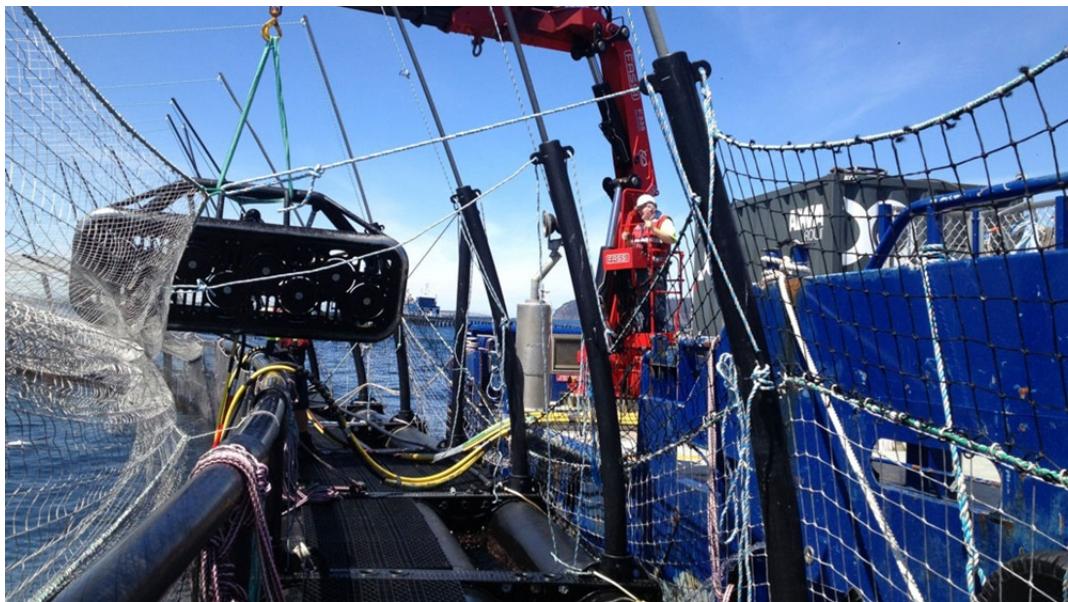
Figure 10: The new AKVA FNCR8 net cleaner being deployed into a sea pen. (Source: Salmonbussines.com, 2018)

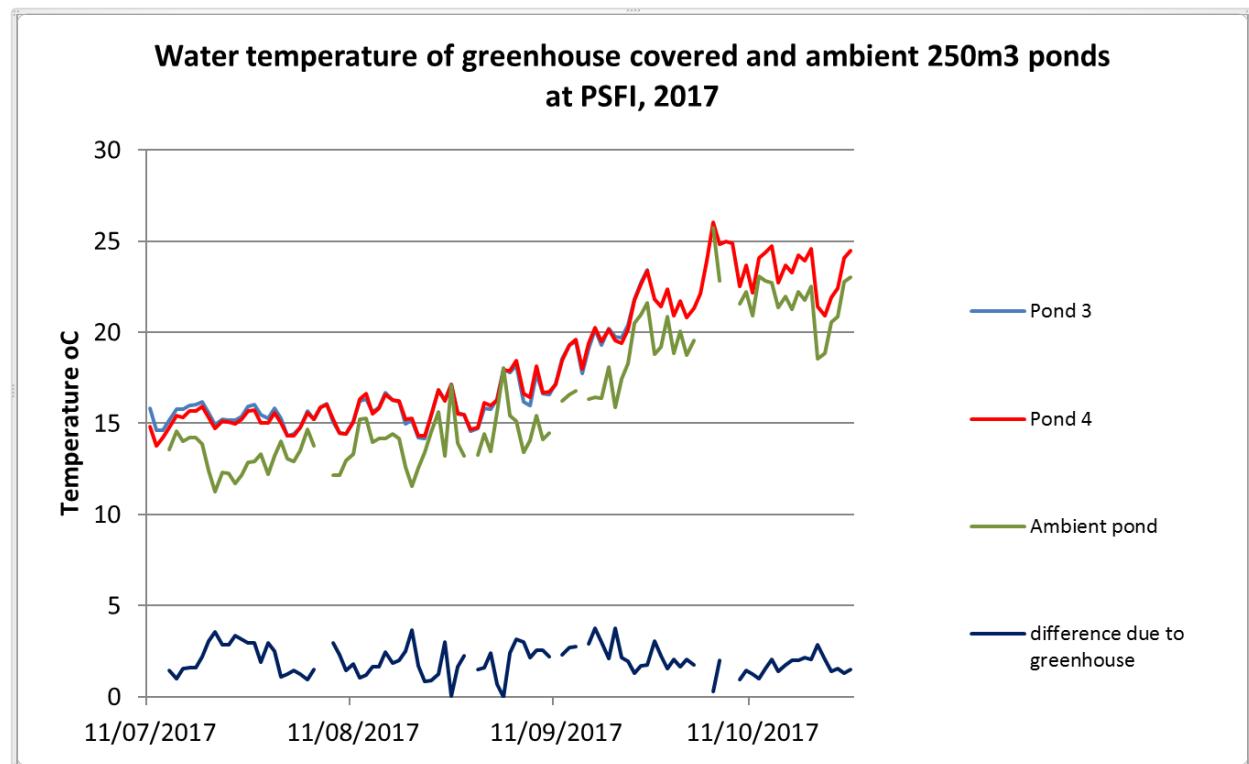
Figure 11: Graph showing water temperature of greenhouse covered and ambient PSFI ponds (Source NSW DPI 2018)

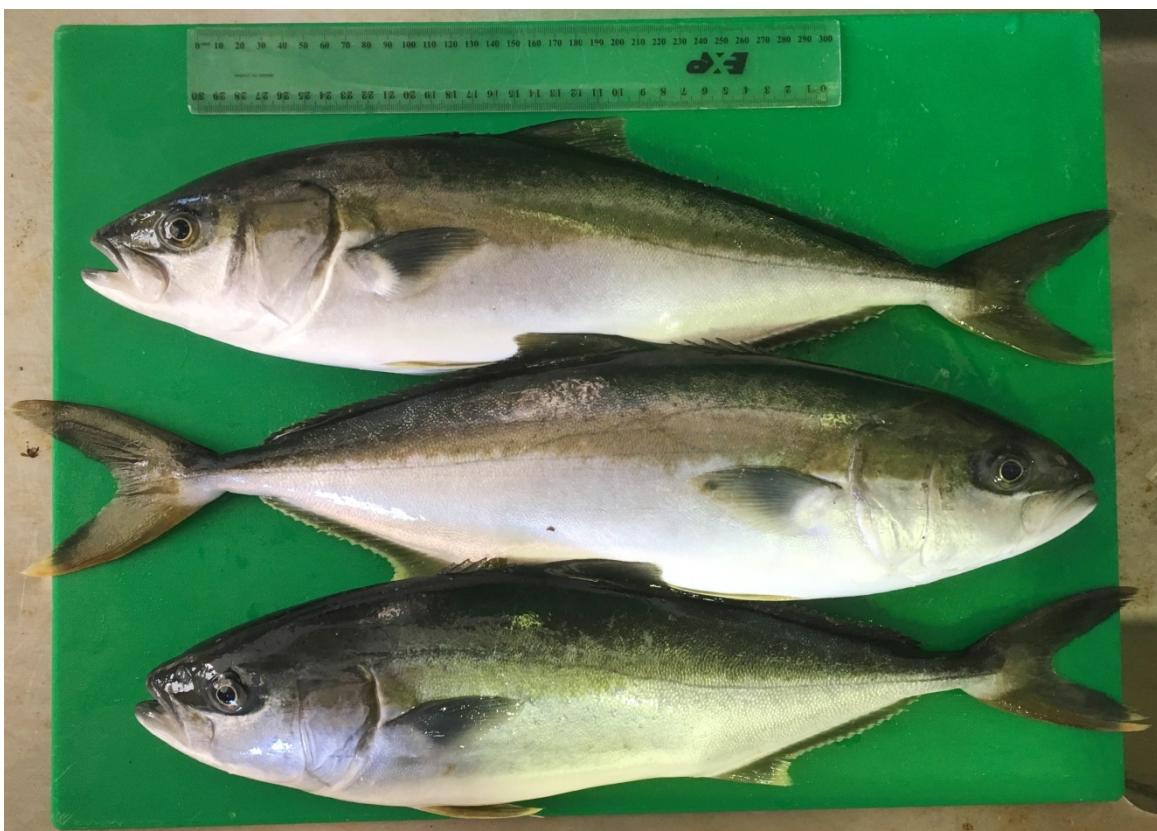
Figure 12: YTK harvested after 114days (July-November 2017) of culture in polyhouse-covered, plastic-lined ponds at PSFI. Fish were 1.0 kg.

A further hatchery run (Batch 3b) was started as soon as the hatchery was emptied in an attempt to produce target numbers of fingerlings for stocking to the MARL sea pens. Management of water temperature with room airconditioning was a significant challenge during extreme heatwaves and water temperature occasionally exceeded the target temperature of 24°C by 2°C. Compared with previous hatchery batches, survival of larvae to metamorphosis appeared to be compromised by the higher temperature and ranged from 1.9% to 6.6%. A total of 17,500 juvenile YTK were produced (Figures 12 and 13).

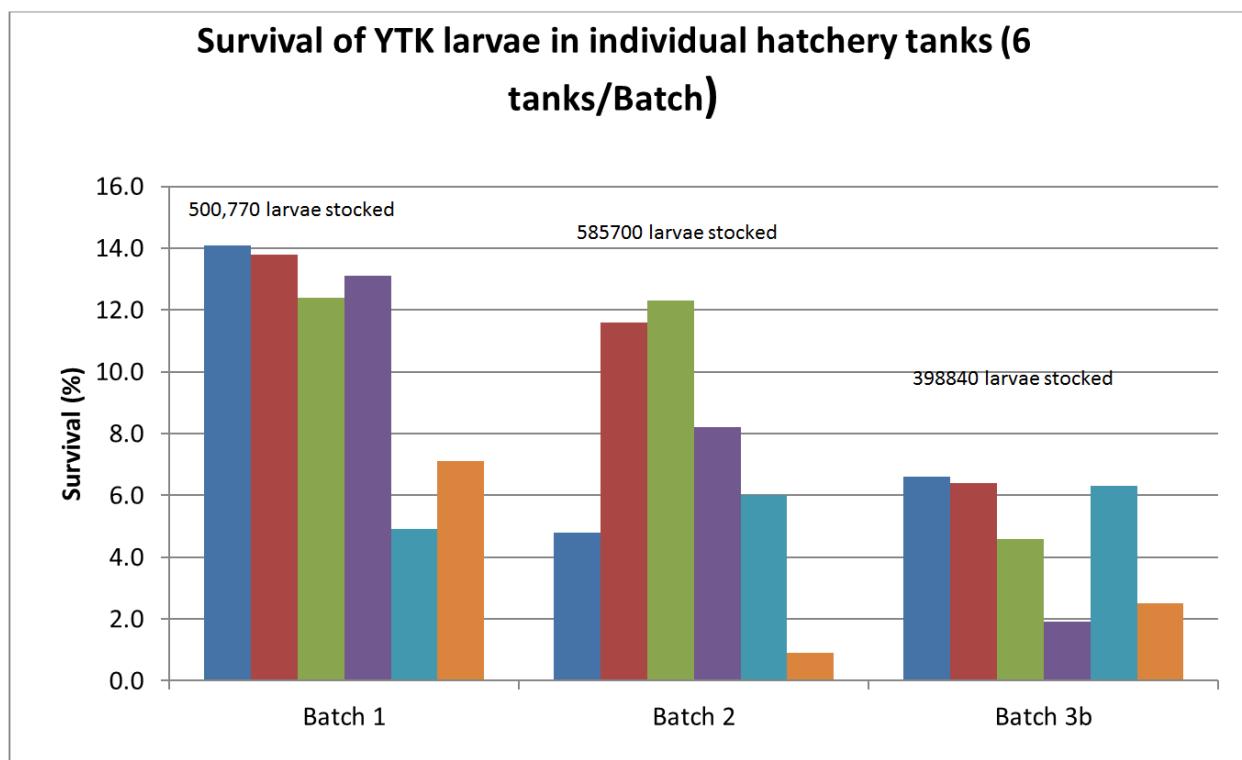
Figure 13: Graph, Survival of YTK larvae in individual hatchery tanks (six tanks/Batch)

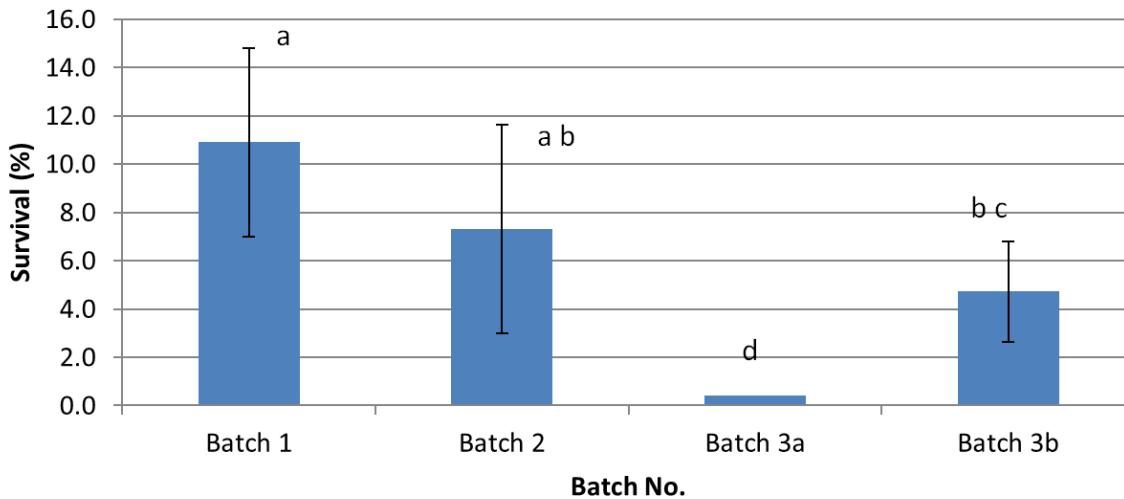
Figure 14: Graph, Mean survival of YTK 2016/2017 (Source: NSW DPI, 2016/2017)

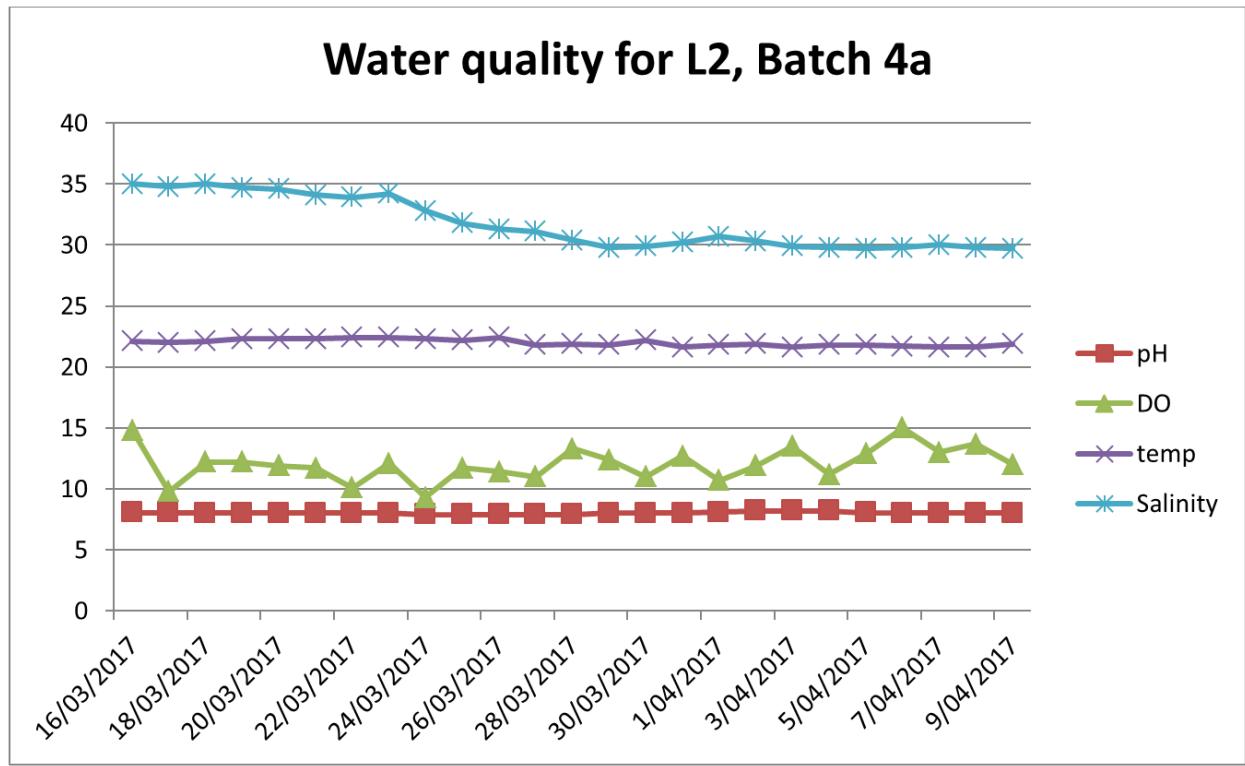
Although the larval rearing tanks at PSFI are designed to provide upwelling to potentially avoid the larval sinking phenomenon which is greatest when YTK larvae have the greatest body density at 9-12 days post hatch, we hypothesise that a rapid decrease in salinity from 35 to 29ppt, exacerbated the sinking problem and resulted in high larval mortality.

Figure 15: Representative larval rearing tank water quality Batch 4a

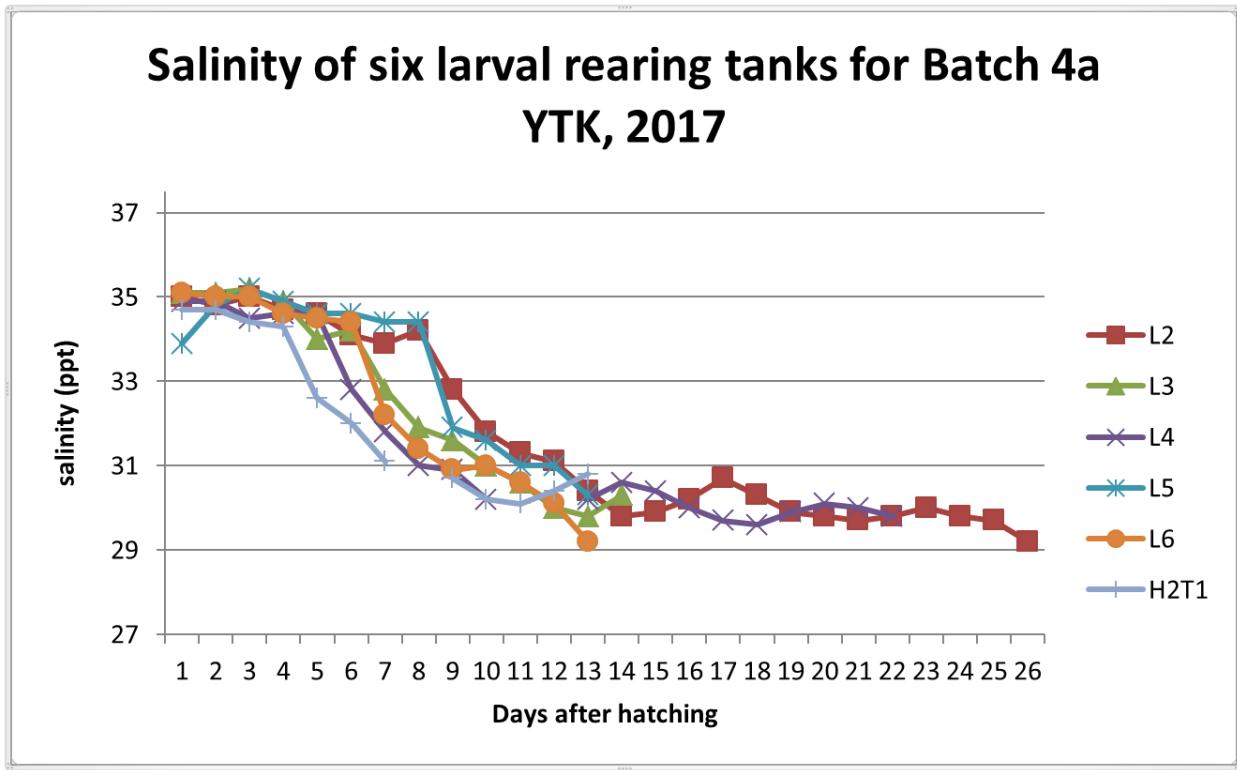
Figure 16: Salinity for all hatchery tanks Batch 4a.

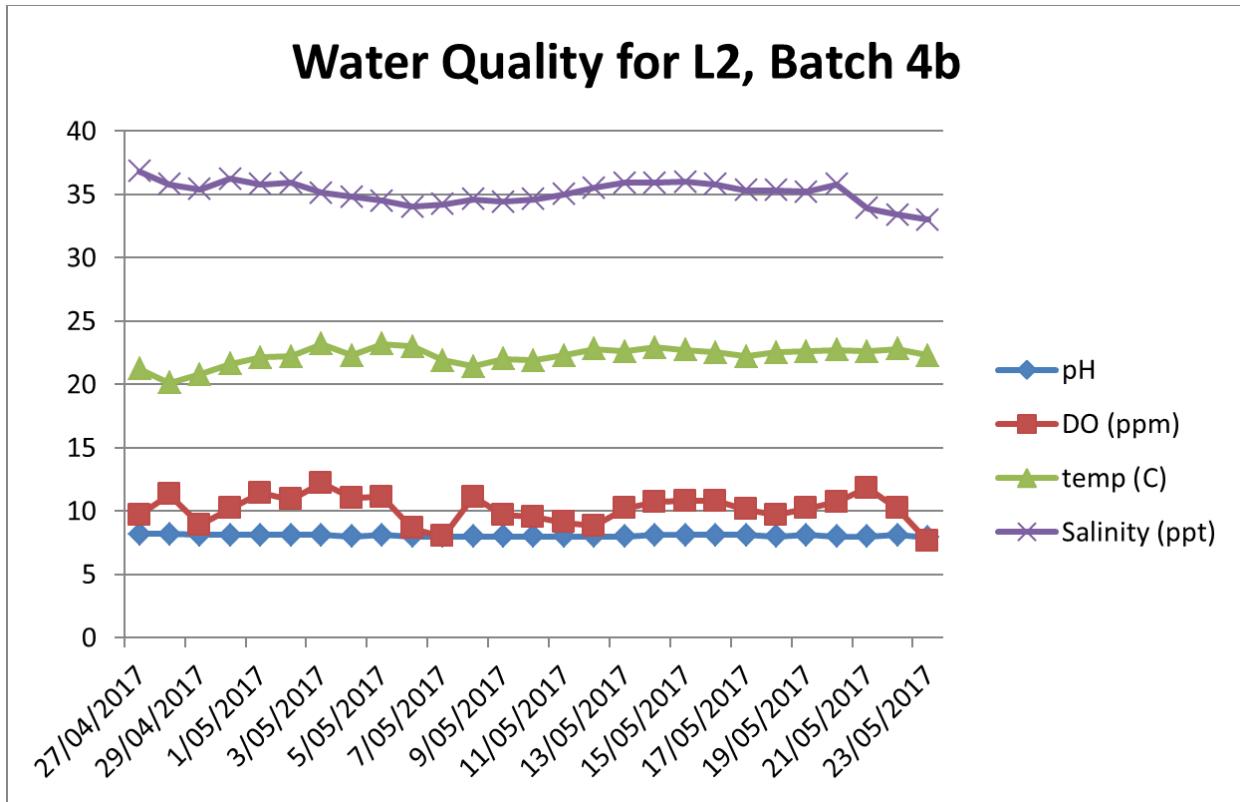
Figure 17: Water quality of a representative larval rearing tank, Batch 4b

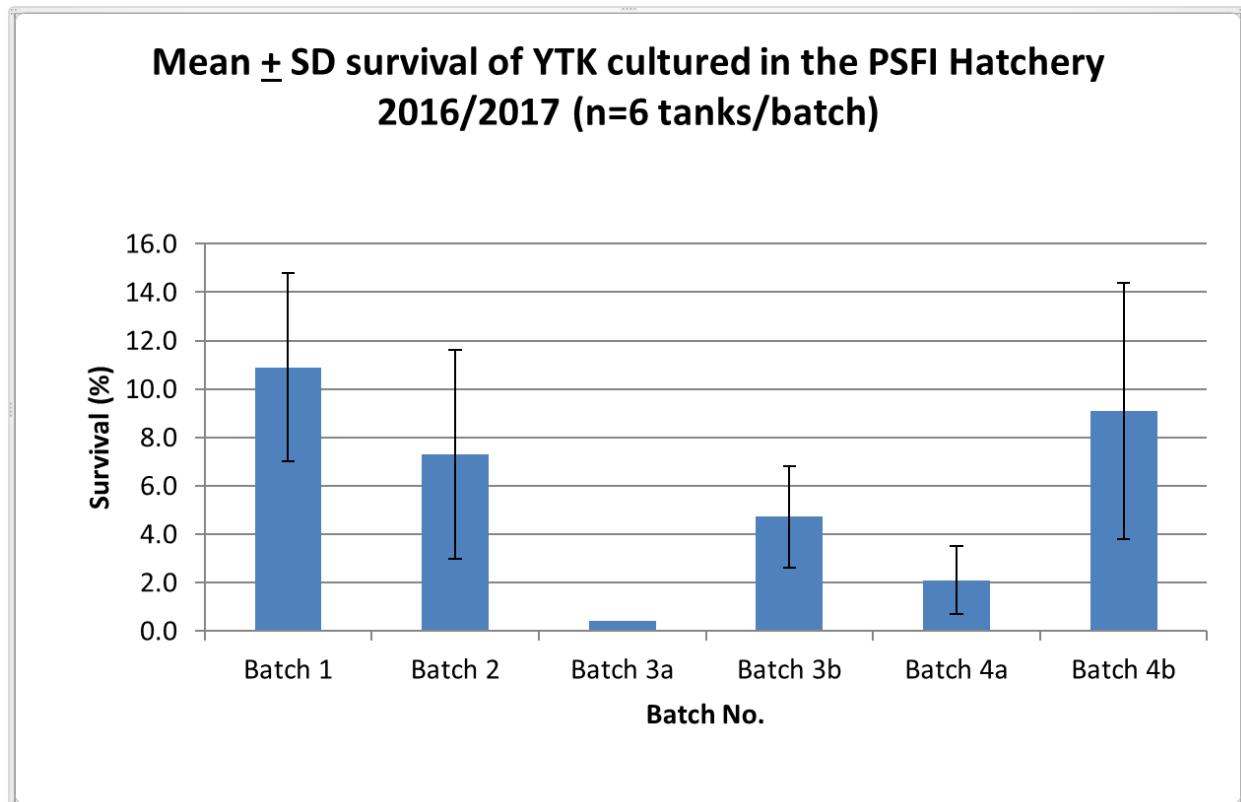
Figure 18: Survival of YTK larvae in all larval batches completed at PSFI

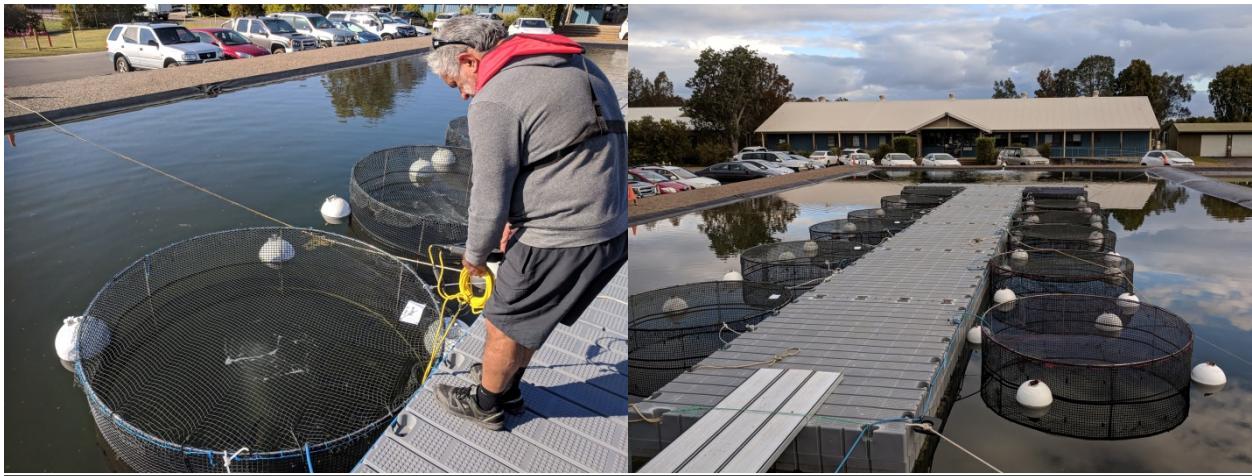
**Figure 26: Yellowtail Kingfish nutrition research trials being conducted in outdoor ponds at PSFI (photos courtesy of Mark Booth; NSW DPI 2018).**

This six pen field-based trial was stocked in the first week of September and will be run until early December 2018. The experiment is designed to evaluate the performance of juvenile Yellowtail Kingfish fed diets that completely replace prime quality, wild-captured fishmeal with reclaimed fishmeal. As for the first pond trial, we have incorporated new information on the nutrition of Yellowtail Kingfish into the formulations and have based the feeding regime on successful strategies identified from earlier experiments. We will also conduct an adjunct experiment to determine the digestibility of the diets in this study and the growth results will be compared theoretically to our improved bioenergetic model.

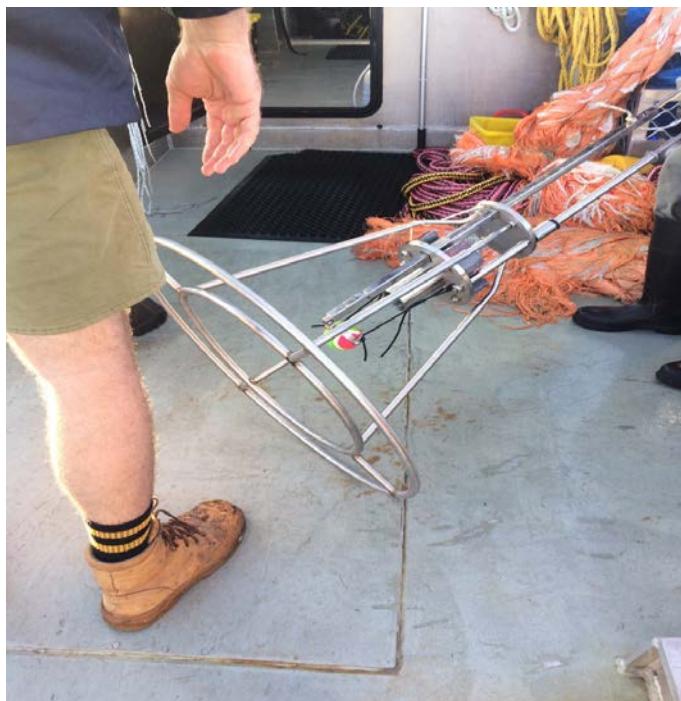
**Figure 28: Core Sample equipment used during the Water Quality and Benthic Environment Monitoring Program.**  
(Source: Huon, 2017)

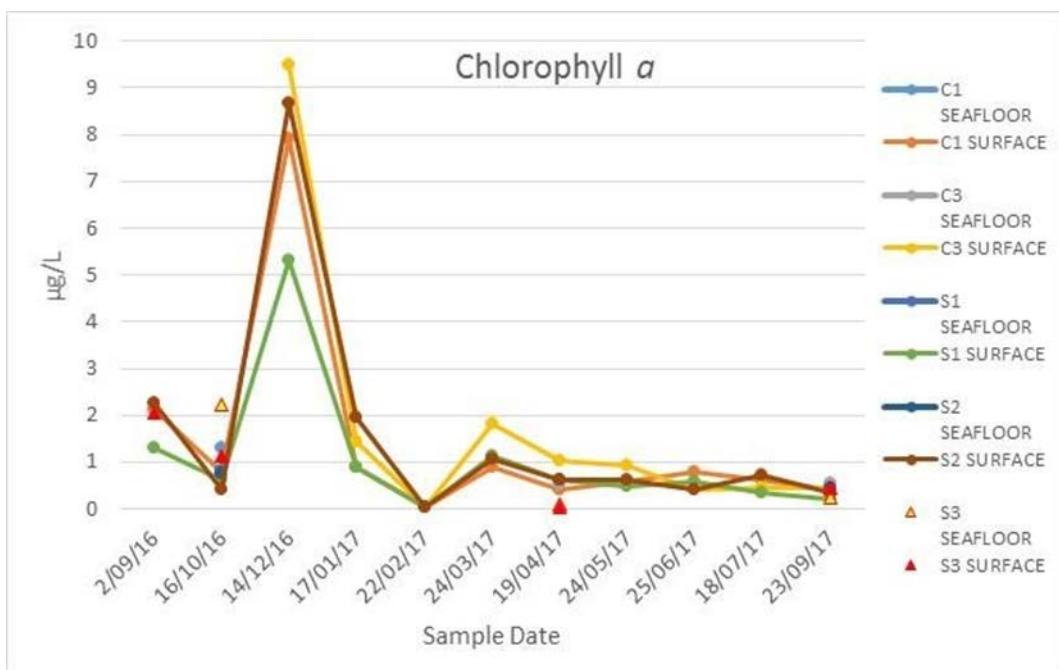
Across all sites, Chlorophyll  $\alpha$  levels ranged from <0.2-0.65 $\mu$ g/L. Mean levels did not differ greatly between surface (0.37  $\mu$ g/L) and seafloor (0.40  $\mu$ g/L) sites.

Figure 30: Monthly Chlorophyll  $\alpha$  levels at sites C1, C3, S1 and S2 (Source: AMD, 2017)

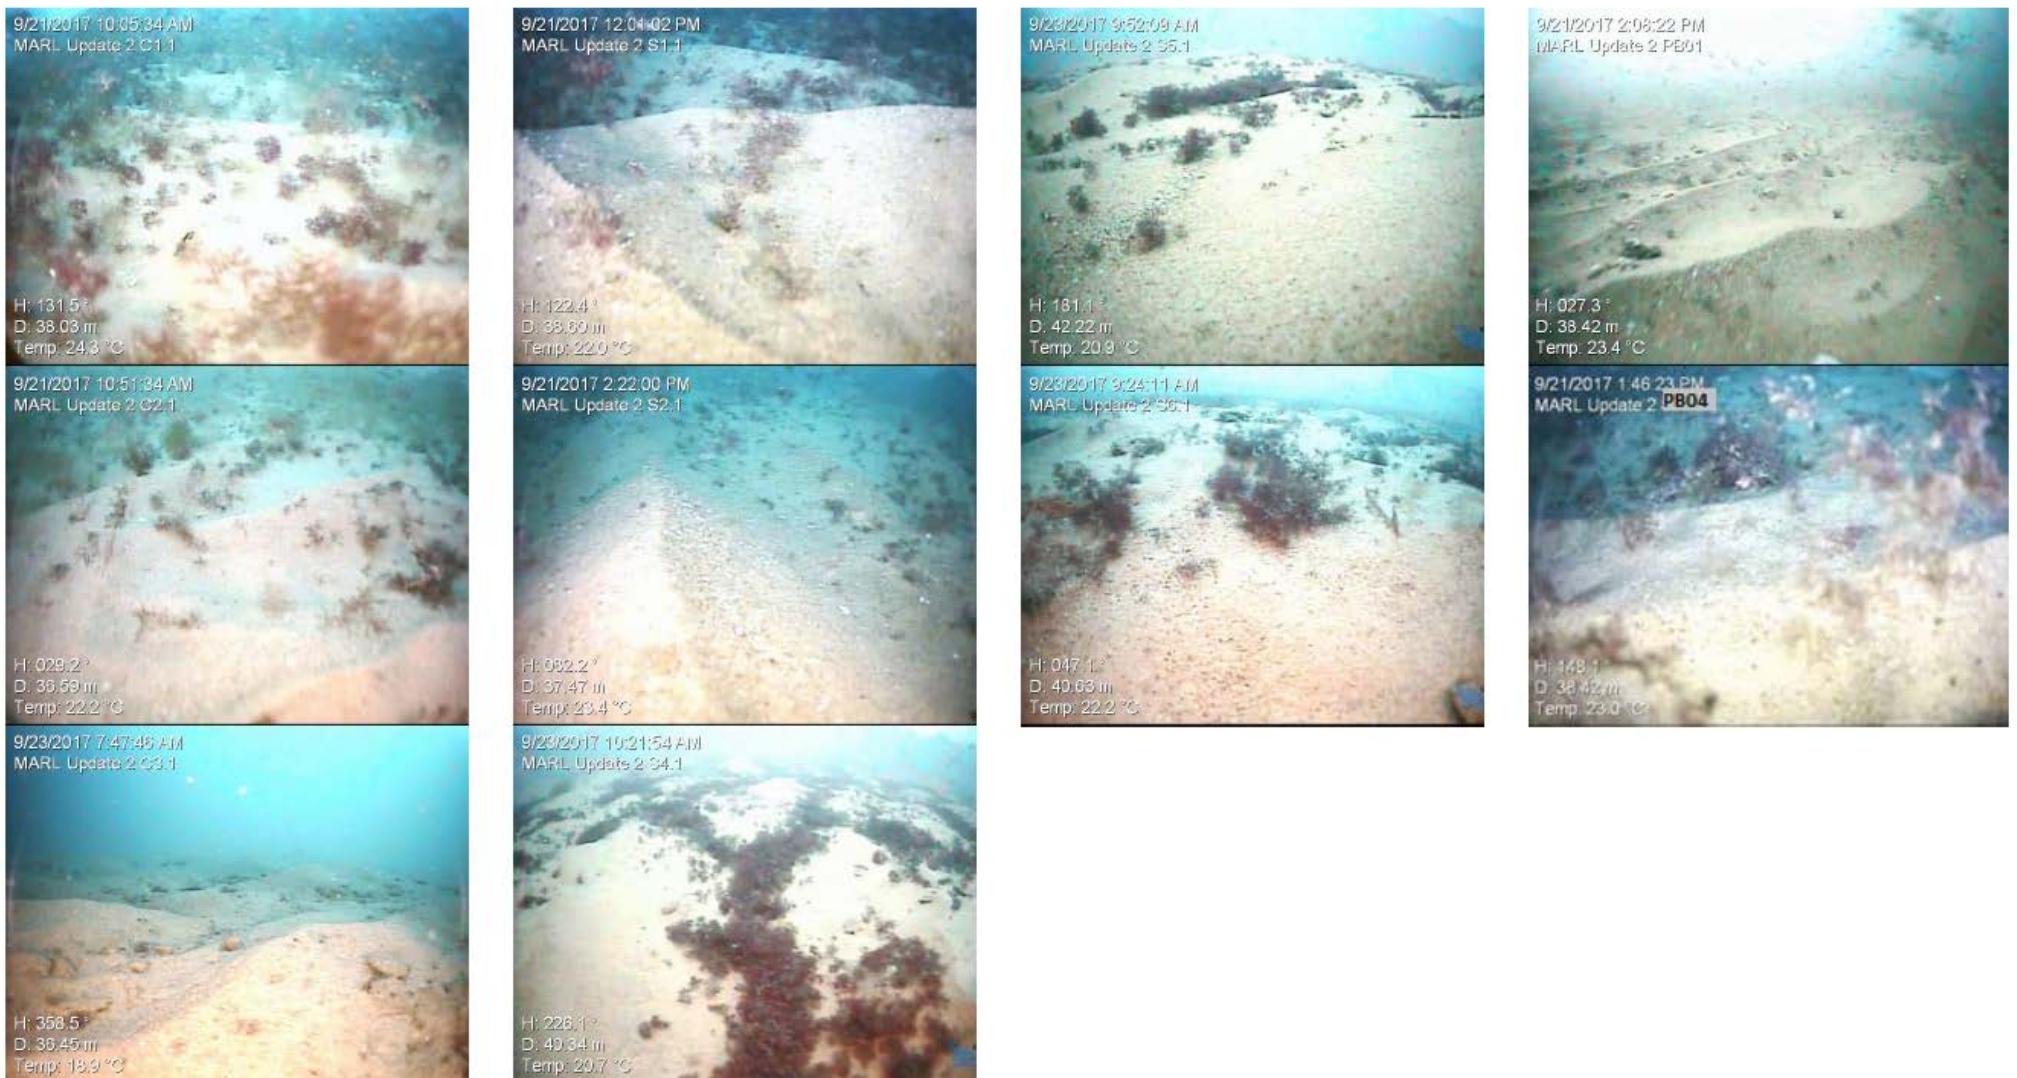
Figure 31: Screenshots of ROV footage from all sites during Update 2 Survey highlighting the presence of drift algae.

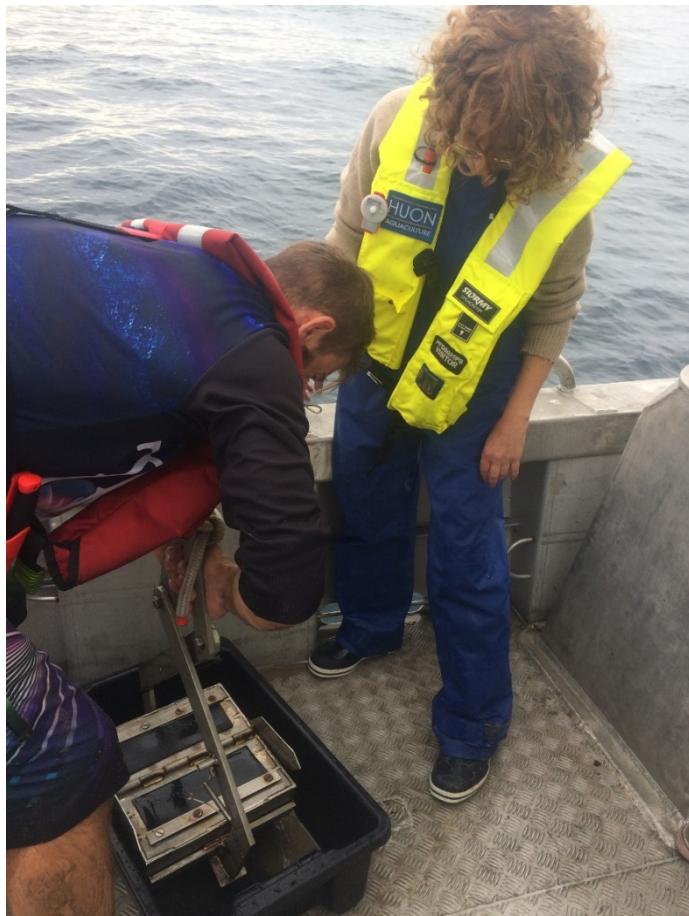
Figure 32: University of Newcastle collecting sediment samples using a Van Veen grab (Source: Huon, 2018).

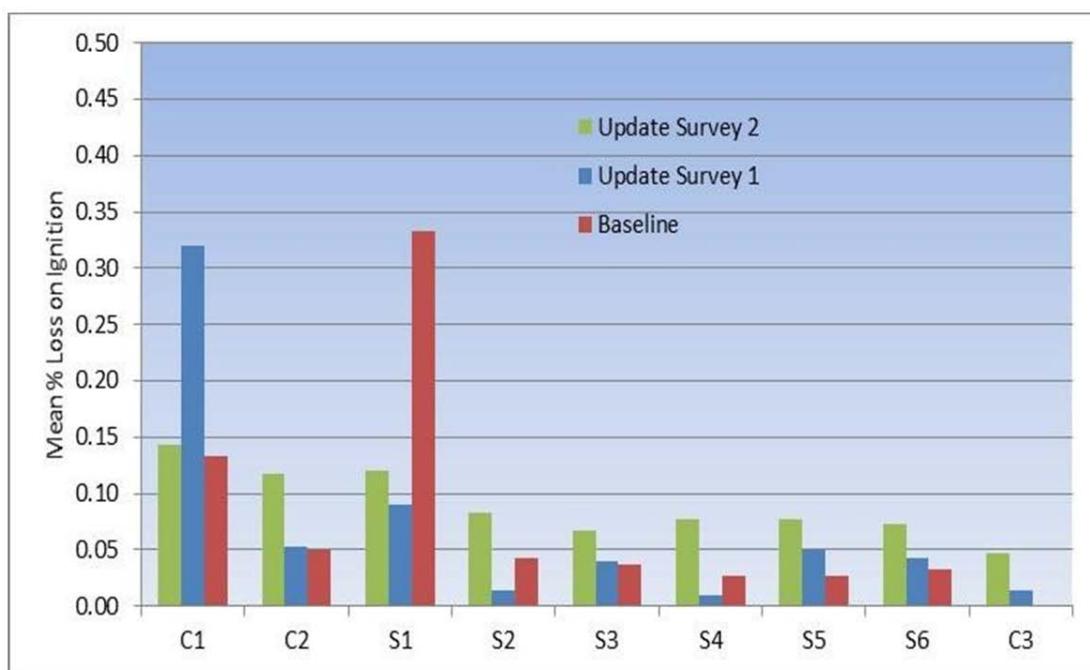
As for both previous surveys, the organic content was very low for all samples, ranging from <0.04% to 0.18% with an average of 0.07% across all samples. Total organic carbon (TOC) levels would appear to be slightly higher in the northern end of the survey area than the south as shown by higher levels at C1, C2 and S1. There would appear to be no significant increase in TOC levels at the pen site (S3) since Baseline. A comparison of the results from all three surveys (Figure 32) shows the relative decrease in organic content at sites C1 and S1 between this and the previous surveys.

Figure 33: TOC comparison between Baseline survey (red) and Update 1 survey (blue) and Update Survey 2 (green) (Source: AMD, 2017).

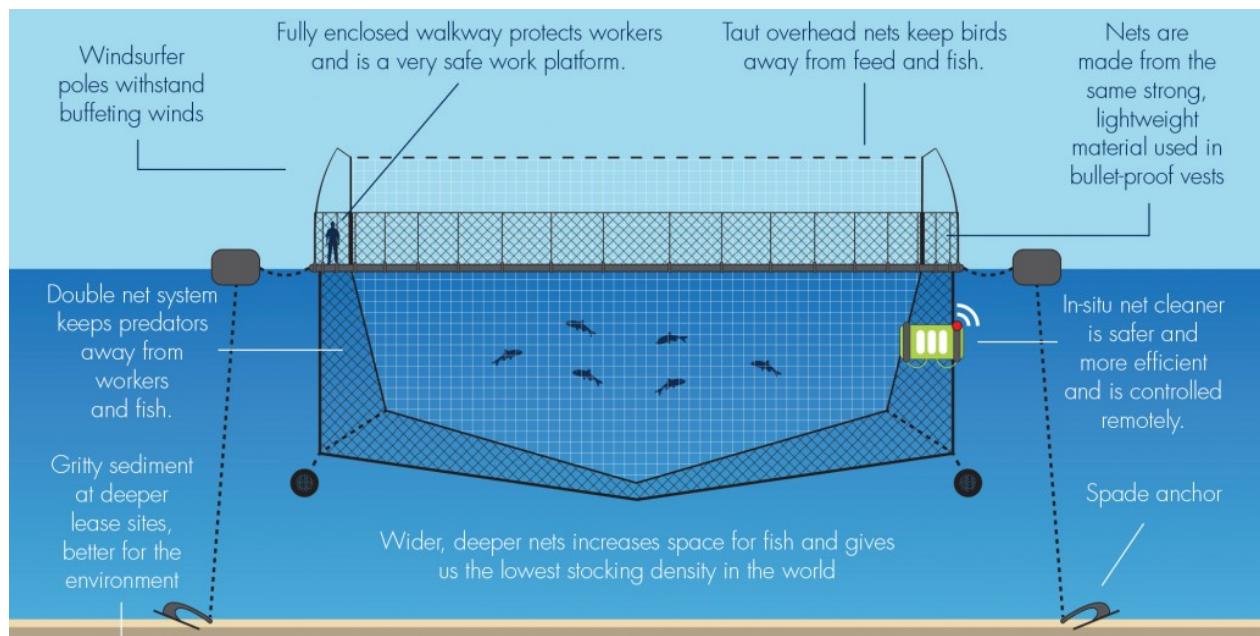
The Huon sea pen design has proven effective in limiting marine fauna interactions on the MARL (Figure 33). The design seeks to prevent marine fauna from entering the pens, accessing stock and fish feed, as well as discourages marine fauna from resting on the infrastructure. The effective prevention of predatory interactions on the MARL has greatly minimised fish stress, injury and loss ([Web Reference 2](#)).

Figure 34: Huon sea pens (Source: Huon Aquaculture, 2017).
