NSW DEPARTMENT OF PRIMARY  
INDUSTRIES

**SITE SUMMARY  
STATUS REPORT**  
GEORGE DOWNES  
DRIVE, MANGROVE  
MOUNTAIN, NSW

Site summary status report  
George Downes Drive, Mangrove Mountain, NSW  
NSW Department of Primary Industries

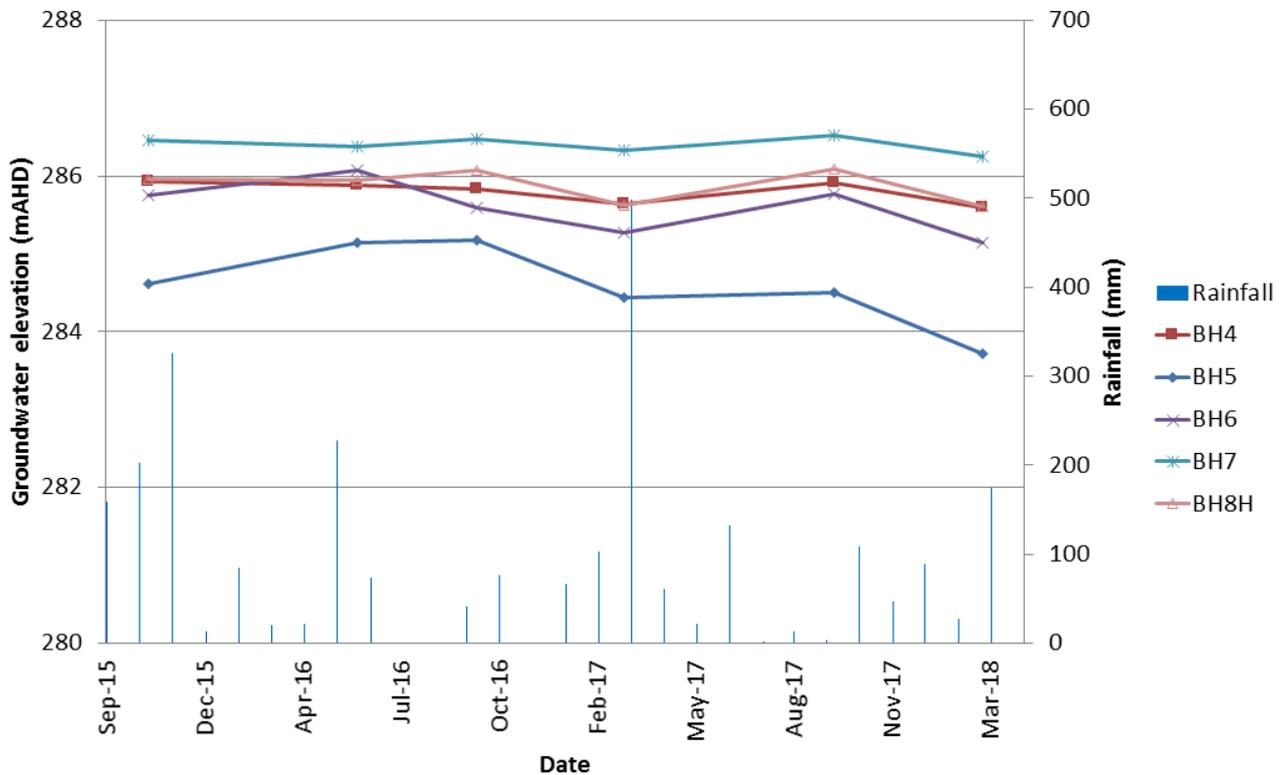
**Chart 1 - Groundwater elevation (mAHD)<sup>(1)</sup> and monthly rainfall at George Down Road - November 2015 to March 2018**

Chart 1 shows groundwater elevations from November 2015 to March 2018 in the five groundwater monitoring wells located at George Downes Drive. The groundwater elevation in the primary monitoring wells ranged between 283.722 mAHD and 286.525 mAHD over the three-year period. Groundwater elevation in each monitoring well did not fluctuate much over time, with most variation evident in BH5. Groundwater elevations in the down gradient monitoring well (BH5) is noticeably lower in elevation than groundwater levels in BH6, BH7 and BH8H, and the nominated up gradient deep monitoring well (BH4), based on surface landscape features. The groundwater elevation in BH7, and in some cases in BH8H, is slightly higher than that measured in the nominated up gradient bore, BH4. Long-term trends in groundwater elevation and rainfall are presented in Appendix A (Figure 4).

- increased recharge through the cap, into the cell and, if the cell is not tight, increased head in surrounding bores;
- possibly the more elevated groundwater pressure measured near BH7 may be caused by that portion of the site having minimal trees whereas other bores (e.g. BH4 and BH8H) are surrounded by established trees that through deep transpiration could be lowering groundwater levels compared to the vicinity of the cell.

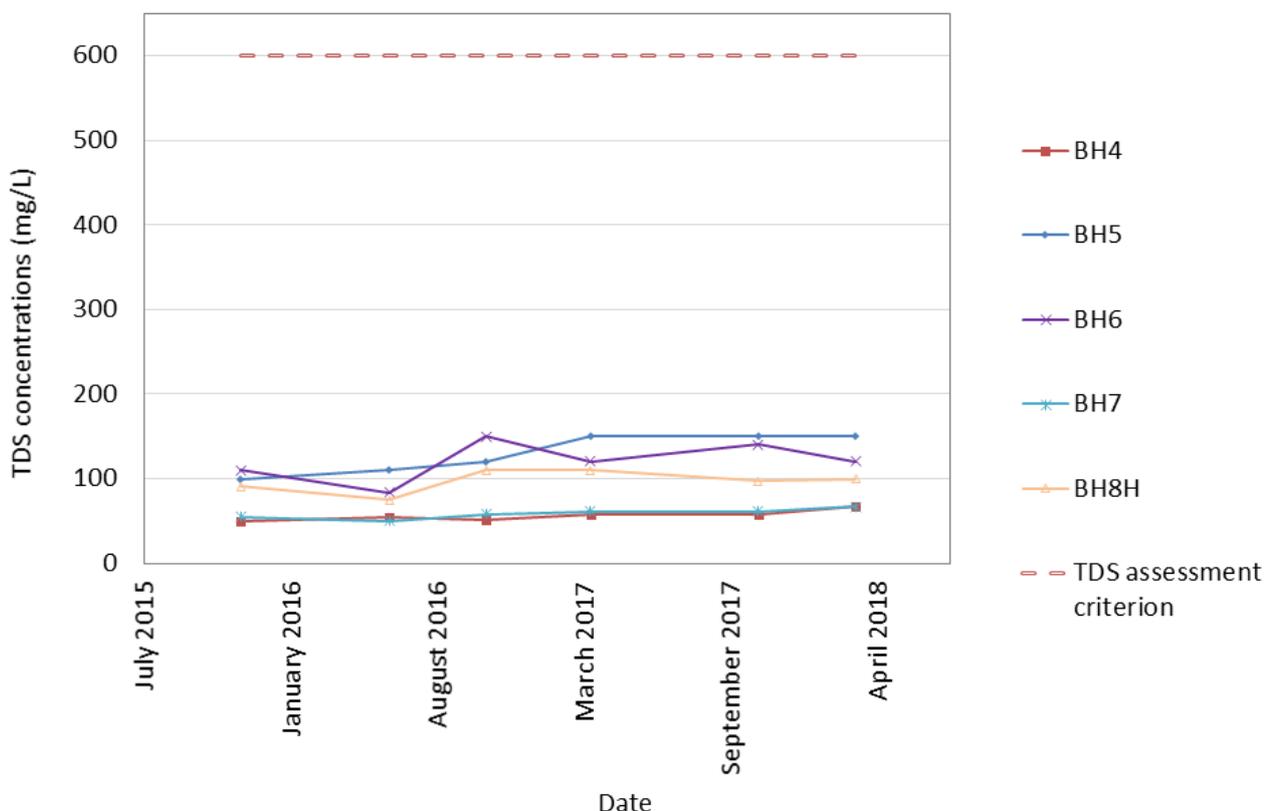
**Chart 2 - Trends in TDS concentrations at George Downes Road**

As shown on Chart 2, concentrations of TDS were generally consistent in each well throughout the monitoring period. However, variation was observed between the wells on the site with TDS concentrations ranging from as low as 50 mg/L in the up gradient well BH4 to concentrations of 150 mg/L in wells BH5 and BH6. These results are all consistent with very fresh groundwater.

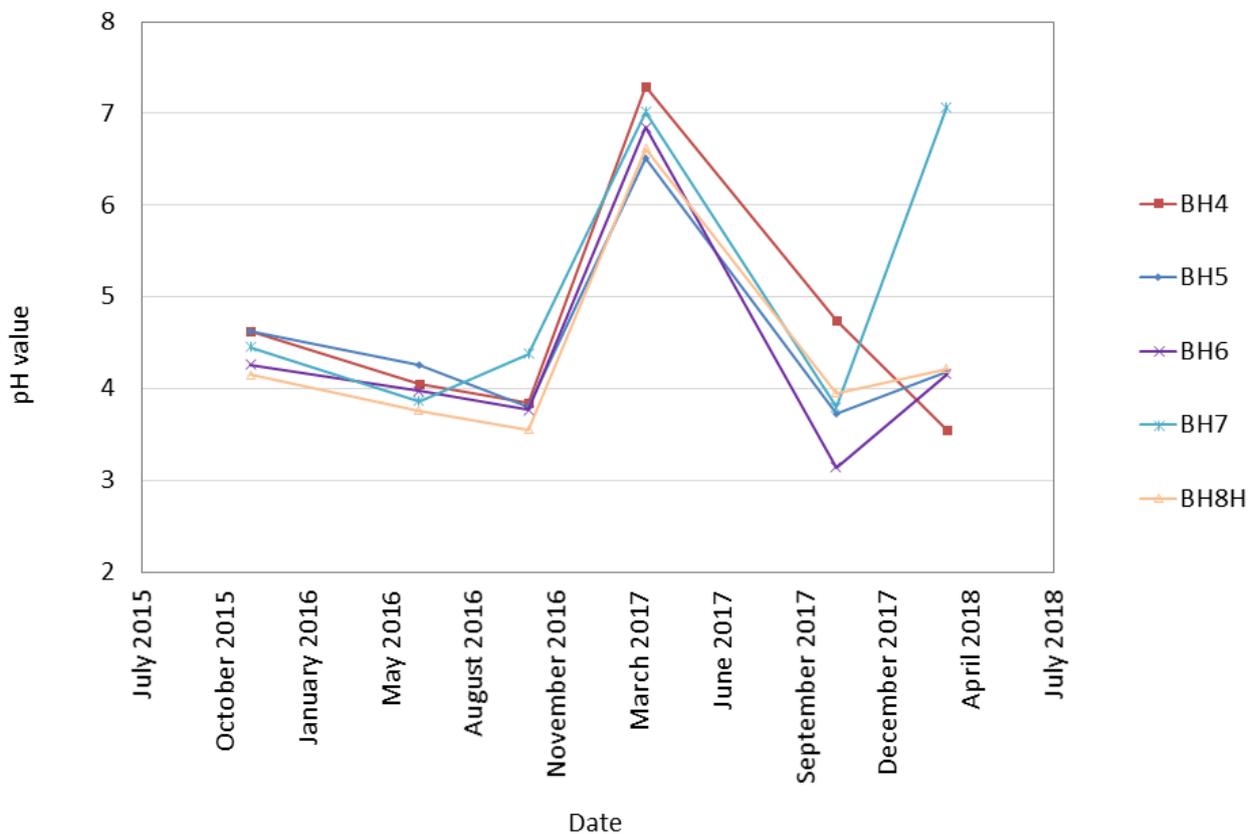
**Chart 3 - Trends in pH at George Downes Road**

Field pH values generally range between 3.1 and 7.3, and fluctuate between GMEs. Relatively high pH values were measure in March 2017 following heavy rainfalls; the near neutral pHs measured during the March GME indicate significant infiltration of rainwater in the groundwater system. Long-term trends in groundwater elevation and rainfall are presented in Appendix A (Figure 4).

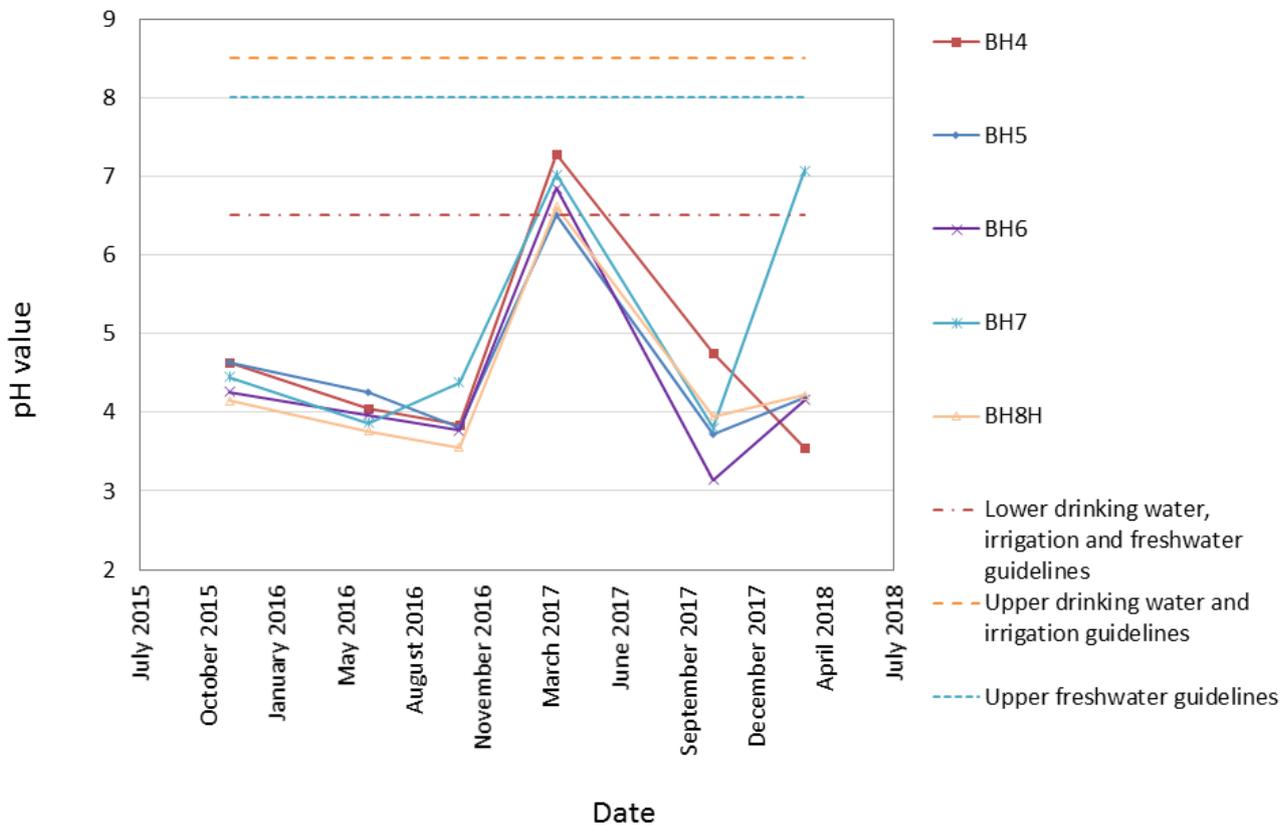
**Chart 4 - pH values in groundwater and guidelines values at George Downes Road, November 2015 to March 2018**

Chart 4. The low pHs detected at the George Downes Drive site reflect the acidic nature of groundwater that interacts with the Hawkesbury Sandstone formation.

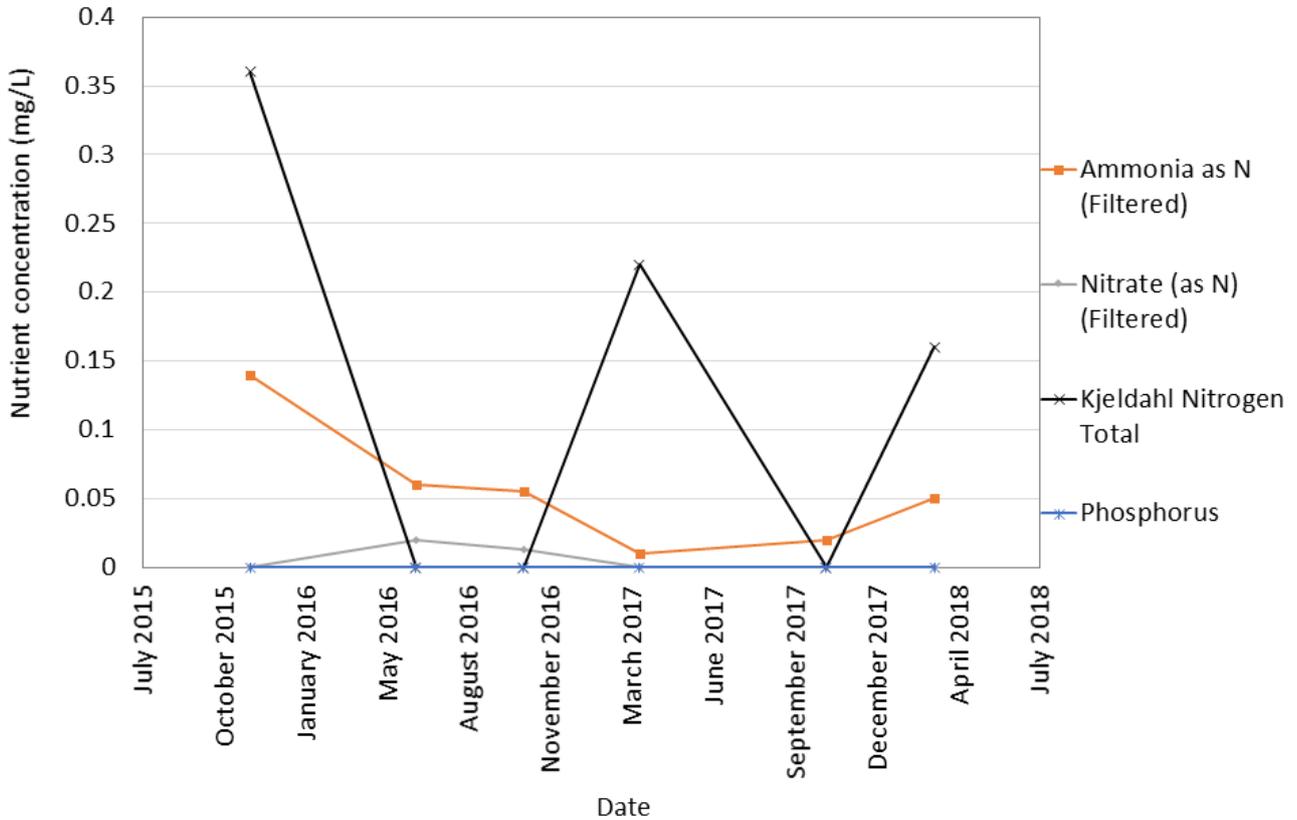
**Chart 5 - Nutrient concentrations in BH5 at George Downes Road**

Nitrogen and phosphorus are released during the decomposition of organic material, including animal carcasses, they are also agricultural fertilisers. Their presence in groundwater downgradient of the burial pit could potentially indicate migration of leachate. Chart 5 presents the trends in key nutrients in the most down gradient well, BH5. While nitrate (as nitrogen-N) and phosphorous concentrations remained stable between November 2015 and March 2018, total Kjeldahl nitrogen showed fluctuations. Ammonia (as nitrogen-N) concentrations presented a slight decrease over time in well BH5.

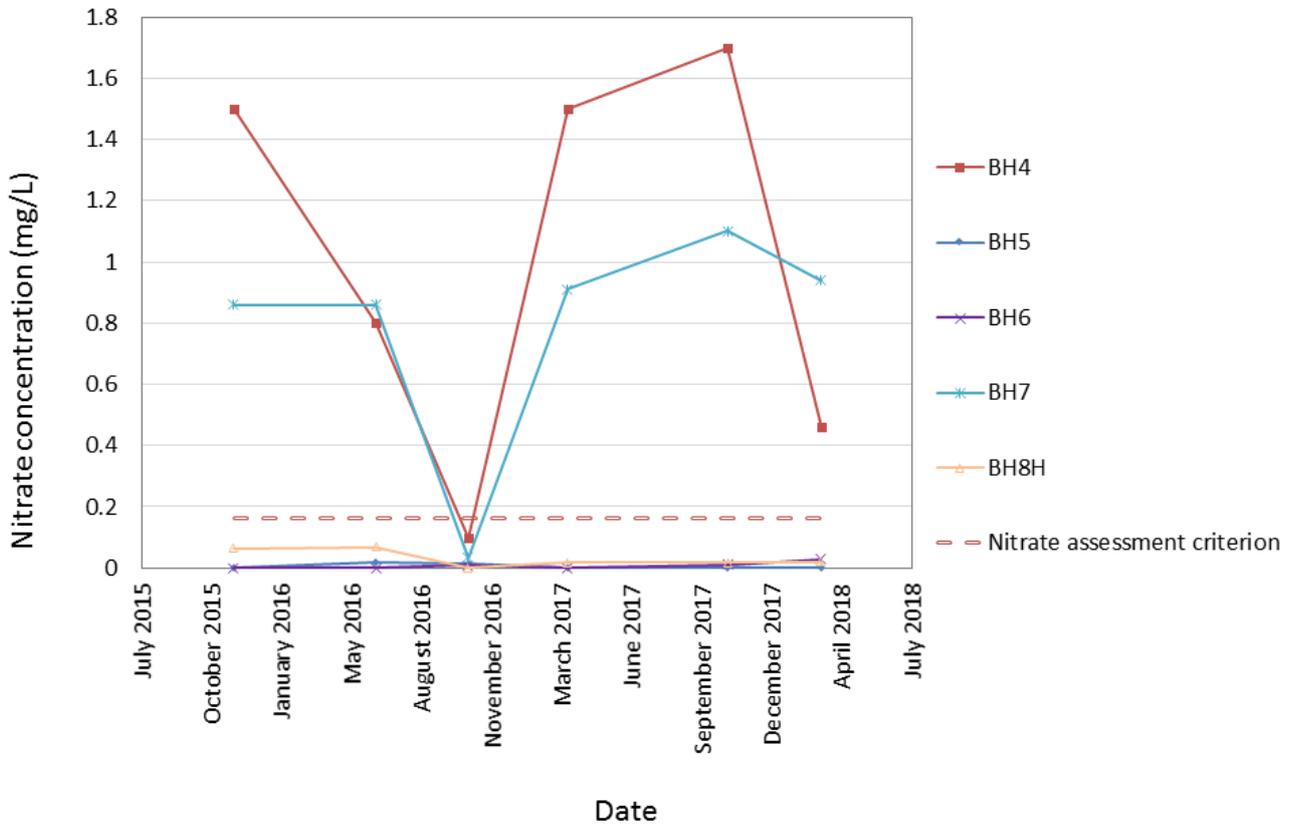
**Chart 6 - Nitrate (as N) concentrations and adopted assessment criterion at George Downes Road, November 2015 to March 2018**

Concentrations of nitrate (as N) in groundwater collected from the down gradient well BH5 remained low, below the adopted assessment criterion, and relatively stable between November 2015 and March 2018 (Chart 6). Similar concentration trends were presented by wells BH6 and BH8H. In contrast, nitrate concentrations detected in wells BH4 (thought to be up gradient) and BH7 were high and showed relatively high degree of variations over time, with values below and above the adopted assessment criterion.

Concentrations of nitrate (as N) in groundwater consistently remained above the adopted assessment criterion for the protection of freshwater ecosystems (0.16 mg/L) in up gradient well BH4 and down gradient well BH7, as presented on Chart 6. The only exception was during the GME undertaken in October 2016, when groundwater samples collected from wells BH4 and BH7 showed nitrate (as N) concentrations below the adopted assessment criterion. It is possible the nitrate presence is predominantly due to regional nitrate from agricultural activities rather than leakage from the cell, particularly due to the presence in the (assumed) up-gradient location BH4.

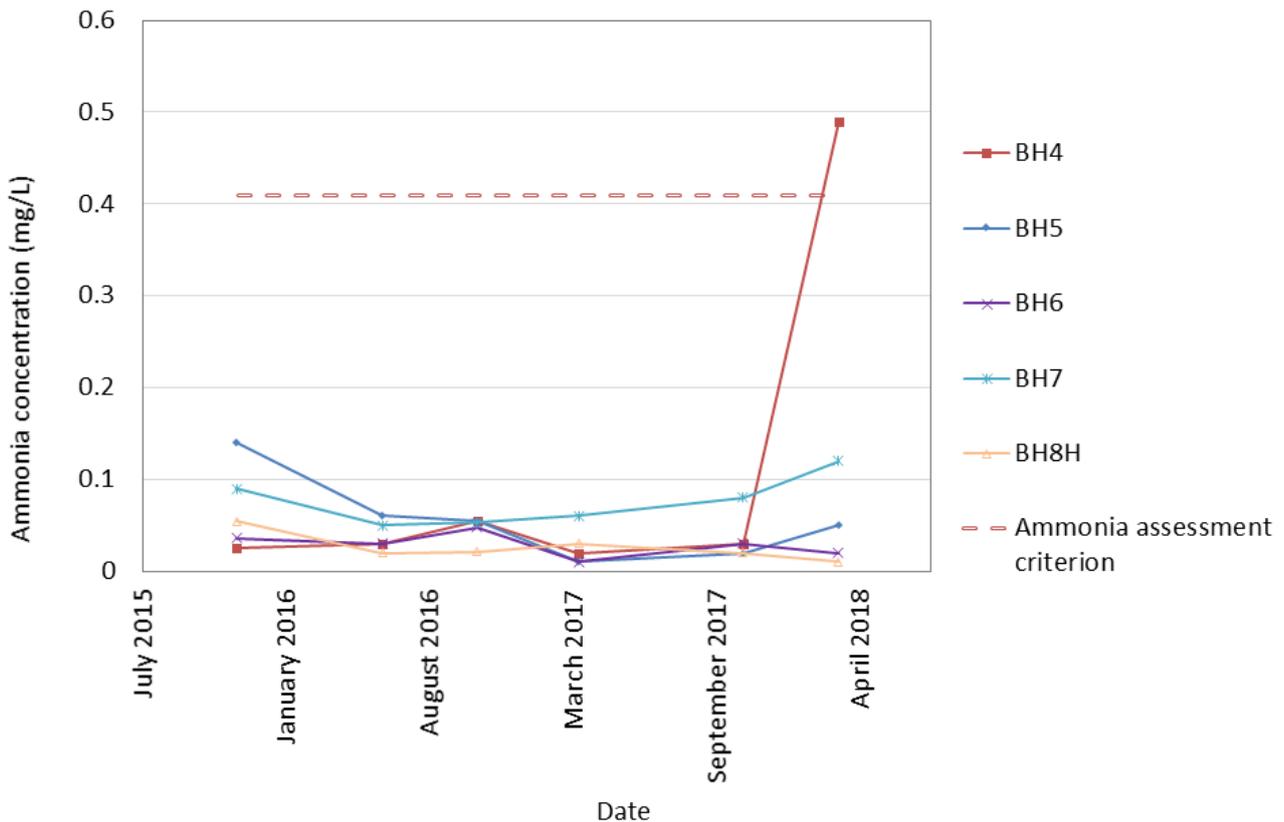
**Chart 7 - Ammonia (as N) concentrations and adopted assessment criterion at George Downes Road, November 2015 to March 2018**

Concentration of ammonia (as N) in all monitoring wells on the site did not fluctuate significantly between November 2015 and March 2018, generally ranging from values equal to the LOR (0.01 mg/L) to 0.14 mg/L. The only exception was the ammonia (as N) concentration detected in the up gradient well BH4 during the March 2018 GME, which was significantly higher than any other measured concentration and above the assessment criterion of 0.41 mg/L. This should be monitored closely in subsequent rounds, though it is noted that occasional elevated levels of ammonia at this location have occurred in the past (2013). Concentration trends in down gradient well BH5 are presented on Chart 7 and Chart 5.

The adopted assessment criterion for ammonia of 0.41 mg/L was exceeded only in one case throughout the monitoring period, as shown on Chart 7. In March 2018, the groundwater sample collected from up gradient well BH4 showed an ammonia concentration of 0.49 mg/L. All remaining samples collected between November 2015 and March 2018 presented ammonia concentrations below the laboratory assessment criterion.

The elevated ammonia (as N) concentration observed in BH4 in March 2018 is considered likely to be indicative of regional sources, e.g. due to the intensive agricultural land use around the Kulnura- Mangrove Mountain locality.

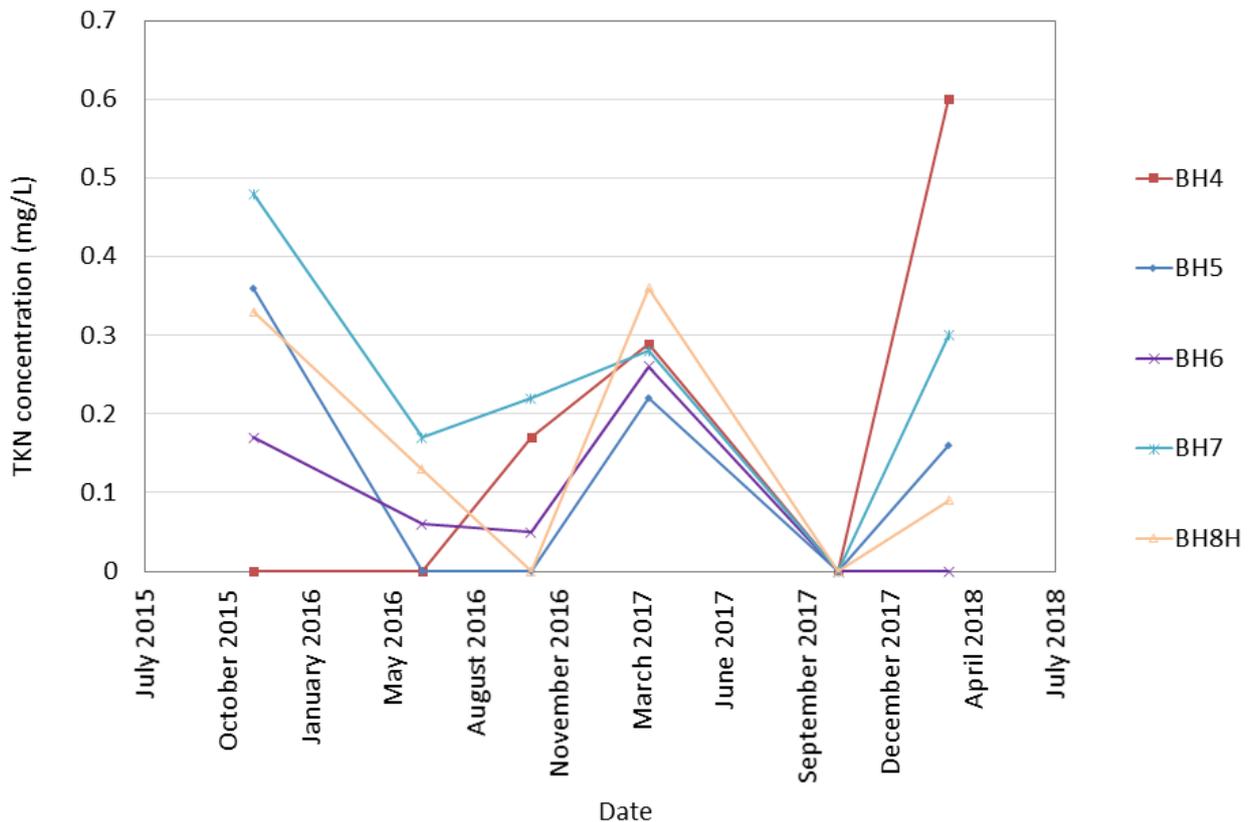
**Chart 8 - TKN concentrations at George Downes Road, November 2015 to March 2018**

TKN concentrations were similar in all groundwater monitoring wells in the period from November 2015 to March 2018, ranging between the laboratory LOR (0.05 mg/L) and 0.6 mg/L, as presented on Chart 8. The highest TKN concentration was recorded in the groundwater sample collected from BH4 in March 2018. This is possibly a reflection of background elevated nitrogen (in various forms) in BH4.

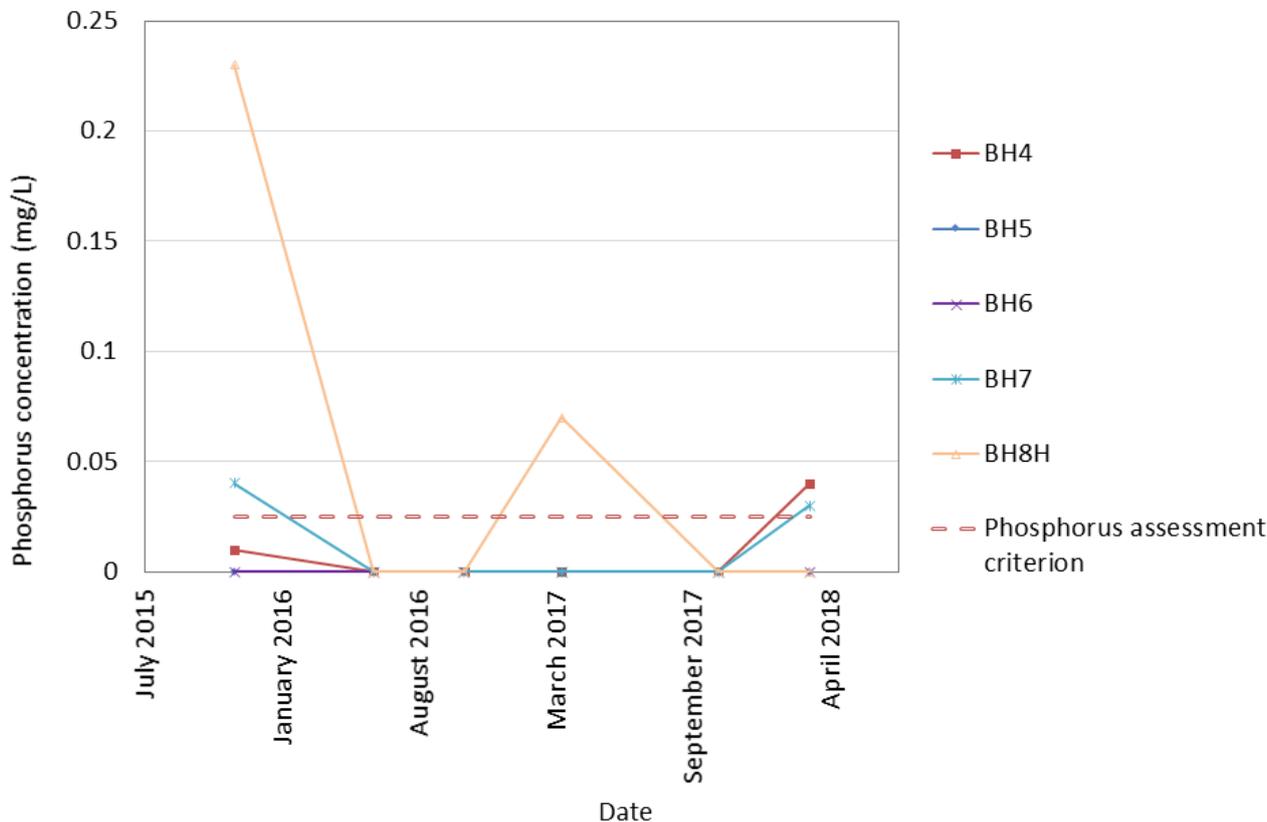
**Chart 9 - Phosphorus concentrations and adopted assessment criterion at George Downes Road, November 2015 to March 2018**

showed a higher variability, with phosphorus concentrations ranging from values lower than the LOR to 0.23 mg/L. No clear pattern are apparent.

Total phosphorus has been reported above the adopted assessment criteria for the protection of freshwater aquatic ecosystems in up gradient well BH4 (March 2018), BH7 (November 2015 and March 2018) and BH8H (November 2015 and March 2017) with no apparent pattern to the fluctuation. There are no guidelines established for phosphorus for the protection of human health or aesthetic criteria.

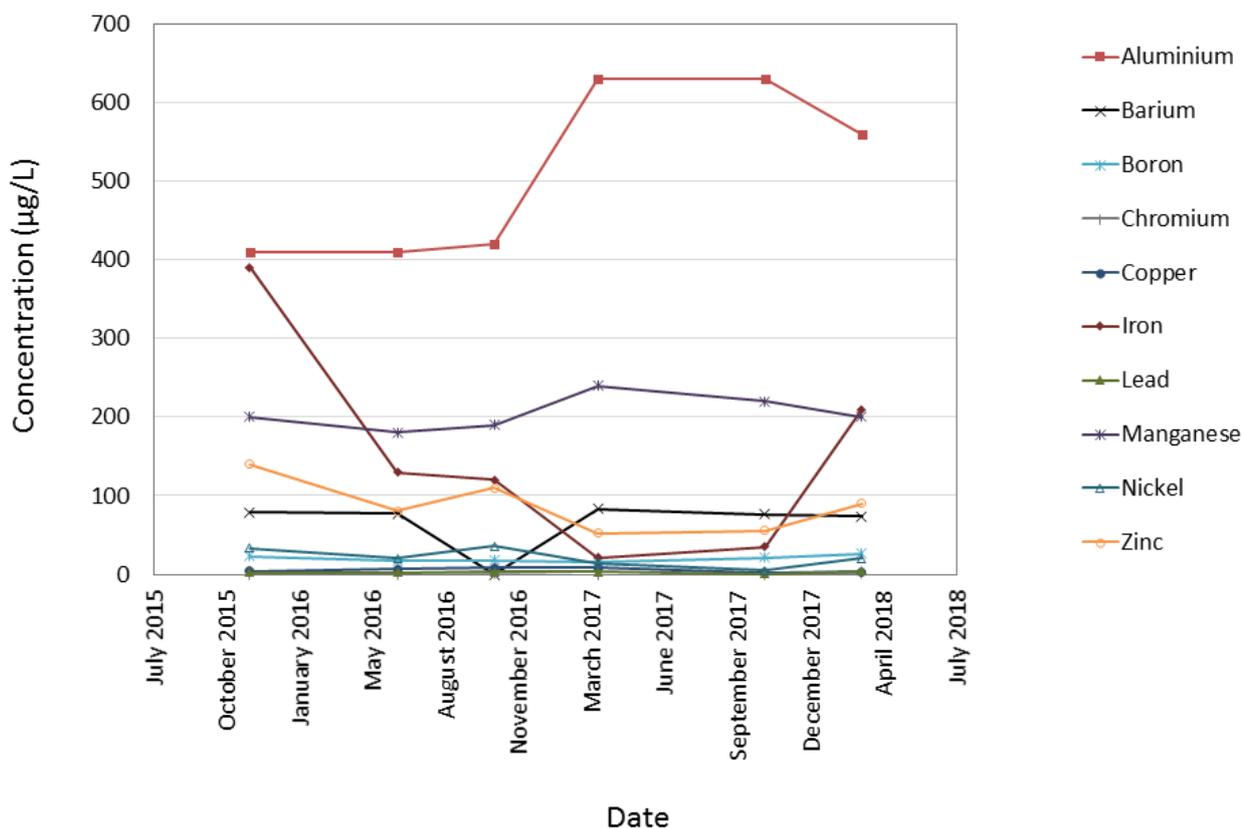
**Chart 10 - Metal concentrations in BH5 at George Downes Road**

Concentrations of barium, boron, chromium, copper, lead, manganese, nickel and zinc in well BH5 fluctuated slightly between November 2015 and March 2018. An increasing trend was also presented by aluminium concentrations, which rose from about 400 µg/L to 560 throughout the monitoring period. Iron concentrations in down gradient well BH5 were variable and declined from 390 µg/L in November 2015 to 21 µg/L in March 2017, and then rose to 210 µg/L between March 2017 and March 2018.

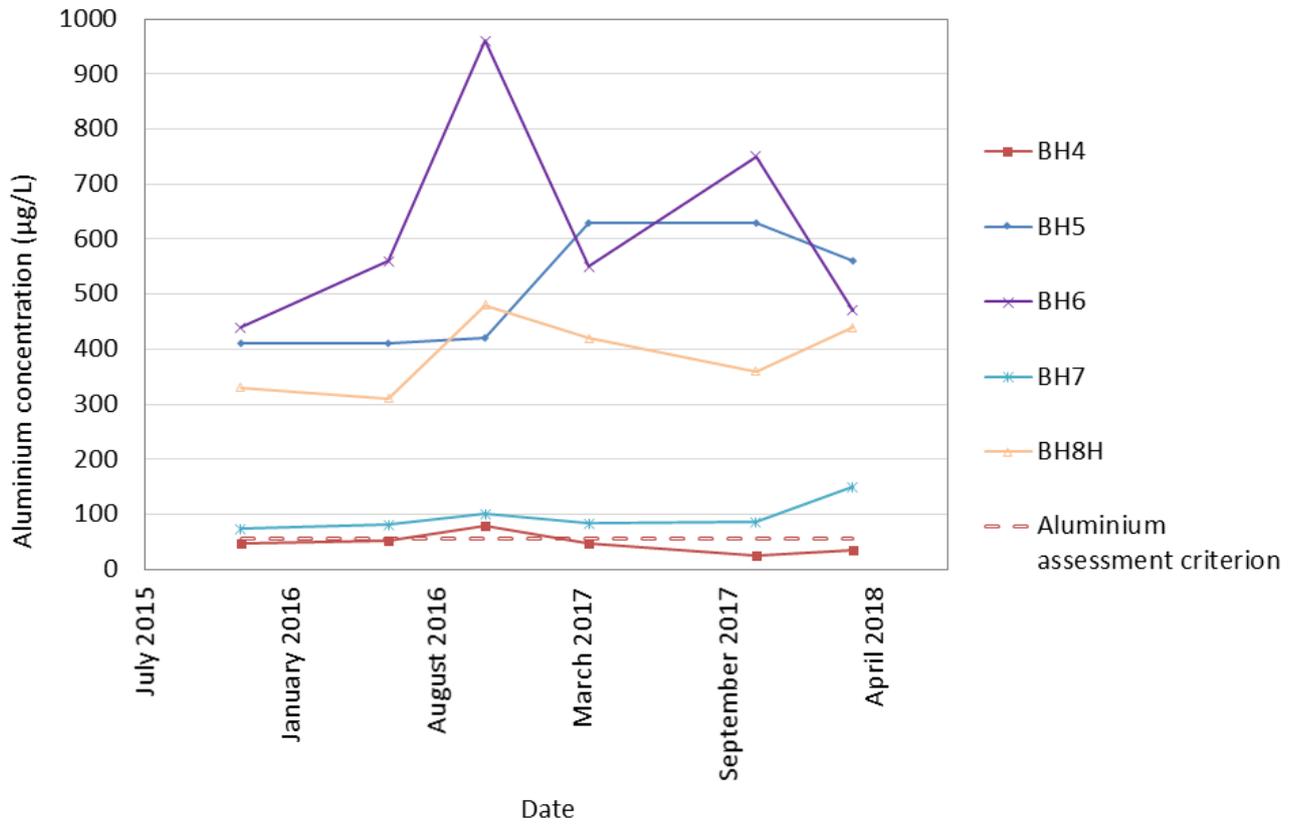
**Chart 11 - Aluminium concentrations and adopted assessment criterion at George Downes Road, November 2015 to March 2018**

During all GMEs, the highest concentrations were presented in downgradient wells BH6 and BH5. Considering the natural chemical conditions of the local aquifer, WSP considers the results are likely to be due to the acidity of the local groundwater resulting in greater dissolution of heavy metals from the aquifer matrix. ANZECC (2000) only provides an aluminium criterion for groundwater with a pH greater than 6.5 as there is insufficient data for groundwater with a pH lower than 6.5. The aluminium concentrations also exceeded the aesthetic drinking water guideline criterion of 200 µg/L in BH5, BH6 and BH8H.

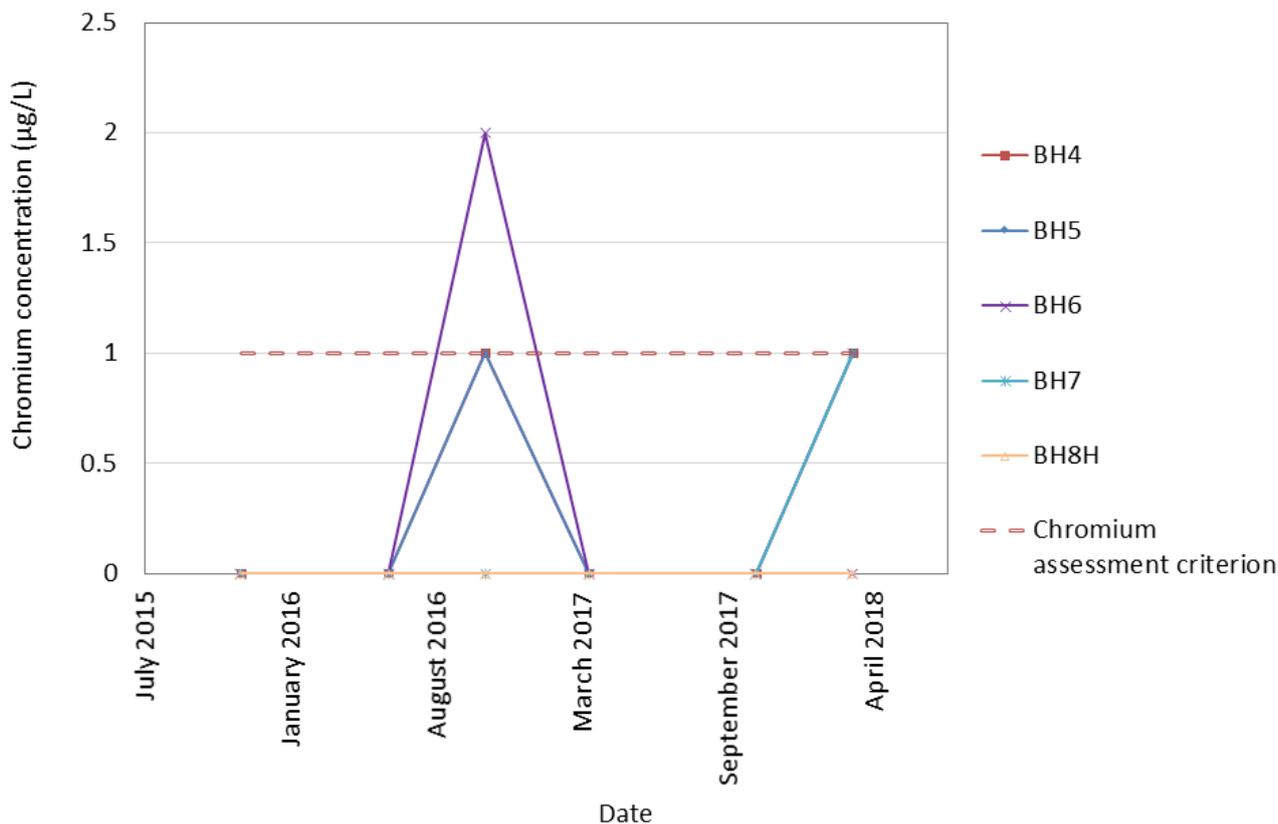
**Chart 12 - Chromium concentrations and adopted assessment criterion at George Downes Road, November 2015 to March 2018**

Concentrations of chromium were only reported above the adopted assessment criterion (1 µg/L) in well BH6 in October 2016 (2 µg/L), as presented on Chart 12. These sporadic chromium results are unlikely to be due to leakage from the cell but more likely natural variability.

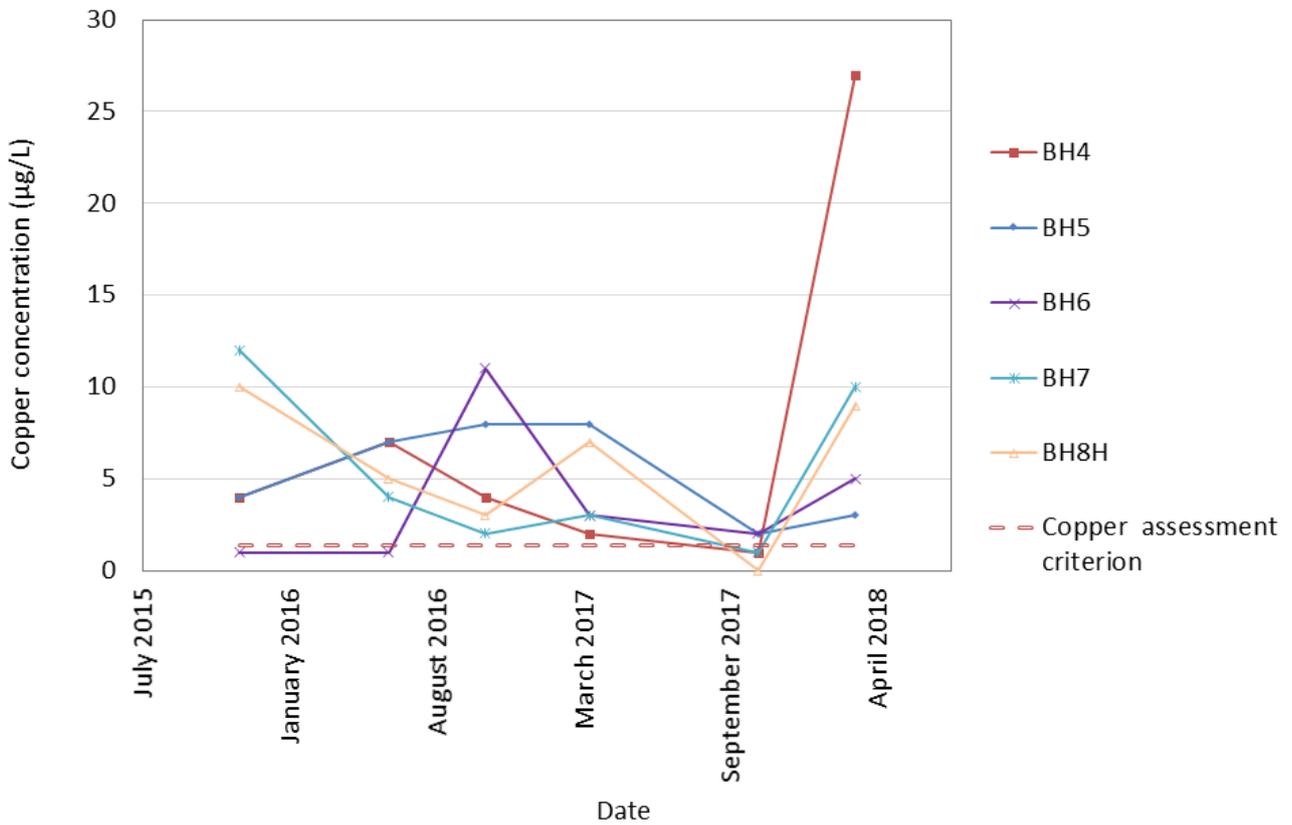
**Chart 13 - Copper concentrations and adopted assessment criterion at George Downes Road, November 2015 to March 2018**

Copper concentrations were generally reported at levels approaching or above the adopted assessment criterion of 1.4 µg/L in most occasions since November 2015. The concentrations of copper on the site were considered representative of background levels.

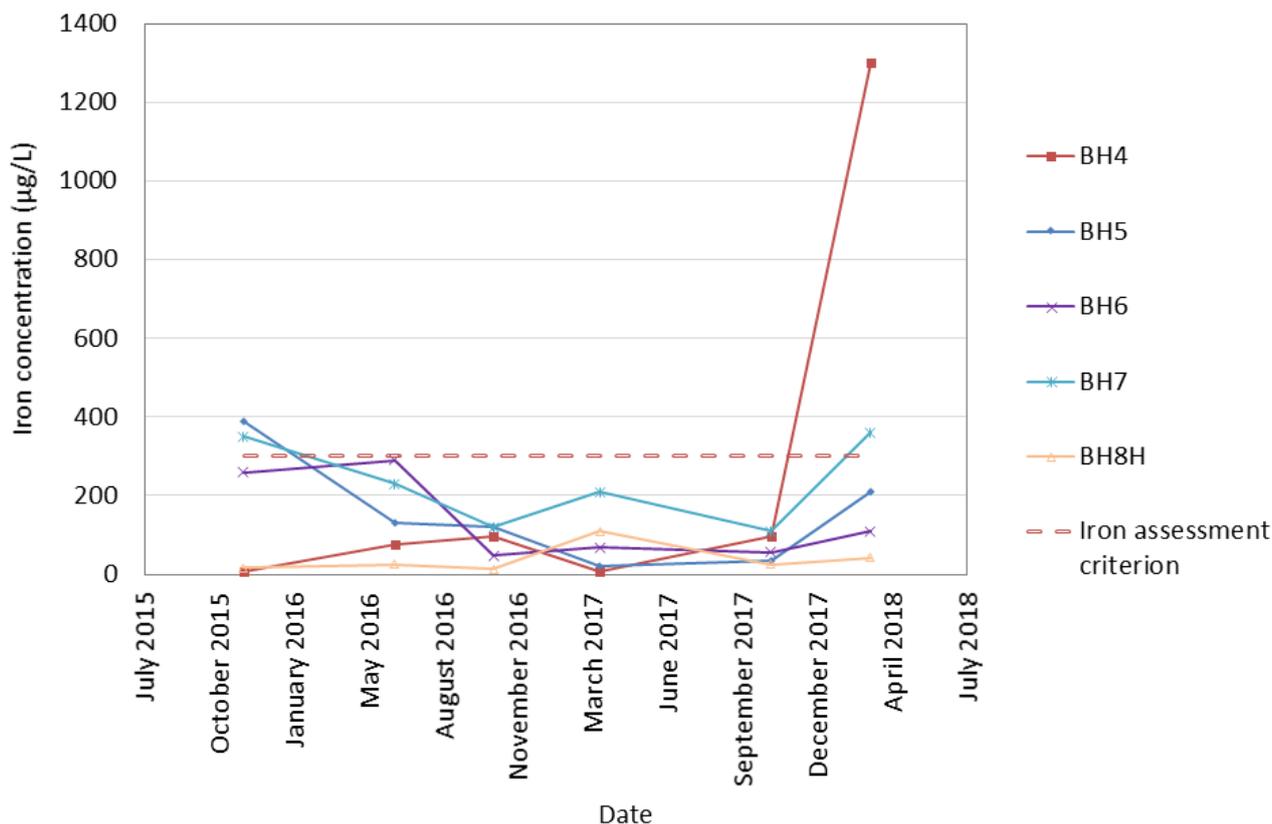
**Chart 14 - Iron concentrations and adopted assessment criterion at George Downes Road, November 2015 to March 2018**

Iron concentrations in groundwater samples collected from the George Downes Drive site were normally lower than the recreational assessment criterion of 300 µg/L during the monitoring period. A total of four exceedances occurred in November 2015 (BH5 and BH7) and in March 2018 (BH4 and BH7), with the highest concentration presented by up gradient well BH4 (1,300 µg/L). Hence, the iron concentrations above the assessment criterion are likely due to naturally high iron levels in the local aquifer under the low pH conditions.

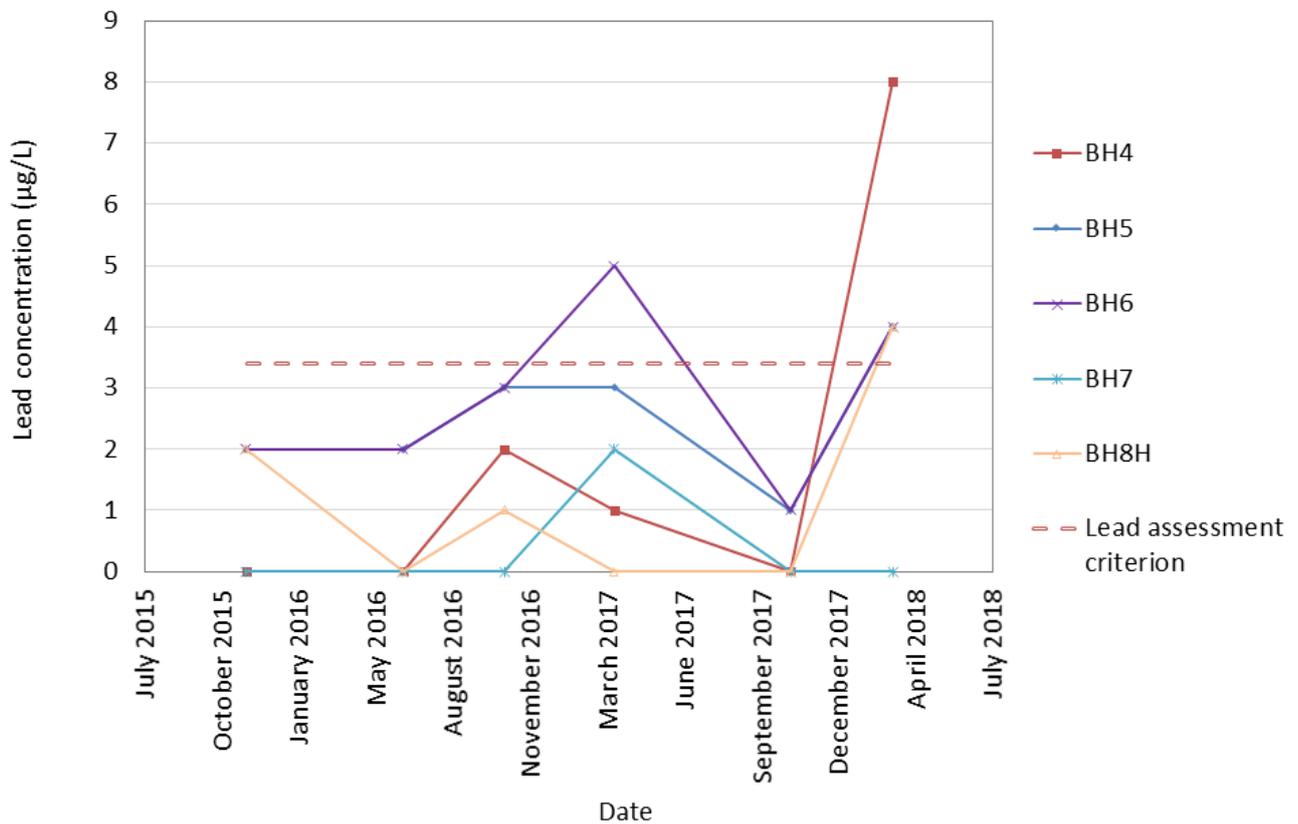
**Chart 15 - Lead concentrations and adopted assessment criterion at George Downes Road, November 2015 to March 2018**

Concentrations of lead were generally below the adopted assessment criterion (3.4 µg/L), as presented in Chart 15. The only exceptions were the groundwater samples collected from BH6 in March 2016, and BH4 (up gradient), BH6 and BH8 in March 2018. Up gradient well BH4 presented the highest lead concentration at the site, indicating that relatively high levels of lead are representative of background levels.

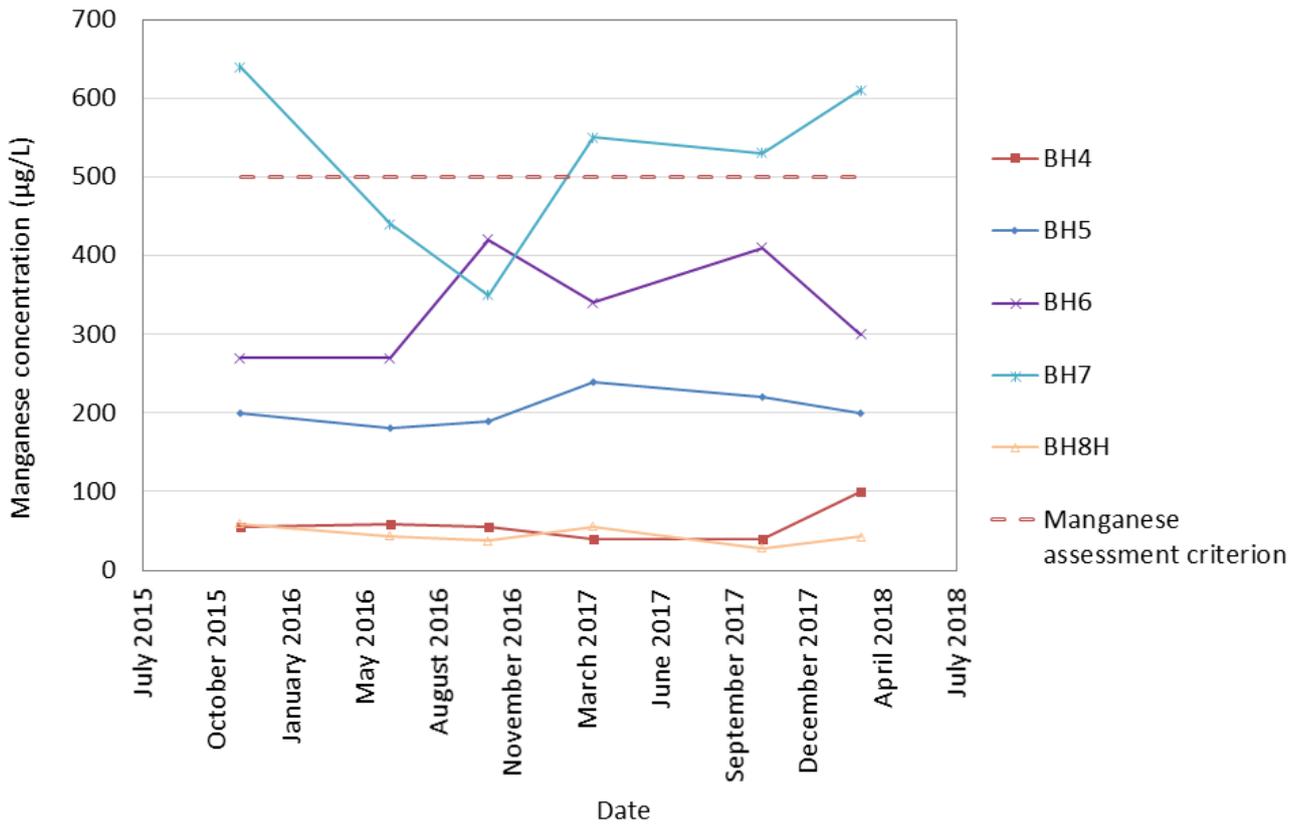
**Chart 16 - Manganese concentrations and adopted assessment criterion at George Downes Road, November 2015 to March 2018**

Manganese concentrations, presented in Chart 16, exceeded the drinking water assessment criterion of 500 µg/L only in downgradient well BH7, in four of the six groundwater monitoring events. The remaining up gradient and downgradient wells showed manganese levels below the assessment criterion. It is presumed the levels observed are likely to be due to natural sources under the low pH conditions.

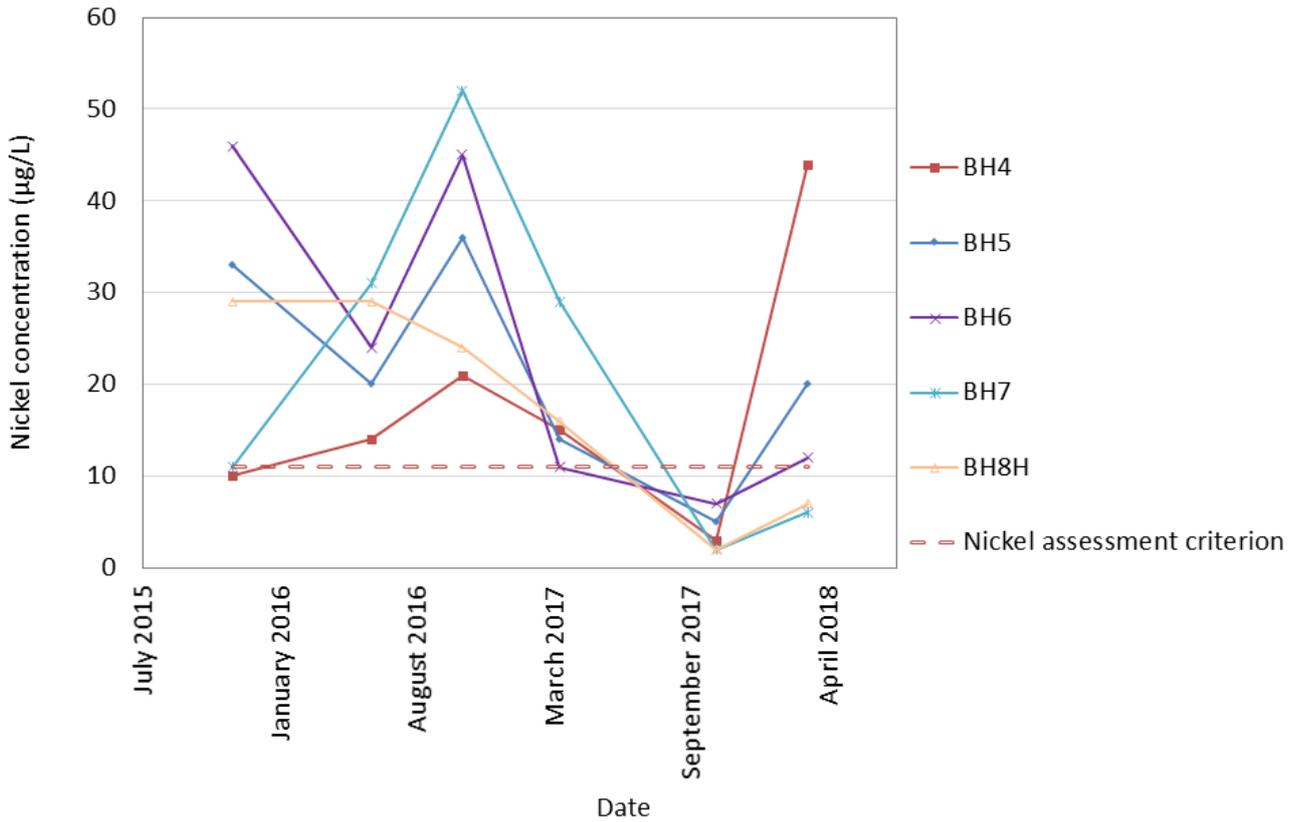
**Chart 17 - Nickel concentrations and adopted assessment criterion at George Downes Road, November 2015 to March 2018**

Concentrations of nickel were generally reported at levels above the adopted assessment criterion of 11 µg/L, and above the Australian drinking water guideline level (20 µg/L), in most wells since November 2015 (Chart 17). An exception was the GME undertaken in November 2017, during which all wells showed nickel concentrations below the assessment criteria. Up gradient well BH4 has historically had amongst the highest nickel concentrations on the site. Thus, the concentrations of nickel on the site were considered representative of the background levels under low pH conditions.

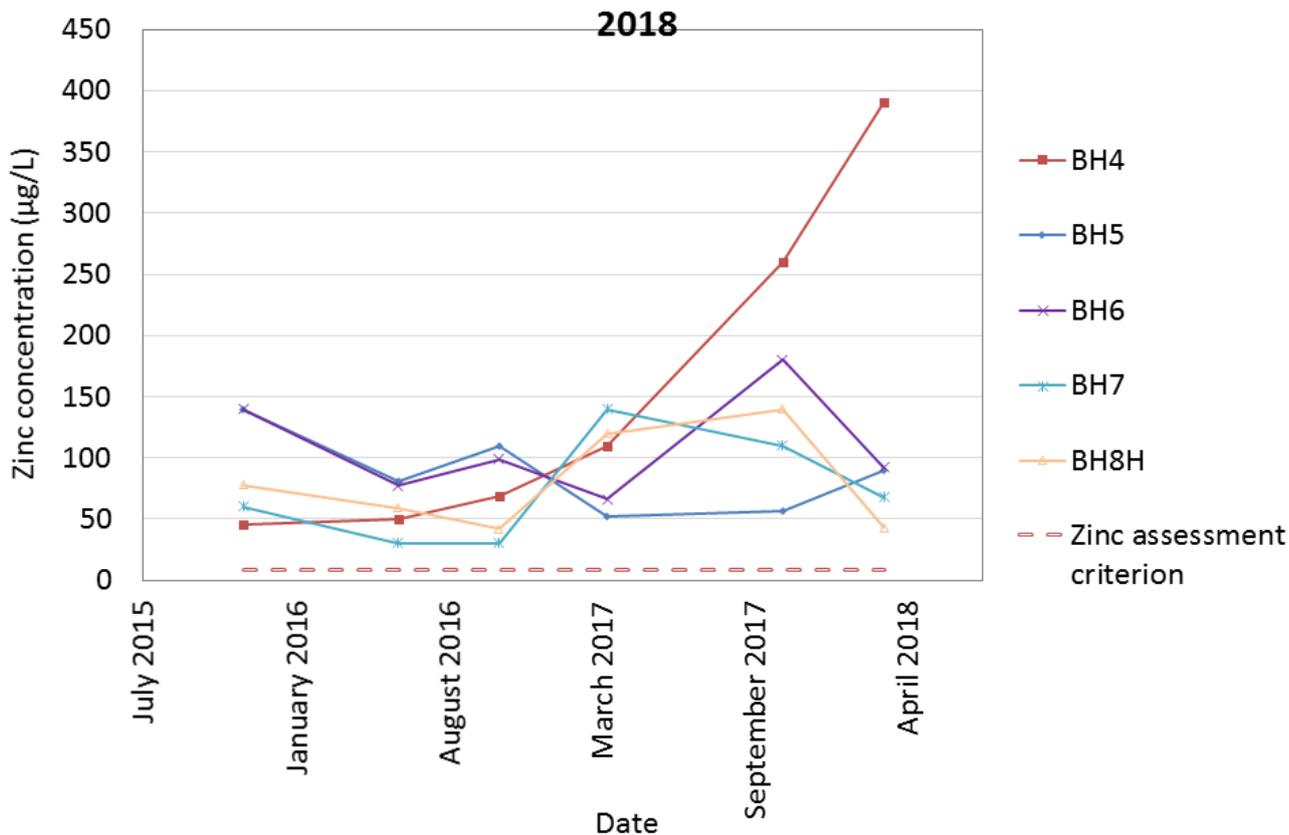
**Chart 18 - Zinc concentrations and adopted assessment criterion at George Downes Road, November 2015 to March 2018**

Zinc levels have remained above the adopted assessment criterion of 8 µg/L in both up and down gradient monitoring wells between November 2015 and March 2018. While zinc concentrations remained relatively stable in down and cross gradient wells BH5, BH6, BH7 and BH9H, they gradually increased in up gradient well BH4 from 45 µg/L to 390 µg/L. The high zinc concentrations on the site were considered generally representative of background levels, though the rising trend in BH4 warrants ongoing assessment. Nevertheless, it is noted that zinc in BH4 has fluctuated up to similar levels in the past (March 2014). There is no established health guideline level for zinc in the Australian Drinking Water Guidelines (2000).
