NSW DEPARTMENT OF PRIMARY  
INDUSTRIES

**SITE SUMMARY  
STATUS REPORT**  
GEORGE DOWNES  
DRIVE, MANGROVE  
MOUNTAIN, NSW

Site summary status report  
George Downes Drive, Mangrove Mountain, NSW  
NSW Department of Primary Industries

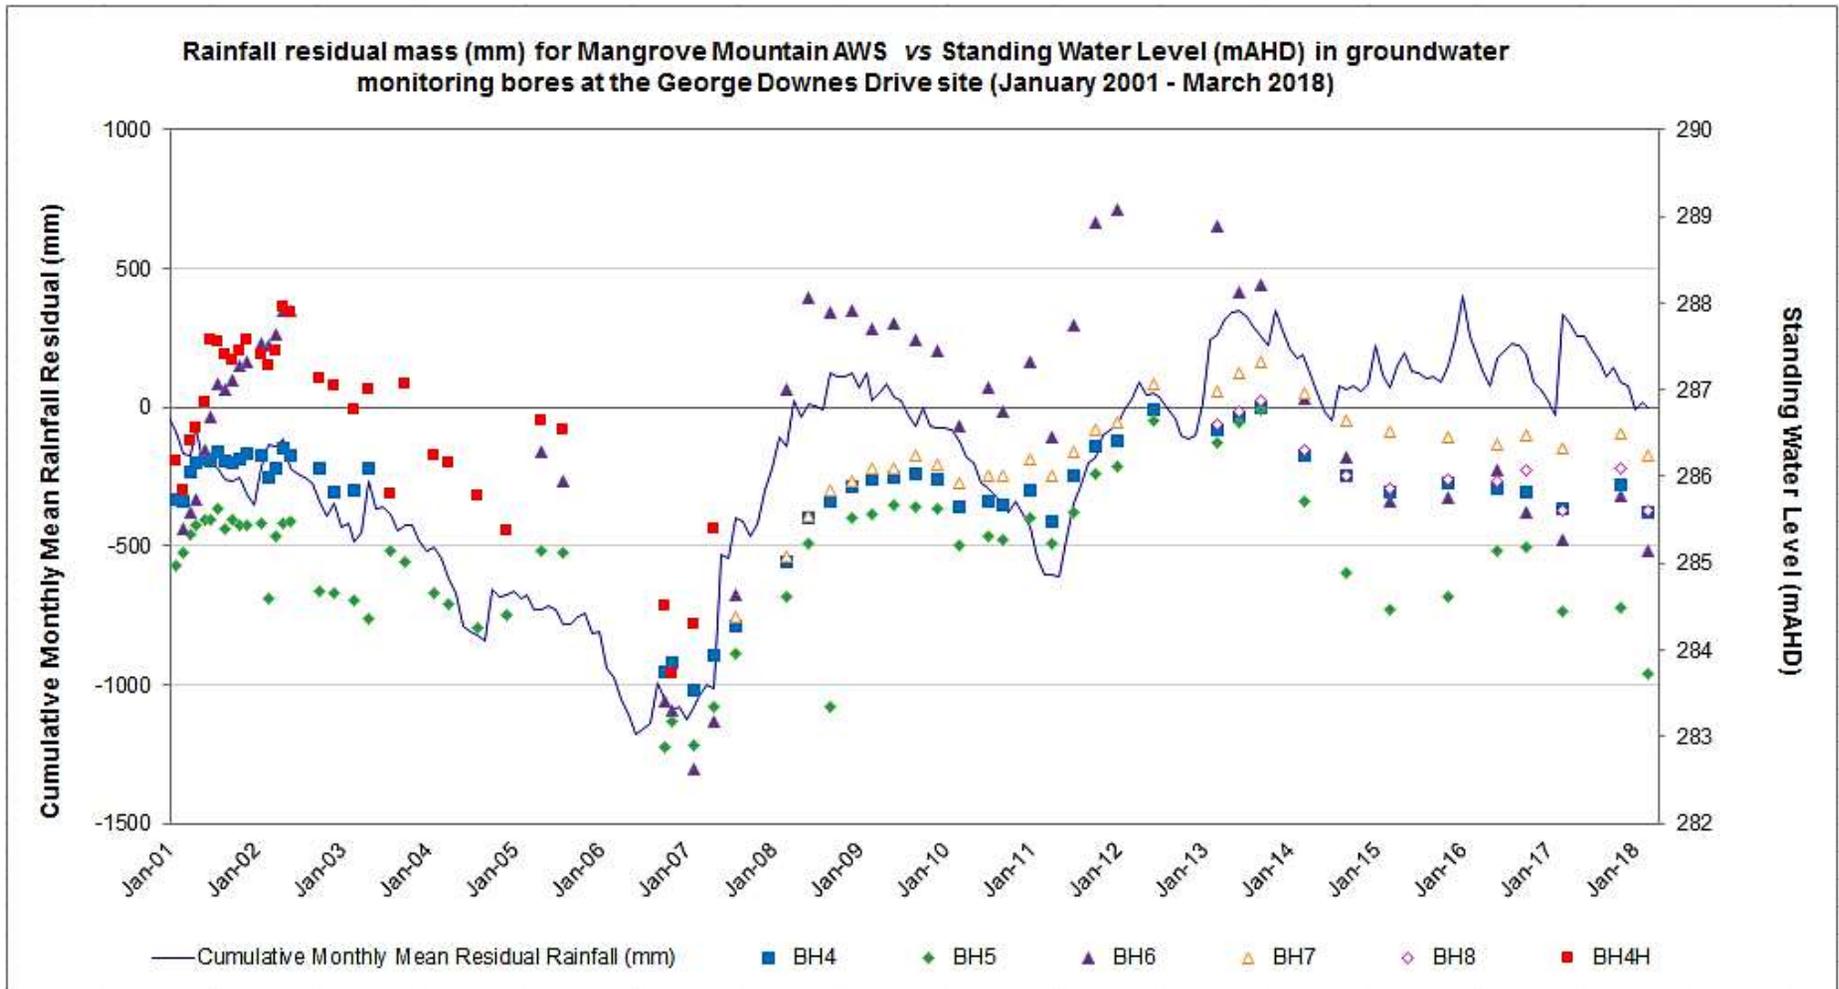
**Figure 4:** Rainfall residual mass (mm; Jan 2001 – Mar 2018) vs Standing Water Level (mAHD) in groundwater monitoring bores at the George Downes Drive poultry burial site (January 2001 – March 2018)<sup>(1)</sup> (Average monthly rainfall (mm) = Jan 2001 – Mar 2018 @ Mangrove Mountain AWS
