Oysters and acid sulfate soil outflows

Michael Dove

Damian Ogburn

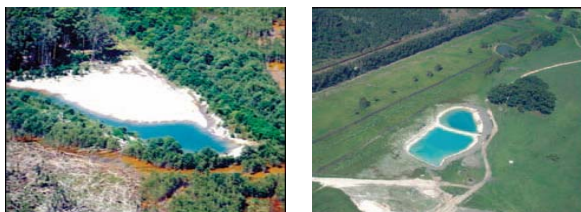
Figure 1. Acid sulfate soil-affected waters can appear very clear. This is caused by low pH (3-4) and high levels of dissolved aluminium, which clarifies the water.

ASS-affected waters can cause a dramatic change in the appearance of floodplain drain and estuarine waters. An early indicator of acidic water from ASS is a sudden change in water colour, from turbid brown to either crystal clear or azure blue/green following a flood.

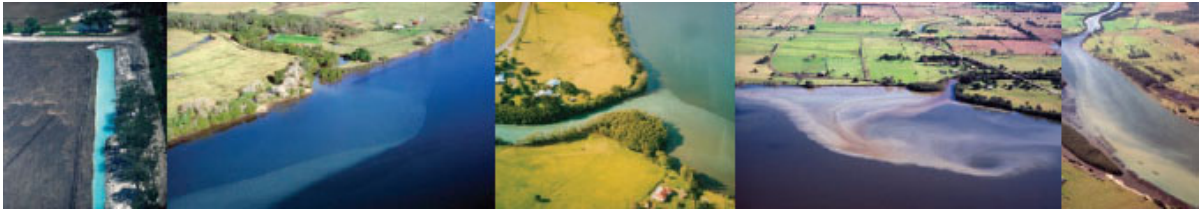
Figure 2. Acid sulfate soil outflows can also appear blue-green at pHs below 5, or milky white at pHs just above 5. This appearance is caused by the presence of very fine particles of aluminium minerals suspended in the water column.

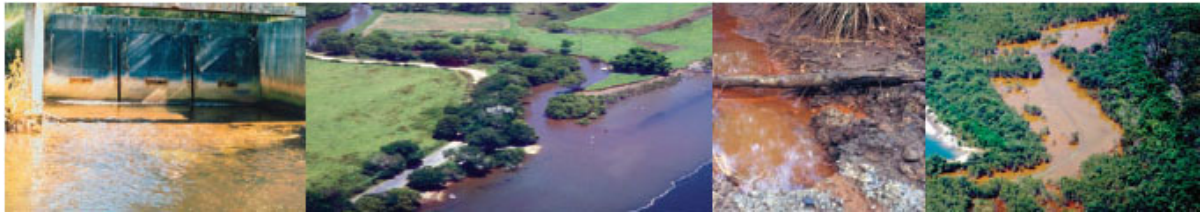
Figure 3. Examples of acid sulfate soil outflows appearing yellow to red due to the presence of iron minerals. High levels of iron at low pHs (<4) appear yellow; at higher pHs the water appears red, due to the fine particles of iron minerals suspended in the water column.

Water impacted by ASS outflows on a longer-term basis can also appear milky or yellow to red, depending on the chemistry of the water. A graphic indicator of acid-impacted drains is rusty-coloured water, caused by the presence of iron oxides.

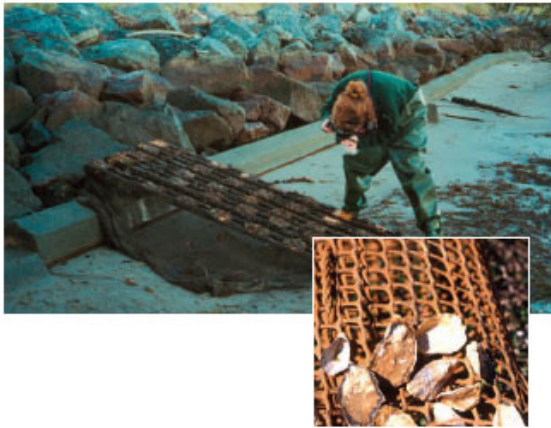
Iron-rich coating on oyster trays, racks or the stream bank. Iron is a very good indicator of the presence of acidity.

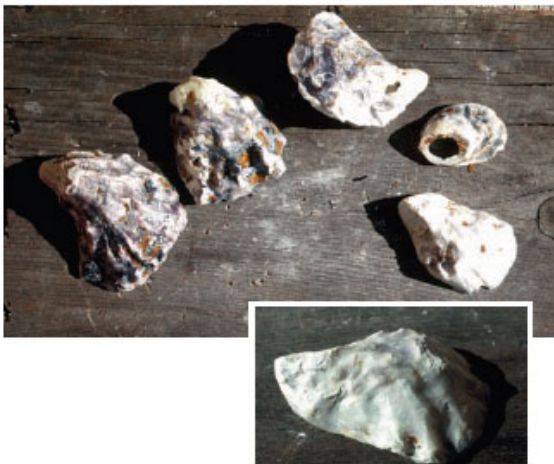
Bleached and degraded shells are revealed when the iron-rich coating is removed. Severe shell bleaching occurs during extended exposure to acid sulfate soil outflows. Episodic acute events may not result in shell bleaching.

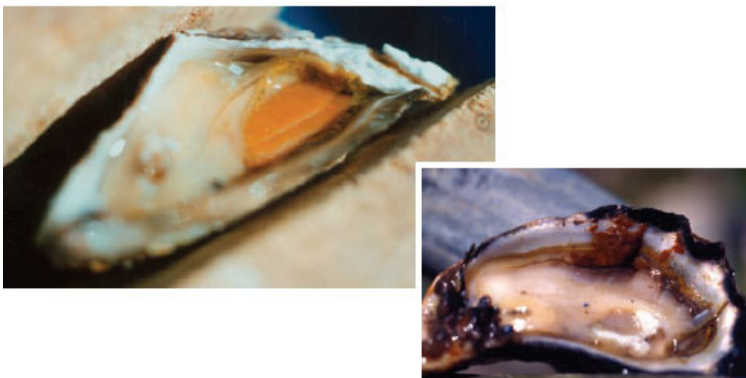
Red discoloration of the soft tissue (particularly the gills), which is caused by high levels of iron.

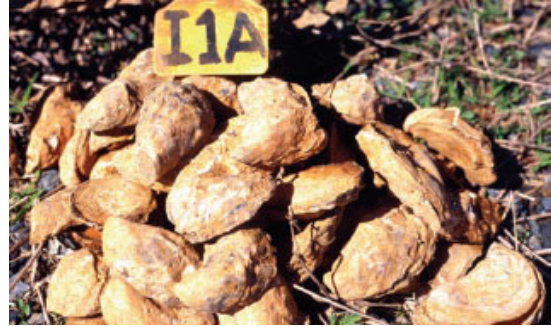
Red shells caused by the iron minerals settling on the oysters.

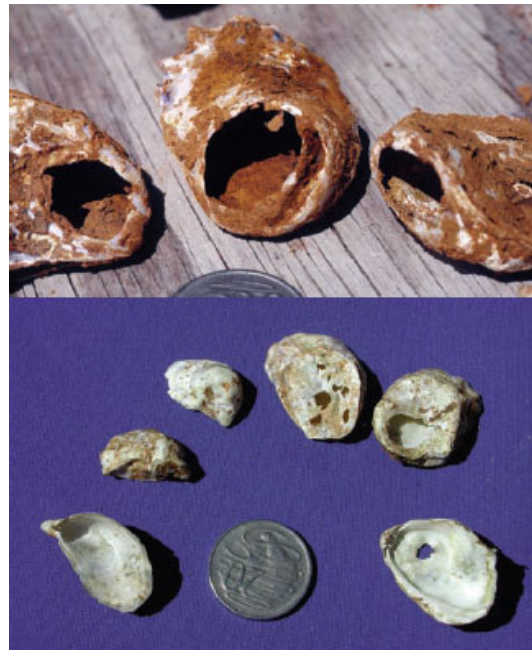
Perforation occurs in the back section of oyster shells, after approximately 25 days of chronic exposure to acid sulfate soil outflows.
