**SITE SUMMARY
STATUS REPORT**
WARATAH ROAD,
MANGROVE
MOUNTAIN, NSW

Site summary status report
Waratah Road, Mangrove Mountain, NSW

NSW Department of Primary Industries

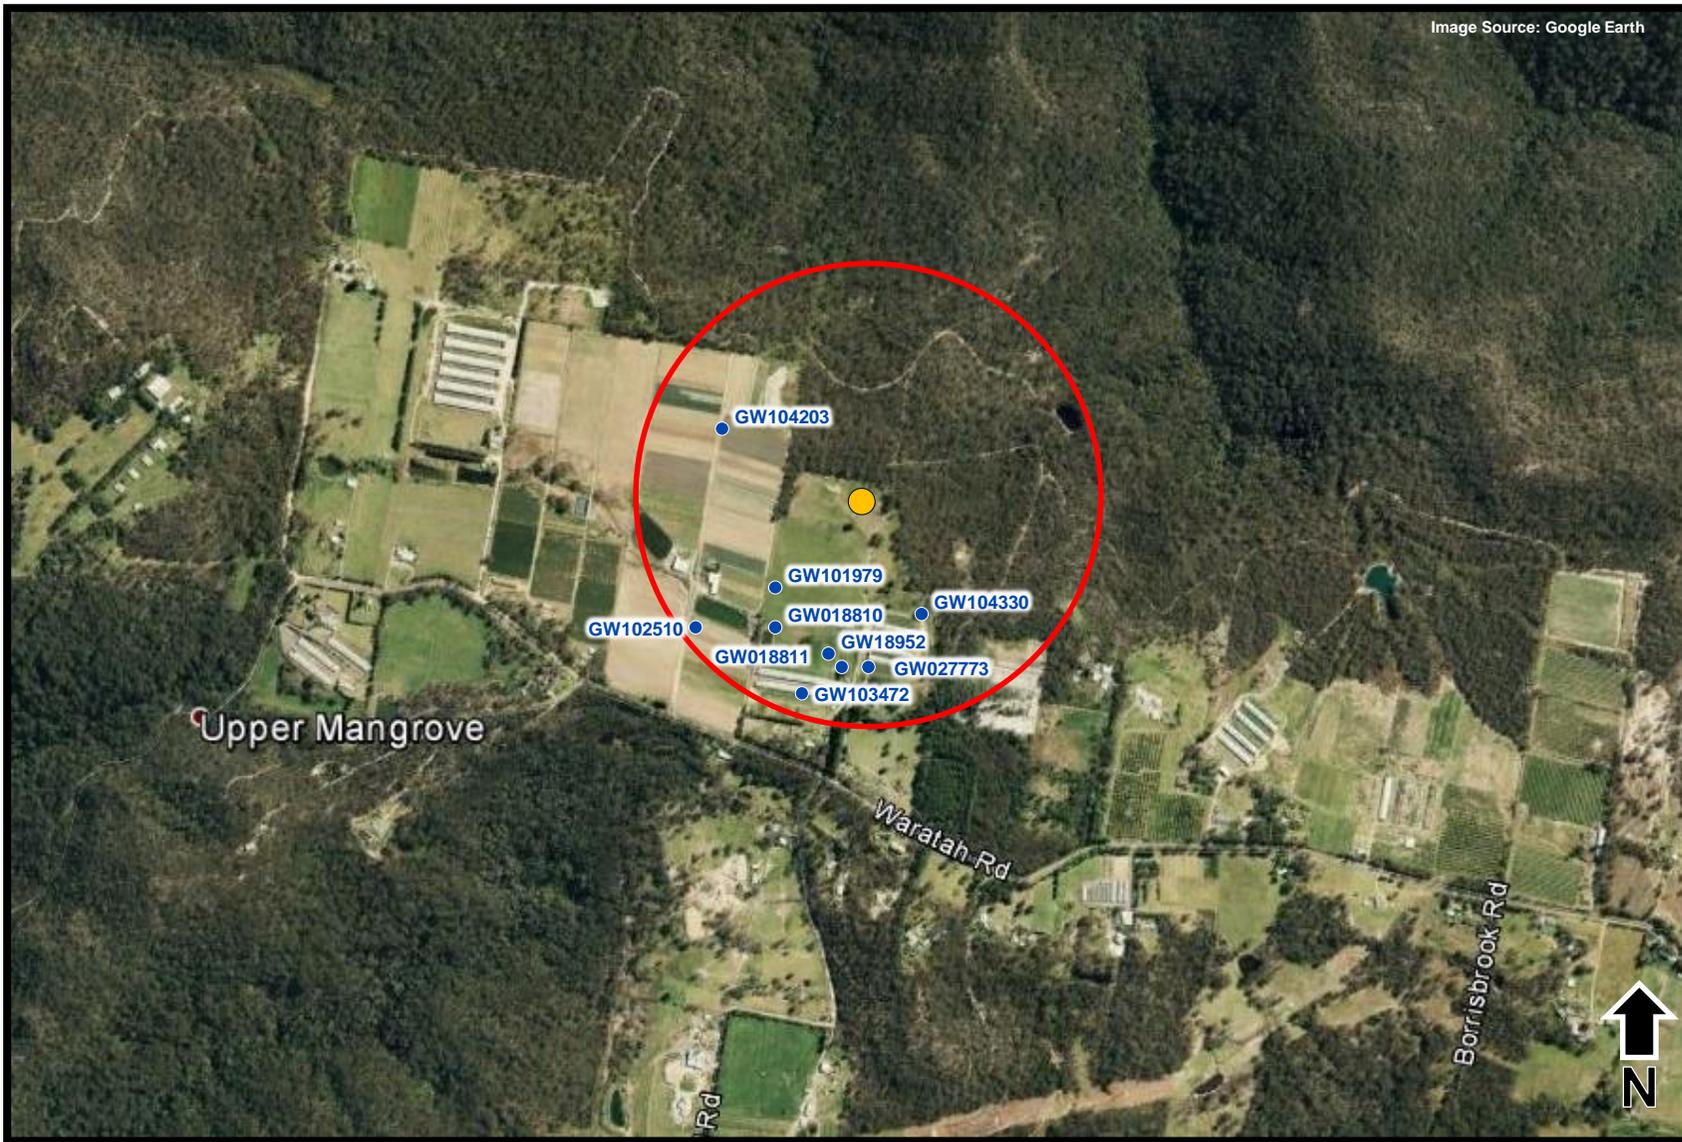
Registered Groundwater Bores-Waratah Road, Mangrove Mountain

A search of the NSW Office of Water groundwater database (www.nratlas.nsw.gov.au) indicated that several groundwater bores are registered within 500 m of the site. The recent review of the database (<http://allwaterdata.water.nsw.gov.au/water.stm>) (on 3 July 2018) did not identify any new bores in the vicinity of the site. A summary of the registered bores and their distance from the Waratah Road site is provided in Table 2.2 and shown in Figure 2 in Appendix A. The table does not include bores in which license has been cancelled, namely GW018952, GW027773, GW018811, GW018810 and GW104203.
