## APPENDIX 6. WETLAND MANAGEMENT STORIES

## MALCOLM STARRITT - WOMBOOTA PASTORAL

Where	Benarca Creek, 30km south-west of Deniliquin, NSW (adjacent to the Murray River)
Enterprise	Sheep, prime lambs, wool & cropping
Size	2000 hectares
Wetland area	119 hectares

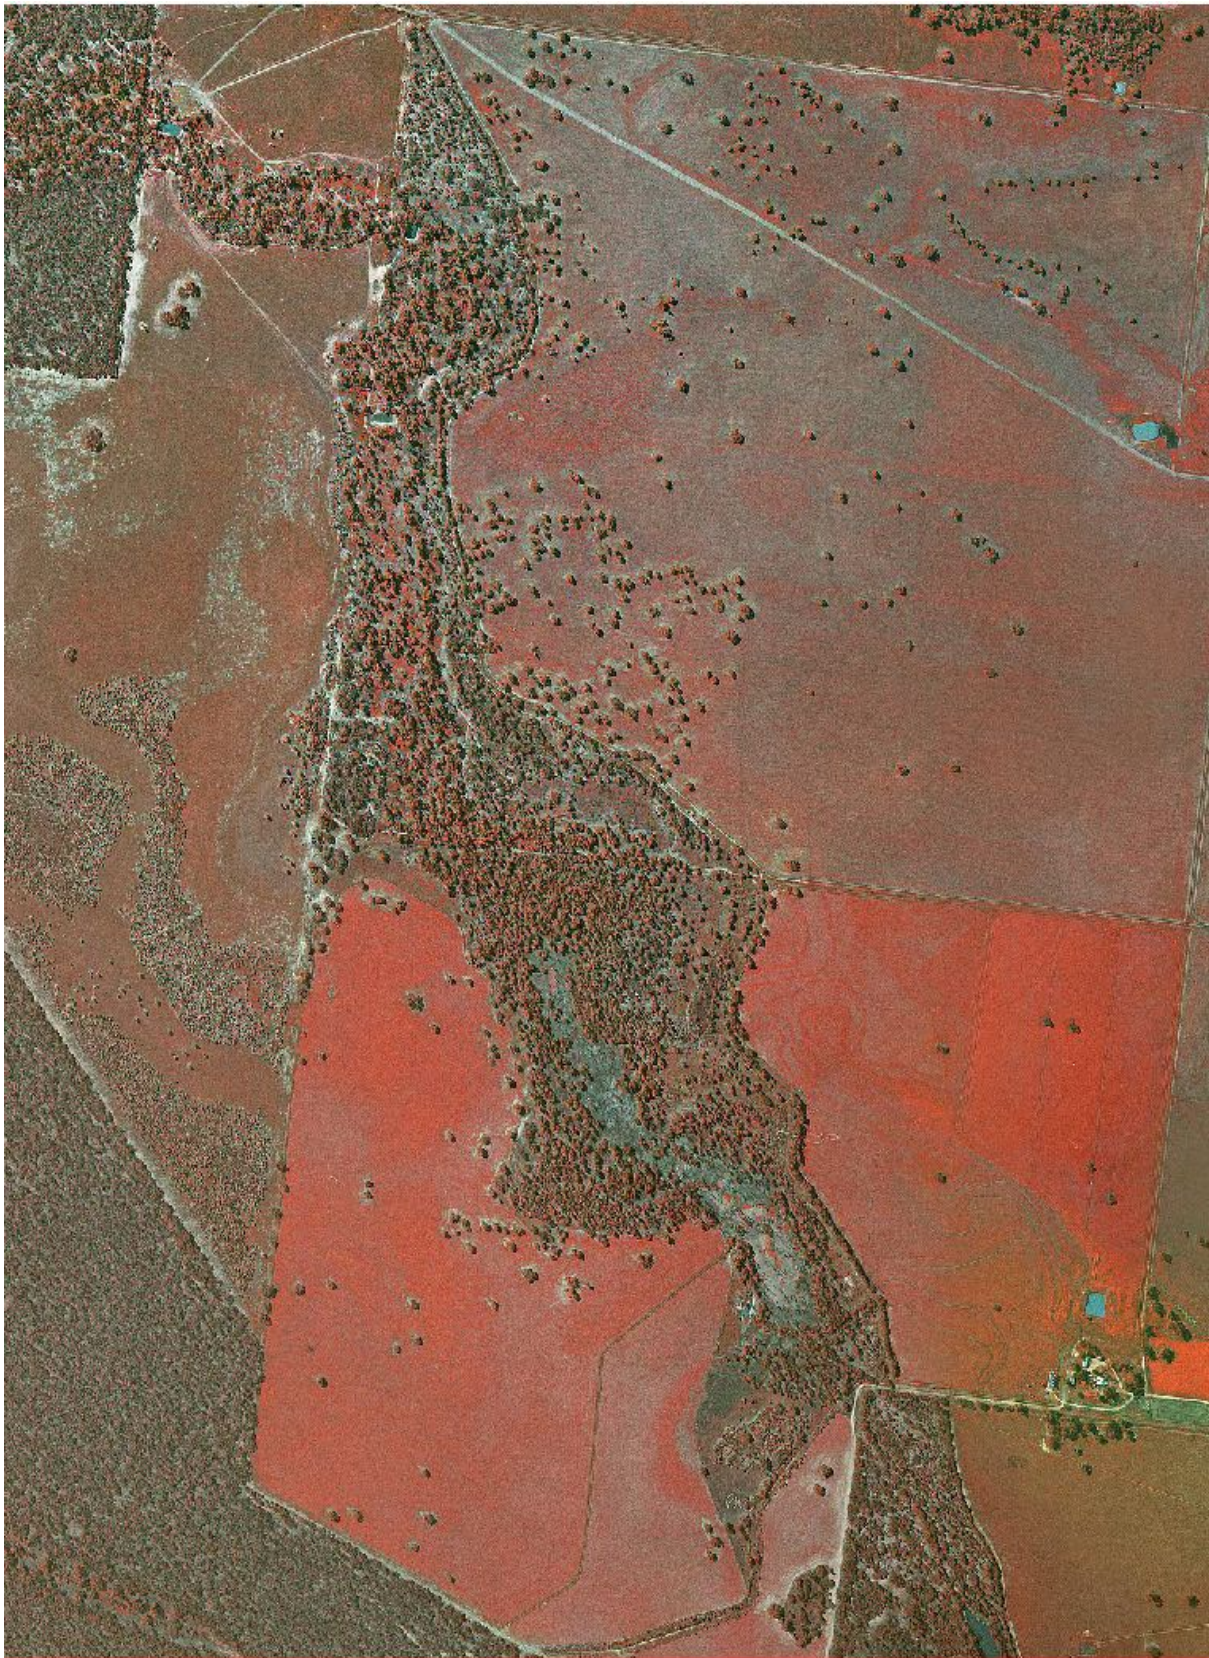
Map 3: Infra red enhanced aerial photograph of the Kooyong & Suncroft wetlands, 2001. (Courtesy of Murray Irrigation Ltd.)

Within the area locally known as the Benarca Water Holes, the Kooyong and Suncroft Wetlands (see page 42) are about 29 and 90 hectares respectively. The Kooyong wetland, which is the northern of the two and the subject of this case study, has been owned by WP since 2003. The Suncroft wetland was acquired by WP in 2007 and as a consequence the pair will be managed in a more holistic manner in the future.

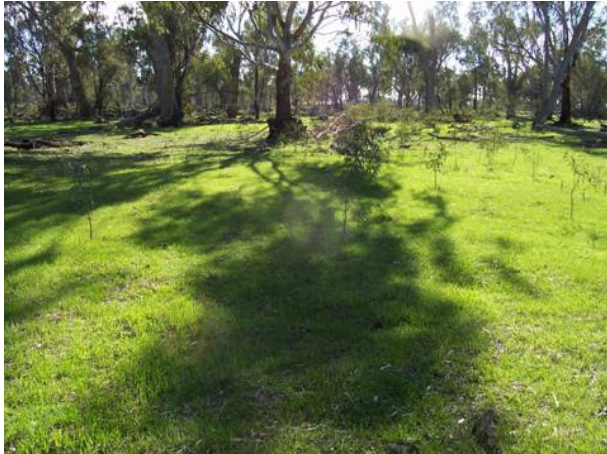
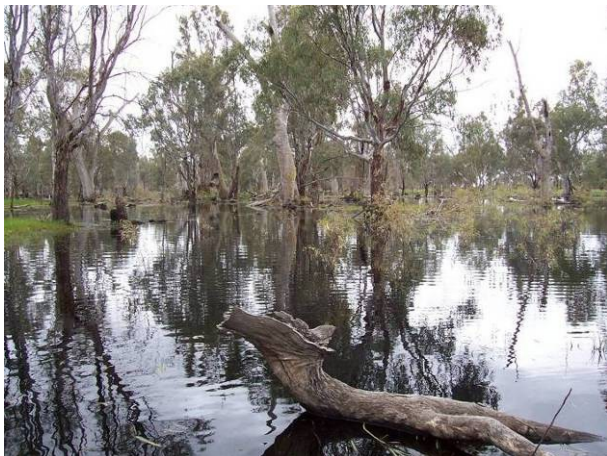
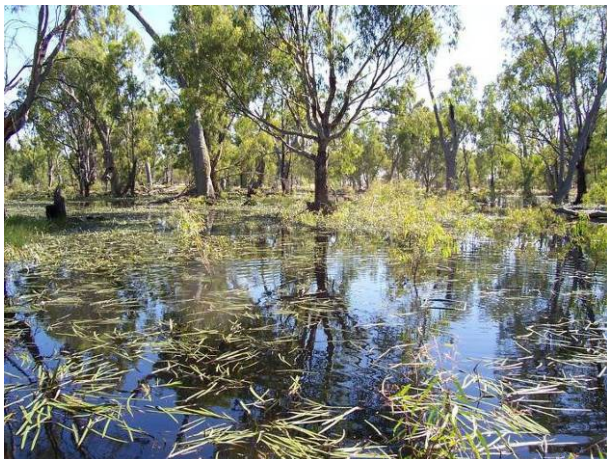
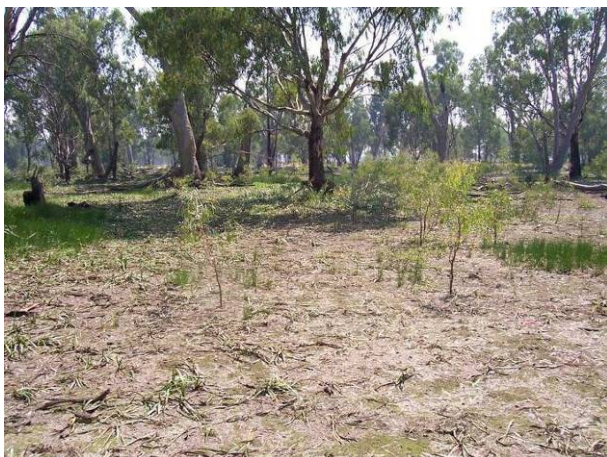
**Image 9: pictures taken at the Kooyong/Suncroft wetland clearly demonstrating the value of this monitoring and evaluation technique.**

**From top to bottom:**

- Before wetland flooding**
- week 6**
- week 12**
- week 15**

Photographs taken at regular intervals from fixed photo-points often provide the best visual picture of vegetation changes over time. The pictures taken at the Kooyong/Suncroft wetland clearly demonstrate the value of this monitoring and evaluation technique (see page 45).
