# LOOK OUT FOR European House Borer

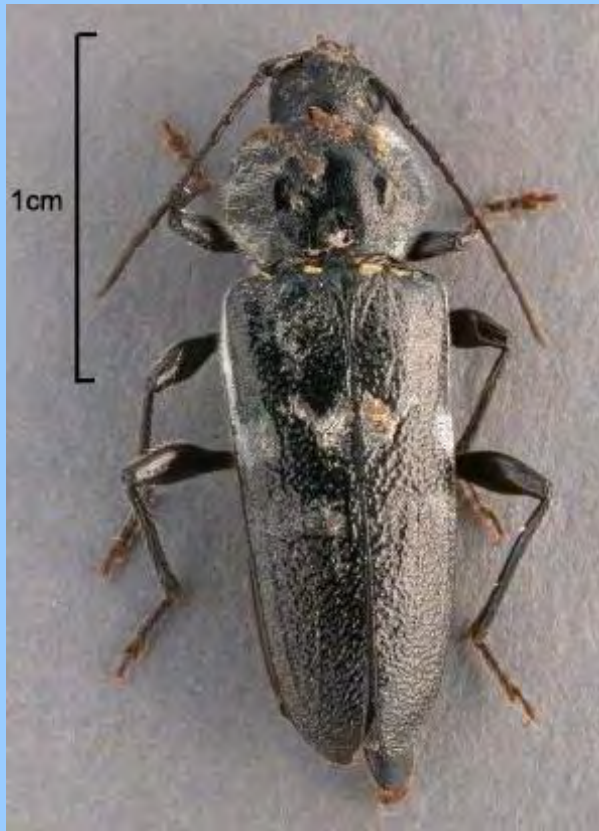
Above: Adult European house borer – Picture not actual size  
(Dept of Agriculture Western Australia)

- Adult beetles which are brownish-black to black and have a slightly flattened appearance. The beetle's wings are usually all black and may have distinctive white patches. The top surface of the first body segment behind the head has two raised, black, shiny knobs that resemble eyes. Adults are approximately 18-25mm in length with antennae about half as long as the body.

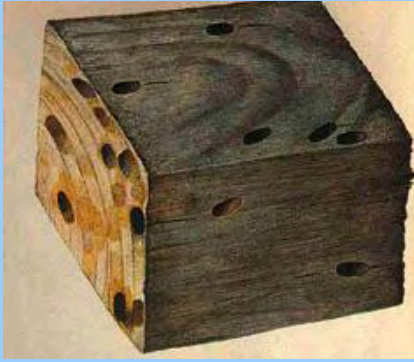
**Above:** Off-cut of timber exhibiting oval-shape exit holes caused by emerging adult beetles

- Characteristic oval-shaped holes, approximately 5-10mm in length and running in line with the grain of the timber on the surface of infested timber from which the adult beetle has emerged.

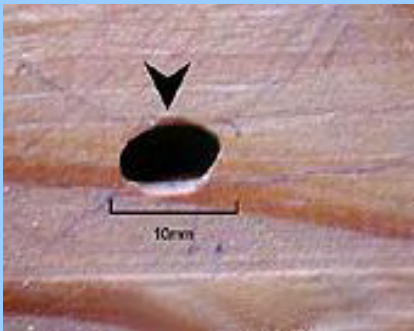
**Below:** Close-up of adult beetle exit hole running along the grain of the timber – Picture not actual size (CD Pless and G Schweiger UT E&PP)

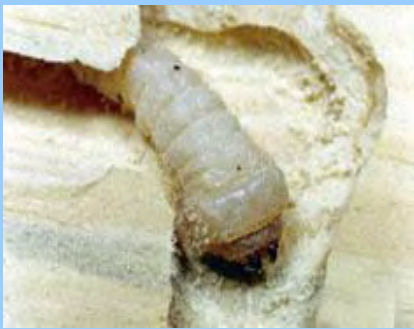
**Above:** Exposed larvae boring through timber. Picture not to scale (Clemson University USDA Cooperative Extension Slide Series)

- Soft scraping sounds made by the larvae as they feed. This can often be heard at night and may be audible from some distance.
- EHB larvae within the timber. Larvae are elongate and cylindrical in shape with an enlarged and flattened head. The larvae are between 19-41mm long and around 7.5mm wide at maturity. Larvae can be identified by a row of three small black single-lens eyes on each side of the head.
- Galleries (tunnels) within the timber which are formed by the boring larvae and are frequently tightly packed with frass. Galleries within the timber rarely break through the surface of the timber and are therefore seldom detected.
- Batches of up to 120 eggs which are laid in crevices or cracks in timber.
