REDUCING THE IMPACT OF WEIRS ON AQUATIC HABITAT

NSW DETAILED WEIR REVIEW

NAMOI CMA REGION

MOLLEE WEIR, NAMOI RIVER

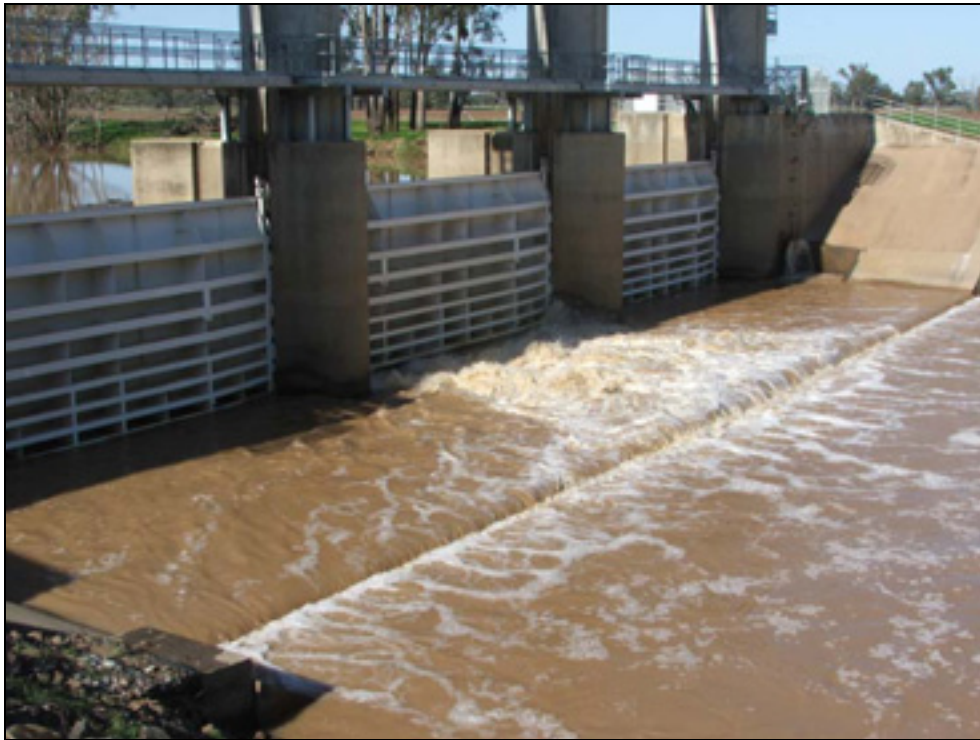
Figure 1. Mollee Weir, Namoi River (08.09.2005, 604ML/day).

Mollee Weir (Figure 1) is located approximately 20km West of Narrabri on the Namoi River in the lower end of the Namoi catchment. The site is accessed via the Wee Waa Road. The weir is approximately 5 metres in height and is approximately 60 metres across the length of the crest. Mollee Weir is a regulating structure with three bays that act as a barrier to fish passage in all but flooding conditions, when the gates are opened to prevent drown out of the weir. Below flooding flows, the weir restricts fish passage due to excessive head loss and increased turbulence across the face of the structure. Currently there is an ineffective submerged orifice fishway (Figure 2) at this site that does not pass fish.

Mollee Weir is a total barrier to fish passage except when the gates are lifted free of the water. As a result it is recommended that fish passage options be further investigated at this site, management of the vertical lift gates be re-assessed, and investigations be undertaken to improve the functionality of the existing fishway.

It is recommended that the installation of a Deelder fishlock into the existing submerged orifice fishway be investigated along with an appropriate lighting source to dispel potential behavioural aversion to the fishlock (Option 1). In addition, appropriate management of the vertical lift gates to minimise their effect on fish larvae is also a priority for this site.

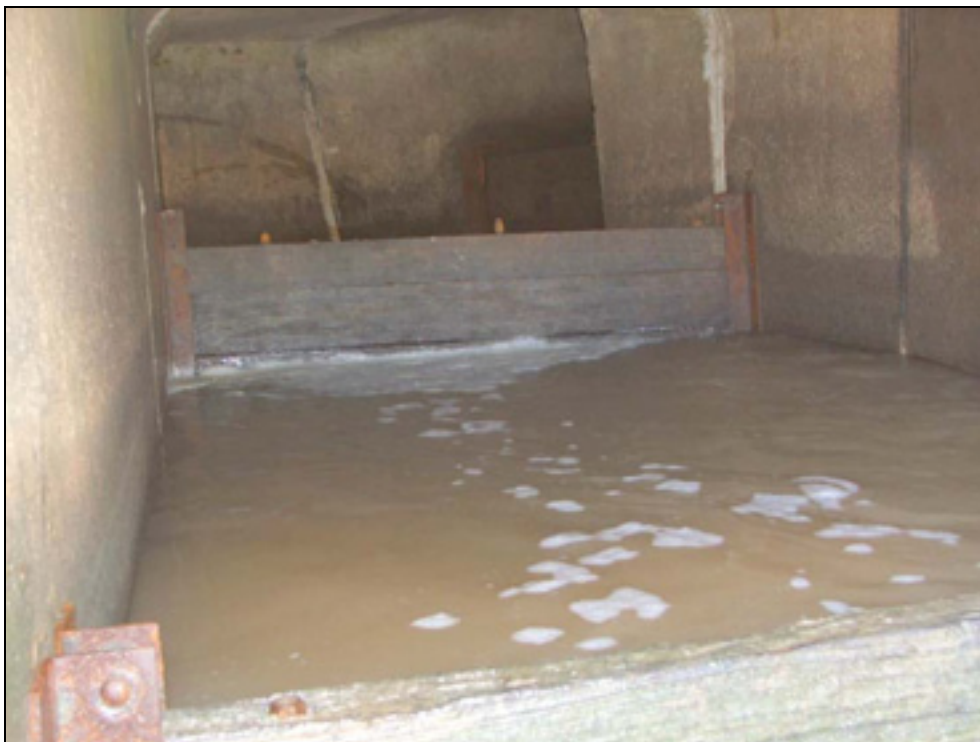
Figure 2. Mollee Weir, submerged orifice fishway, Namoi River (08.09.2005, 604ML/day).

At present Mollee Weir is a total barrier to fish passage alienating fish from the Upper Namoi River. During several site inspections by NSW DPI, fish were observed congregating below the weir, unable to negotiate the highly turbulent conditions and high velocities experienced at the entrance to the fishway. Currently the fishway consists of an enclosed concrete channel with an estimated gradient of 1:6. There are many cells within this channel, which are created by wooden baffles with a single submerged orifice. The fishway is fully enclosed which has created a behavioural barrier to many fish as a result of poor lighting.

Further investigations for Deelder fishlocks have been recommended by Thorncraft and Harris (2000) at other sites along the Murrumbidgee River, including Berembred and Yanco Weirs, which currently have ineffective submerged orifice fishways. As with Balranald Weir, the Deelder fishlock could be incorporated into the existing fishway at Mollee Weir at a relatively low cost.

The removal of the old fishway and replacement with a vertical slot fishway is a viable option at Mollee Weir. With varying headloss the vertical slot fishway would be more effective in passing a greater range of fish size classes. Vertical slot fishways are considered one of the most effective fishway designs and are the preferred option when located on the main stem or major tributary of a waterway or where threatened species are present (this site is within the expected distribution of silver perch, olive perchlet, and purple spotted gudgeon).

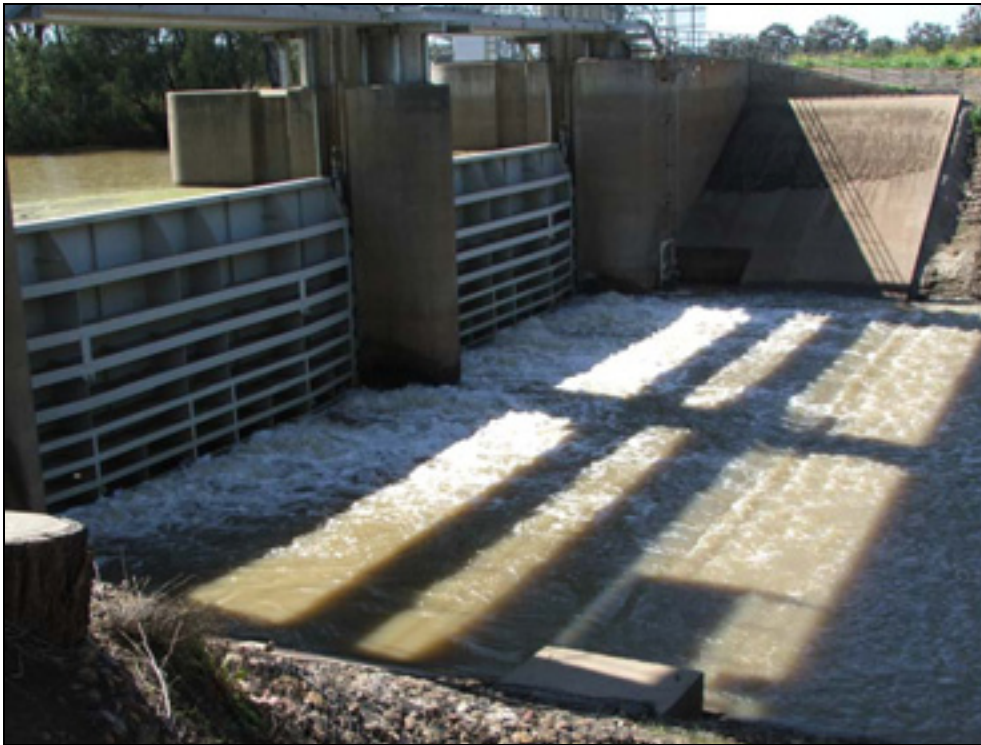
Figure 1. Gunidgera Weir, Namoi River (08.09.2005, 365ML/day).

Gunidgera Weir (Figure 1) is located 3km North of Wee Waa and can be accessed via Tulladunna Lane. The weir is situated on the Namoi River in the lower end of the catchment. The weir is approximately 5 metres in height and is approximately 50 metres across the length of the crest. The weir is a regulating structure with two bays. Gunidgera Weir acts as a barrier to fish passage throughout the year due to excessive head loss during all flow conditions except flooding flows, when the gates are opened to prevent drown out of the weir. There is currently an ineffective fishway (Figure 2) at this site, which does not meet NSW DPI standards and restricts the passage of fish.

As the weir is a total barrier to fish passage at all times other than when the gates are lifted free of the water, it is recommended that fish passage options be further investigated at this site and the management of the vertical lift gates be re-assessed to facilitate fish movement past the structure.

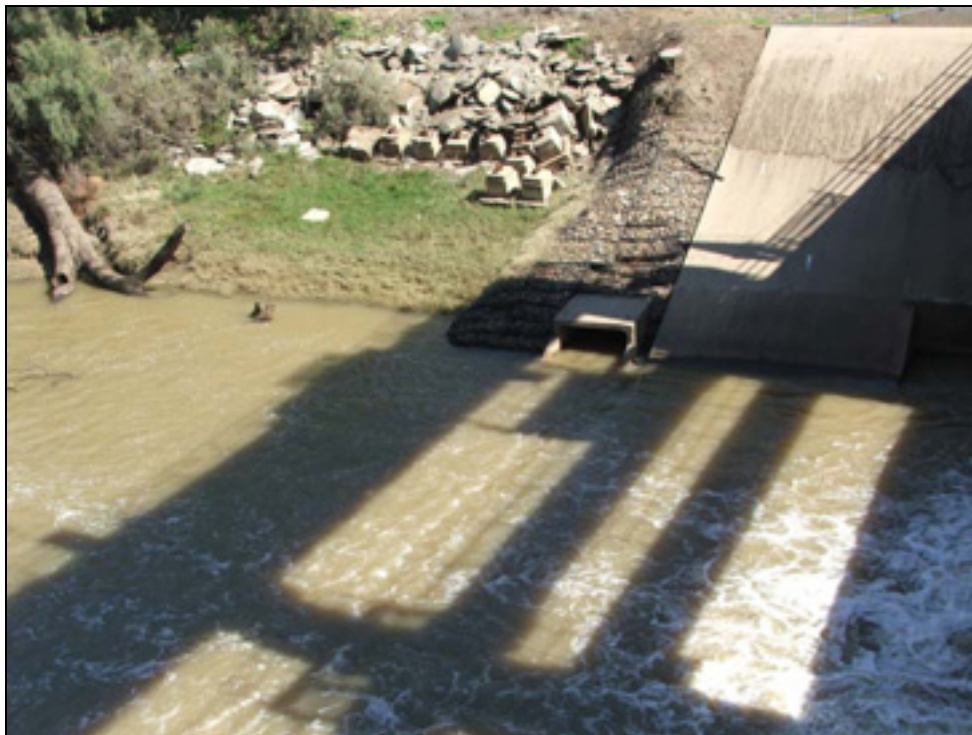
Figure 2. Gunidgera Weir, submerged orifice fishway, Namoi River (08.09.2005, 365ML/day).

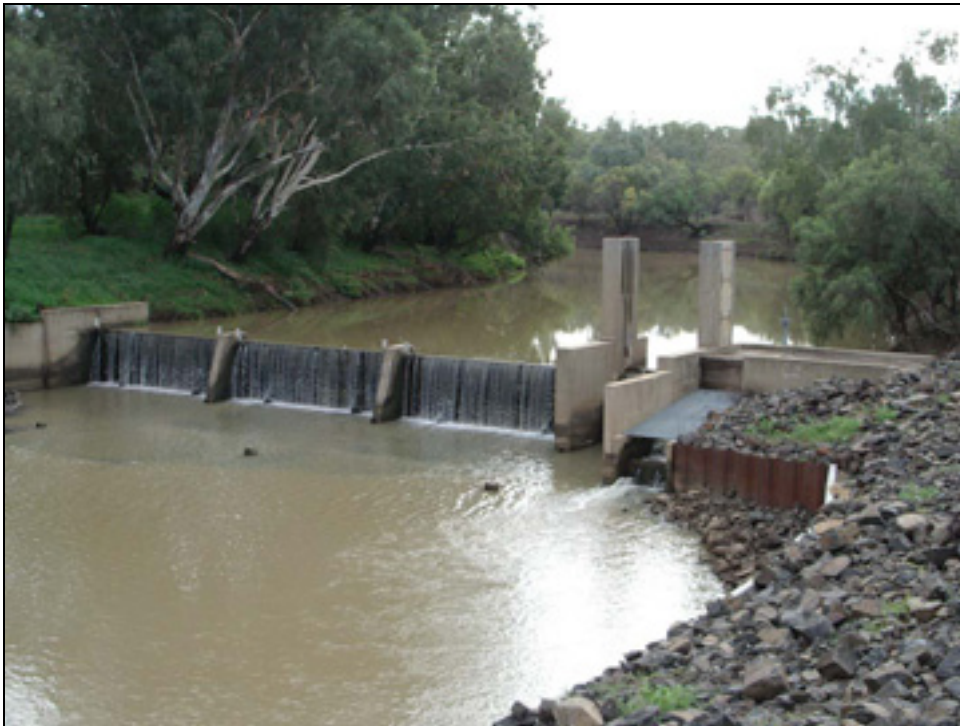
Figure 1. Weeta Weir, Namoi River (08.09.2005, 576ML/day).

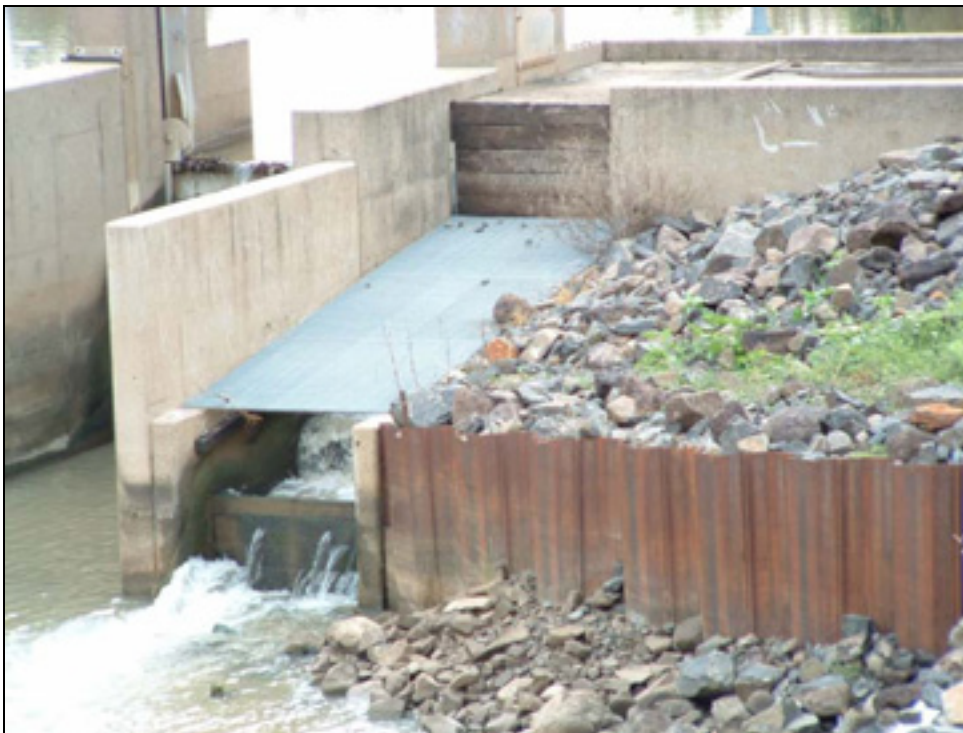
Figure 2. Submerged orifice fishway, Weeta Weir, Namoi River (21.03.2005, 53ML/day).

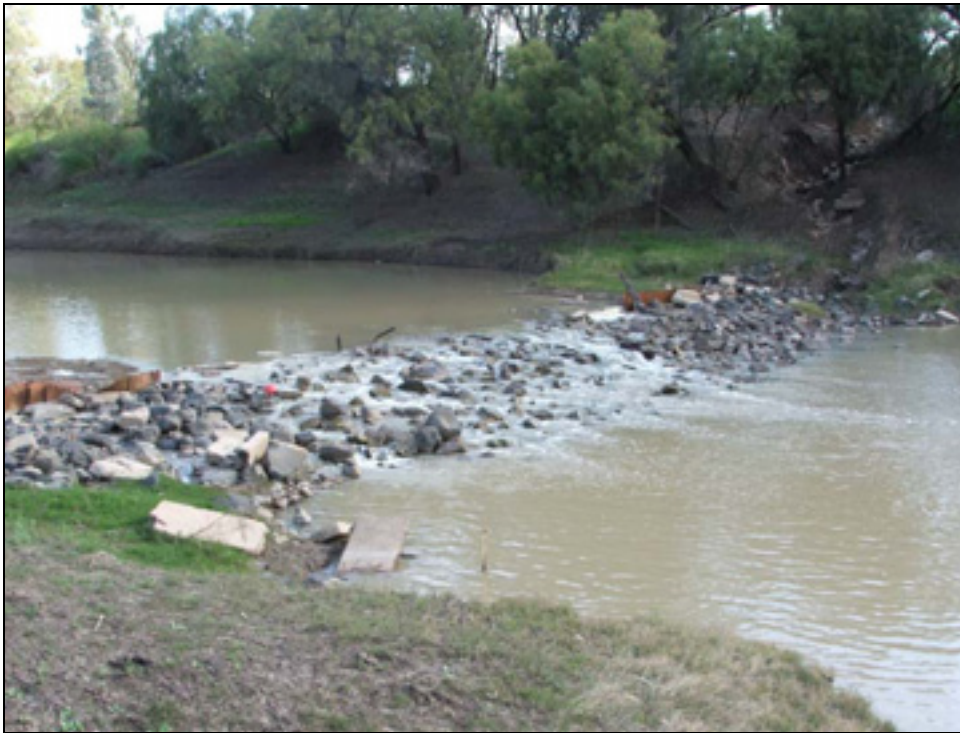
Figure 1. Walgett Shire Council Weir, Namoi River (08.09.2005, 50ML/day).

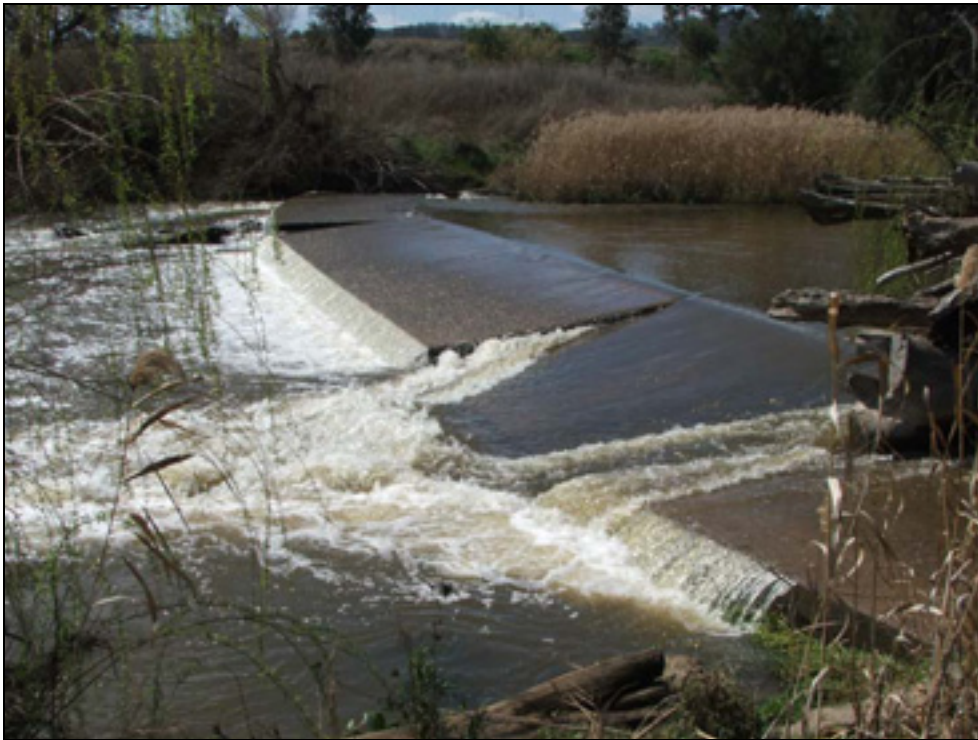
Figure 1. Jewry Street Crossing, Peel River (08.09.2005, 667ML/day).

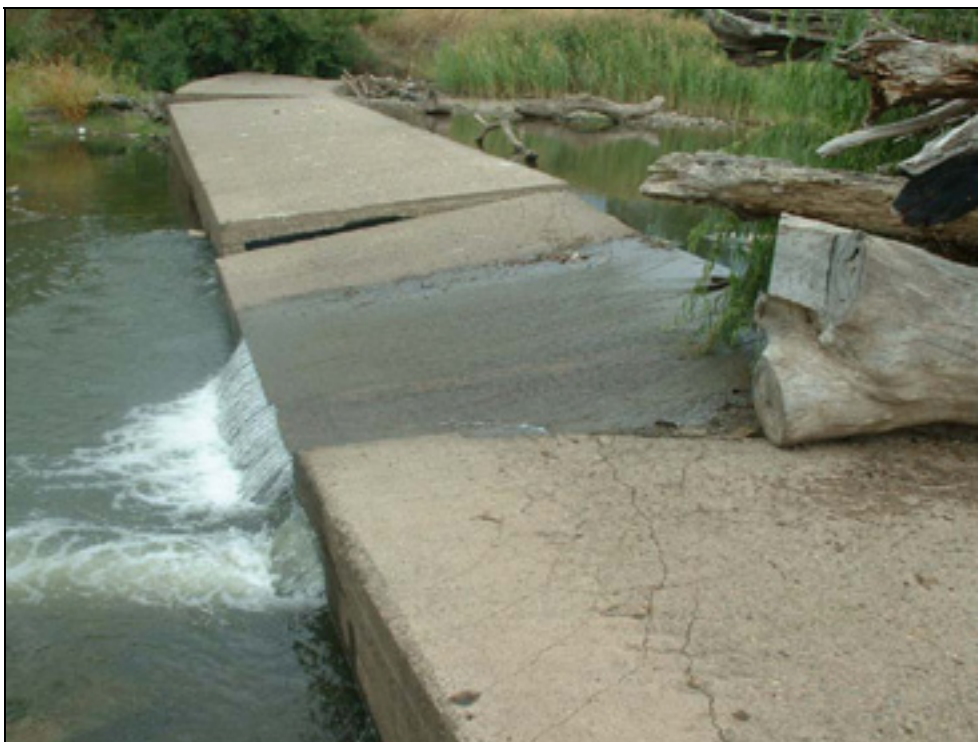
Figure 2. Jewry Street Crossing, Peel River (17.03.2005, 50ML/day).

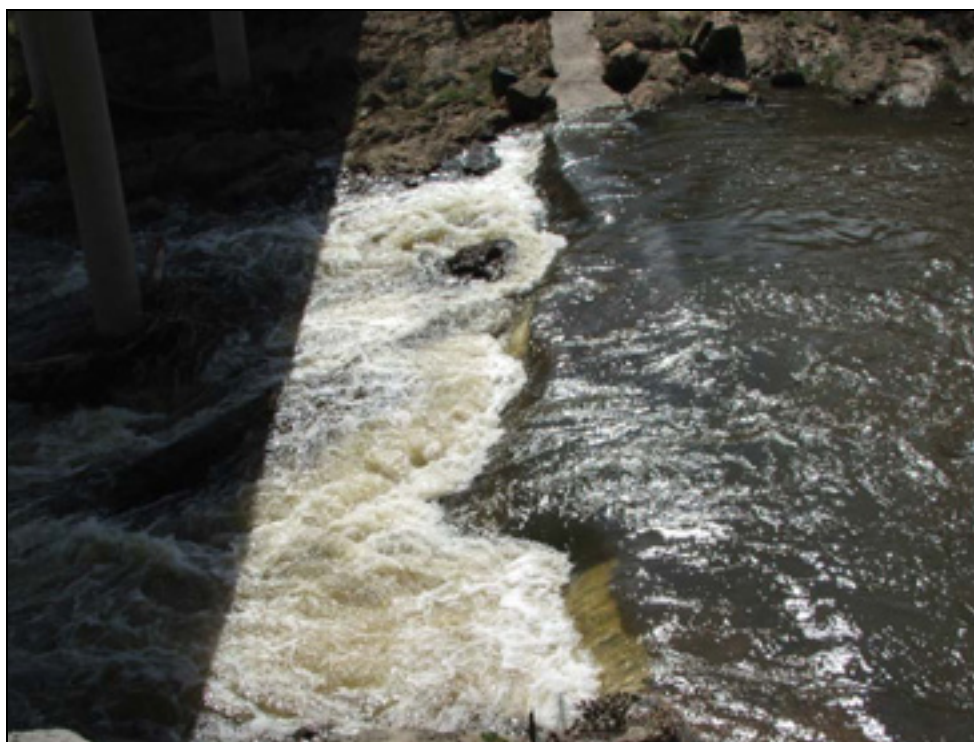
Figure 3. Council owned water supply pipe, Peel River (08.09.2005, 776ML/day).

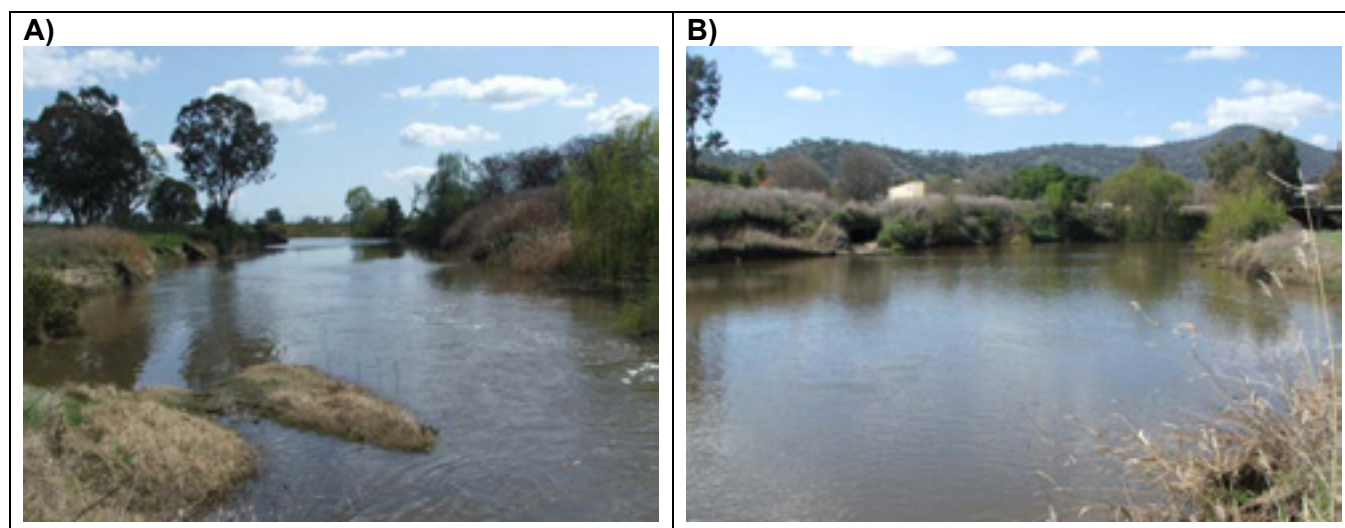
Figure 3. Peel River habitat A) downstream and B) upstream of Jewry Street Crossing (08.09.2005, 667ML/day).

The area surrounding Jewry Street Weir is highly urbanised, with a football field and storm water outlet on the right bank, and a public reserve on the left bank. At the time of inspection, there was limited riparian vegetation, with the grass understorey mown to within 2 metres of the riverbank. Downstream of the crossing the banks are highly eroded with steep vertical banks in need of stabilisation.

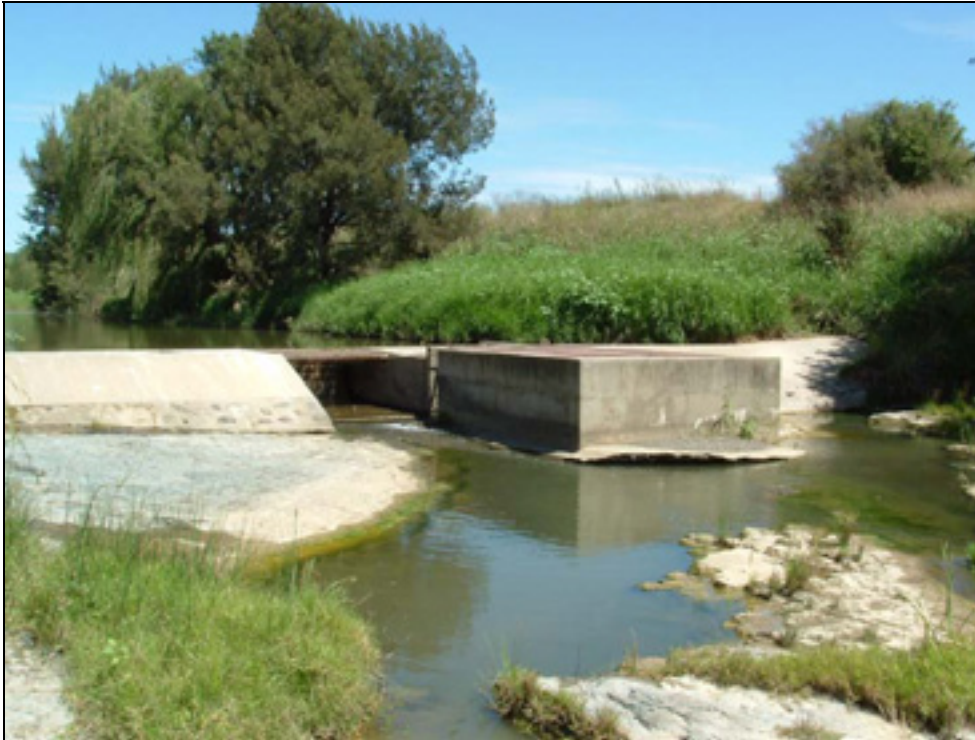
Figure 1. Barraba Weir, Manilla River (10.03.2004, 4ML/day).

Willows are present in high numbers both upstream and downstream from this site (Figures 1 and 2) and their management should be a priority in conjunction with any fish passage remediation works at this site.

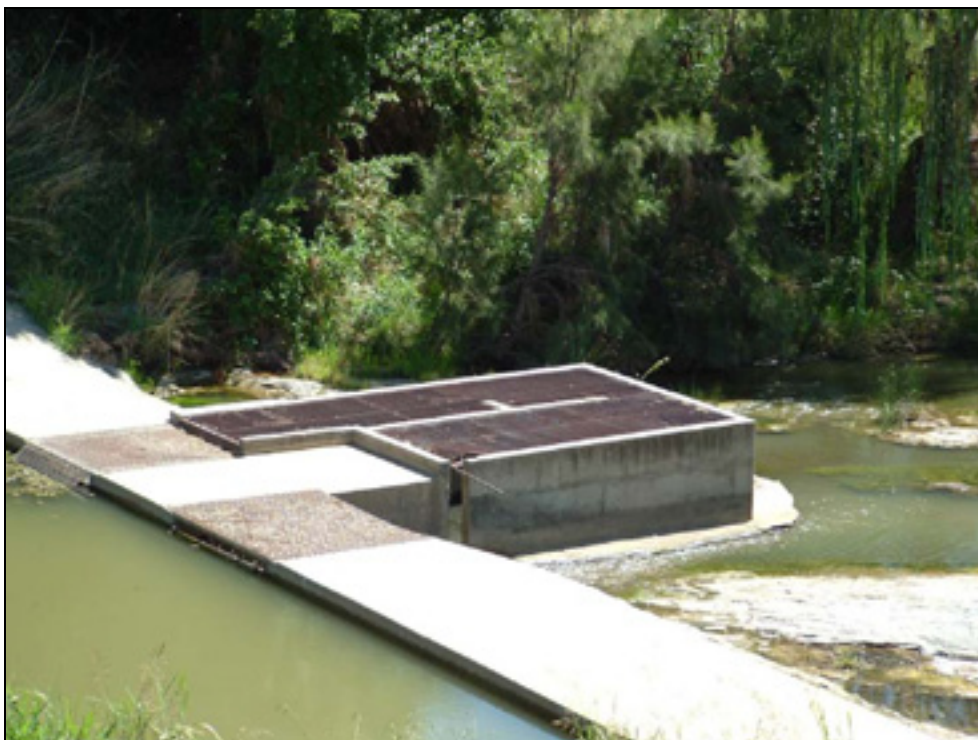
Figure 2. Barraba Weir, Manilla River, showing ineffective vertical slot fishway (10.03.2004, 4ML/day).

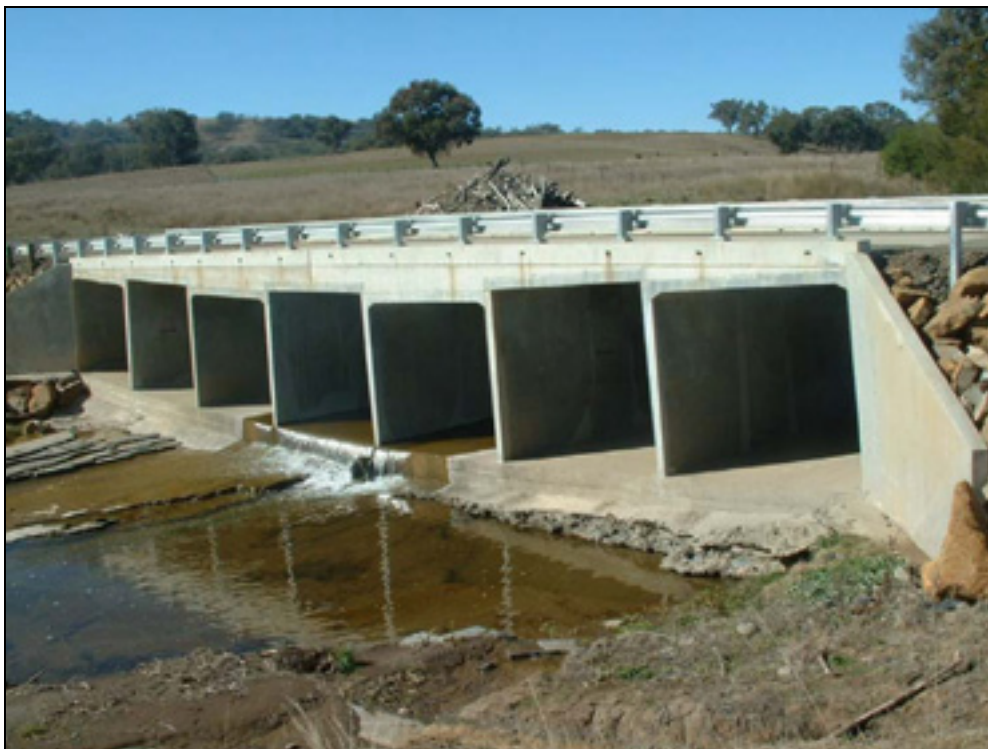
Figure 4. Tamworth Regional Council owned road crossing (Mayvale Road) located 29km upstream of Barraba Weir, Manilla River (21.07.2005, 27ML/day).

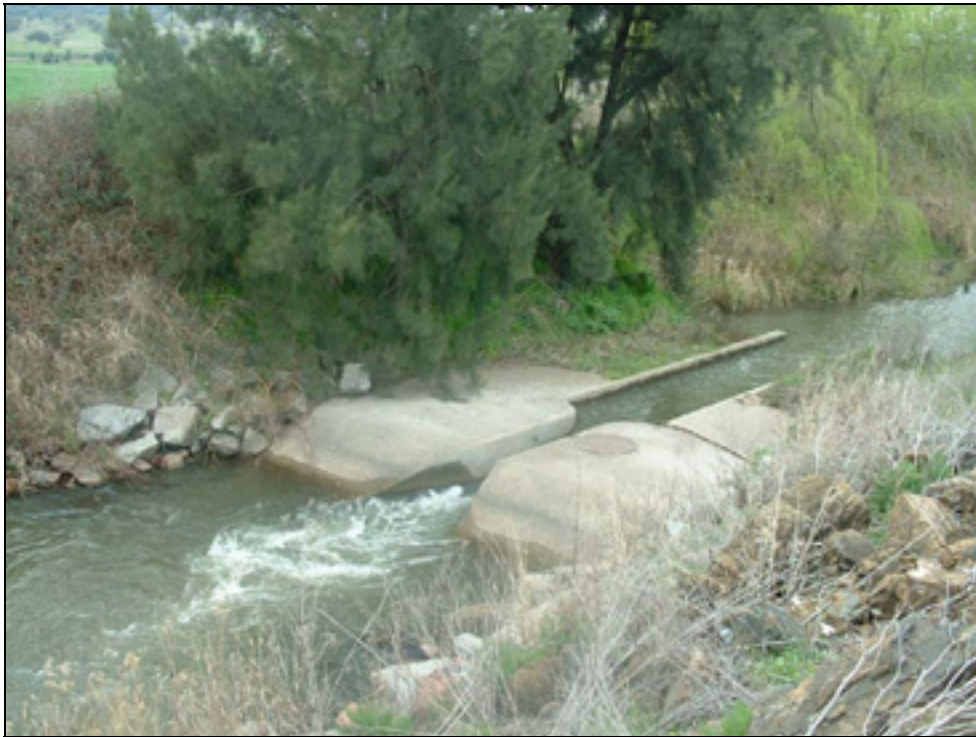
Figure 1. Calala Gauging Weir, Peel River (12.09.2005, 99ML/day).

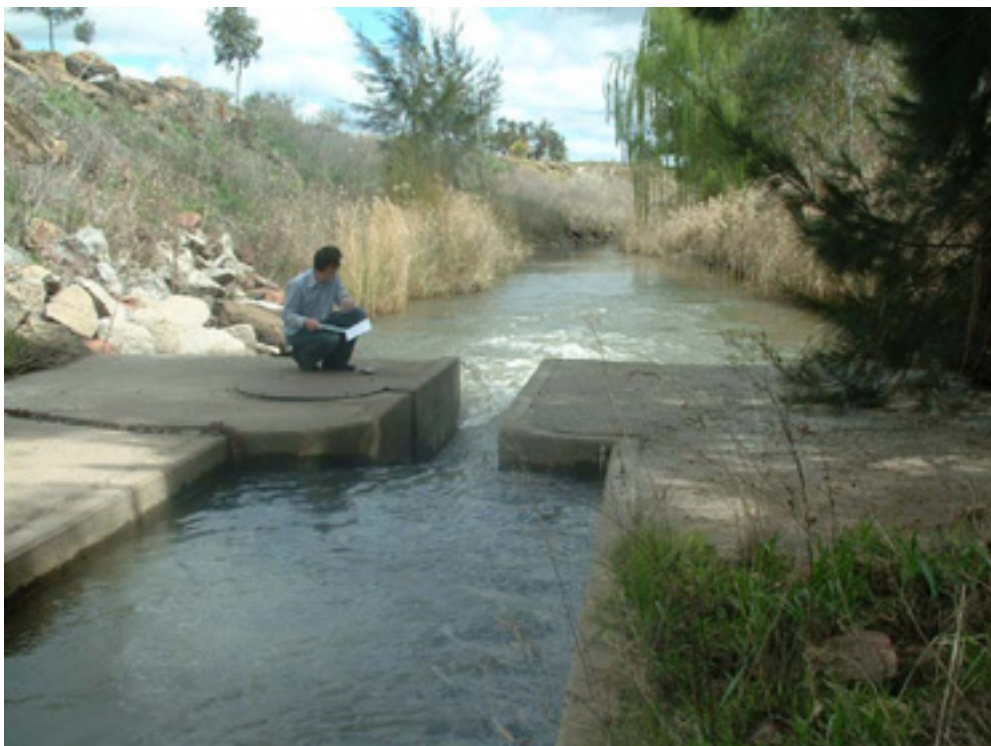
Figure 2. Calala Gauging Weir looking downstream, Peel River (12.09.2005, 99ML/day).

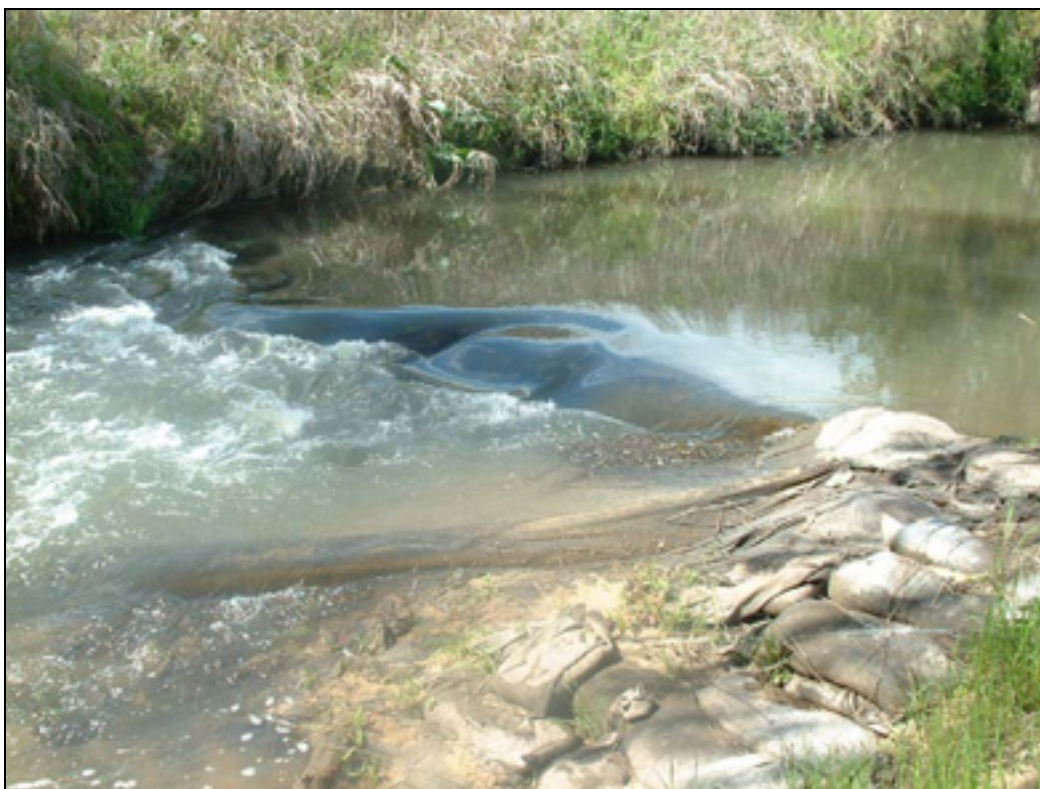
Two hundred metres downstream, however, there is a temporary sandbag weir that is managed by Tamworth Regional Council (Figure 3), and aims to secure town water during low flow periods. This sand bag weir is estimated to drown out during flows in excess of 110ML/day.

Figure 3. Temporary sandbag weir, Peel River (12.09.2005, 99ML/day).

The temporary sandbag weir located downstream drowns out during flows in excess of 110ML/day, which occurs approximately 23% of the time. Ideally, the permit conditions for this temporary weir would require that during key migration periods (generally throughout late spring and summer months), the structure would be removed to allow the upstream and downstream movement of migratory species within the Peel River.

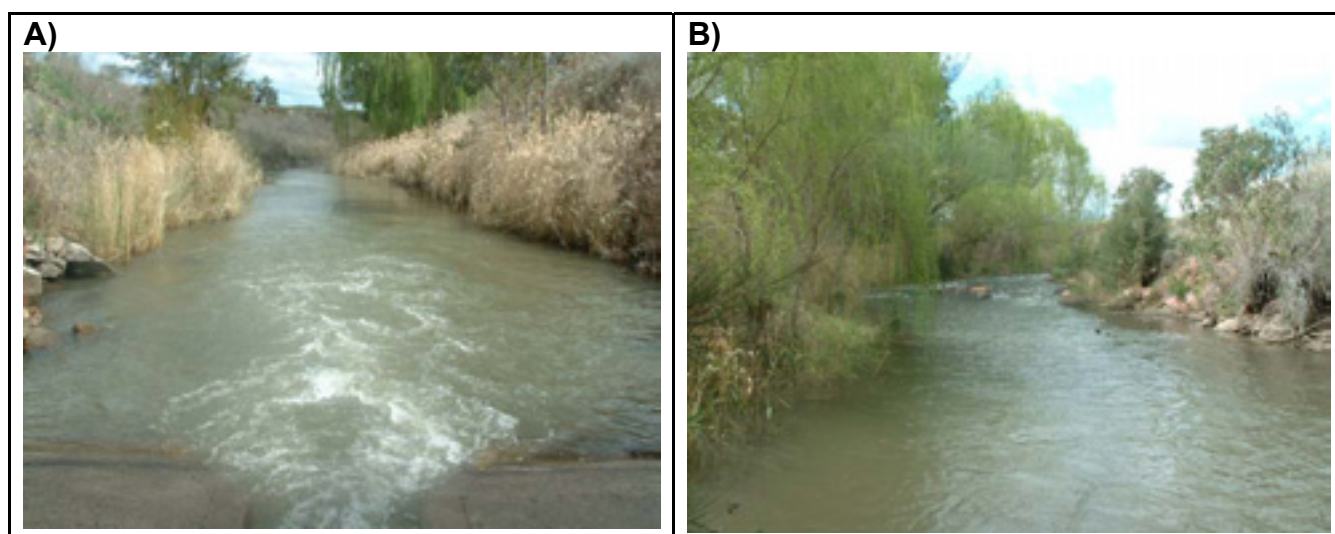
Figure 4. Peel River habitat A) downstream and B) upstream of Calala Gauging Station (12.09.2005, 99ML/day).

The river banks adjacent and either side of the structure are well vegetated (Figure 4). Erosion control structures have been put in place downstream to reduce the likelihood that the banks will be undercut as a result of the regulated flows. There is little or no instream woody debris surrounding the site - it is likely that this was previously removed so that it did not interfere with the gauging weir. Willows are also present upstream and downstream and should be eradicated in conjunction with any fish passage works at this site.
