Fairbridge Weir Removal Case Study, Molong Creek

The Project

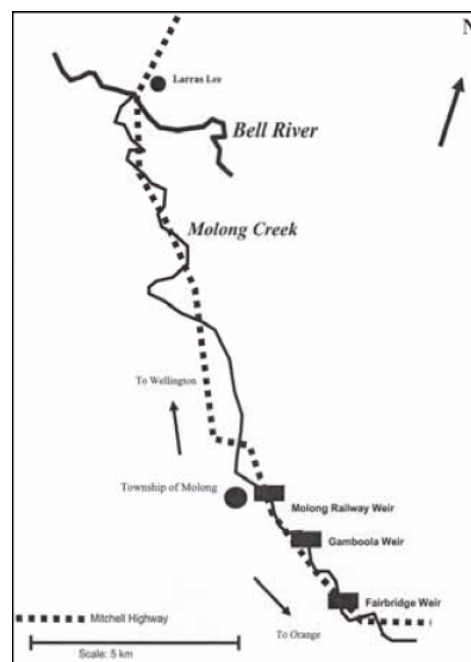
Figure 1: Location of Fairbridge Weir in relation to other weirs in the Molong Creek.

Fairbridge Weir was the uppermost of three structures (Fairbridge, Gamboola and Railway Weirs) situated along Molong Creek near the town of Molong, located in the Central-West region of NSW. Molong Creek is a system influenced by natural springs and is situated in the upper part of the Bell River Catchment. Fairbridge Weir was approximately 1.2m in height, 6m wide and constructed of concrete. The weir was located approximately 2km upstream of Gamboola Weir and 5km upstream of Railway Weir (Hobson & Richardson, 2004).

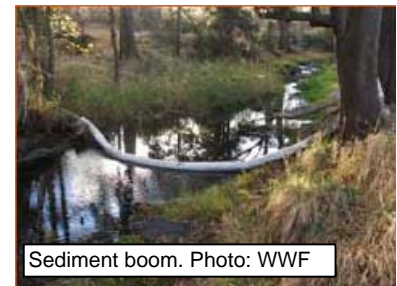
Sediment boom. Photo: WWF

Day 1: A management plan ensured that there were minimal impacts during the works phase. A sediment/oil boom was installed downstream of the structure prior to removal, and remained in place until after the works were completed. Siphon hoses were run over the weir overnight to move water downstream and allowed the weir pool to be drawn-down prior to the commencement of works. Dewatering the weir pool assisted in preventing bank slumping upstream and prevented the collapse of any burrows being utilised by platypus. In addition pre removal draw-down reduced high water velocities associated with breaching a full weir pool, and thus reduced the potential for increased erosion and turbidity levels downstream.

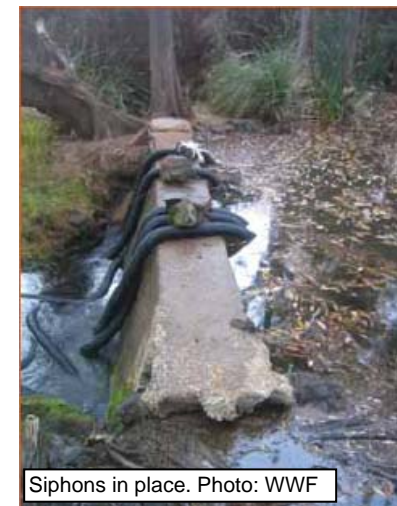
Siphons in place. Photo: WWF

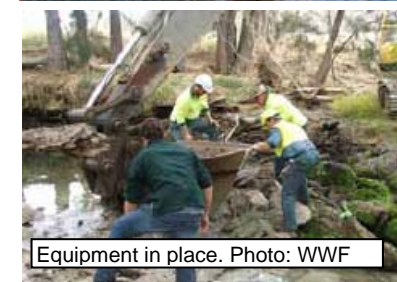
Equipment in place. Photo: WWF

Day 2: Access to the site was established and a stand of willows removed. Several branches from some nearby casuarinas were also lopped to allow access for the excavator, which broke up the weir and loaded the debris onto a truck. The removal works were completed on Day 2 with all material from the structure relocated offsite.

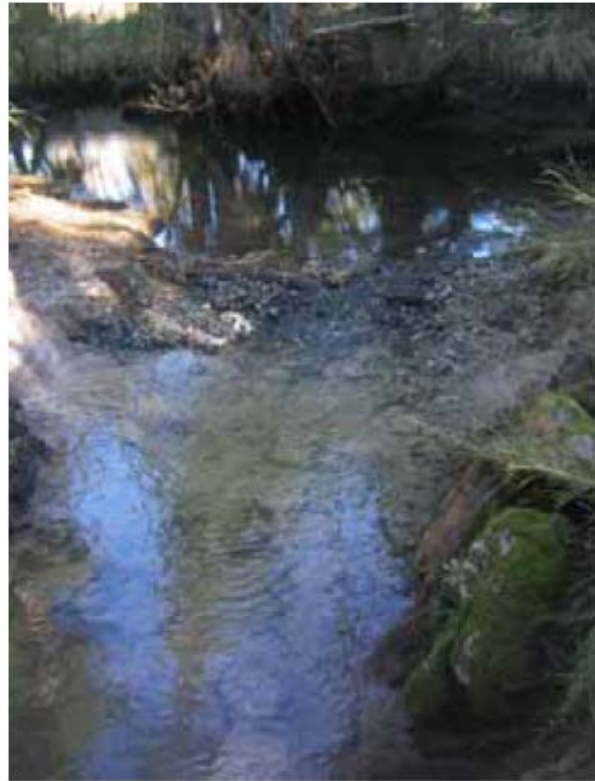
Molong Creek after Fairbridge Weir removal. Photo: WWF

The site will be visually monitored over time and it is expected that natural regeneration of native plant species will cover the exposed banks below the old water level. If required, post bed level surveys may be carried out to determine any changes to the creek bed over time.
