# **THE IDENTIFICATION, ASSESSMENT AND PRIORITISATION OF THREATENING PROCESSES TO THE AQUATIC ENVIRONMENT OF THE LOWER LACHLAN CATCHMENT**

## **REPORT TO THE LACHLAN CATCHMENT MANAGEMENT AUTHORITY**

## NSW DEPARTMENT OF PRIMARY INDUSTRIES

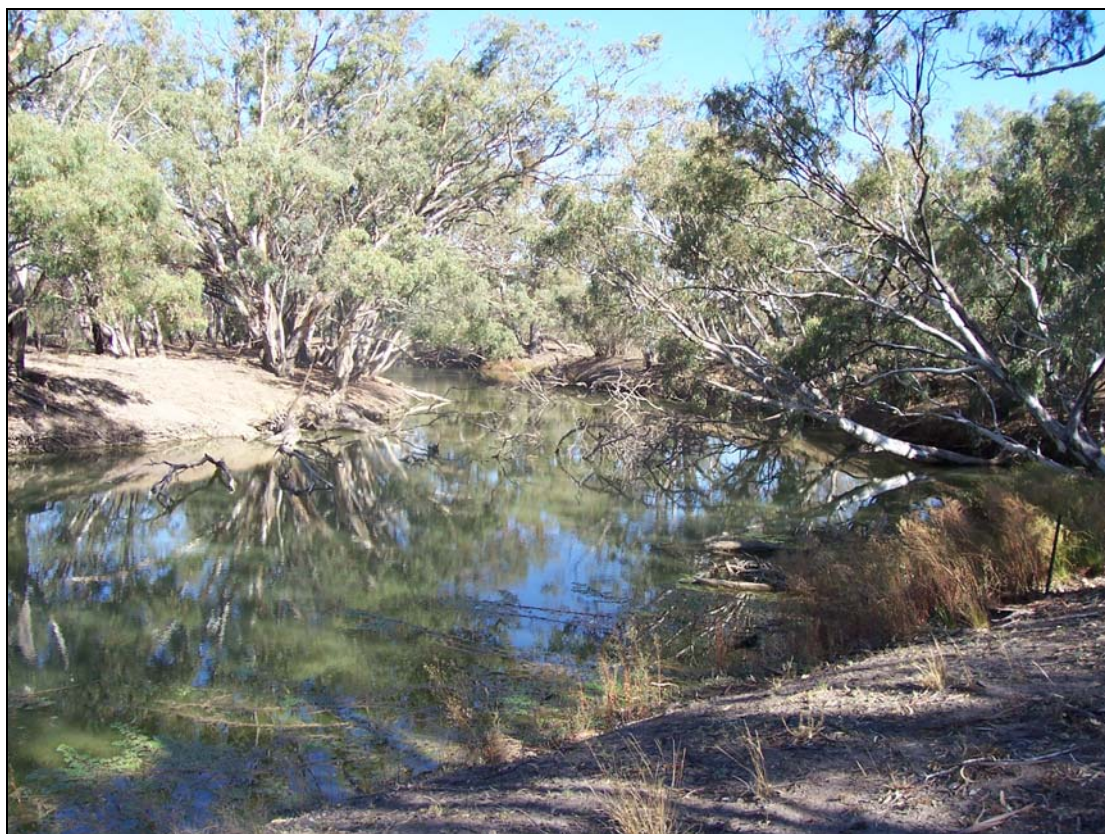
Cover photo: Lachlan River at Booligal, showing reduced understorey vegetation and bank erosion (Lower Lachlan region, Management Zone 11).

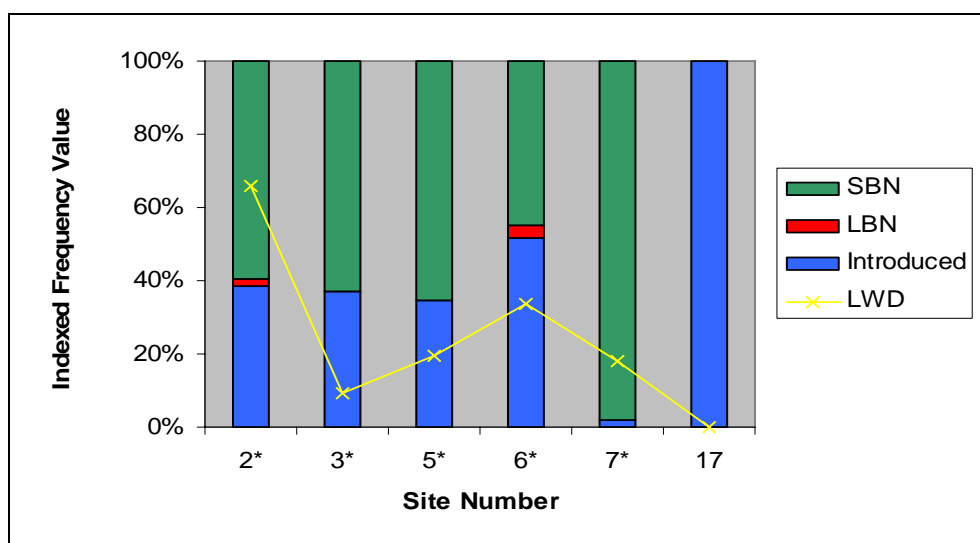
**Figure 7:** Comparison of fish assemblage and woody debris present at Zone 11 (Note: \* denotes site located on Lachlan River).

Zone 11 possessed six sampling sites that were assessed during the study, with five of these occurring on the Lachlan River. The habitat assessment for Zone 11 displayed levels of variation between the sites, reflecting the differences between the mainstem Lachlan River and the effluent creeks. Fish assemblage and the coverage of woody debris in Zone 11 were examined together, allowing for any relationships to be observed (Fig. 7).

Fish assemblage of Zone 11 was dominated by the presence of small bodied natives, which accounted for the highest percentage at four of the six sites (Fig. 7). Site 7 had the greatest value in the zone (98.20%), whilst Site 17 had no small natives in its assemblage. The assemblage of large bodied natives in Zone 11 was in a poor condition, with only Sites 2 and 6 recording these species as a very small proportion of the population. Introduced species were present in all six sites of Zone 11, dominating the effluent creek site (Site 17).

The large woody debris of Zone 11 provided moderate instream habitat, with four out of the six sites having a value greater than 15% (Fig. 7). Site 2, which occurs on the Lachlan River, had the largest LWD value recorded in the zone and during the study (65.61%). It can also be noted that the two sites with the largest woody debris cover (Sites 2 and 6) were the only two sites within the zone that had large bodied natives present in their fish assemblage. Site 17, which had the lowest woody debris cover (0%), was dominated by introduced fish species.
