Redundant Weir Removal: The Branch River Crossing - A Case Study

THE BRANCH RIVER CROSSING

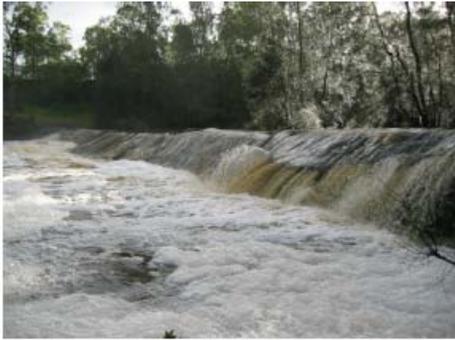
The Branch River Crossing during flood - note height of the structure. Photo: C. Thrupp.

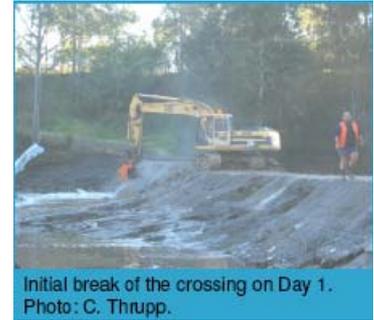
An excavator and rock breaker were used to break through the top of the concrete cap on one side of the crossing so that the excavator could work back along the crossing. This enabled trucks to reverse along the crossing for loading.

Initial break of the crossing on Day 1. Photo: C. Thrupp.

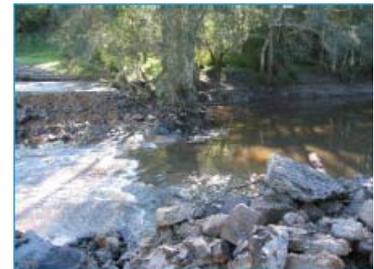
After breaking away a small section of the crossing, a 15 hour interval was required to allow water levels to drop to the new height. This minimised the movement of suspended solids during the removal and exposed the whole structure.

Allowing for the outflow of water, to reduce upstream water levels late on Day 1. Photo: C. Thrupp.

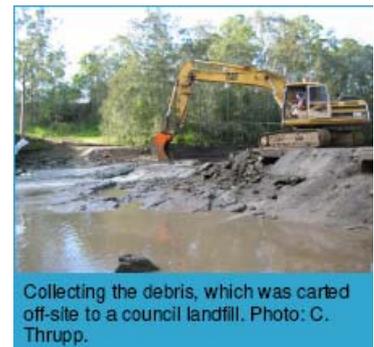
After the crossing was exposed, the excavator was able to break-up the structure and remove the debris with the help of 6 tip trucks. All potential issues were considered including the possibility of acid sulfate material within the debris. To minimise any risk, all spoil was taken off-site.

Collecting the debris, which was carted off-site to a council landfill. Photo: C. Thrupp.

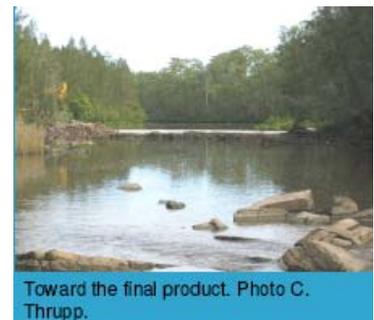
The old culverts also needed to be broken-up before being removed. Finally after 3 days of work the removal of the structure was nearly complete. The natural rock bar on which the crossing was originally built remained intact.

Toward the final product. Photo C. Thrupp.

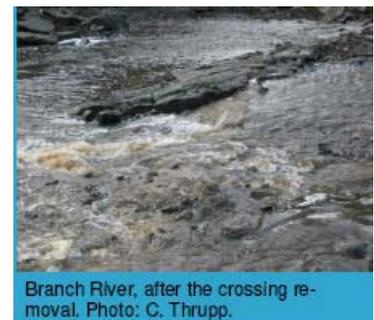
A couple of metres of the crossing was left near the edge to help maintain bank stability. The site was then cleaned-up and a clear fish passage reinstated. For the first time in 52 years, high tides are able to flood-out the natural rock bar.

Branch River, after the crossing removal. Photo: C. Thrupp.

There is potential for erosion of the upstream riverbank to occur after removal due to scouring downstream of the old crossing. To lessen the potential impact, a couple of metres of the crossing has been retained on both banks to promote stability under altered hydrological conditions.
