# **REDUCING THE IMPACT OF WEIRS ON AQUATIC HABITAT**

## **NSW DETAILED WEIR REVIEW**

**REPORT TO THE NEW SOUTH WALES ENVIRONMENTAL TRUST**

**NORTHERN RIVERS CMA REGION**

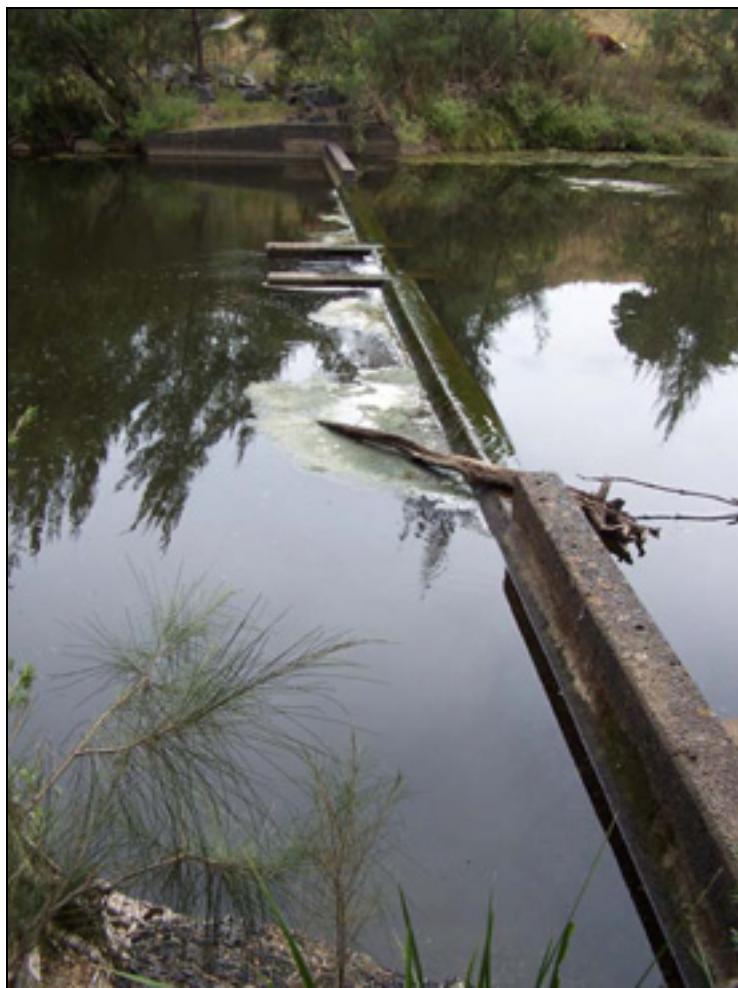
**Figure 1.** Cookes Weir over the Richmond River near Casino. View of the weir is from the left bank (17-03-05, 0.573 metres, 22.5ML/day).

Water levels within the impoundment are generally maintained at maximum levels; however, the central drop boards can be removed to top up Jabour Weir, the principle water supply for Casino, during dry periods. The weir is considered to be in working condition, with a satisfactory structural safety level being achieved (Opus and Golder, 1999). Minor erosion is evident around the left bank abutment.

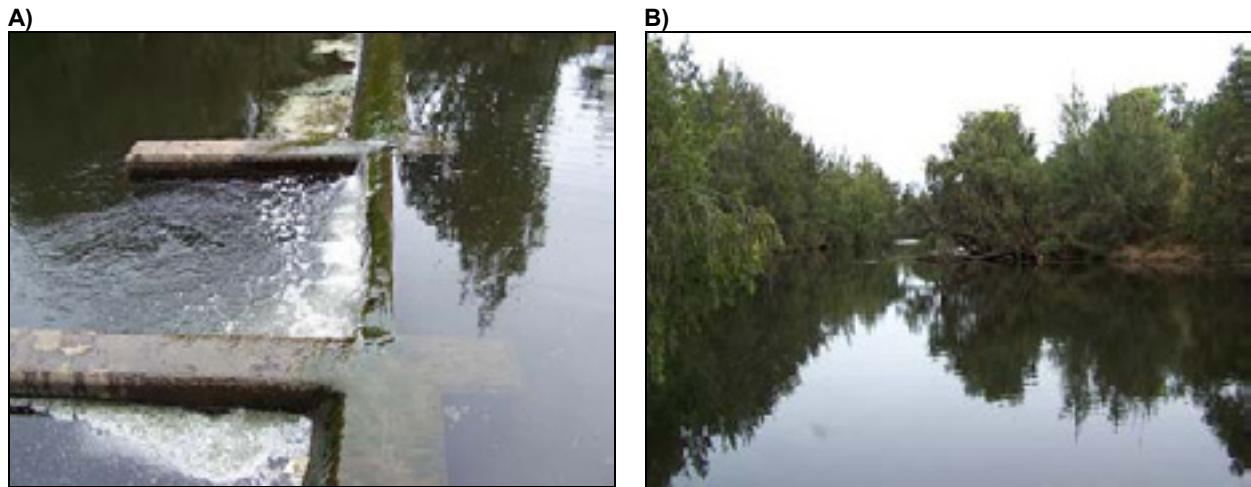
**Figure 2.** (A) View of drop board structure in Cookes Weir. (B) Riparian and instream habitat immediately downstream of Cookes Weir, Richmond River.

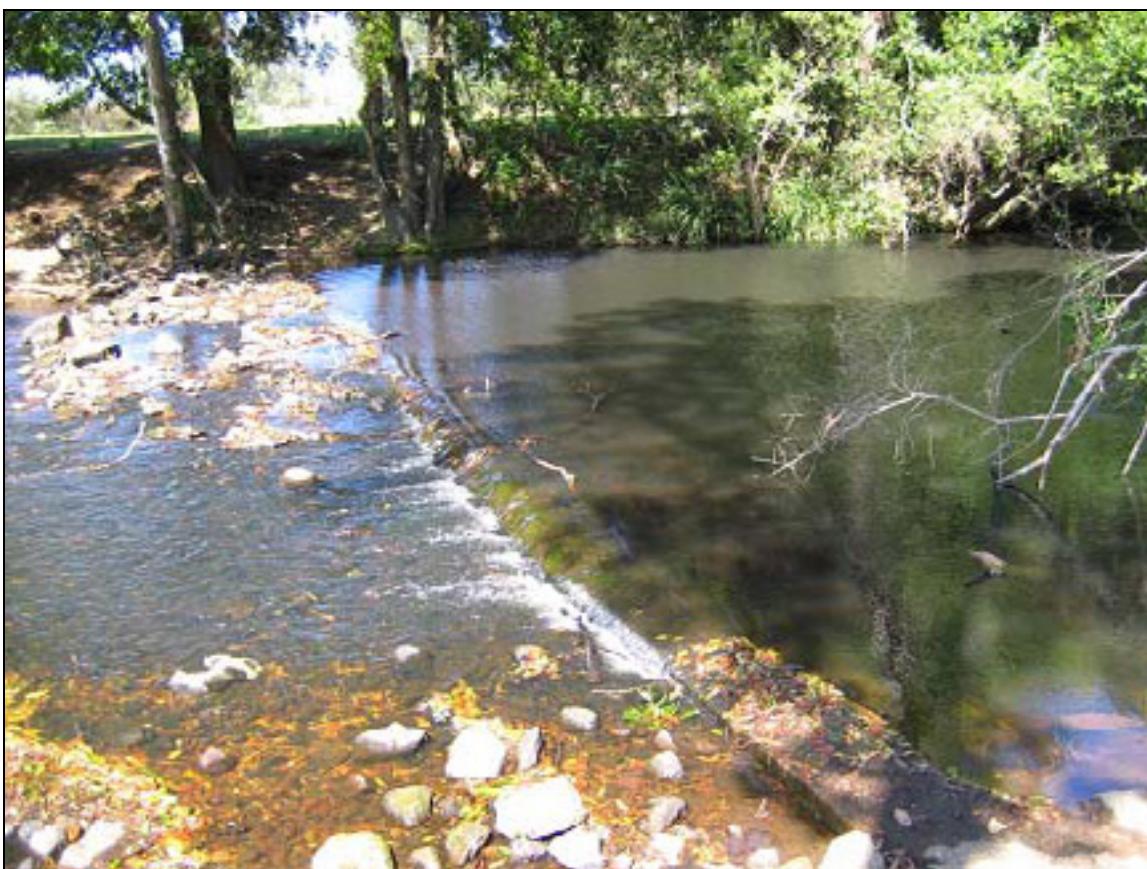
**Figure 1.** Stewarts River Weir over the Stewarts River near Johns River as viewed from the downstream left bank.

Stewarts River Weir (Figure 1) is located approximately 1km north of Johns River on the mainstem Stewarts River, and is accessible via private property. The fixed crest concrete weir acts as a tidal barrage that limits the intrusion of brackish water from Watson Taylors Lake located approximately 3km downstream. The weir measures 0.5 metres high by 20 metres wide and pools water 600 metres upstream at depths > 1.5 metres. Water cascades over the crest of the weir, with fish passage being restricted due to excessive headloss (200mm) along the left bank during low-flow conditions. However, the weir quickly drowns out following minor river rises during which fish passage is unimpeded.

Due to the low height of the weir, a full-width rock-ramp would provide the best option of remediating fish passage while maintaining the structure. Full-width rock ramp fishways are generally considered one of the most effective designs for passing various species and size classes of fish within Australian streams. Due to the small size of the river, flows would be concentrated to the centre of the structure to ensure fish passage during low-flow conditions.

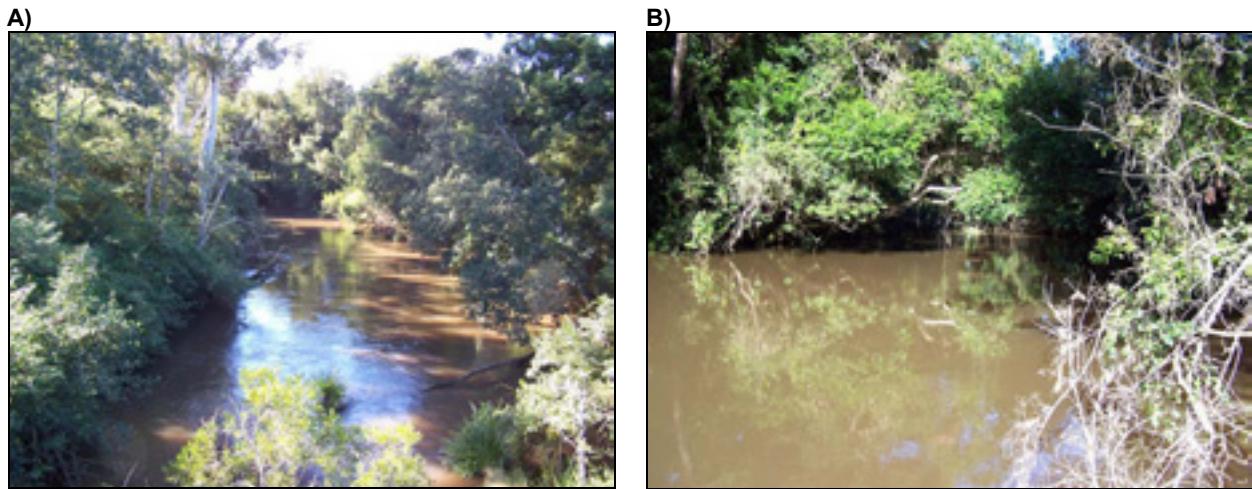
**Figure 2.** Riparian and instream habitat (A) immediately downstream and (B) upstream of Stewarts River Weir, Stewarts River.

The weir pool displays intact, vegetated banks with minor erosion due to unrestricted cattle access. Riparian vegetation is primarily composed of mixed sub temperate rainforest species (e.g. Bangalow Palms, Waterhousia floribunda, and Guioa), with groundcover considered sparse and dominated by introduced weeds (e.g. lantana and privet) and *Lomandra hystrix* (Figure 2). Overall creek health would be improved by the insertion of riparian fencing followed by the revegetation of disturbed banks, which reach up to 3 metres above the water level. Siltation is considered minor within the weir pool due to the low height of the structure, with a difference in bed level of 300mm being recorded across the face of the weir.

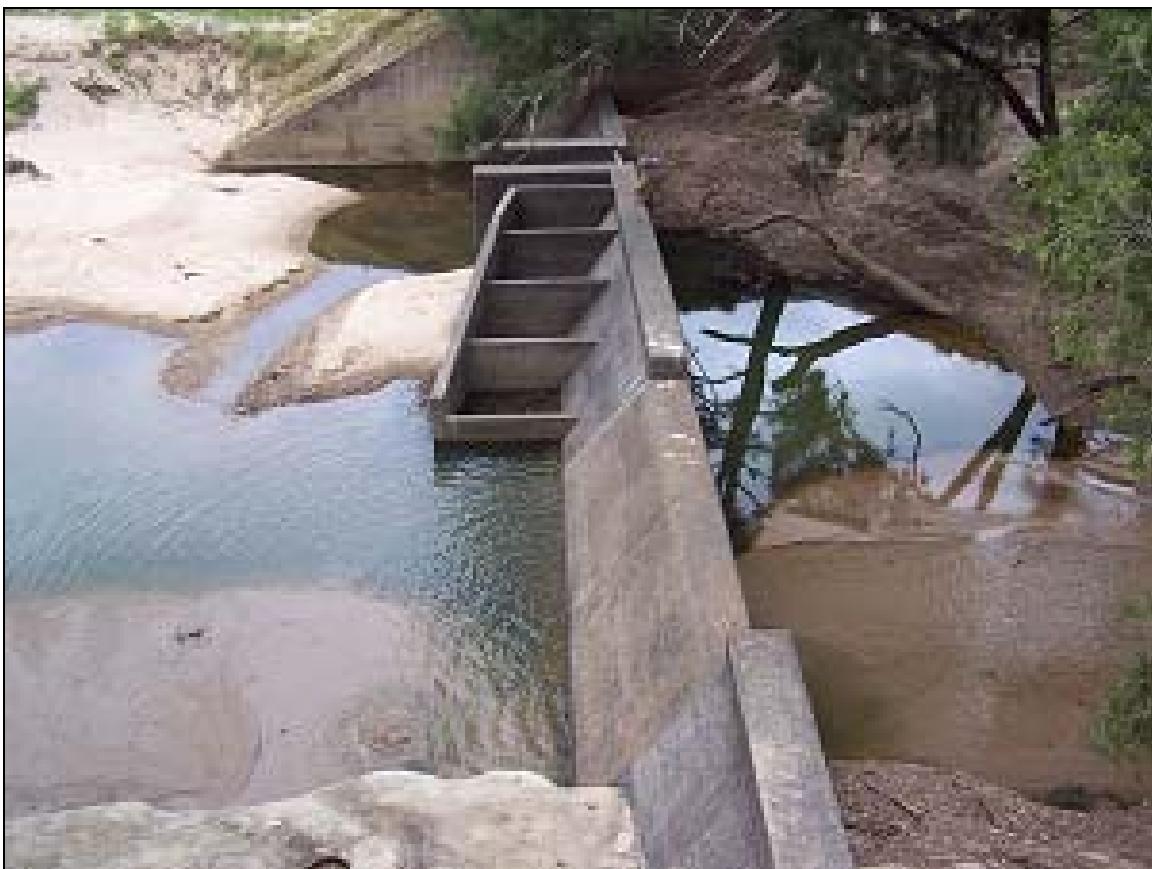
**Figure 1.** Shannon Brook Weir on Shannon Brook near Casino as viewed from the left bank (23-08-05: 0.639 metres, 65.514ML/day).

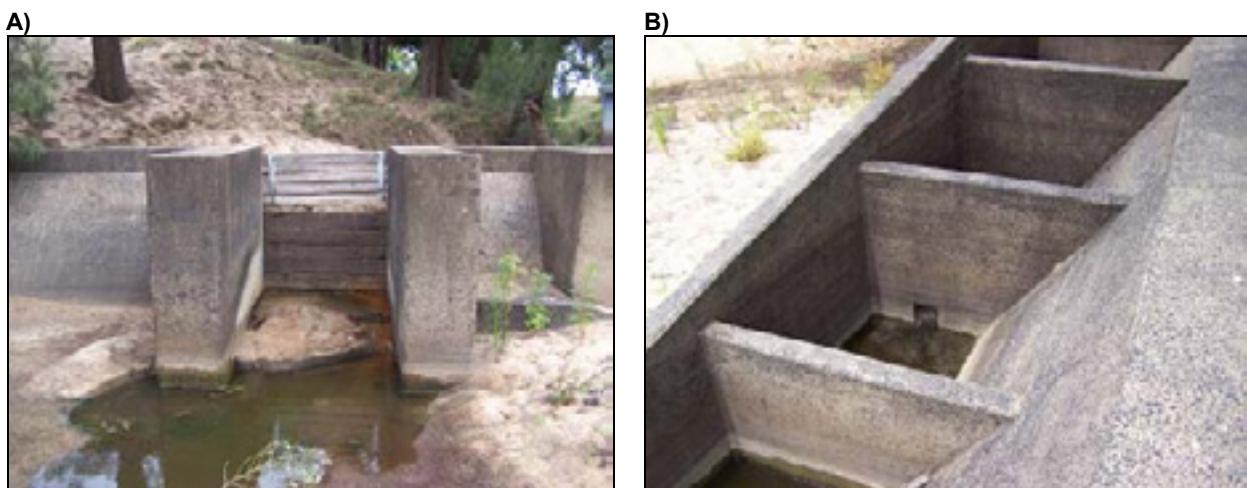
**Figure 2.** View of (A) the removable drop board structure along the weir's right bank and (B) the centrally placed submerged orifice fishway.

Removal of the drop boards in conjunction with blocking the scour valve along the left abutment would provide fish passage during low-flow conditions within Shannon Brook. At present, no water is pooled within the weir, thus removal of the drop boards would not alter the ability of adjacent landholders to acquire water for stock or domestic use. Effect of removing the drop boards upon upstream bank stability would need to be investigated, given that water flow would be redirected towards the upstream right bank.

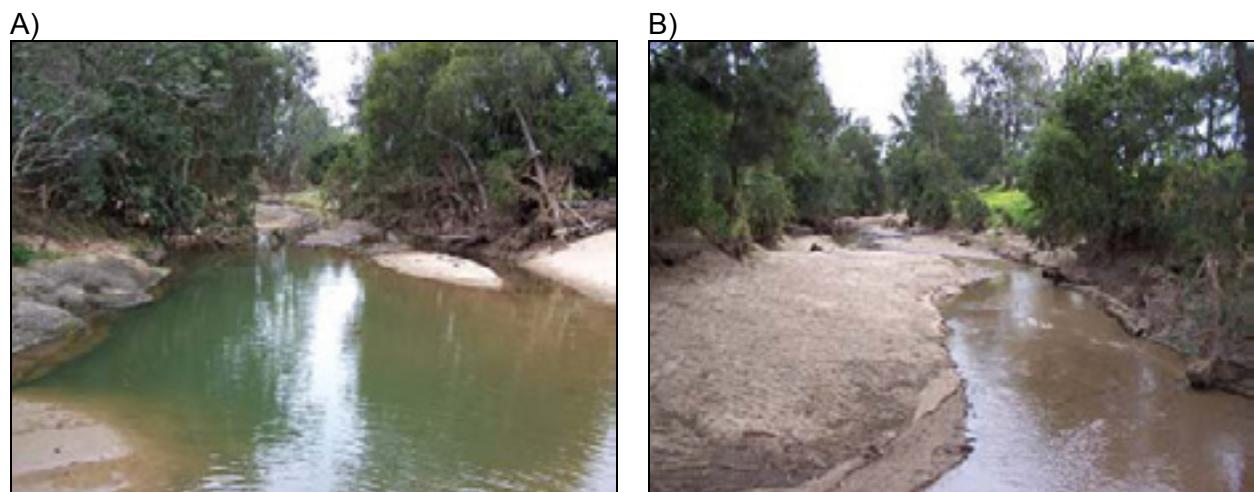
Water quality within Shannon Brook is described as fair to good except during drought periods when stagnant pools form. The weir displays poorly vegetated banks with extensive erosion present both upstream and downstream of the structure, presumably due to cattle access and associated clearing of riparian and floodplain vegetation. Riparian vegetation is sparse, primarily composed of casuarinas (*Casuarina cunninghamiana*), *Callistemon* spp., and tuckeroos (*Cupaniopsis anacardioides*). Groundcover is dominated by pasture grasses, introduced weeds (e.g. lantana and castor oil) and sparse patches of *Lomandra hystrix*. Despite fencing on both sides of the creek, cattle appear to gain regular access to the waterway. Thus, overall creek health would be improved by maintaining riparian fencing and revegetating disturbed banks that reach up to 4 metres above the weir pool. Siltation in the weir pool is minor, with a 300mm difference in bed level being recorded across the structure. A highly mobile sandy substrate dominates the banks and stream bed (Figure 3).

**Figure 3.** Riparian and instream habitat (A) immediately downstream and (B) upstream of Shannon Brook Weir, Shannon Brook.

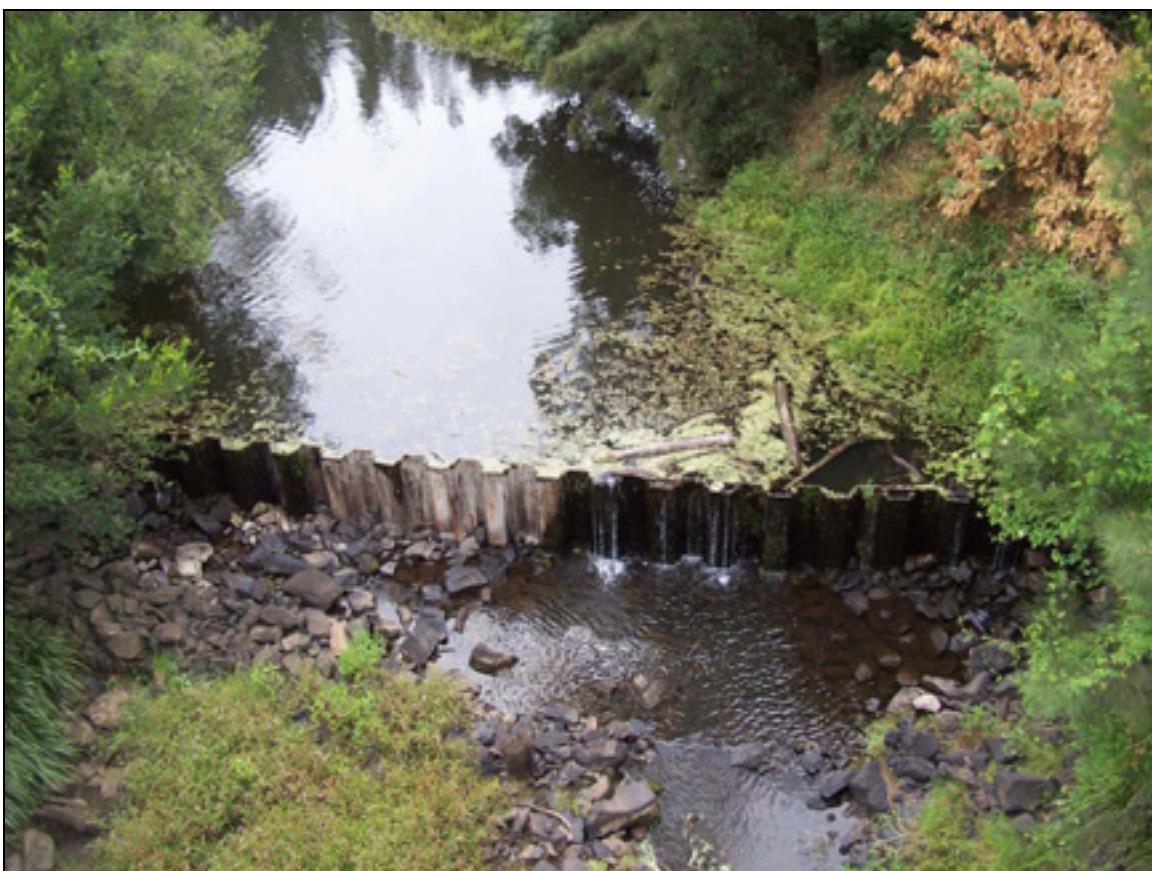
**Figure 1.** Goolmangar Creek Weir on Goolmangar Creek near Lismore.

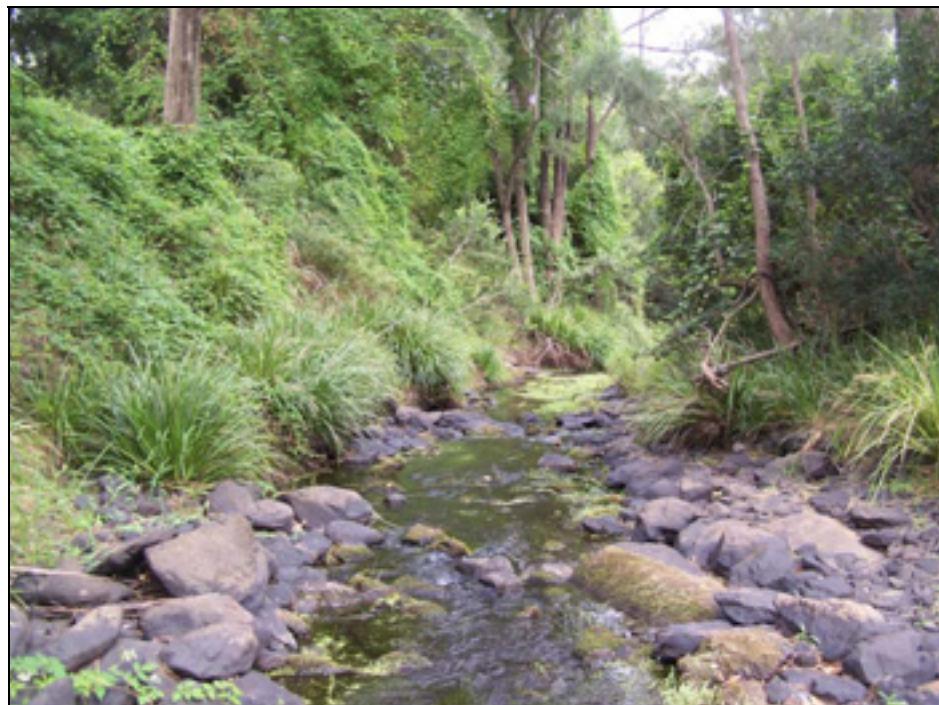
**Figure 2.** Riparian and instream habitat immediately downstream of the weir.

Vegetation within the riparian zone is primarily composed of casuarinas (*Casuarina cunninghamiana*), subtemperate rainforest species, and introduced species (e.g. *Camphor laurel*), while groundcover adjacent to the waterway is dominated by *Lomandra hystrix*, tobacco bush, and lantana). Siltation was not recorded within the weir pool, with a minor scour pool (0.5 metres deep) observed immediately downstream of the structure.

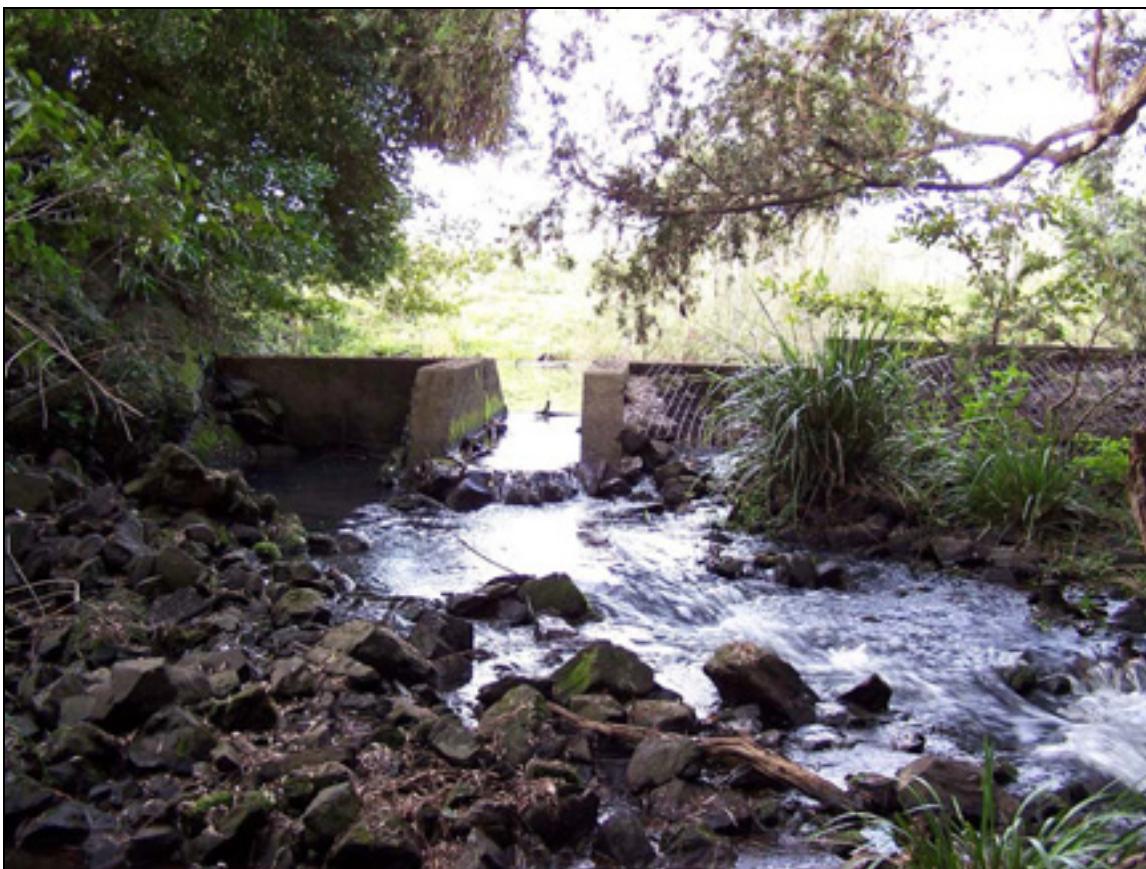
**Figure 1.** Hickeys Creek Weir on Hickeys Creek near Kempsey, as viewed from downstream.

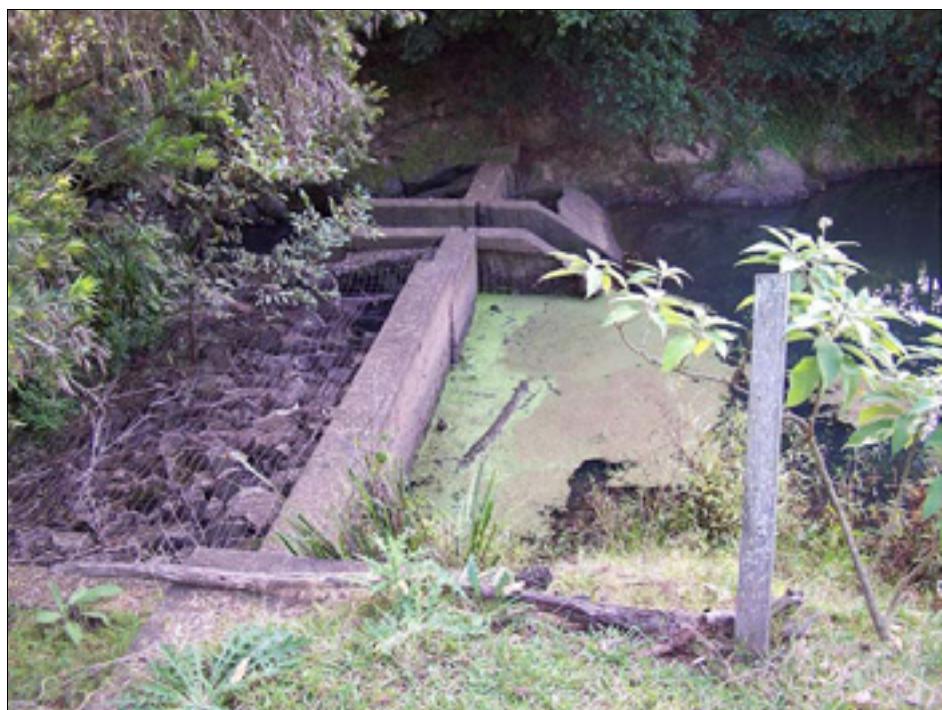
**Figure 2.** View of Hickeys Creek Weir from the left bank displaying downstream rock protection. The right bank is bedrock controlled.

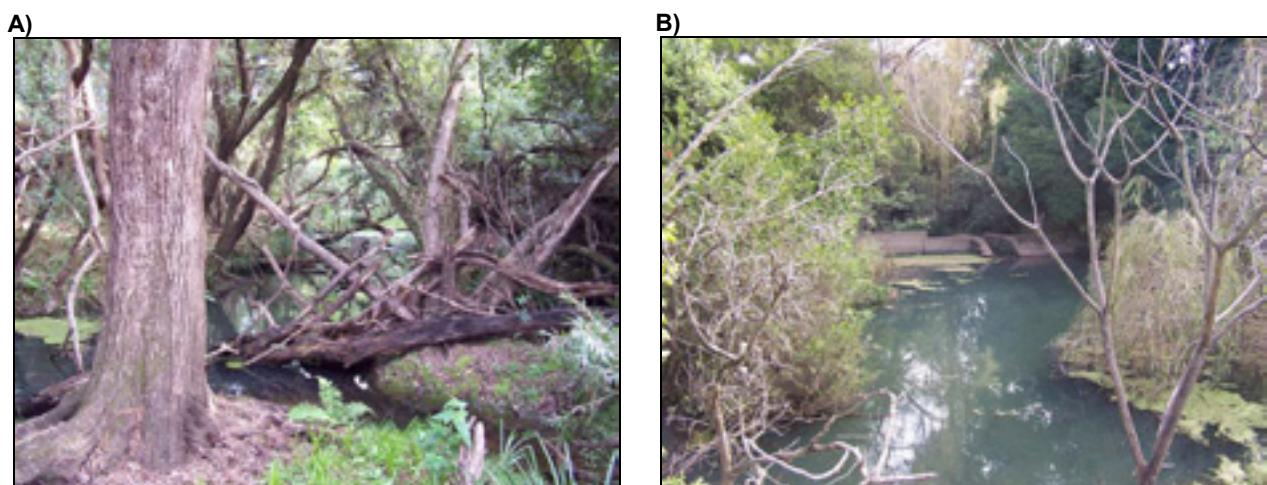
**Figure 3.** Riparian and instream habitat (A) immediately downstream and (B) upstream of Hickeys Creek Weir, Hickeys Creek.

Water quality within Hickeys Creek is described as good to excellent except during drought periods when stagnant pools form. The weir and surrounding reaches display moderately-to-well vegetate banks (Figure 3), with minor erosion being recorded on the upstream side of the structure due to cattle access on both sides of the creek. Downstream of the weir, riparian vegetation is considered to be in excellent condition with a 10 metre buffer on either side of the creek.

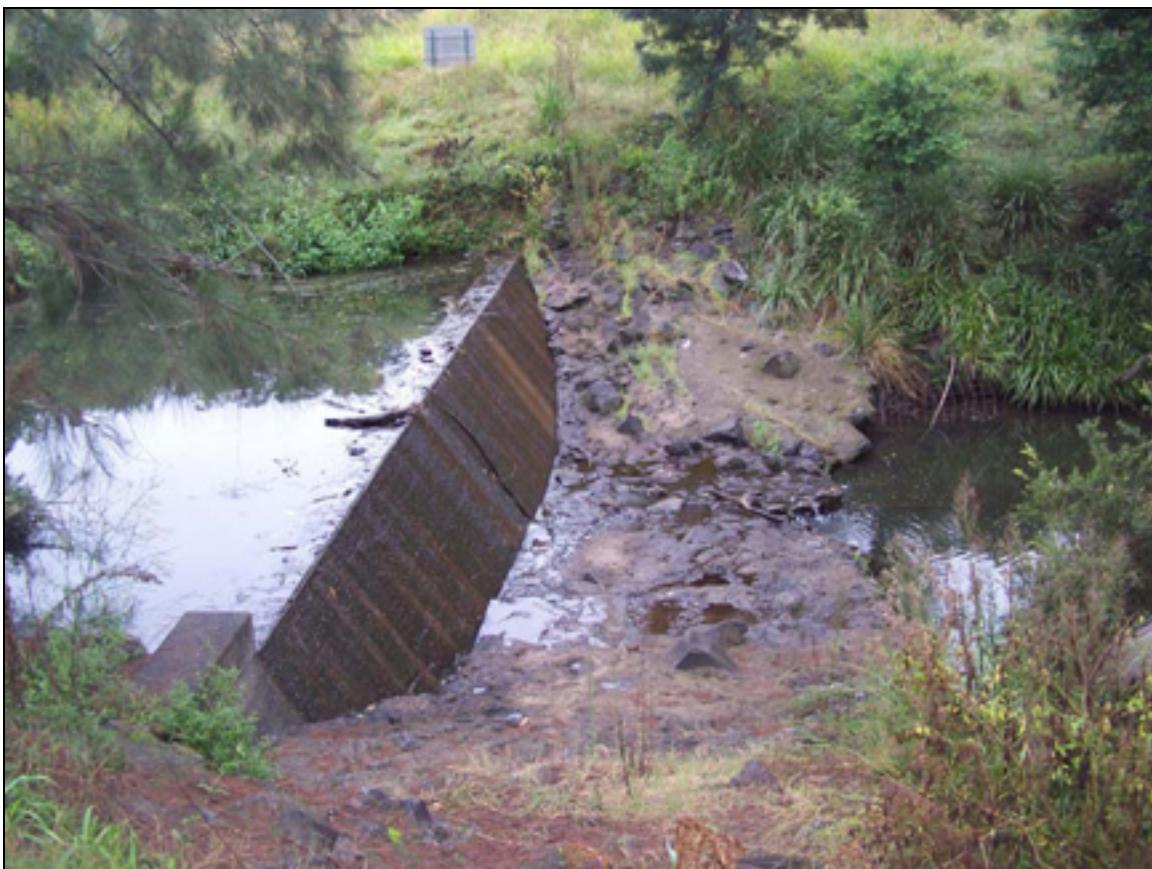
**Figure 1.** View of the Cob-o-corn Weir from the downstream right bank.

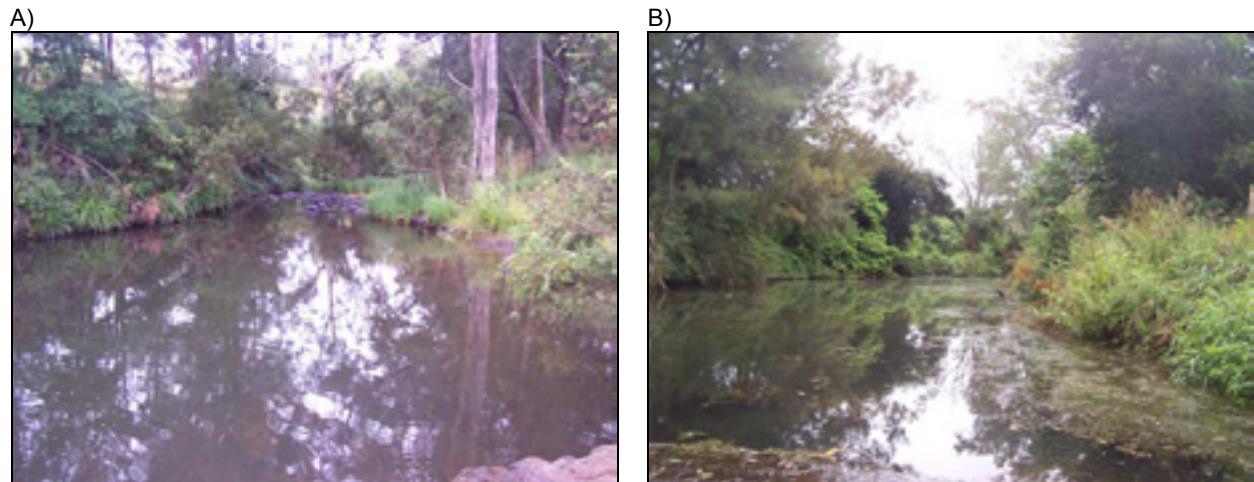
**Figure 2.** Riparian and instream habitat (A) immediately downstream and (B) upstream of Cob-o-corn Weir.

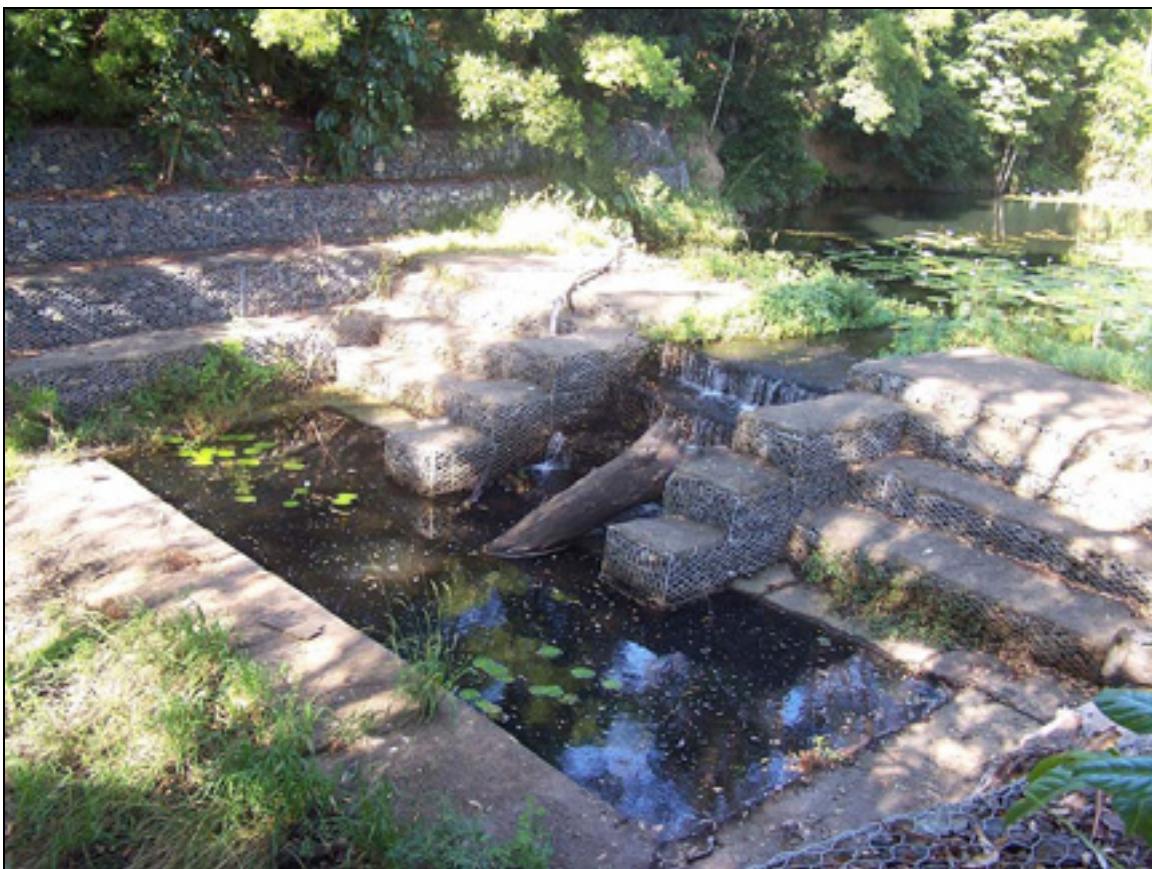
**Figure 1.** Pine Brush Creek Weir on Pine Brush Creek near Coffs Harbour as viewed from the downstream left bank.

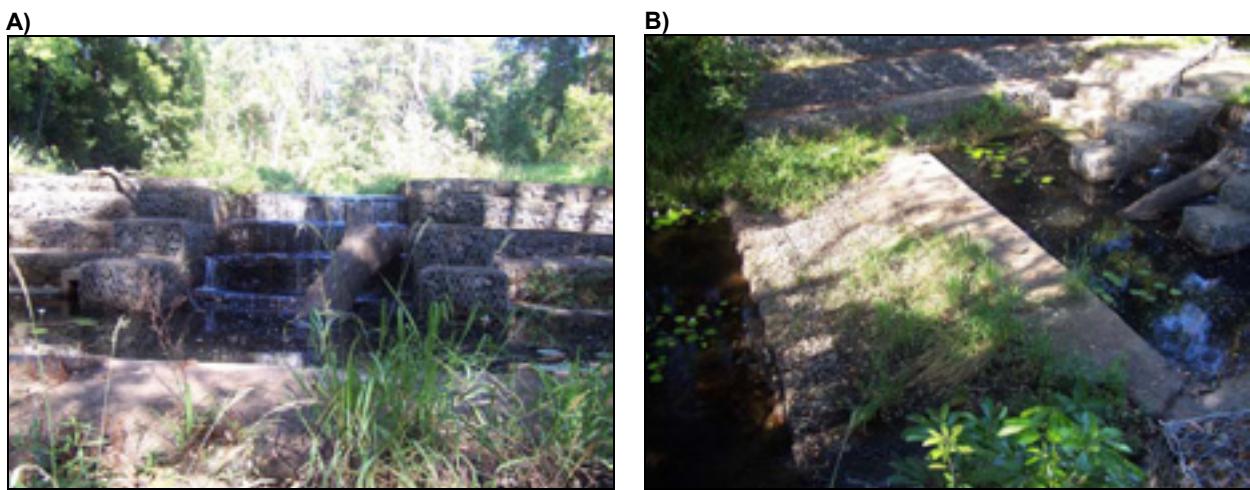
**Figure 2.** (A) Pine Brush Creek Weir from the downstream direction showing the cascading water flow, and (B) view of the downstream concrete gabion apron that further impedes fish passage.

The weir is considered to be in a working condition, with only minor maintenance required to address the undermining of the downstream concrete apron.

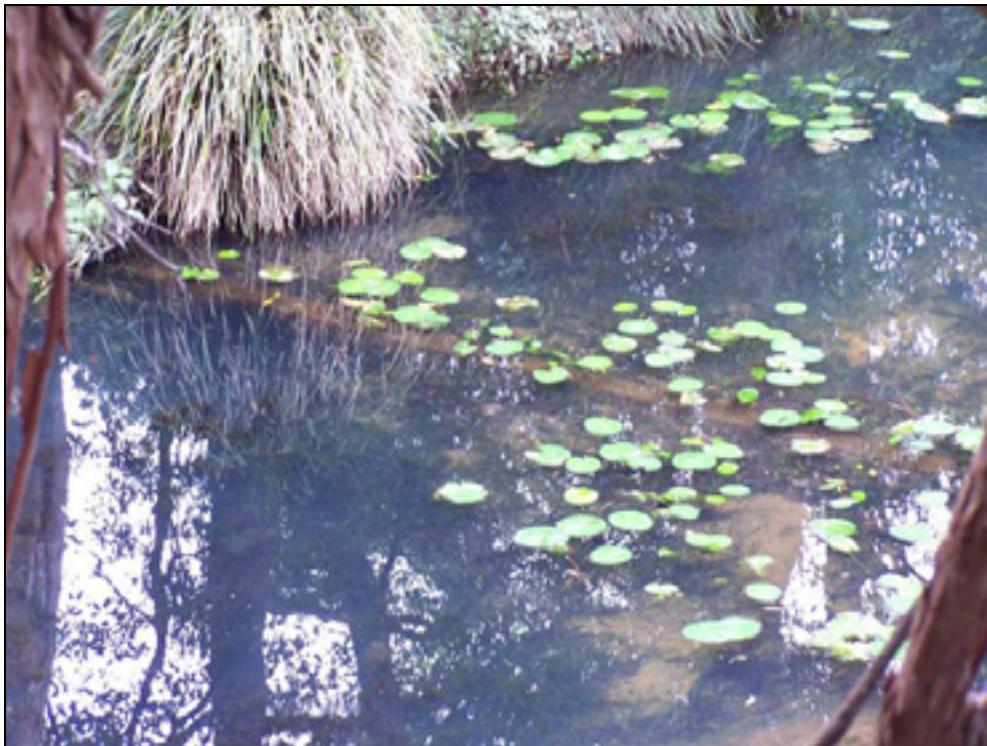
**Figure 3.** A second weir is located 150 metres upstream of Pine Brush Creek Weir, but is drowned out by 200mm of water by the downstream structure.

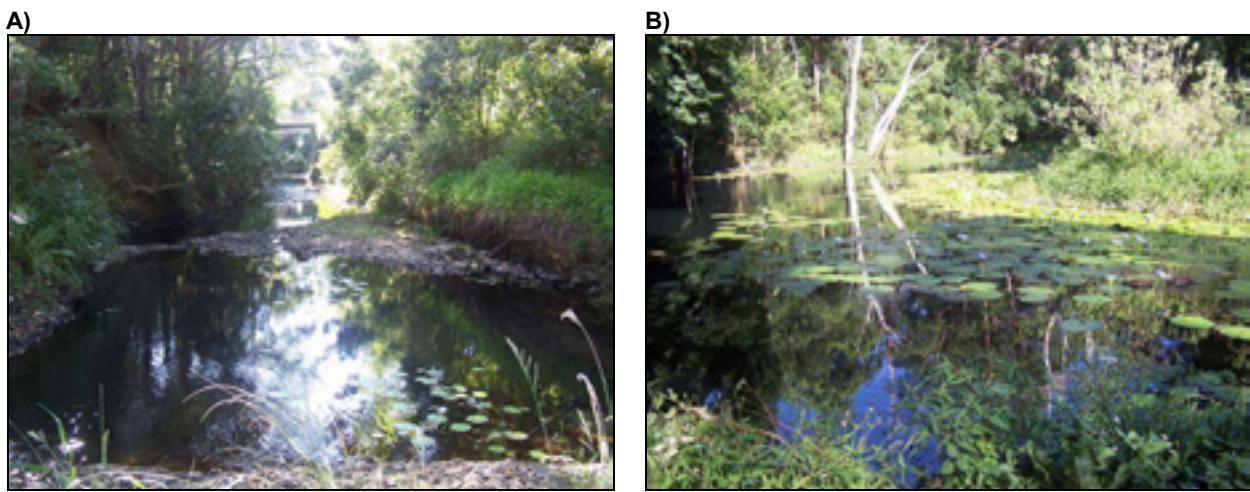
The weir pool displays extensive erosion on the right bank due to massive bank failure, while minor erosion was noted on the left bank. Riparian vegetation cover is considered extensive in the catchment and is primarily composed of mixed sub temperate rainforest species and eucalypts, with groundcover dominated by introduced weeds (e.g. lantana) and *Lomandra hystrix*.

**Figure 4.** Riparian and instream habitat (A) immediately downstream and (B) upstream of Pine Brush Creek Weir, Pine Brush Creek.

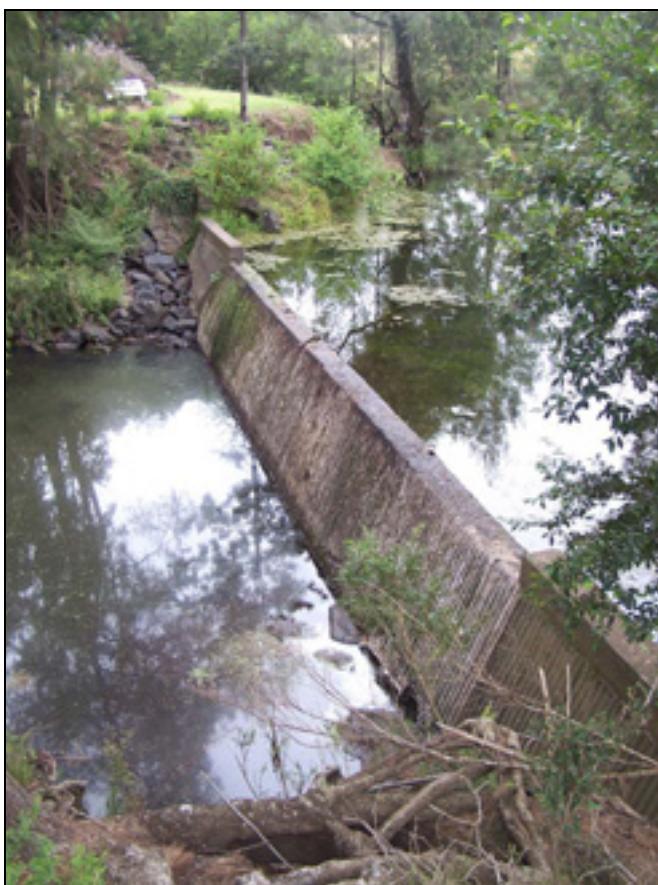
**Figure 1.** Eden Creek Weir on Eden Creek near Kyogle as viewed from the left bank.

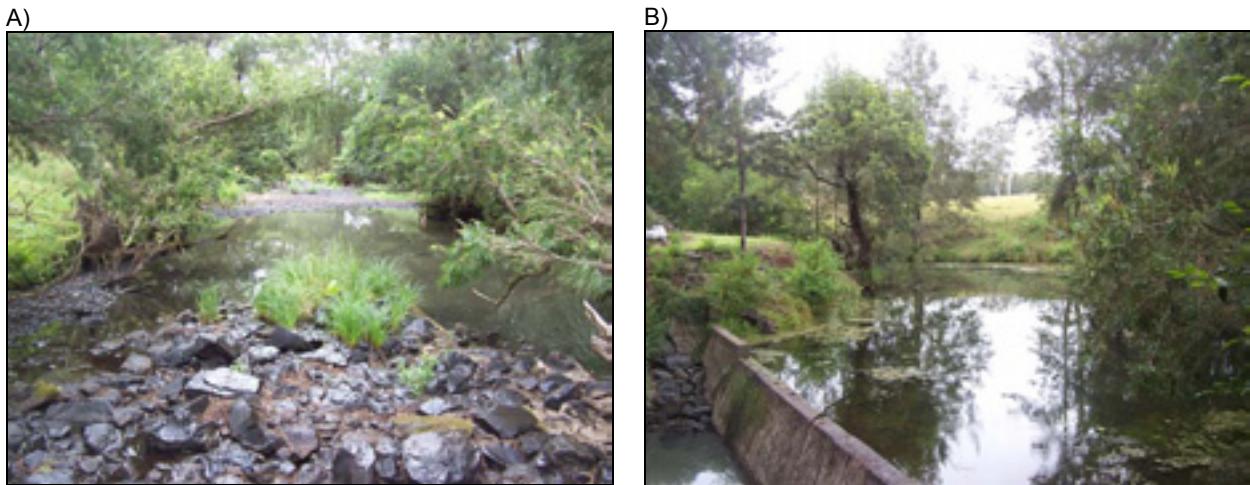
**Figure 2.** Riparian and instream habitat immediately downstream (A) and upstream (B) of Eden Creek Weir.

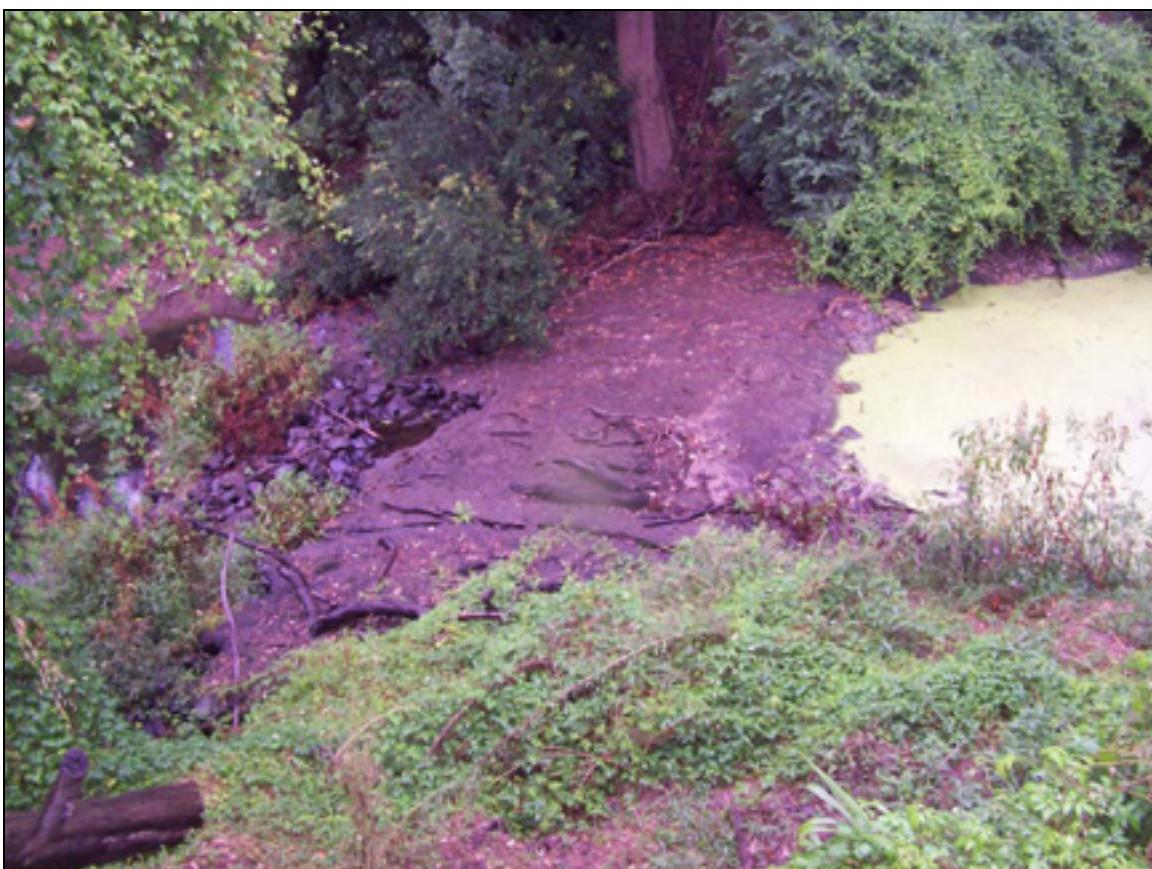
**Figure 1.** View of Fawcetts Creek Weir 3 from the left bank.

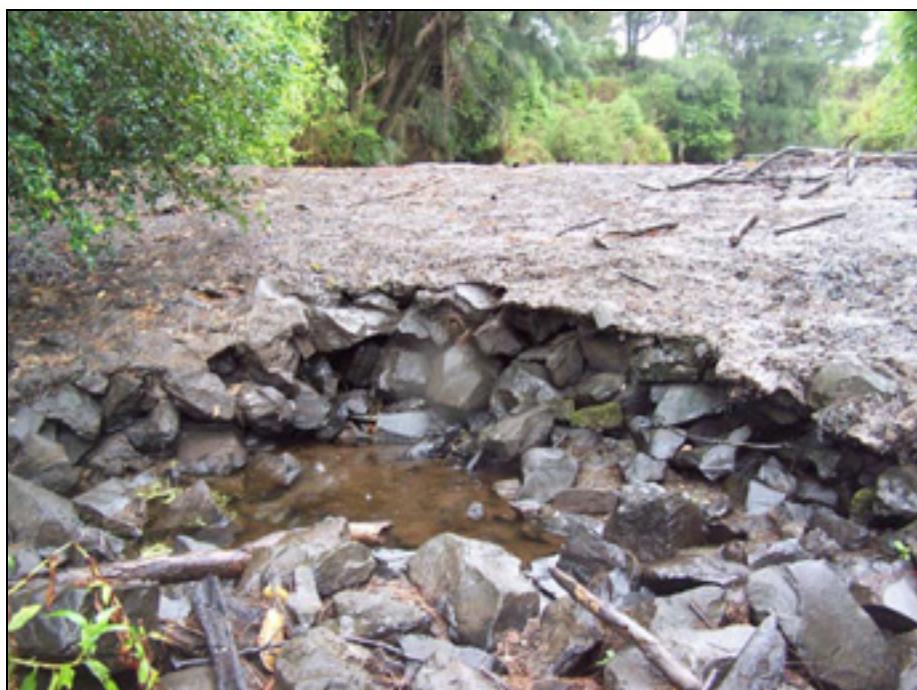
**Figure 2.** Structural damage observed in the central portion of Fawcetts Creek Weir 3.

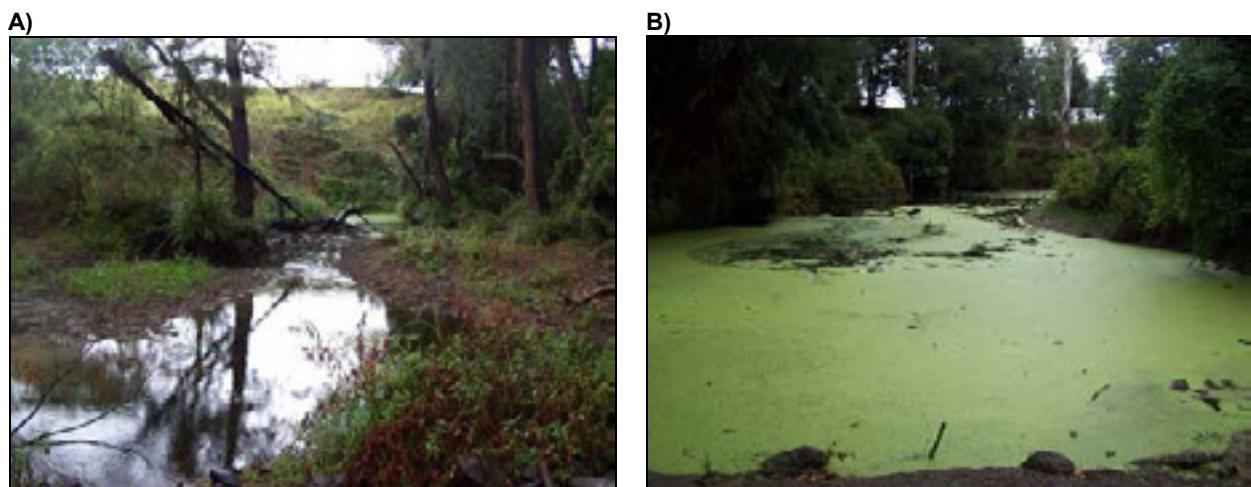
The weir displays moderately vegetated banks with minor erosion present both upstream and downstream of the structure presumably due to cattle access. Riparian vegetation is composed of rainforest hardwoods, eucalypts, casuarinas, and exotics trees (e.g. *Camphor laurel*); while groundcover is dominated by pasture grasses and *Lomandra hystrix*. Extensive erosion is evident on the left bank adjacent to the weir where bank failure has occurred recently. Despite fencing on both sides of the creek, cattle appear to gain regular access to the waterway. Thus, overall creek health would be improved by maintaining riparian fencing and revegetating disturbed banks that reach up to 6 m above the water level. Siltation is evident within the weir pool, with the difference in bed level on the upstream and downstream side of the weir being 1.4 metres.

**Figure 3.** Riparian and instream habitat (A) immediately downstream and (B) upstream of Fawcetts Creek Weir 3, Fawcetts Creek.

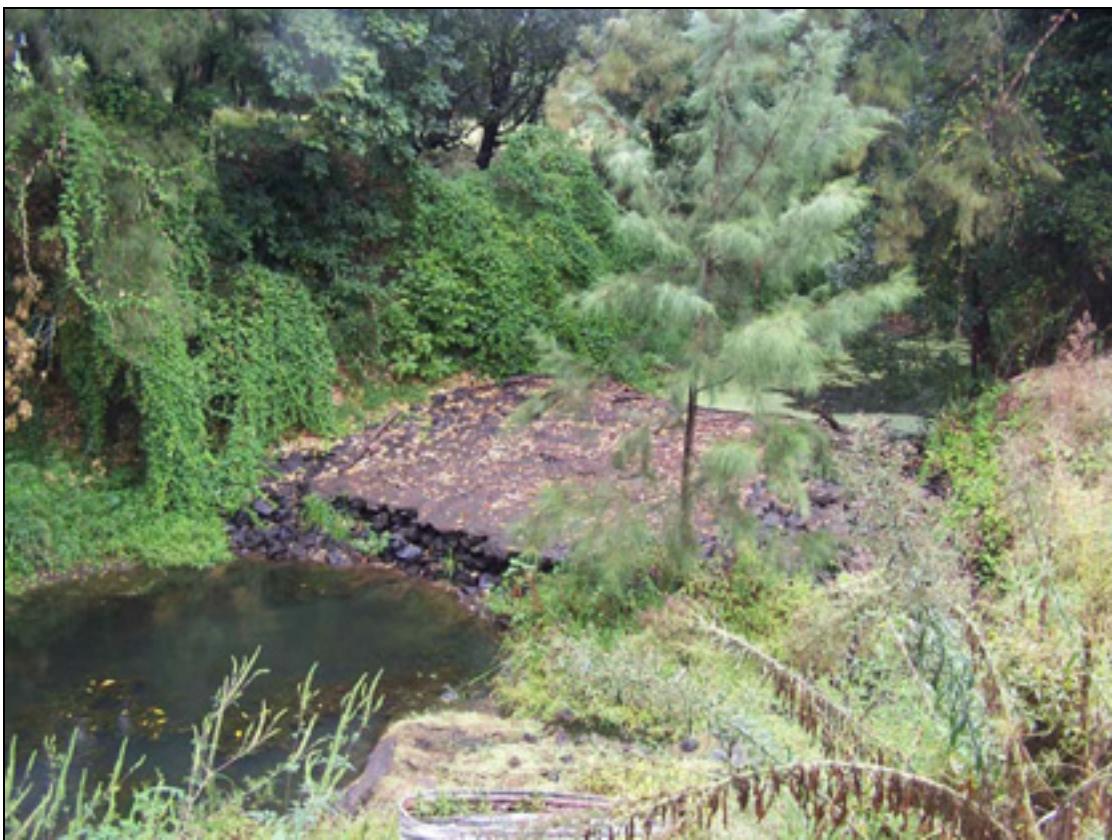
**Figure 1.** Fawcetts Creek Weir viewed from left bank displaying damage to the toe of the structure.

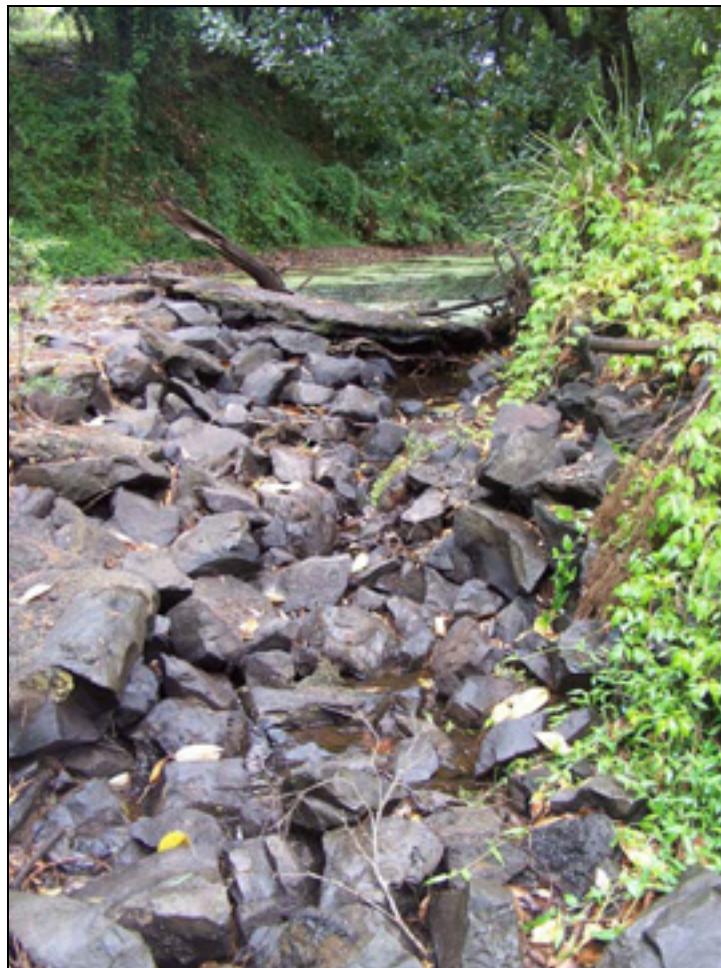
**Figure 2.** View of left bank abutment on Fawcetts Creek Weir 1 displaying structural damage.

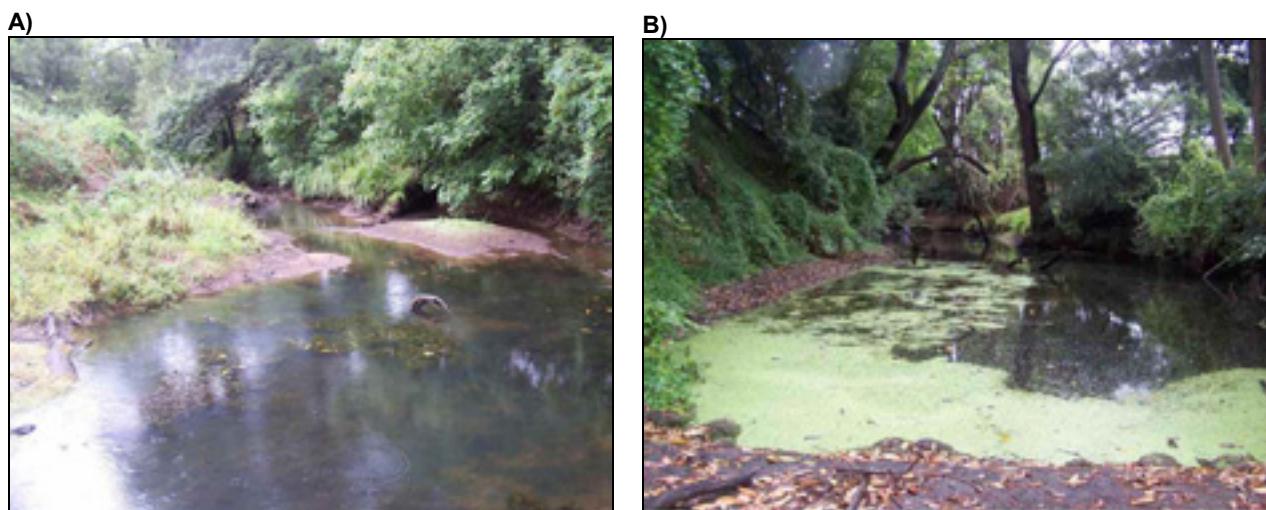
**Figure 3.** Riparian and instream habitat immediately downstream (A) and upstream (B) of Fawcetts Creek Weir 1.

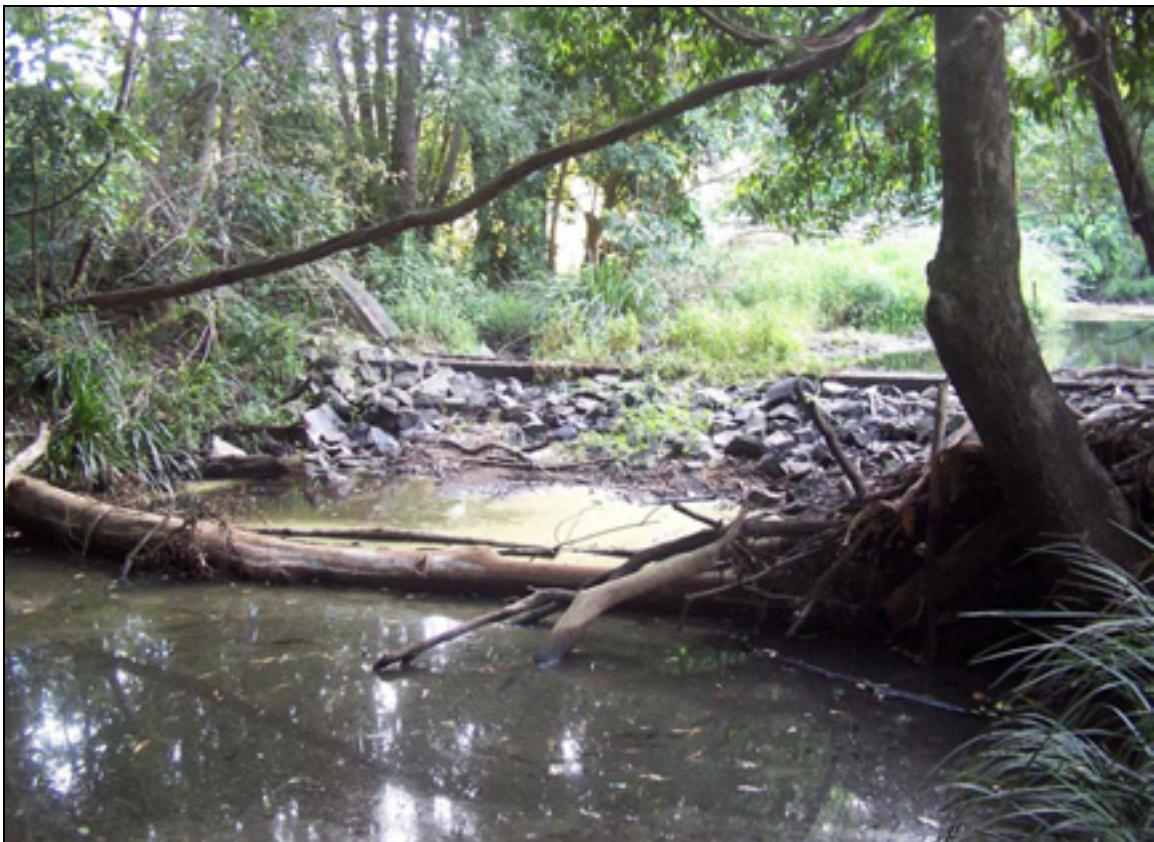
**Figure 1.** Mullumbimby Weir 2 on Mullumbimby Creek as viewed from the downstream left bank.
