# **REDUCING THE IMPACT OF WEIRS ON AQUATIC HABITAT**

## **NSW DETAILED WEIR REVIEW**

**REPORT TO THE NEW SOUTH WALES ENVIRONMENTAL TRUST**

**NORTHERN RIVERS CMA REGION**

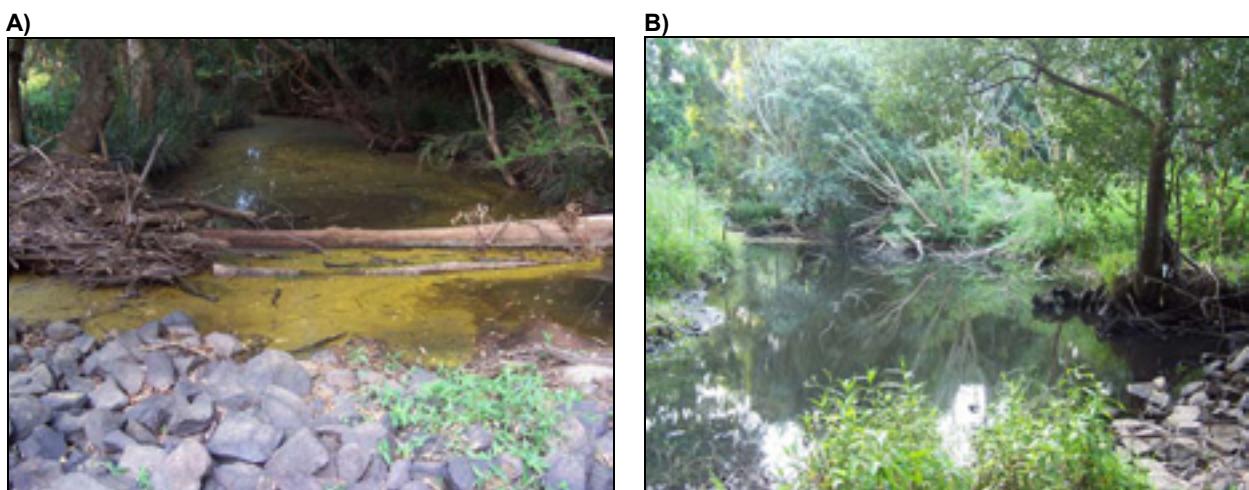
Downstream of the weir, the adjacent property owners (including a private primary/secondary school) have implemented riparian revegetation that has provided a 10 metre buffer on either side of the creek (Figure 2).

**Figure 2.** Riparian and instream habitat (A) immediately downstream and (B) upstream of Mullumbimby Weir 2, Mullumbimby Creek.

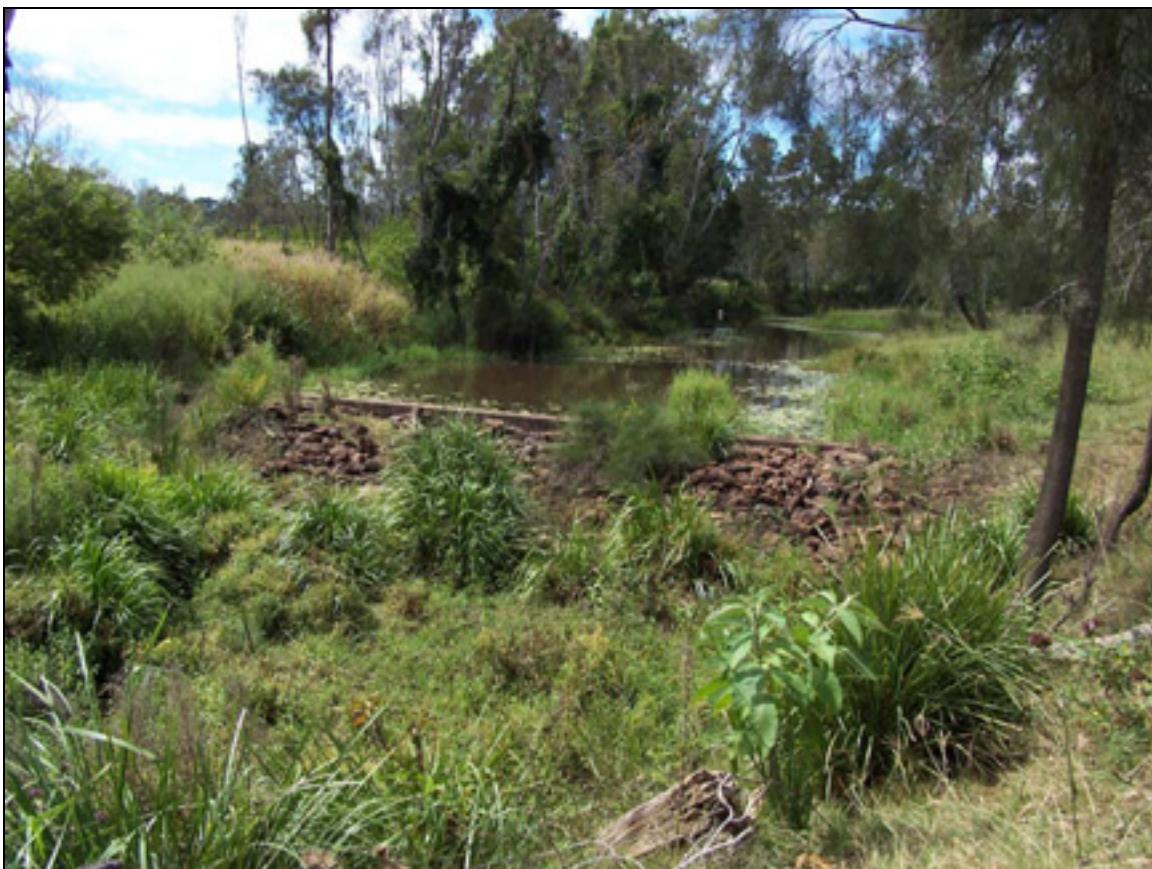
**Figure 1.** Glenugie Creek Weir on Glenugie Creek near Grafton as viewed from the downstream left bank.

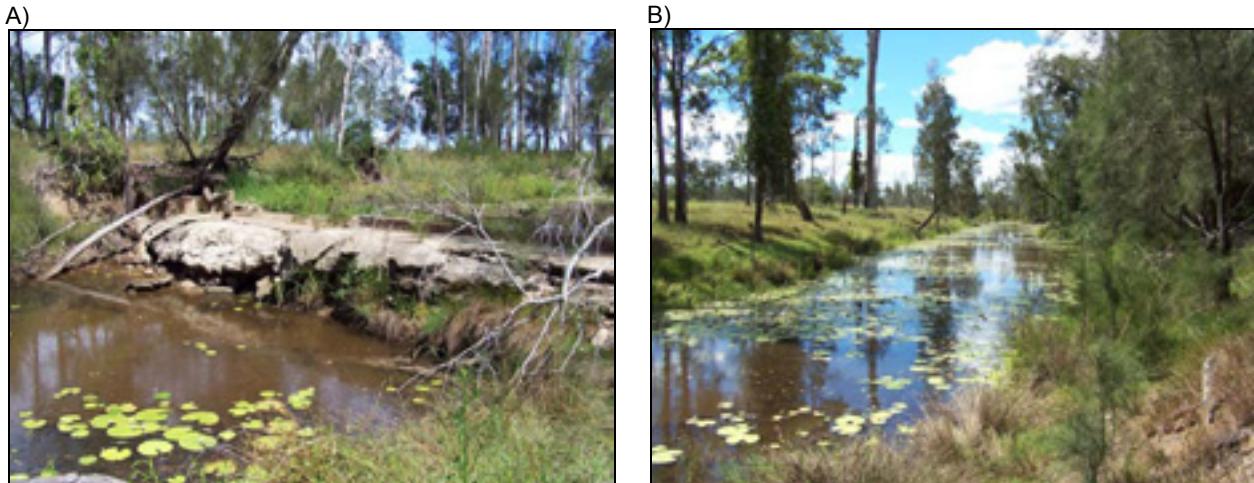
**Figure 2.** A) Unlicensed structure on Glenugie Creek located approximately 2km downstream of Glenugie Creek Weir. B) View of instream and riparian habitat below unlicensed weir.

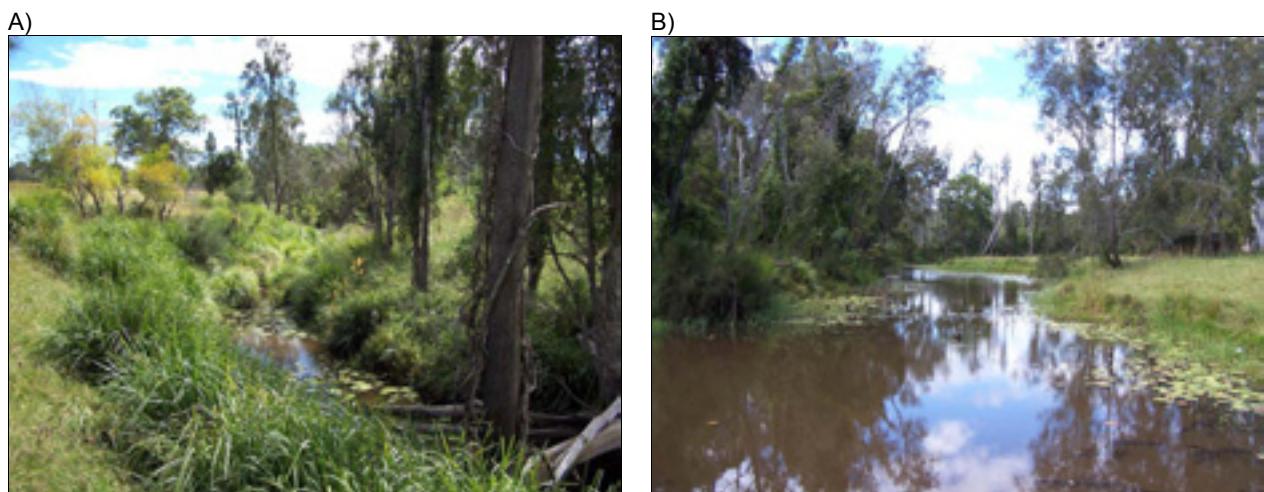
**Figure 3.** Riparian and instream habitat (A) immediately downstream and (B) upstream of Glenugie Creek Weir, Glenugie Creek.

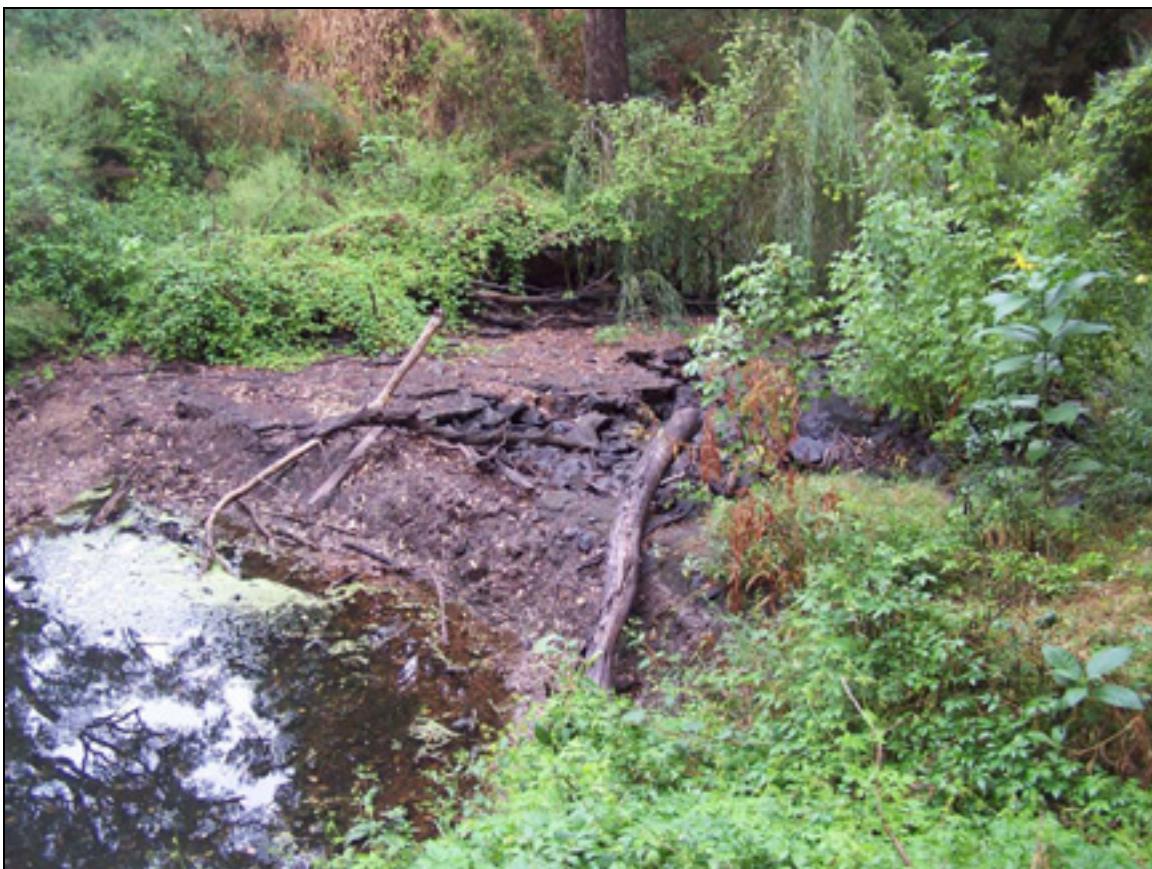
**Figure 1.** View of the top section of Fawcetts Creek Weir 2 from right bank.

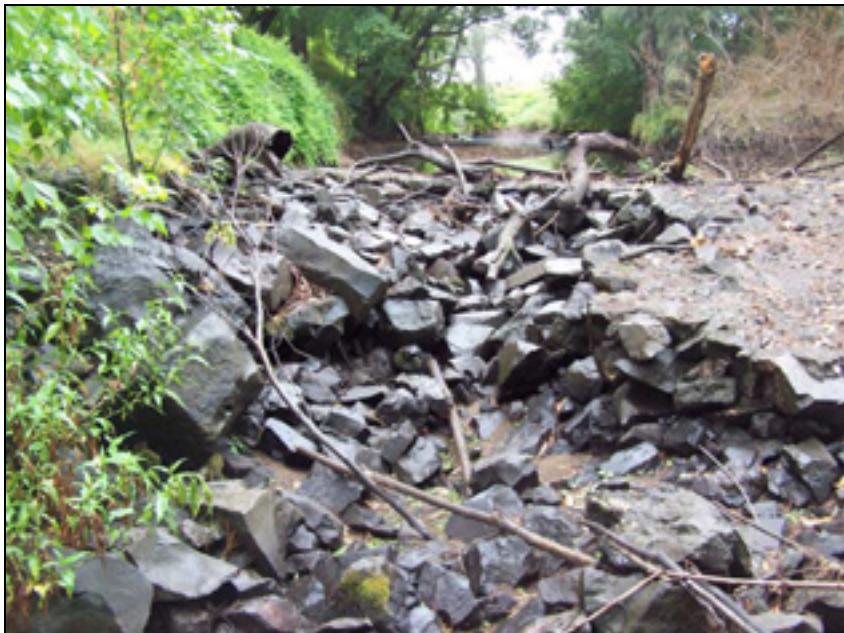
**Figure 2.** Damage to the central portion of the structure demonstrating weir failure.

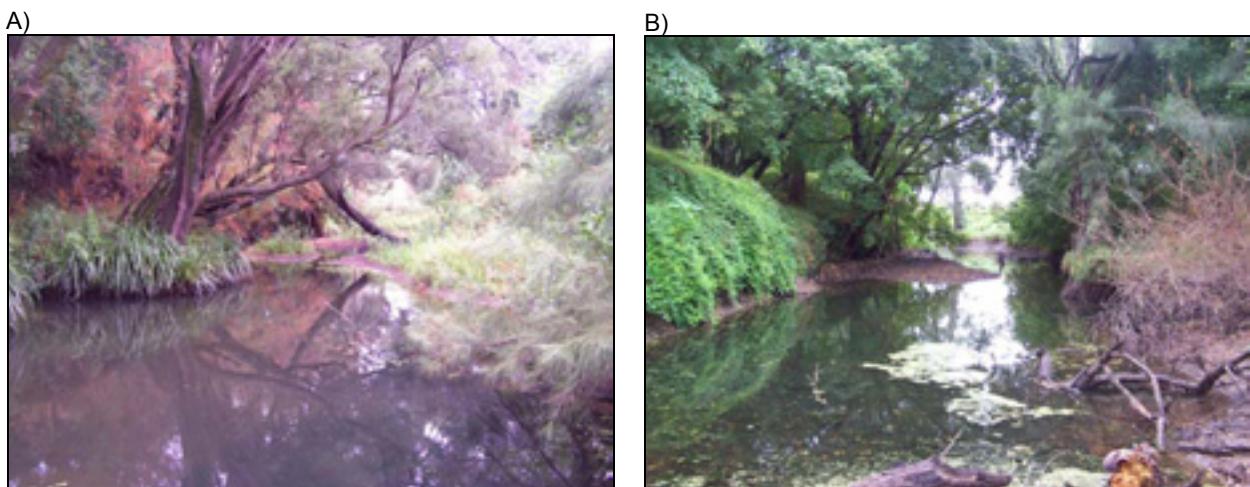
The weir displays moderately vegetated banks with minor erosion present both upstream and downstream of the structure presumably attributed to cattle access. Riparian vegetation is composed of rainforest hardwoods, eucalypts, casuarinas, and exotics trees (e.g. willows and *Camphor laurel*); while groundcover is dominated by pasture grasses and *Lomandra hystrix*. Given the free access of cattle to both banks, overall creek health would be improved by riparian fencing and revegetation along the banks that reach up to 6 metres above the water level.

**Figure 3.** Riparian and instream habitat immediately downstream (A) and upstream (B) of Fawcetts Creek Weir 2.

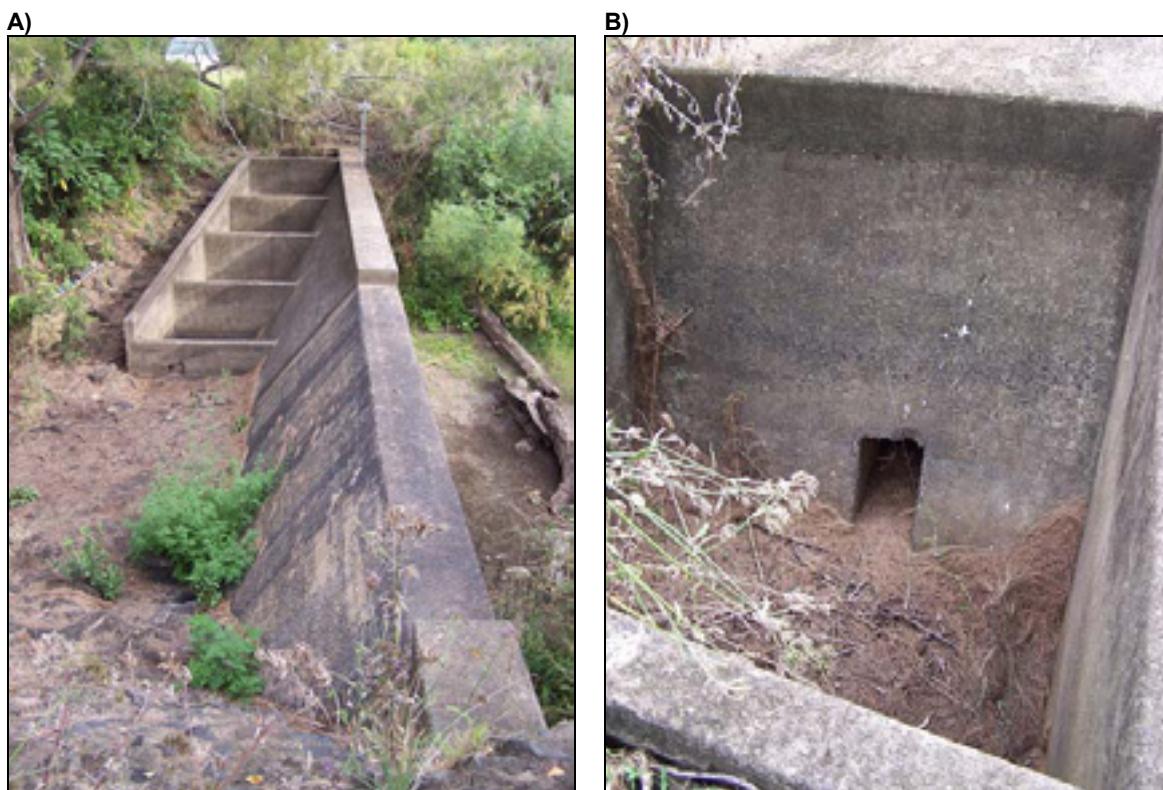
**Figure 1.** Sextonville Weir on Doubtful Creek near Kyogle as (A) viewed from the left bank. The weir incorporates a submerged orifice fishway (close up in B).

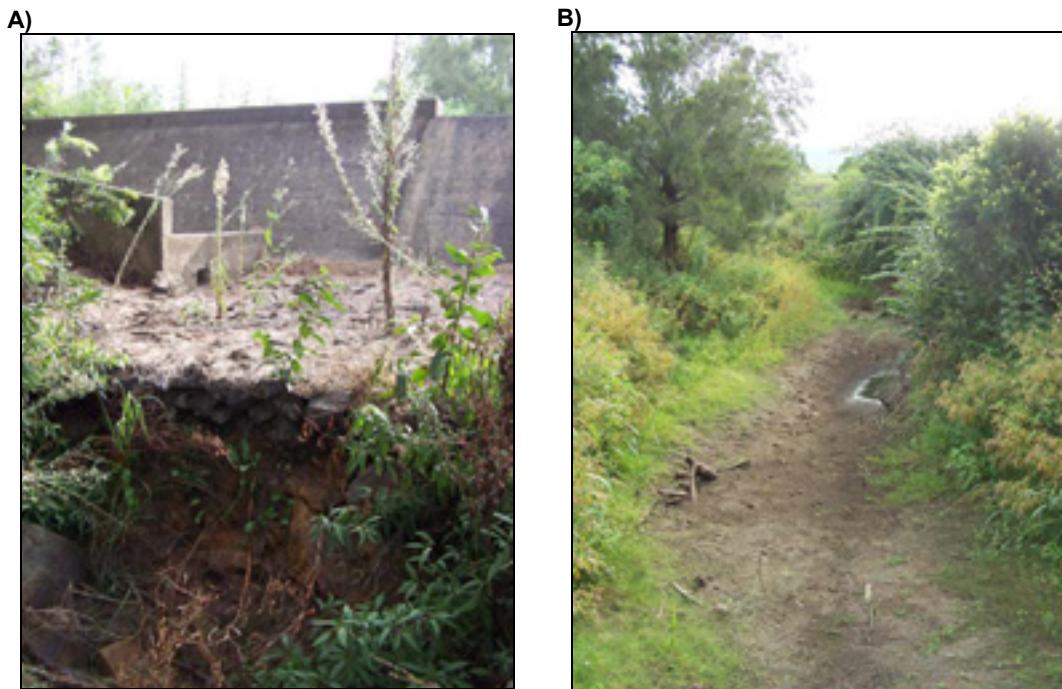
Water quality within Doubtful Creek is described as good to excellent except during drought periods when water flow ceases. The weir and surrounding reaches display moderately vegetated, intact banks, with fencing restricting cattle access on both sides of the creek. Vegetation within the riparian zone is primarily composed of casuarinas (*Casuarina cunninghamiana*), *Callistemon spp.*, and a mix of rainforest hardwoods, while groundcover adjacent to the waterway is dominated by *Lomandra histrix* and introduced weeds (e.g. tobacco bush and lantana). Siltation was not recorded behind the weir; however, a one metre deep scour hole was noted on the downstream side of the structure.

**Figure 2.** (A) View of the downstream scour hole beneath Sextonville Weir. (B) Riparian and instream habitat immediately upstream of the weir.
