An Assessment of the Saltmarsh of the Parramatta River and Sydney Harbour

August 2007

NSW Department of Primary Industries –
Fisheries Final Report Series
No. 90
ISSN 1449-9967

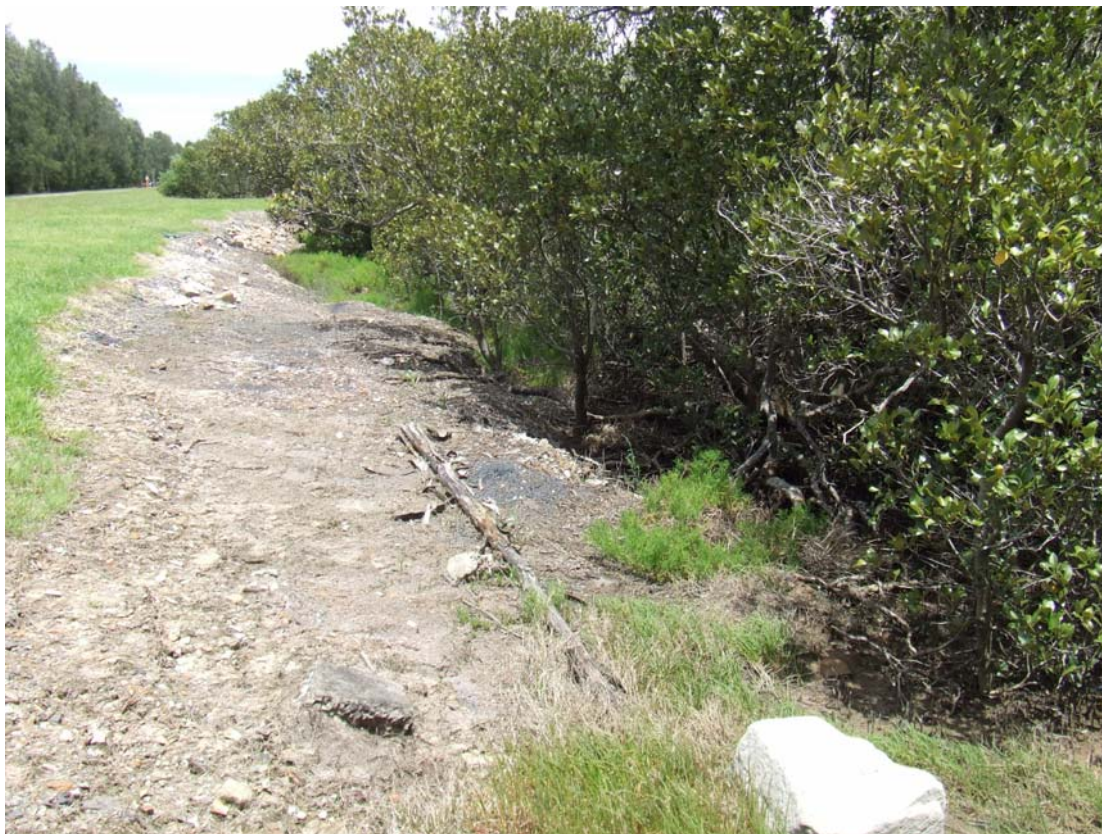
Plate 3. Patchy saltmarsh growth between mangroves and infilled slope (bare and lawn), Homebush Bay.

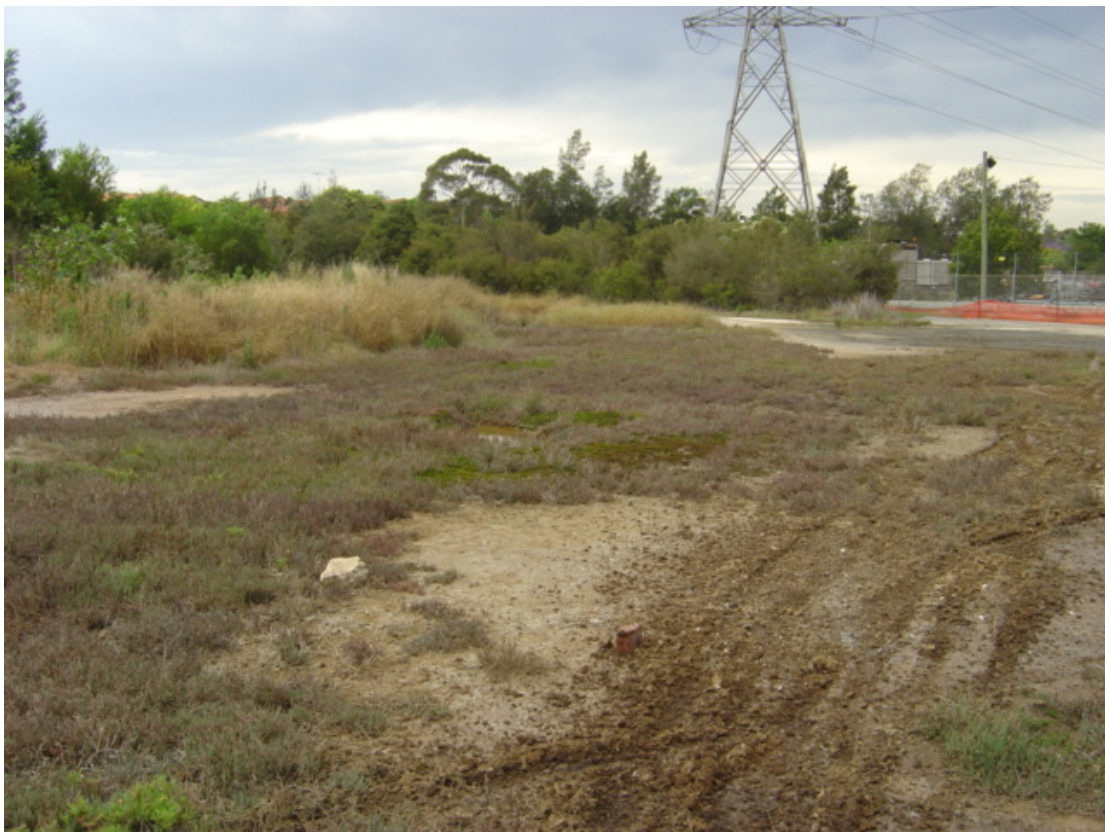
Plate 5. Damage to saltmarsh by trail bike riding, Mason Park, Strathfield.
(SPR304).

The greatest extent of damage from recreational vehicles is concentrated around the southern and eastern boundaries of the Mason Park wetlands at Strathfield (Plate 7). Here, trail bike use has caused a considerable reduction to what was one of the largest stands of *W. backhousei* in the estuary. Vehicle tracks have also been observed through small *L. tegens* stands. If left unchecked, further damage could be done to the remaining *W. backhousei* and *L. tegens* stands, whilst increases in soil erosion and changes to the local hydrology as a result of vehicle use could significantly alter the character of the Mason Park wetland.

Restricting vehicle access to areas that have been damaged, such as Mason Park, as well as sites that are at risk of future damage is essential. Sites most at risk of attracting unauthorised vehicle use include those easily accessed from residential areas (including via fire and access trails) and those with mudflats or unvegetated patches (Kelleway 2005). Any gates, fences, or other mechanisms used to block vehicular access need to be regularly maintained, as they are likely to be subject to vandalism.

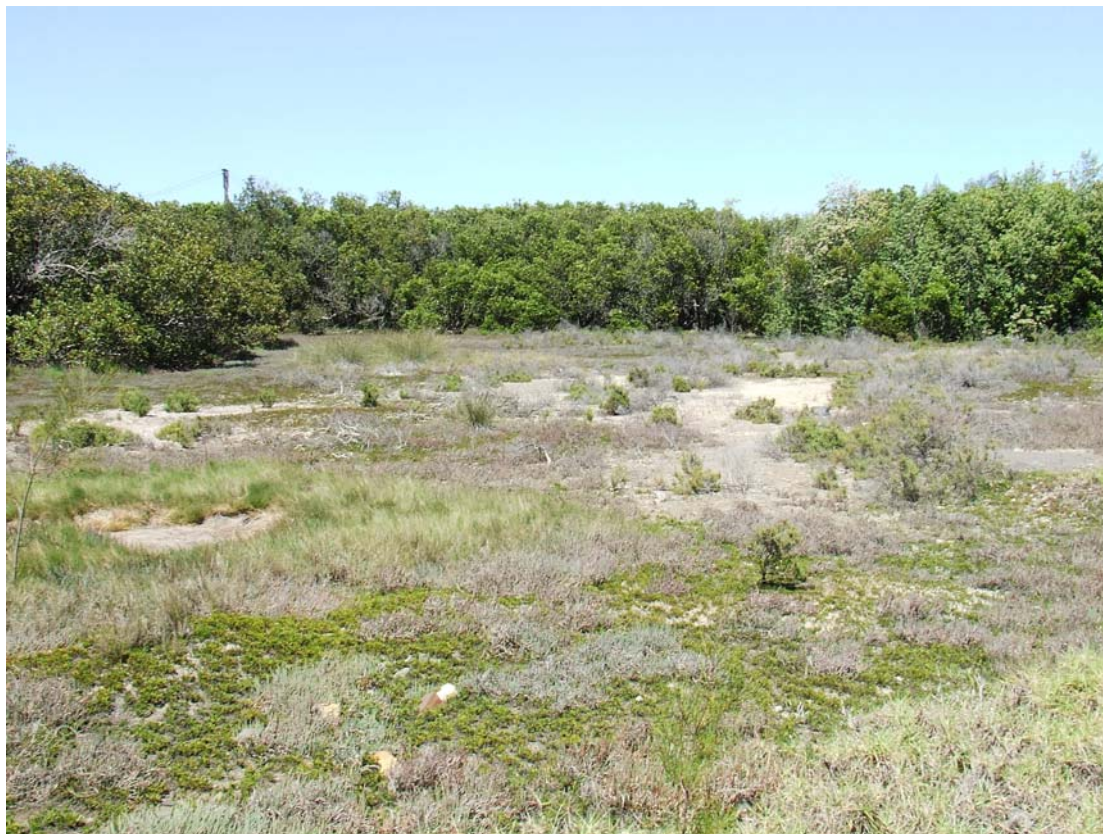
Plate 7. Saltmarsh bordering the Clyde oil refinery on the Duck River. Species include *Wilsonia backhousei* (dark green, foreground), *Sporobolus virginicus* (grass, left mid-ground), *Halosarcia pergranulata* subsp. *pergranulata* (shrub, right mid-ground), *Juncus kraussii* and *Juncus acutus* (sparse, background) and *Sarcocornia quinqueflora* (throughout). (WDR9).

The saltmarshes of the Duck River, many of which are extensive and in fair condition, are not included in the national park estate. These saltmarshes are in the Riverine Channel and are species rich, due possibly to the influence of clay-rich Wianamatta shale substrate and the low gradient of the intertidal lands. Some of the most extensive patches of *W. backhousei* in the estuary occur between the Shell Refinery and encroaching mangroves on the western shore of Duck River (Plate 7). In one location at this site, *W. backhousei* was observed growing continuously from the inundated low marsh to the highest elevation section of the upper saltmarsh. This was the only location where this phenomenon was observed in the entire estuary. Saltmarshes on the western Duck River are also home to the only occurrences of *S. radicans* recorded in this study. The eastern shore of the Duck River includes the Silverwater Wetland (managed by NSW Maritime), which is one of the most extensive in the estuary and contains stands of *W. backhousei* and *H. pergranulata* subspecies *pergranulata*.
