NSW DEPARTMENT OF
PRIMARY INDUSTRIES

NORTH COAST FLOODGATE PROJECT

*Final Report
2002 - 2004*

Walsh S. and Copeland C. (2004). *North Coast Floodgate Project* - Final Report to the Environmental Trust, NSW Department of Primary Industries, Ballina.

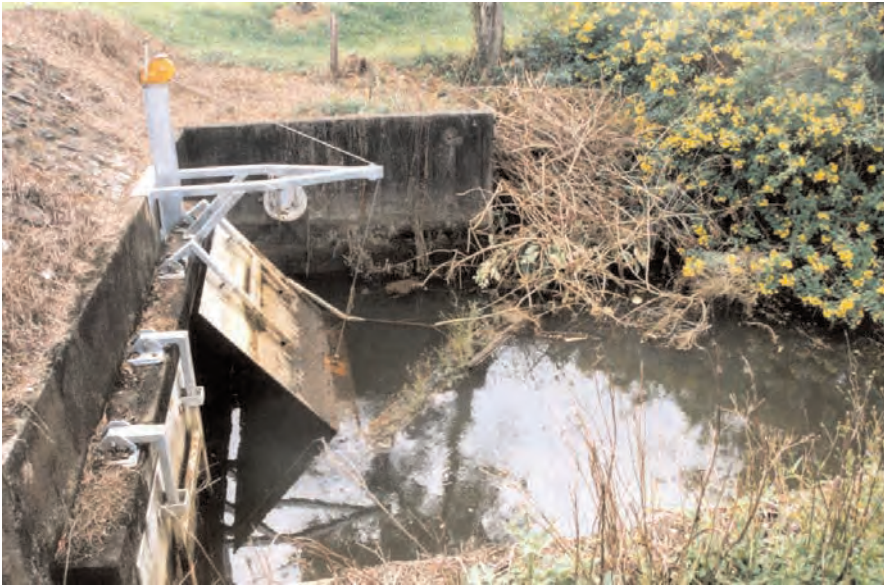
Figure 1: Winch mechanism

1. Winches (Figure 1) are simple to operate, using a winch and pulley system to physically lift the entire gate. These systems allow for the maximum flushing possible to occur. One limitation is that they rely on landholders to maintain an active presence on a regular basis to raise and lower the gate. Over time, other on-farm tasks can take priority with the gates often remaining closed. In addition, suitable training is required to ensure that gates are not opened at inappropriate times (i.e. high tides) when excessive head pressure can buckle or otherwise damage the infrastructure. The winch handle used is generally detachable and stored off-site to prevent unsupervised manipulation of the floodgate.

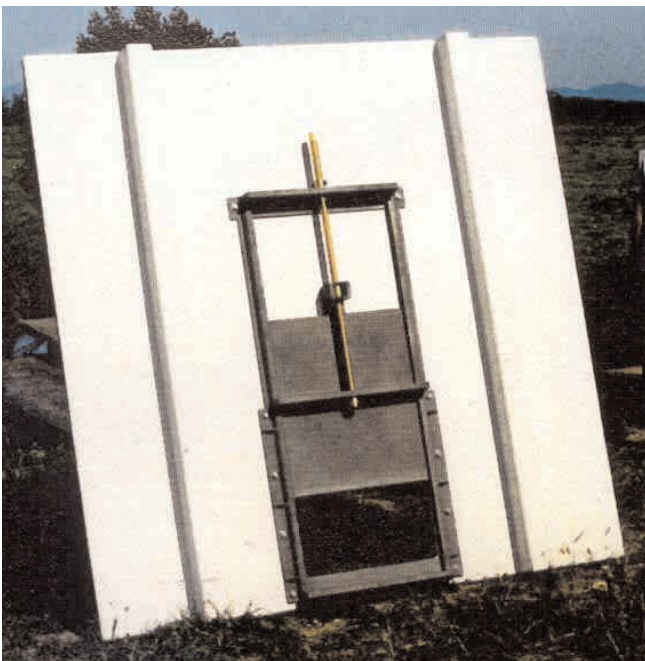
Figure 2: Sluice gate with sliding panel

2. Sluice gates (Figure 2) are comprised of a standard flap gate with a hole removed from the centre of the gate. A sliding panel is fitted over this hole to facilitate the regulation of desired in-flows. A worm drive enables the sluice to be raised or lowered under most conditions. Again a detachable handle is employed to prevent unwanted operations.

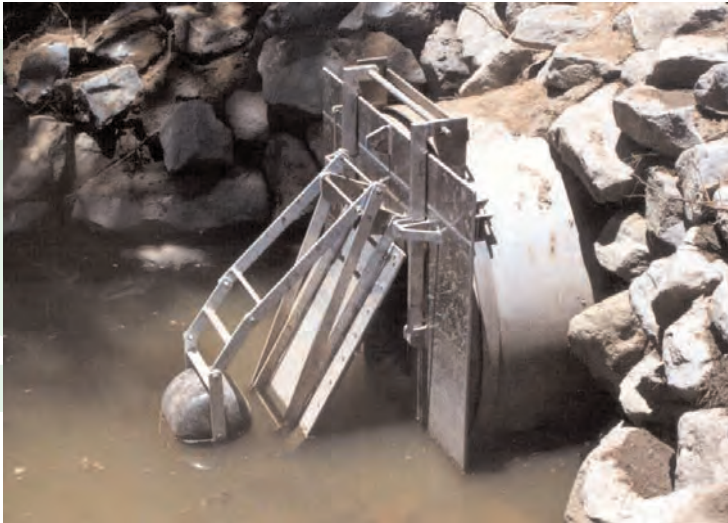
Figure 3: Automatic tidal gate with float

3. Automatic tidally operated gates (Figure 3) have proved to be more useful in areas that are difficult to access or where the floodgate operator is bound by time constraints. A hole in the gate is covered with a rubber sealed panel, which is in turn regulated by a float system. As the float rises on the downstream side due to high tide conditions or a flood event, the panel closes over the hole. When the water level falls again, the panel lifts to reveal the hole again – enabling water

exchange and fish passage. The float can be set to a predetermined level, allowing confidence in setting a desired level of water through the gate. This style of modification also has the advantage of reducing the need for Occupational Health and Safety infrastructure such as access platforms as they are self-regulating.

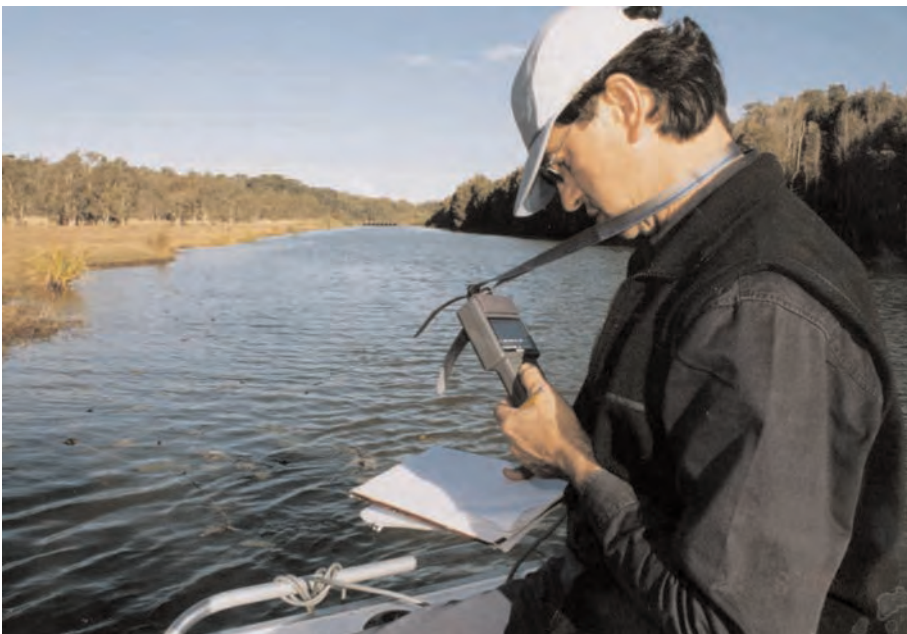
Figure 4: Measuring water quality in the Tuckean system

- Comprehensive chemical analyses;
 - effective in showing the relative concentrations of selected heavy metals and other chemical compounds;
- ‘Snapshot’ sampling using the Horiba U-10 water quality meter, measuring:
 - pH;
 - dissolved oxygen;
 - electrical conductivity;
 - turbidity;
 - temperature;
 - salinity.

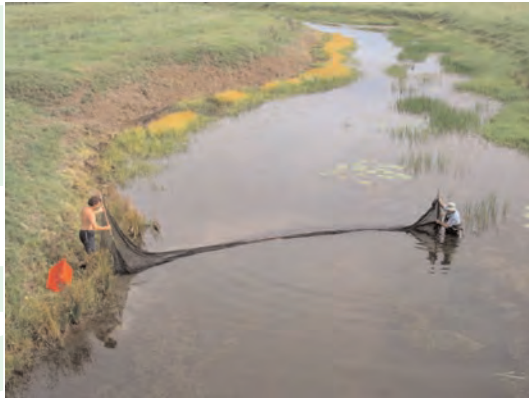
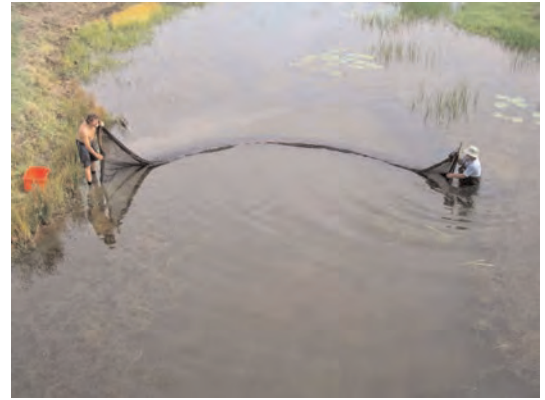
Figure 5: Seine net sequence at Yaegers, Richmond

The fish surveys have utilised a number of methods depending on the particular site and environmental conditions experienced. These have included seine netting (Figure 5), fyke netting (Figure 6) and bait trapping (Figures 7 & 8).

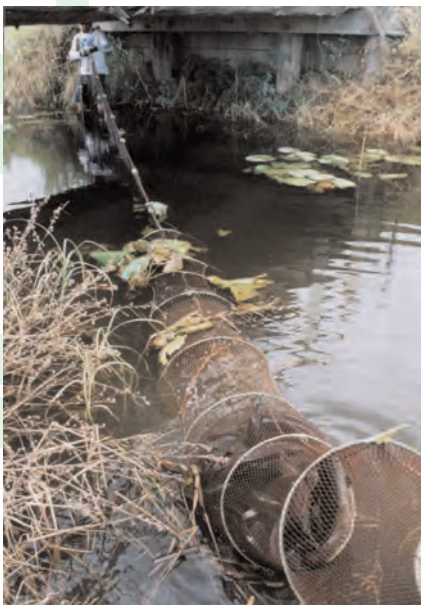
Figure 6: Fyke net

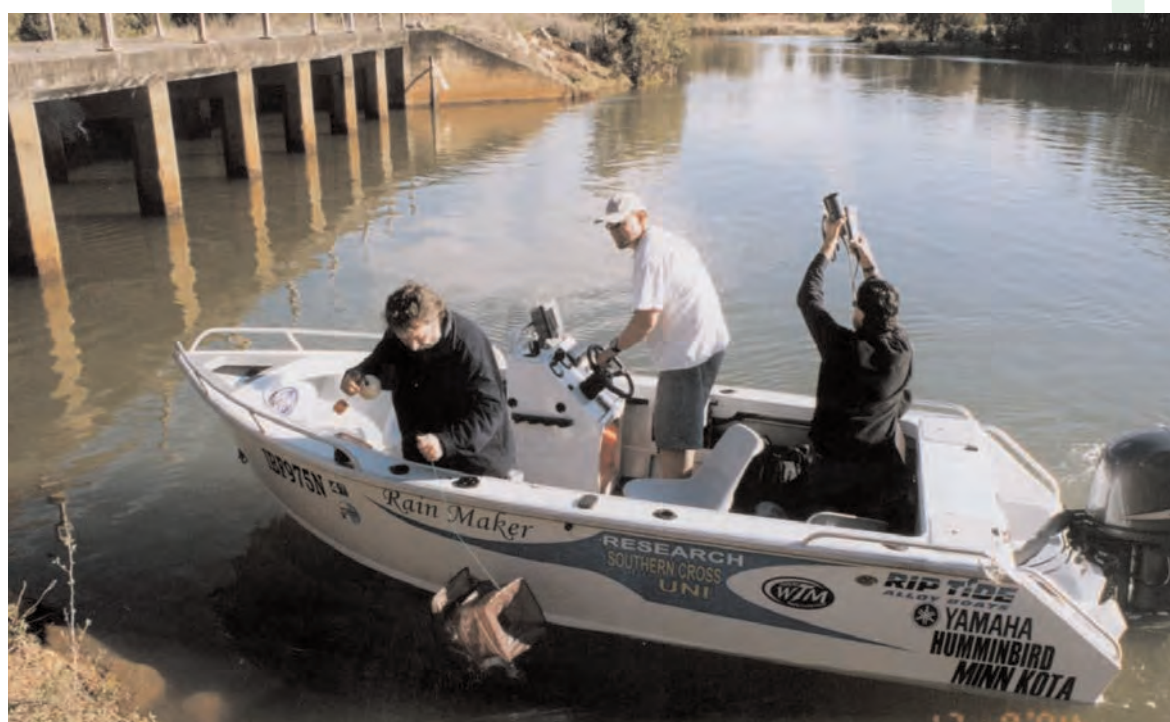
Figure 8: Setting bait traps behind the Tuckean Swamp floodgates

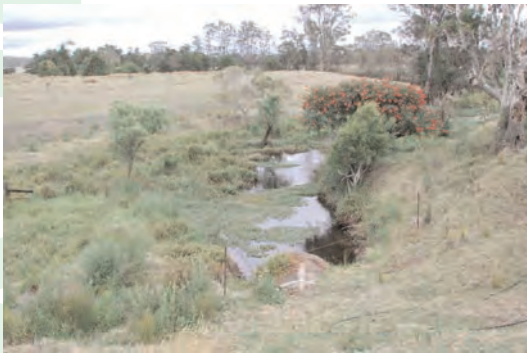
***Fig 9. November 2001
(immediately upstream of floodgate)
before management***

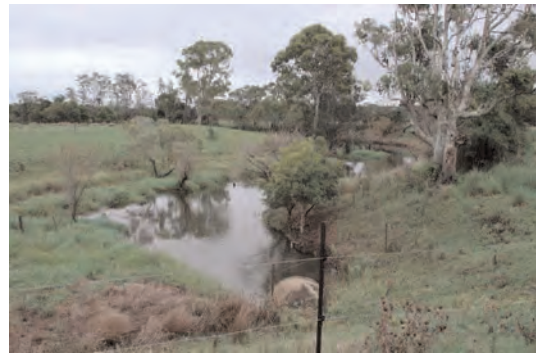
***Fig 10. February 2003
(immediately upstream of floodgate)
after management***

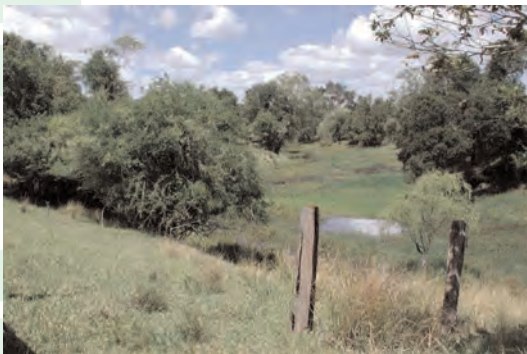
***Fig 11. November 2001
(upstream river bend)
before management***

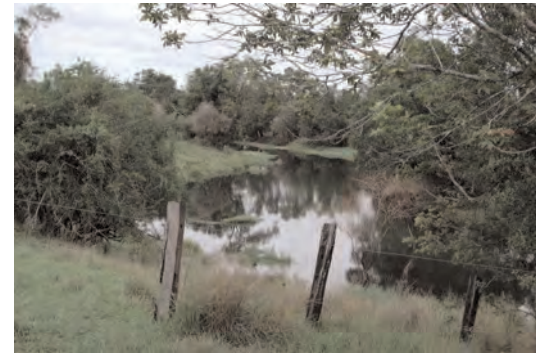
***Fig 12. February 2003
(upstream river bend)
after management***

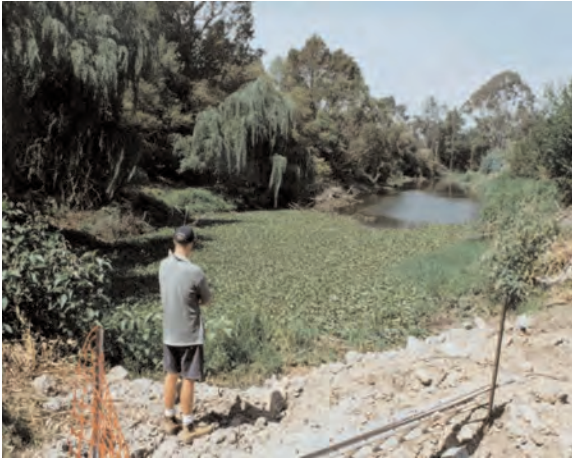
*Fig 13. December 2002
before management*

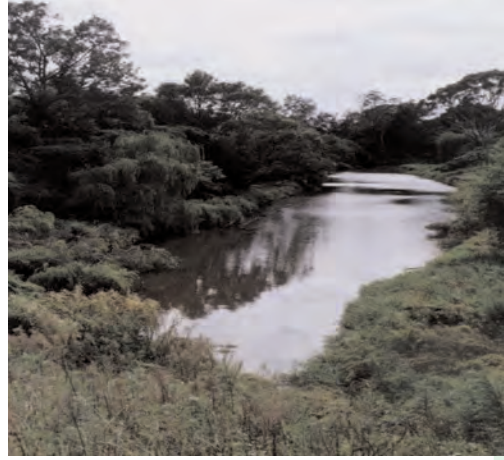
*Fig 14. April 2004
after management*

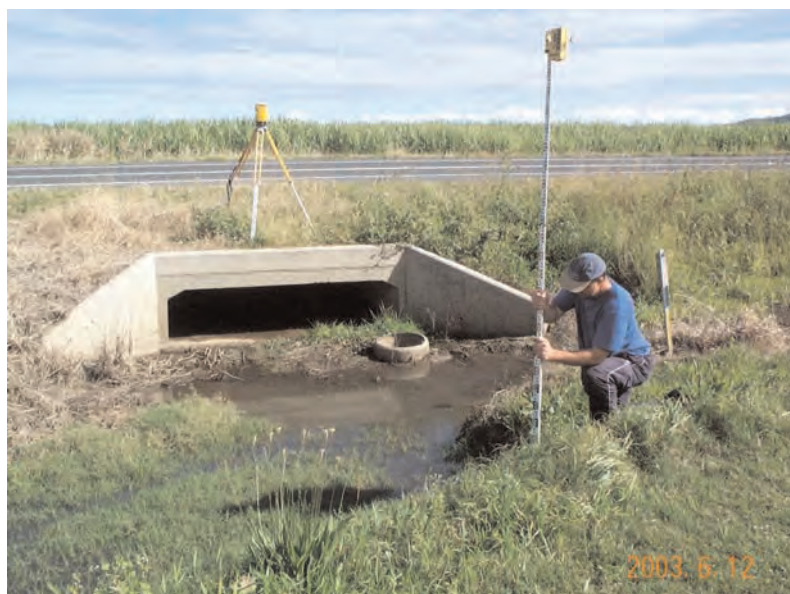
*Figure 15: Measuring relative elevation using a
laser guided theodolite and ranging staff system*

An example of this is the hydrological survey conducted by consultants Fish Fore Shore at a number of sites on Micalo Island, Clarence. Results of this survey are detailed in Appendix 4.

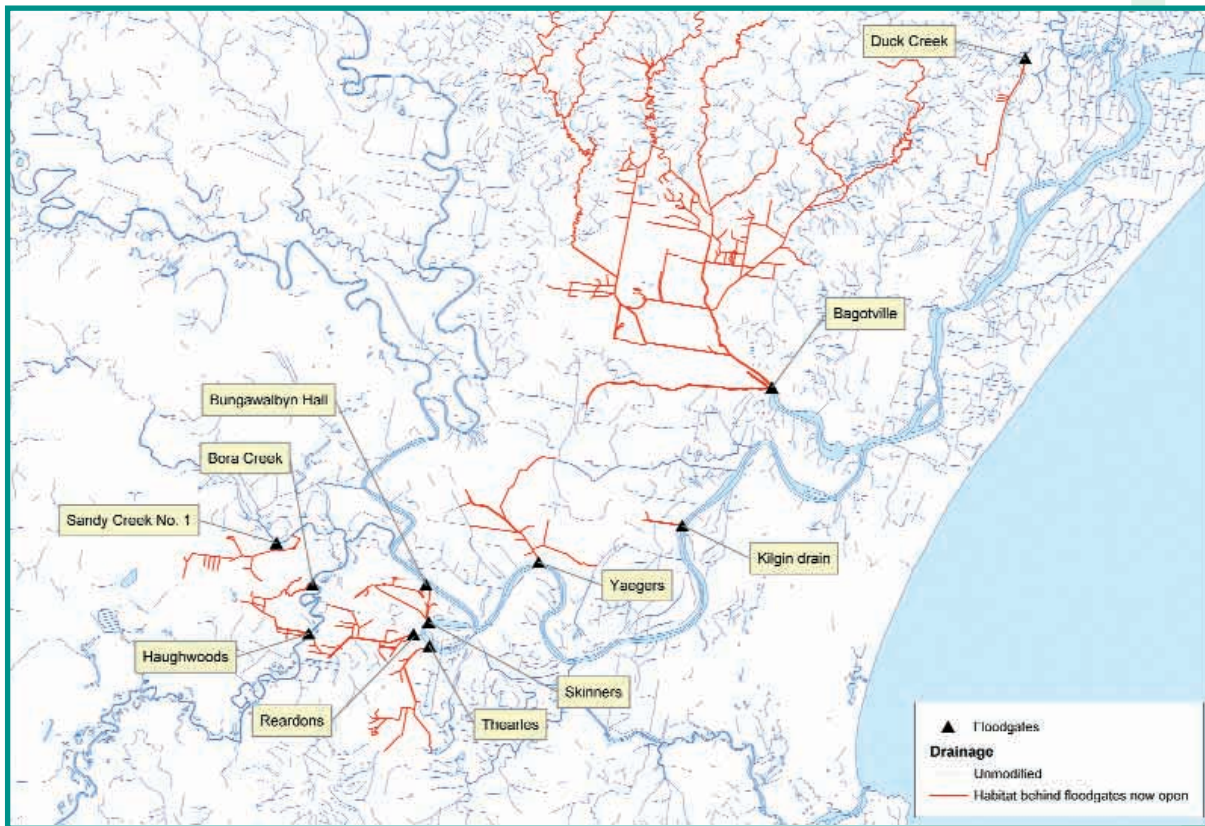
Figure 16: Actively managed floodgates in the Richmond catchment

Most of the floodgate modifications in the Richmond are in the form of sluice gates (9) with 2 additional winches. Richmond River County Council has found sluice gates to be effective for their needs and prefer to utilise this system to reduce maintenance of a wide range of structural modifications.

Individual site locations are shown in Figure 16, with the waterways now open to fish passage highlighted in red.

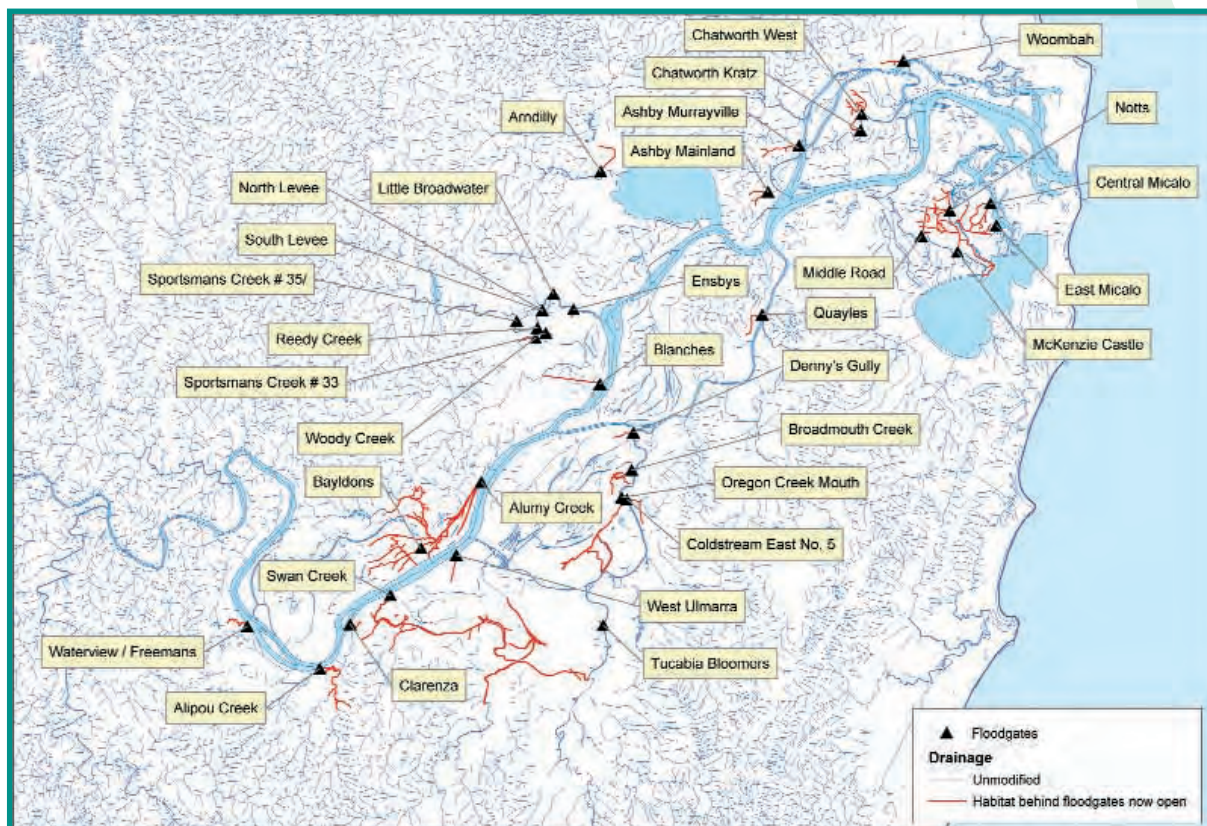
Figure 17: Actively managed floodgate sites in the Clarence catchment

Individual site locations are shown in Figure 17, with the waterways now open to fish passage highlighted in red.

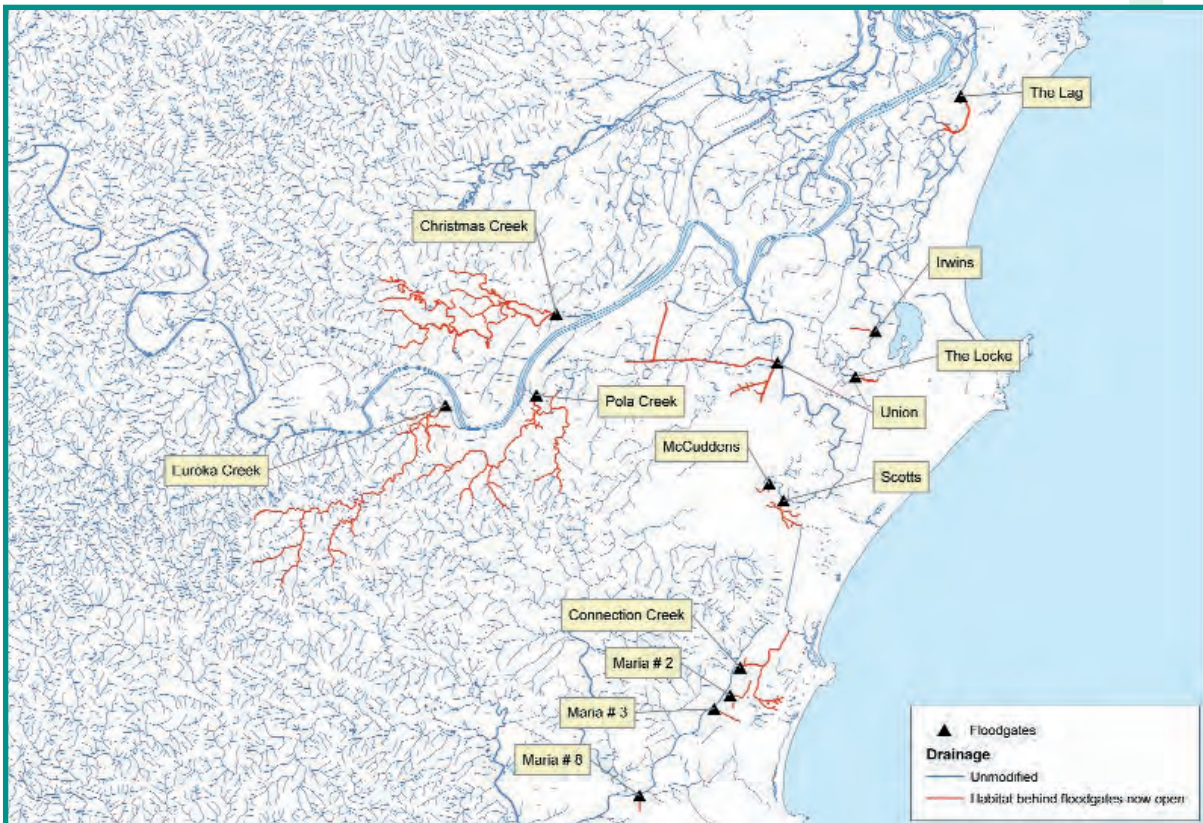
Figure 18: Actively managed floodgate sites in the Macleay catchment

Individual site locations are shown in Figure 18, with the waterways now open to fish passage highlighted in red.

The maps were further refined through consultation with the relevant Council staff to increase their accuracy. It should be recognised that some areas highlighted in red may flow intermittently on occasion. Detailed groundtruthing would be required to identify those areas, particularly during extended drought conditions.

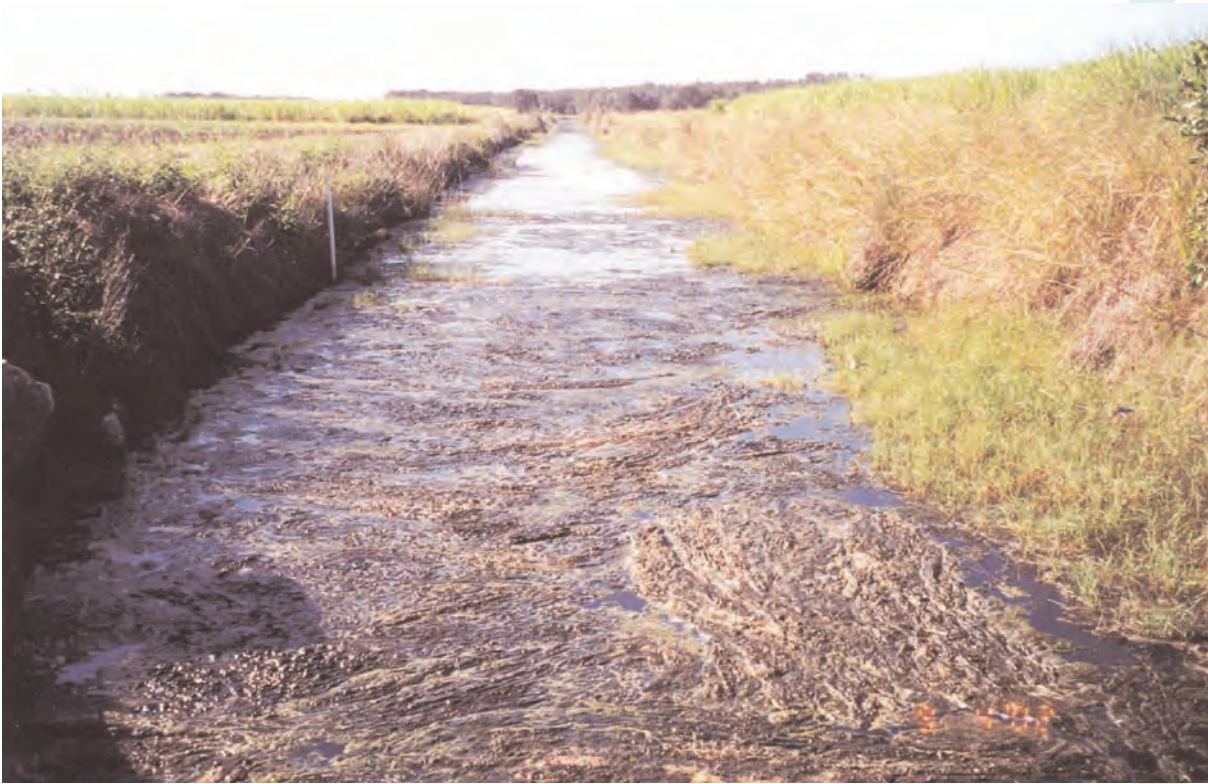
Figure 19: McKenzie – Castle system **before** opening, Clarence

Overall the results indicate that prior to floodgate openings in unmanaged systems, the water quality was generally poor. Sites with closed floodgates were characterised by water with low dissolved oxygen levels, which reduce the

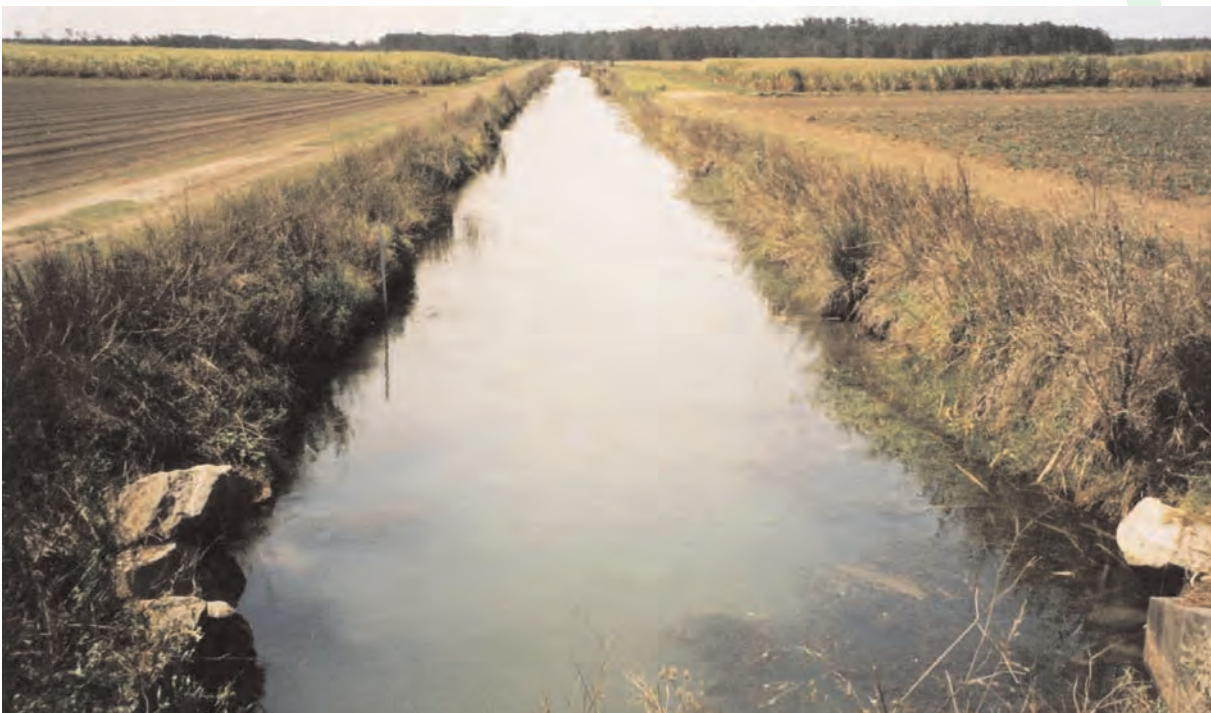
Figure 20: McKenzie - Castle System **after** opening, Clarence

suitability of the water body for aquatic life. These conditions also proved suitable for the growth of in-stream weeds and algal blooms. Following active management, water quality parameters tended to improve with increased oxygen levels, reduced acidity, moderated temperature fluctuations and improved weed management.

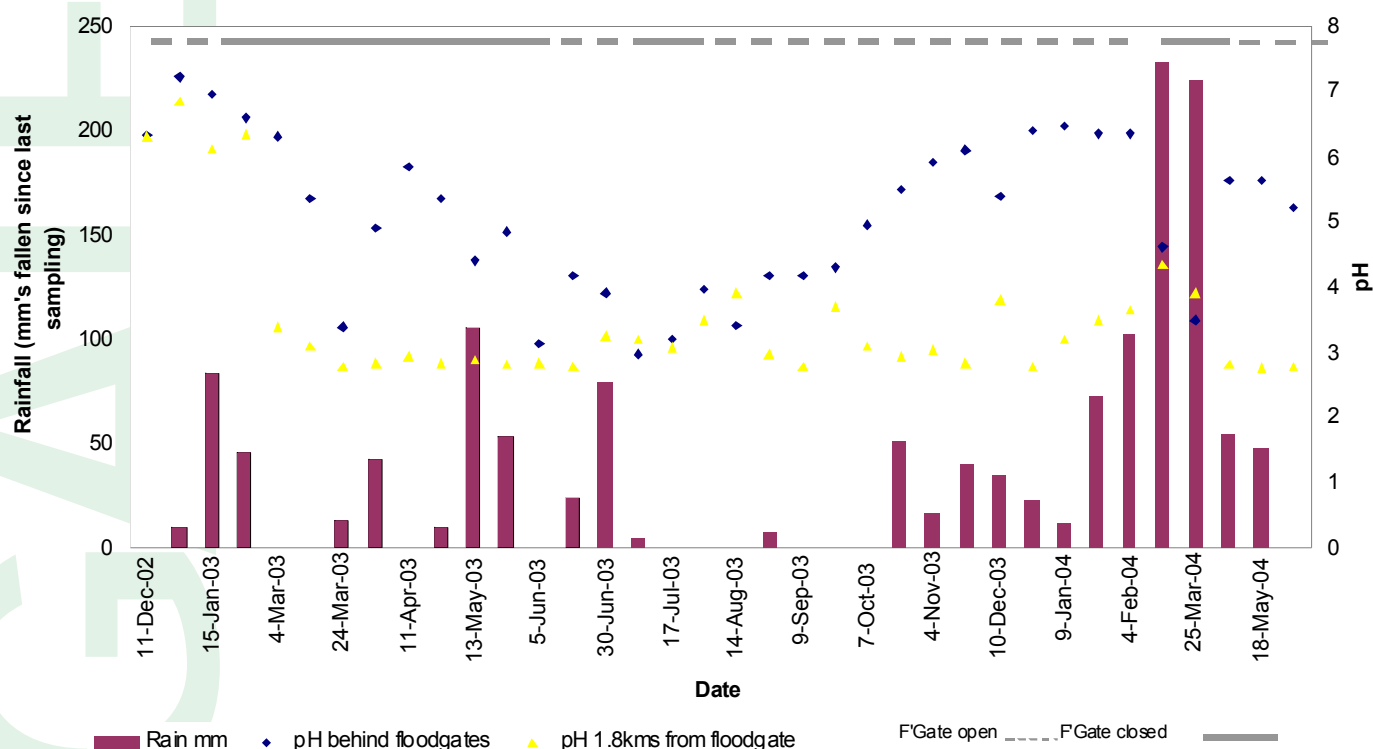
Figure 21: Water quality monitoring results for Haughwoods, Richmond.
(Data courtesy of Chrisy Clay, NSW DPI)

Overall, the site that was furthest upstream from the floodgate (and so further from the flushing effects) displayed more acidic conditions, on occasion below pH 3.

Around midway through the study period shown, the open floodgate allows more flushing and pH levels steadily begin to improve. A rain event in March forced the closure of the floodgate and pH levels again rapidly deteriorated.

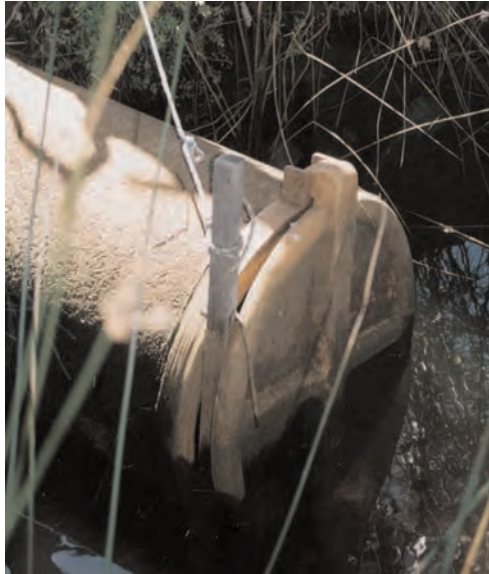
place. At some sites the landholders were already aware of the benefits of keeping floodgates open and had been using 'informal' means such as placing logs or bricks under the flap-gate to provide for water exchange. In these instances, there was no clear 'before' regime to monitor.

Figure 22: Floodgate with stake preventing total floodgate closure

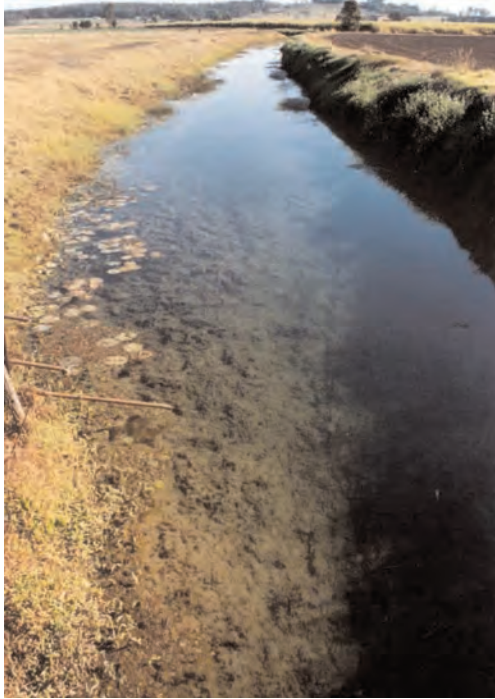
Figure 24: Before opening, 17/7/02

Figure 24 shows the clear, low turbidity conditions caused by an acidic dominated environment. Metals such as aluminium bind to any particulate matter in the water resulting in an unnaturally transparent water column.

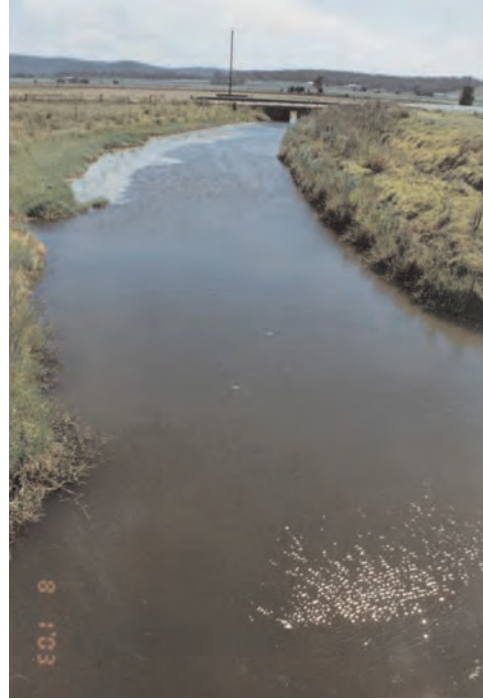
Figure 25: After opening, 8/1/03

Figure 25 illustrates the improvement resulting from the open floodgate flushing the system with better quality river water. The visual results are reinforced by the chemical analyses results detailed below.

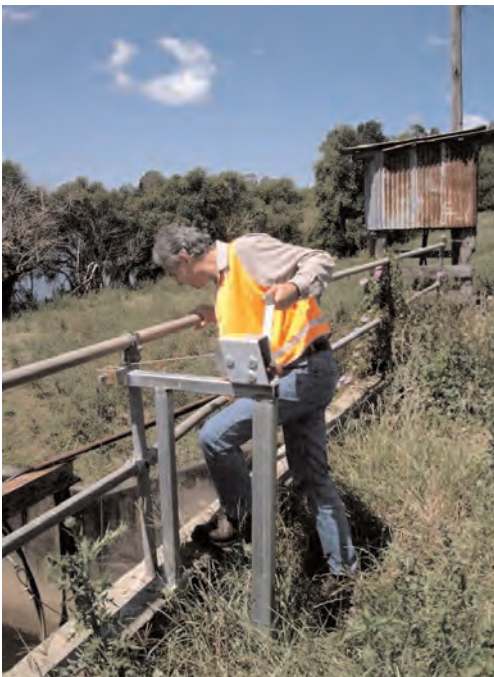
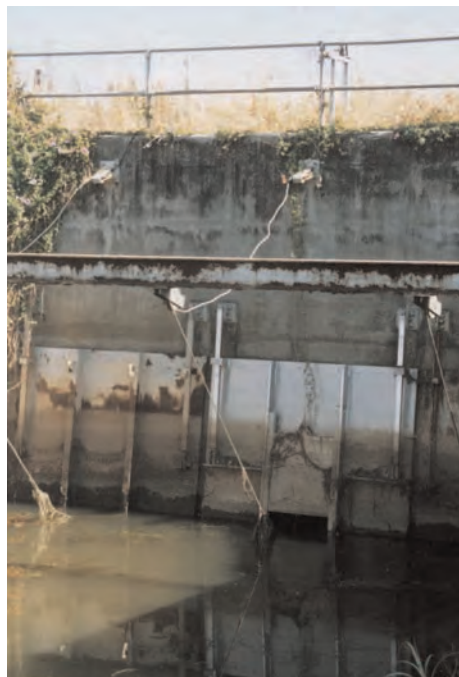
Figure 26: Operating the Thearles winch mechanism to open the sluice

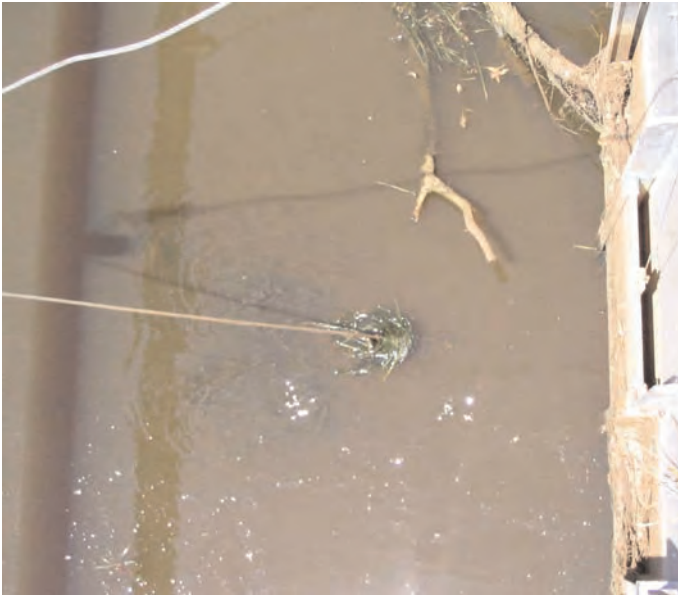
Figure 27: Garfish schooling in front of the now actively managed Thearles sluice gate

Although the main reason for actively managing this particular floodgate was to address the poor water quality arising from the system, there have also been other direct benefits for aquatic life. Figure 27 shows a school of garfish schooling near the open sluice, either preparing to move up into the system or awaiting food to flow downstream.

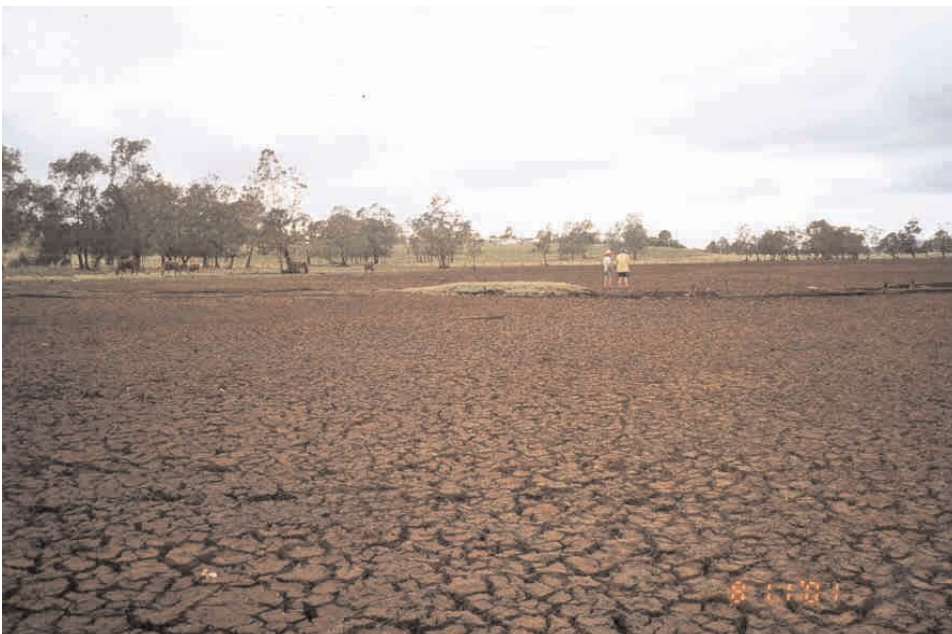
Figure 29: In the 'wetland', prior to floodgate opening - November 2001

The area continued to suffer from acid scalds, with the majority of the management area largely devoid of vegetation following the March 2001 flood.

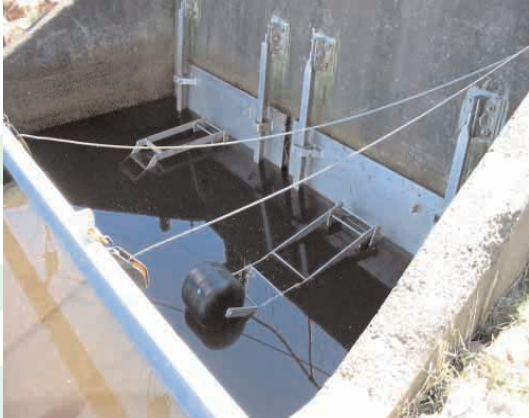
Figure 30: Tidal floodgates

The management of Little Broadwater has involved a funding partnership of the Department of Infrastructure, Planning and Natural Resources ASS Hotspot program, NSW Recreational Fishing Trust and the Environmental Trust program. This project funded the installation of two automatic tidal floodgate modifications, and the placement of drop board structures aimed at raising drainage invert levels. The core area of wetland has also been fenced to exclude stock from key areas.

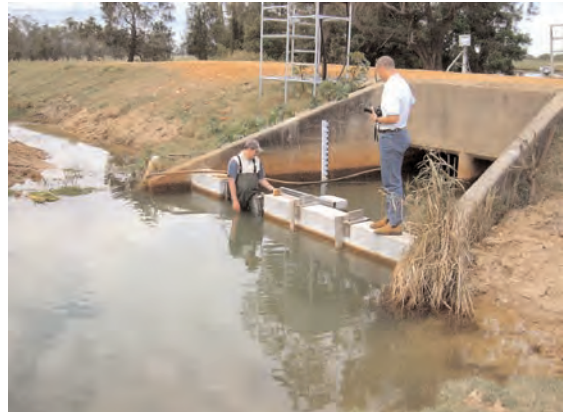
Figure 31: Drop boards and tide gauge

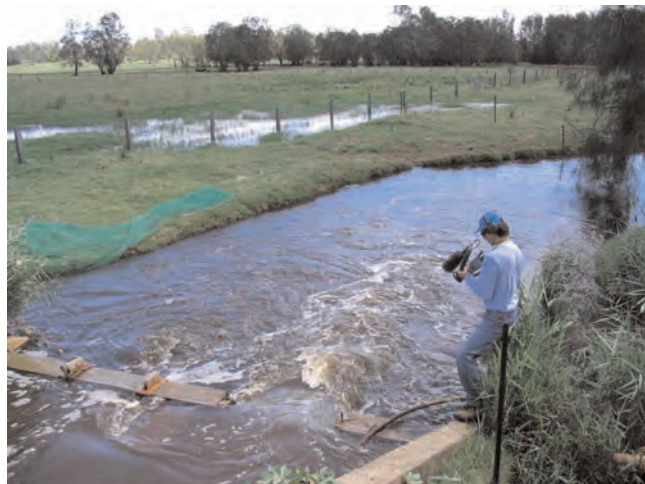
Figure 32: Water flowing into the wetland

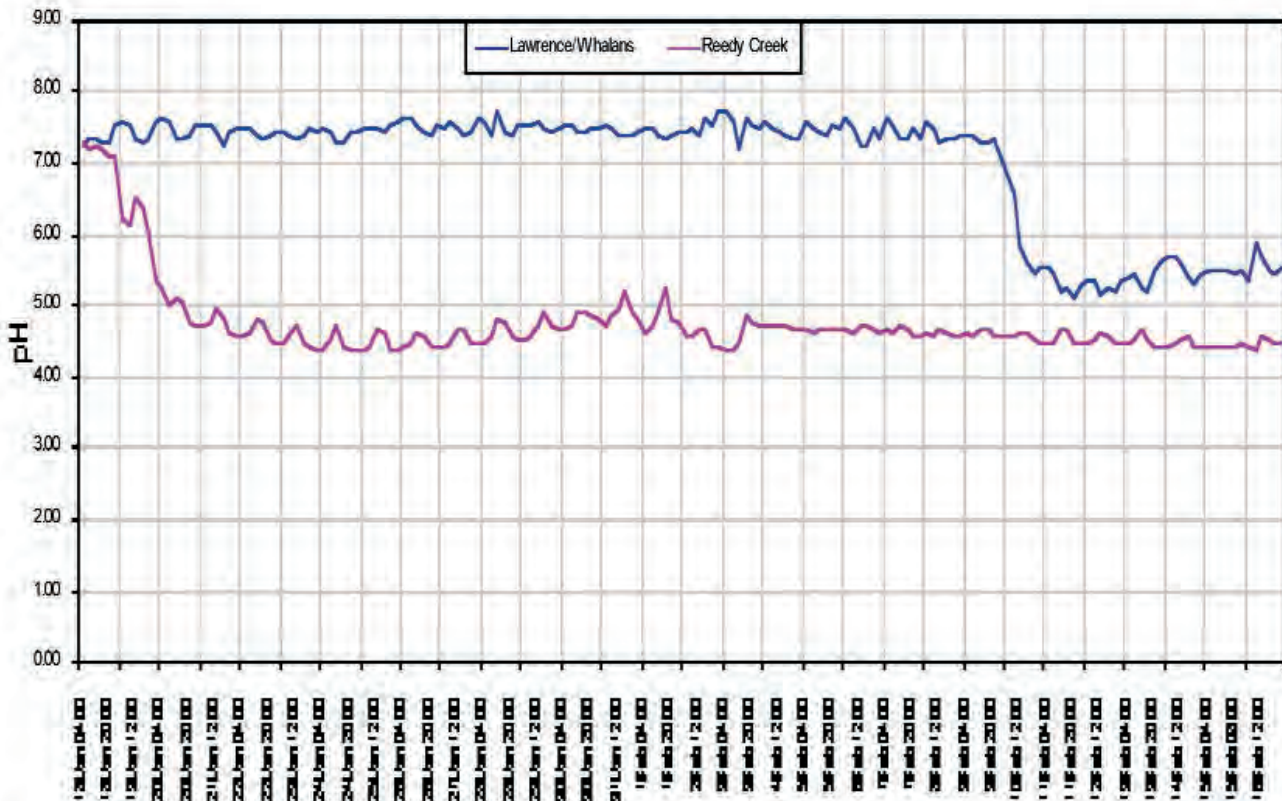
Lawrence/Whalans compared with Reedy Creek 18/01-16/02/2004
(there was 130mm of rain in the preceeding week)

Figure 33: Comparison of acidity at Little Broadwater and an unmanaged site (data courtesy of Clarence Valley Floodplain Services)

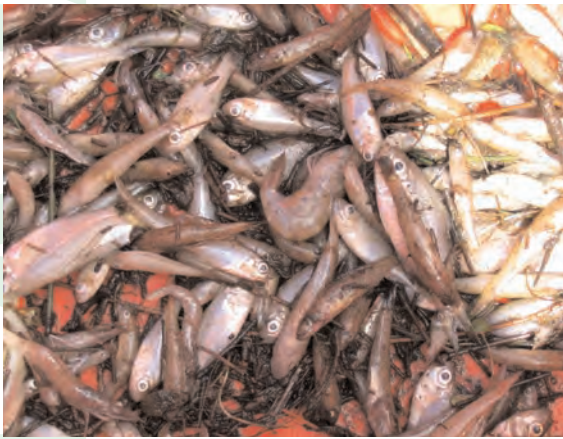
Figure 34: Fish and prawns caught swimming below the floodgate from the wetland

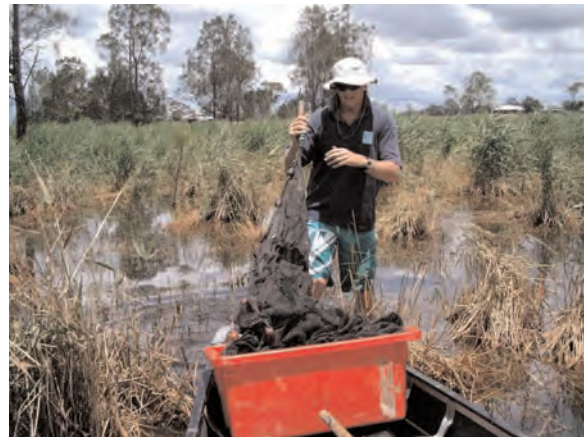
Figure 35: Fish monitoring in the wetland Phragmites community

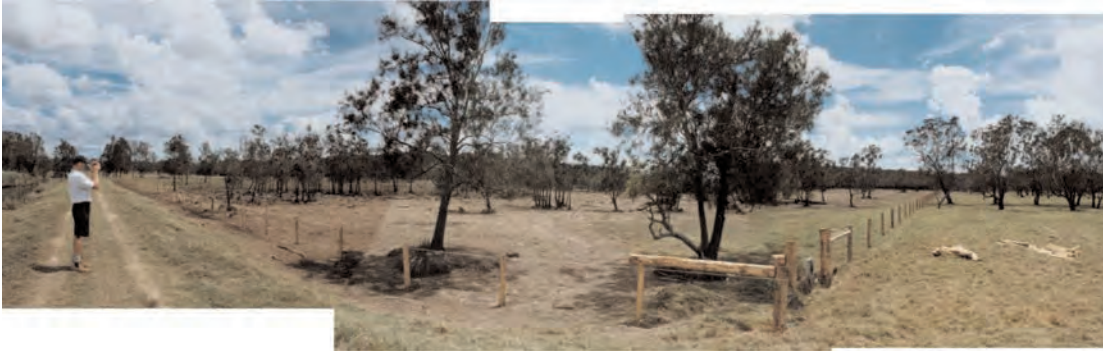
Figure 36: 7th February 2003 – Before opening

The studies undertaken to date by the University of New England have shown a largely positive change in vegetation health over the summer period. During this time, rainfall combined with floodgate openings has resulted in previously dry areas becoming inundated with brackish water. Most plant communities have coped with increased water levels and fluctuating salinities. Some areas have thrived since the floodgate openings.

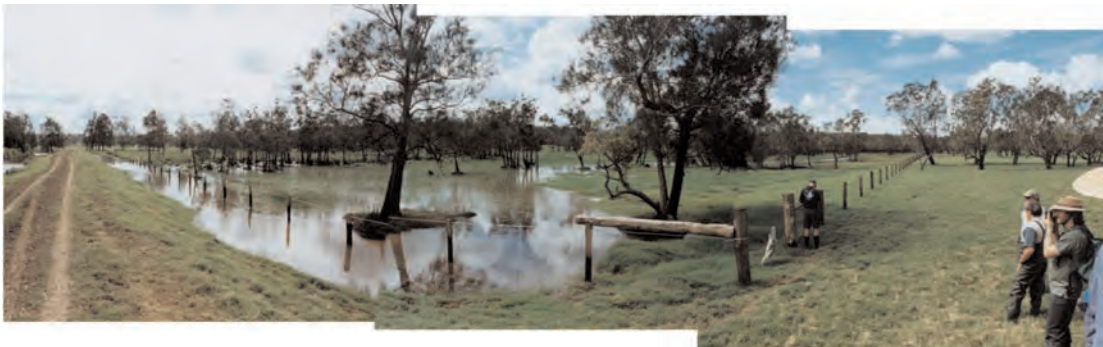
Figure 37: 2nd April 2003 – After opening

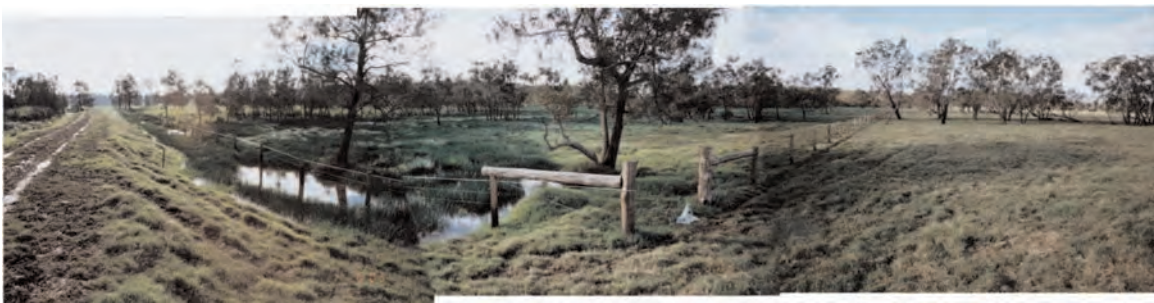
Figure 38: 4th June 2003 – After opening

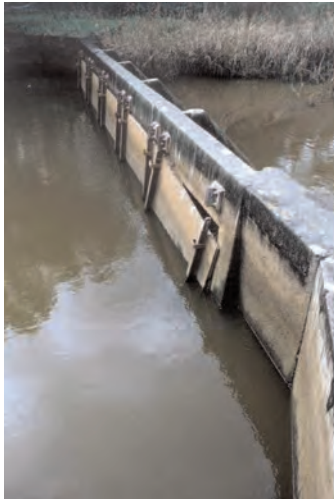
Figure 40: Before modification

The Saltwater Inlet site was identified as part of the video documentary process in August 2003. One floodgate was found to be in a state of disrepair and was allowing the passage of some water behind the system. The Department of Primary Industries then contacted Kempsey Shire Council and the landholders to discuss options for improved management of the waterway. The landholders were keen to pursue the tidal gate option at this site.

Collecting accurate before and after water quality results proved to be difficult given the state of disrepair of the original gate (see Figure 40). The gate had been leaking for some time, which meant that water quality sampling would not indicate a true 'before' value.

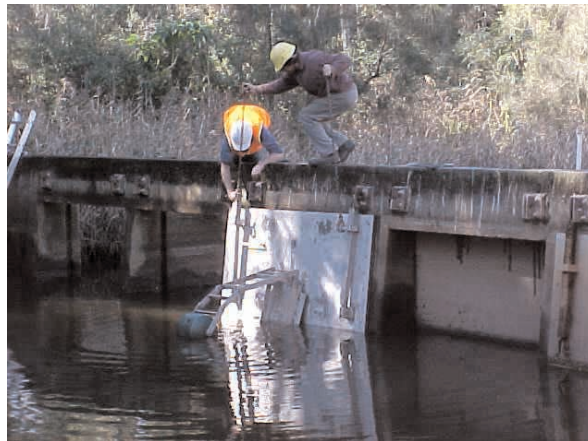
Figure 41: Installing the new tidal gate

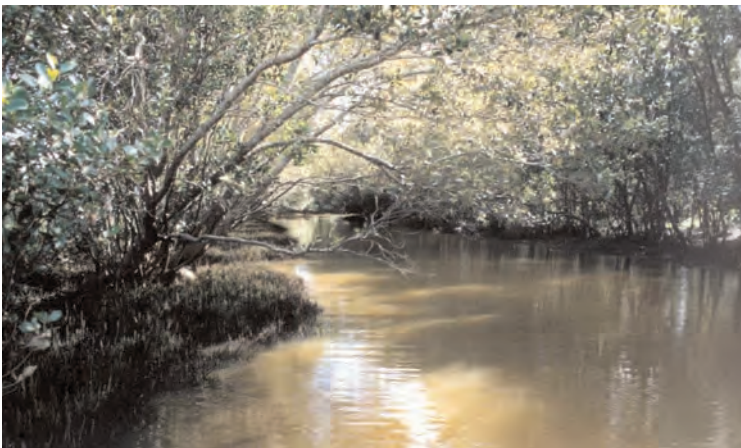
Figure 42: Downstream of the floodgates

Figures 42 and 43 highlight the difference in vegetation communities on either side of the floodgate. Downstream the riparian vegetation is comprised exclusively of mature mangroves, which provide excellent fish habitat. Upstream there were no mangroves – one bank was lined with casuarinas and the other with pasture grass and reeds.

Downstream of the floodgate amongst the mangroves (see Figure 42) a different assemblage was encountered. An abundance of commercially and recreationally valuable large school prawns dominated the catches, with long-armed prawns and mud crab also present. An unusual find was a juvenile silver batfish, normally seen on tropical reefs.

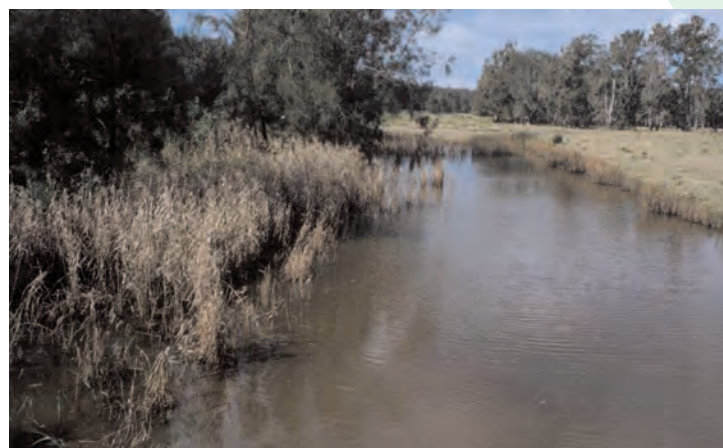
Figure 43: Upstream of the floodgates

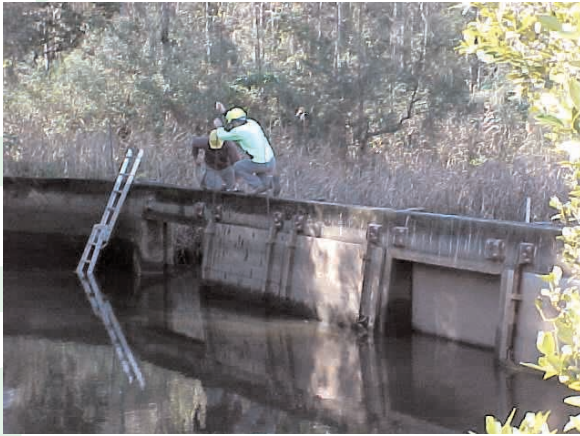
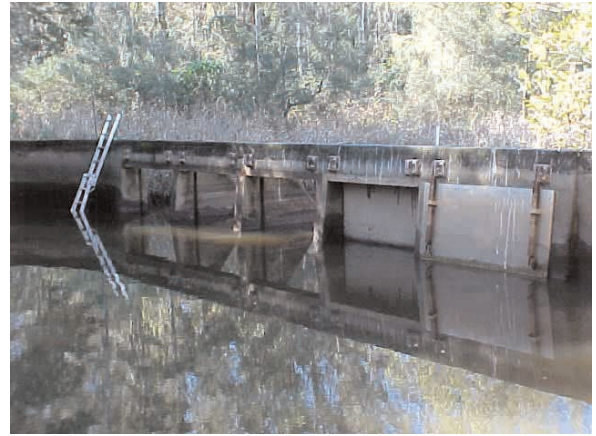
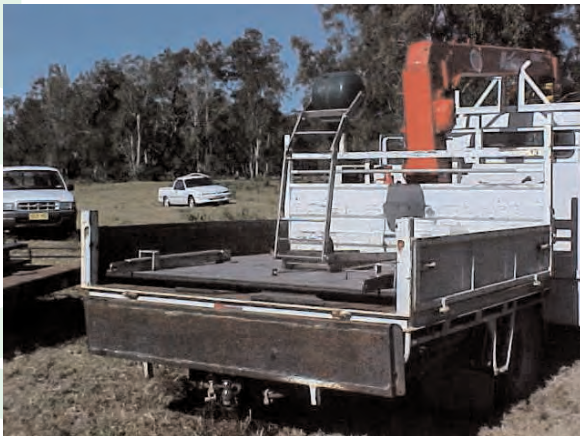
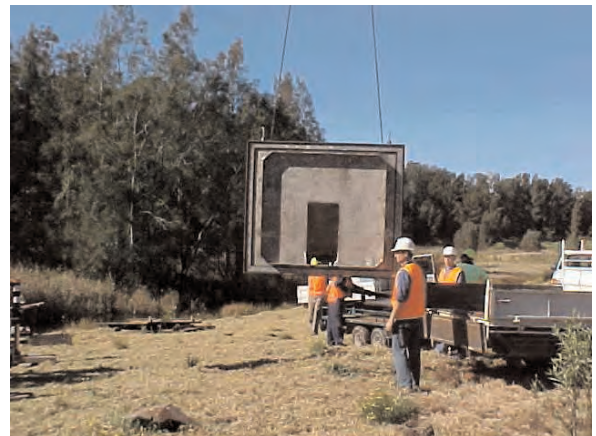
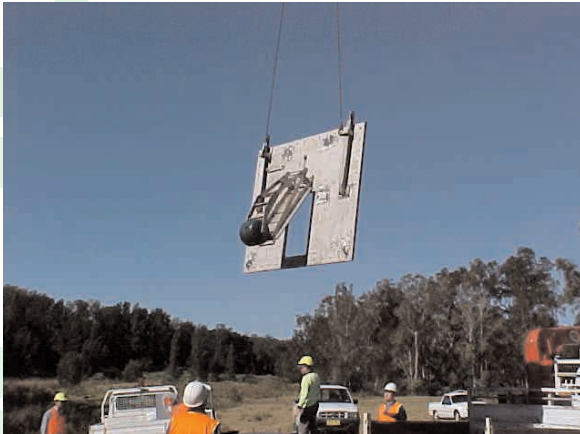
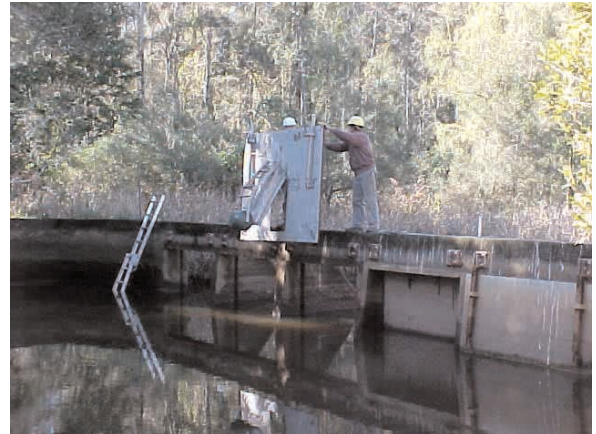
Figure 47: Installation sequence of a tidal floodgate at Saltwater Inlet (The Lag), Macleay – images courtesy of Ron Kemsley, Kempsey Shire Council.

1. Attach old gate to crane wire

2. Old gate removed

3. New tidal gate on truck

4. Lifting the gate from the truck

5. Swinging across to the site

6. Lowering into position

The new floodgate structure was installed during Winter 2004. It is planned to undertake further follow up surveys at Saltwater Inlet during the forthcoming Spring/Summer period in 2004/05, when water temperatures are as close as possible to those of the original survey discussed above.
