NSW DEPARTMENT OF
PRIMARY INDUSTRIES

NORTH COAST FLOODGATE PROJECT

*Final Report
2002 - 2004*

Walsh S. and Copeland C. (2004). *North Coast Floodgate Project* - Final Report to the Environmental Trust, NSW Department of Primary Industries, Ballina.

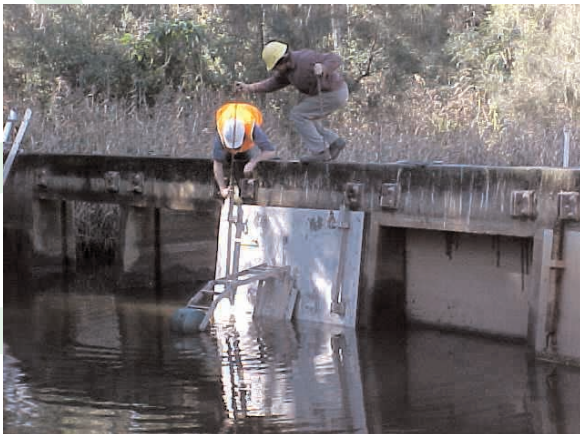
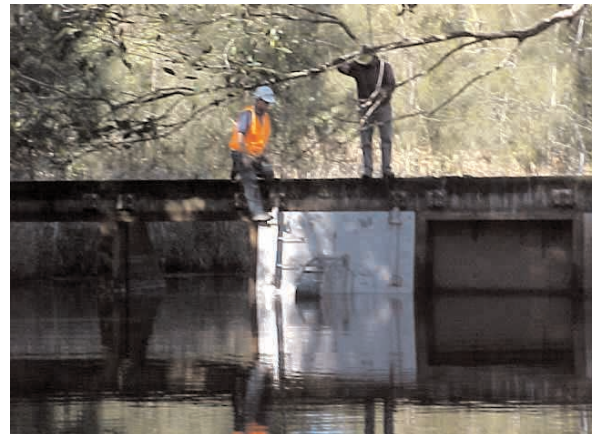
Figure 47: Installation sequence of a tidal floodgate at Saltwater Inlet (The Lag), Macleay – images courtesy of Ron Kemsley, Kempsey Shire Council.

7. Fixing into the final position

8. Installation successfully completed

The new floodgate structure was installed during Winter 2004. It is planned to undertake further follow up surveys at Saltwater Inlet during the forthcoming Spring/Summer period in 2004/05, when water temperatures are as close as possible to those of the original survey discussed above.

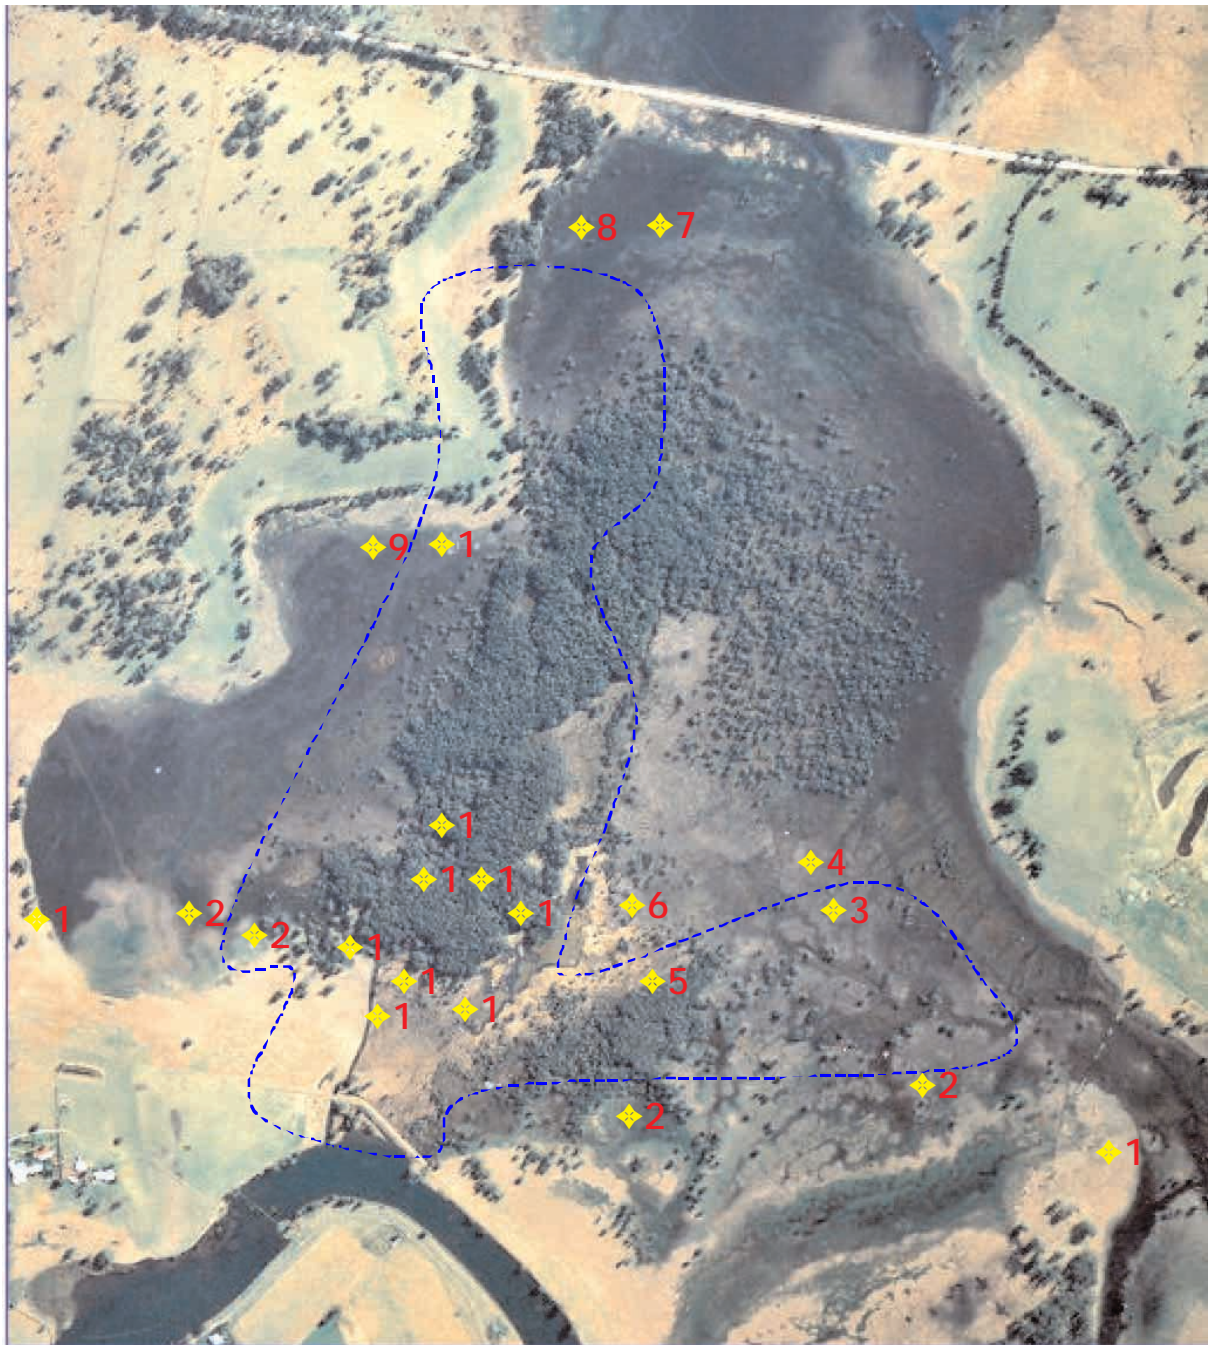
Figure 1. Vegetation monitoring points established August 2003

Twenty-two vegetation-monitoring points were established across all the community types (Table 1) at varying distances from the floodgate (Figure 1). Markers are in place at each site and vegetation condition assessment occurs within 8 1x1m quadrats arranged around the marker at each site (Figure 2). A photo point has been established north of each site and a photo is taken with every seasonal sample.

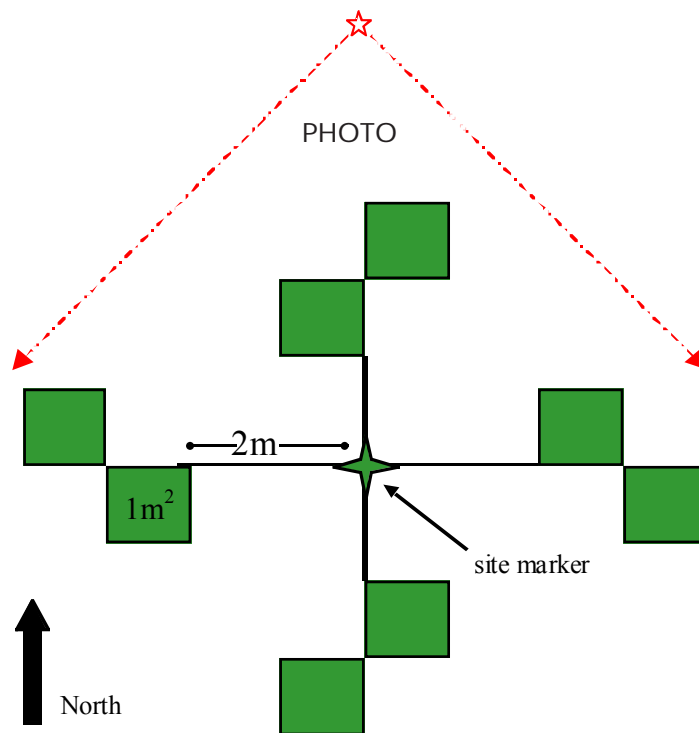
Figure 2. Sampling strategy at vegetation monitoring points

Vegetation condition assessment records the vegetation species present and the percent foliage cover of each for the eight quadrats at each site. The status of each species (dead/alive) is recorded and the percentages of bare ground and litter at each quadrat included. Water depth, salinity and pH are measured in the field for each site.

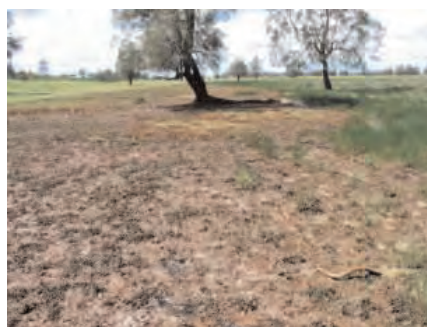
Photo 1. Edge effect in areas previously dominated by Blue Couch (*Cynadondactylon*) as seen in February 2004

The sampling to date has shown a largely positive change in vegetation health over summer, during which time rainfall, coupled with floodgate opening lead to previously dry areas becoming inundated. These conditions, and the mobilisation of acidic salts from drained acid soils have led to an edge effect of dead vegetation and bare earth that is now visible on most aquatic/terrestrial boundary areas of the wetland (Photo 1). This is exacerbated by the previous domination of these zones by Blue Couch (*Cynadon dactylon*), a species that is not tolerant of long periods of inundation and has died off as a result of the new conditions. Such an impact is to be expected following water regime changes in a wetland, and is a natural phase in the move towards vegetation species that favour wetter environments.

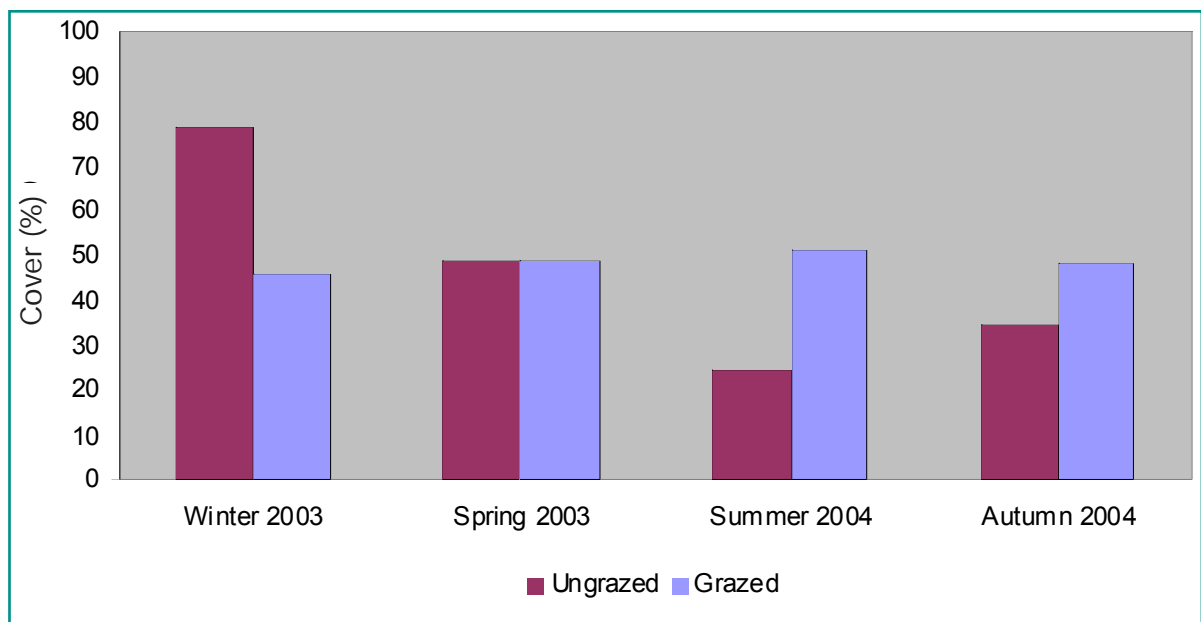
Graph 1. Softrush (Eleocharis equisetina) cover in grazed and ungrazed sampling areas. Grazed zones have maintained their levels of vegetation throughout the seasons, while ungrazed areas exhibit seasonal die off and the impact of increased feeding pressure from birds.

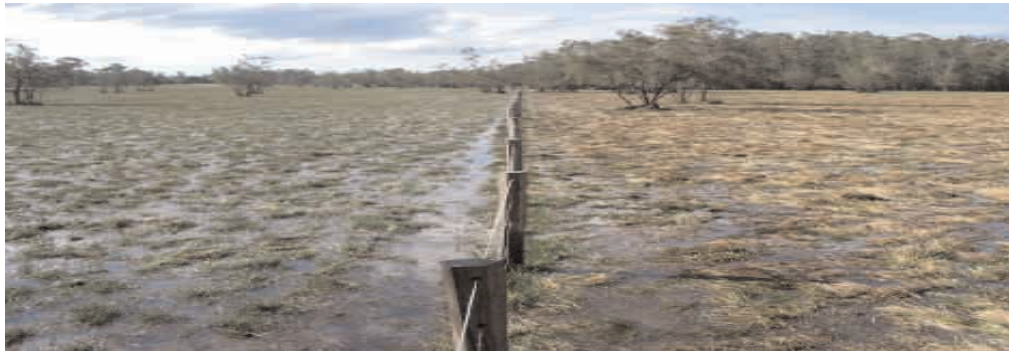
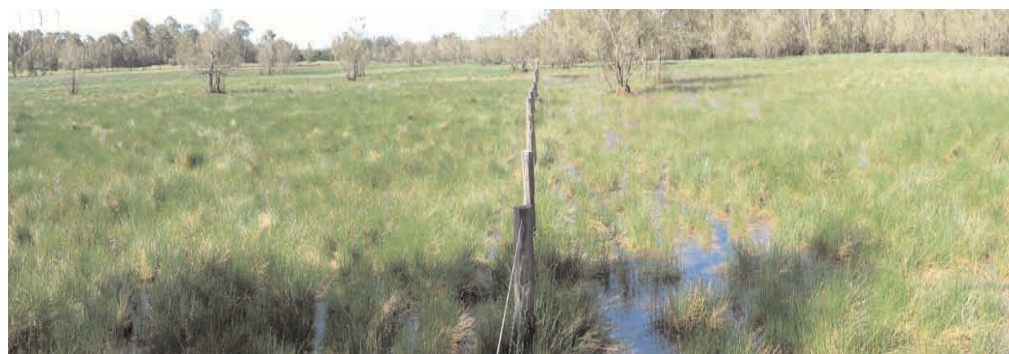
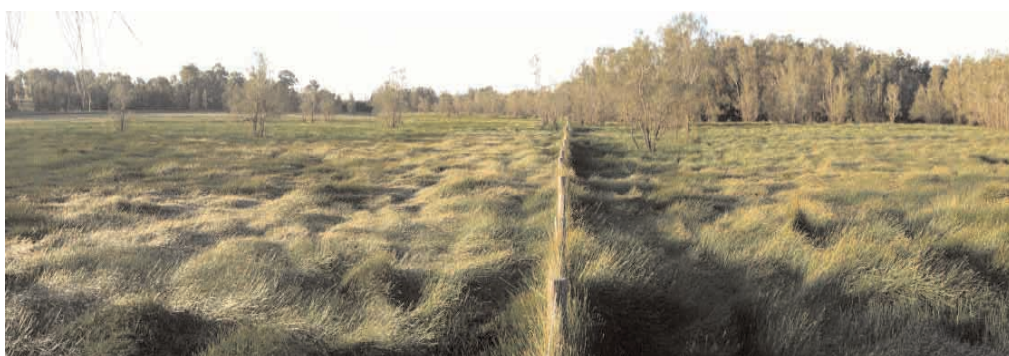
*Photos 2 - 5. Grazing photo point on the western boundary of the exclusion fence showing differences between grazed (left) and non-grazed areas in the Soft rush (*Eleocharis equisetina*) community since the opening of the floodgates.*

The impacts of reinundation on specific vegetation communities have been picked up through our sampling and are illustrated in the graphs and photos below. All but one of the communities sampled have exhibited tolerance to the new water levels and varied salinity in the wetland. The large tracts of Softrush (*Eleocharis equisetina*) that surround open water and forested areas have remained healthy, and in some areas exhibited a marked improvement in cover of the species, mostly visible in the grazed areas (Graph 1, Photos 2-5).

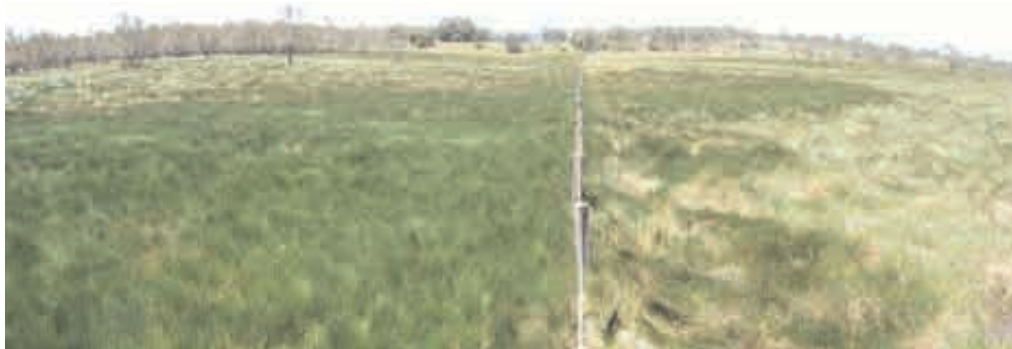
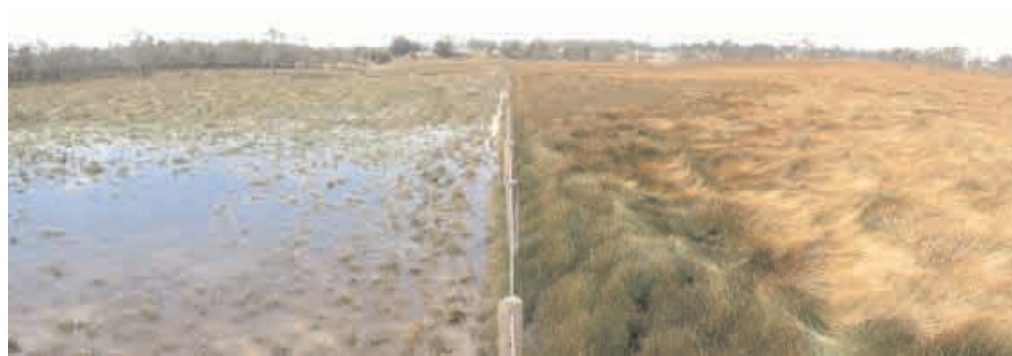
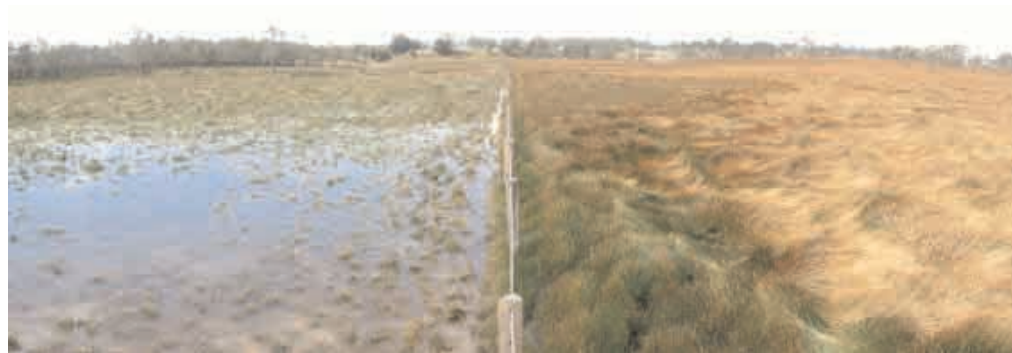
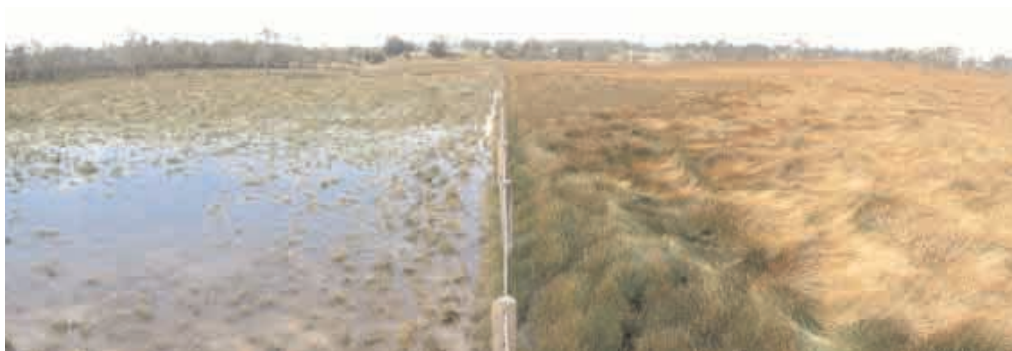
*Photos 6 - 9. Grazing photo point on the eastern boundary of the exclusion fence showing differences between grazed (left) and non-grazed areas in the Softrush (*Eleocharis equisetina*) community since the opening of the floodgates.*

The same species has died off in some of the ungrazed and deeper parts of the wetland, largely as a result of clearing by waterbirds. The black swans have created cleared “flyways” in these areas, as well as pulling up and feeding on the plants. The Softrush that was growing very thickly in some of the ungrazed zones has died off through it’s natural annual lifecycle and, without grazing disturbance, the dead vegetation has remained in place leaving tracts of organic matter on the surface providing a valuable food source for fish and prawns. These changes can be seen clearly in the February and May photos of the eastern photo point (Photos 6 – 9).

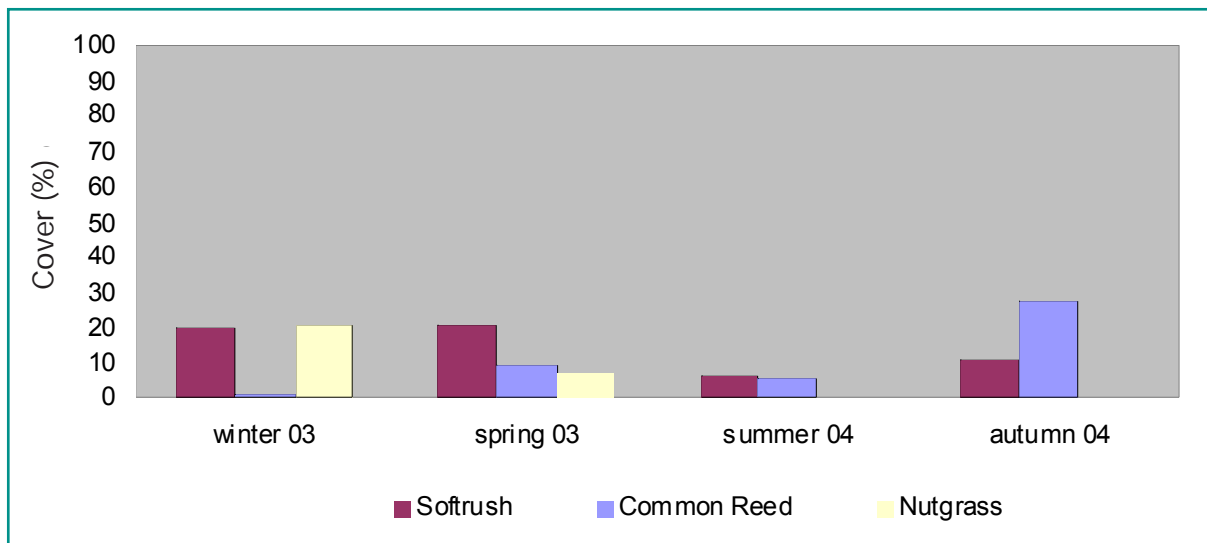
Graph 2. Changes seen in the Nutgrass (*Bolboshoenus caldwelli*) community since gate opening. By Summer 2004 the Nutgrass had completely died off in our sampling areas whilst the Common Reed (*Phragmites australis*) has increased in its place.

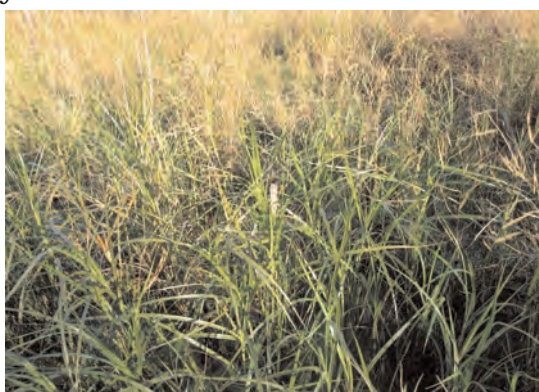
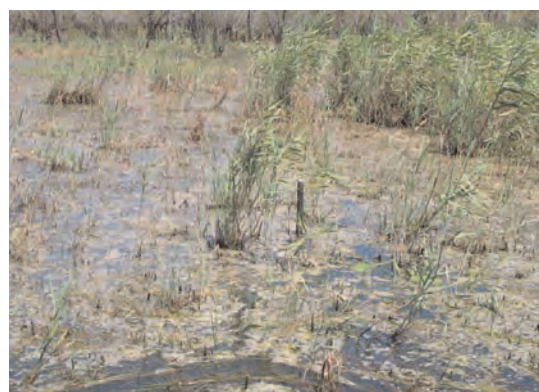
Photos 10 – 11. Nutgrass community die off has occurred since gate opening in July 2003.

Samples taken in the open water and fringing vegetation communities of the top and bottom ponds (sites 11 – 18) have shown a dramatic change in one species, known as Nutgrass (*Bolboshoenus caldwelli*), and seen other communities maintain or improve their health. The nutgrass species is the most sensitive to salinity changes, exhibiting little or no tolerance to the low levels of salinity that have been recorded in the swamp (Graph 2, Photos 10-11). Other species that have been previously recorded as salt sensitive have maintained their health throughout the sampling periods, illustrating that salt levels have remained within a threshold acceptable to most fringing aquatic communities.

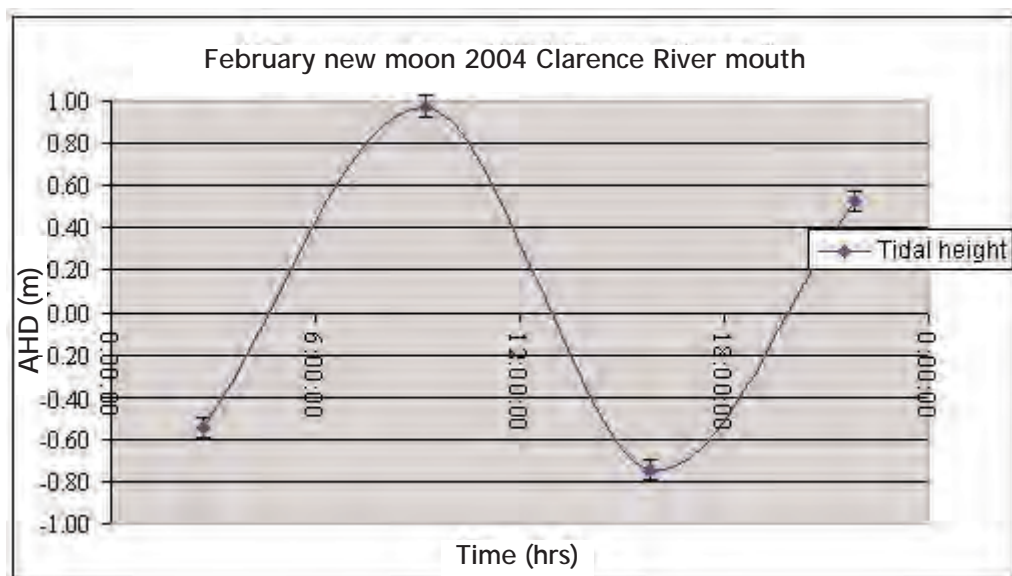
Figure 1: Spring tide height at the Clarence River mouth on 20/02/2004 sourced from Fort Denison tide time predictions and adjusted to AHD using the Iluka Port Datum of Indian Spring Low.

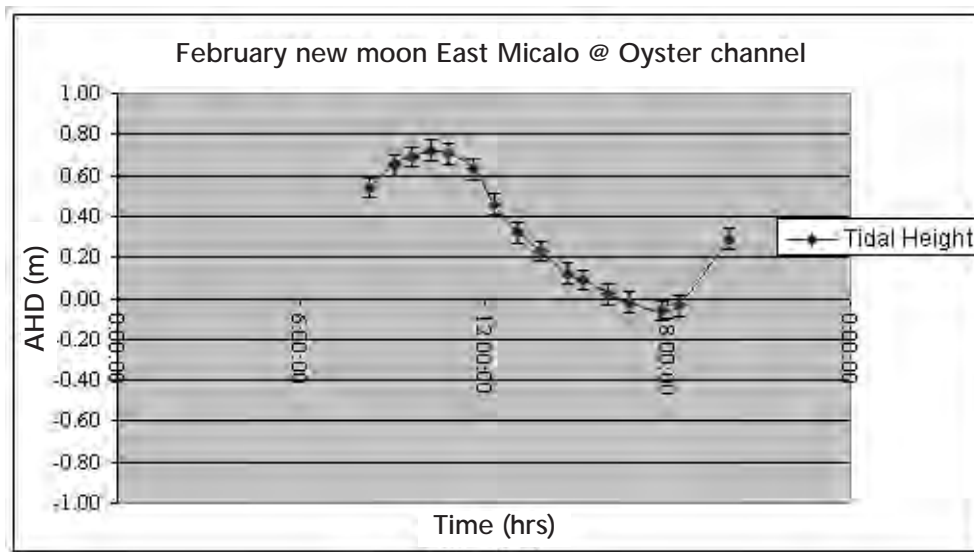
Figure 2: Spring tide height at east Micalo Island in Oyster channel (site EM) 20/02/2004.

Comparison of Figures 2 and 3 indicates a tidal lag of approximately 2hrs from east Micalo Island at site EM to west Micalo Island at site WM with spring high tide peaking at approximately 10:15hrs (Figure 2) at the Oyster channel site EM and 12:15hrs (Figure 3) at the west Micalo Island road crossing site WM. However, it must be noted that the west Micalo site is within the confines of a non-floodgated drain and not in the open channel and therefore the accuracy of this observation may be compromised. It is recommended an additional site be added at the confluence of drain 3 with Shallow channel in an effort to establish the exact tidal

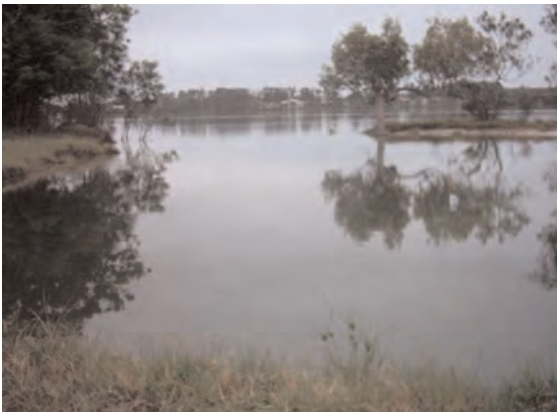
Plate 1: Spring high tide at east Micalo Island in Oyster channel looking down stream from floodgate 2 on drain 2 (site 2.1) 20/02/2004.

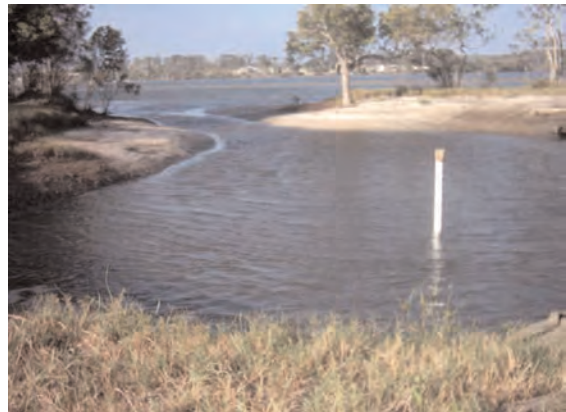
Plate 2: Spring low tide at east Micalo Island in Oyster channel looking down stream from floodgate 2 on drain 2 (site 2.1) 20/02/2004.

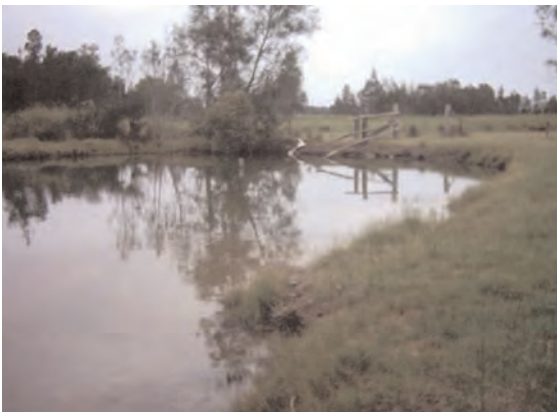
Plate 3: Spring high tide at east Micalo Island in Oyster channel looking up stream towards floodgate 2 on drain 2 (site 2.1) 20/02/2004

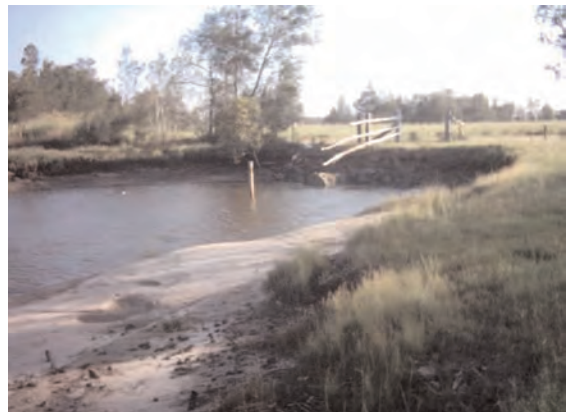
Plate 4: Spring low tide at east Micalo Island in Oyster channel looking up stream towards floodgate 2 on drain 2 (site 2.1) 20/02/2004.

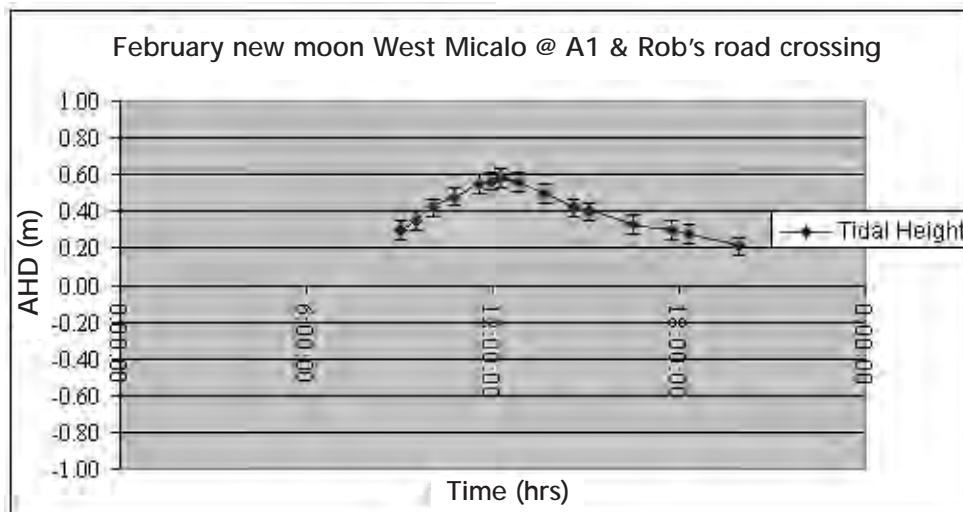
Figure 3: Spring tide height at west Micalo Island road crossing on drain 3 (site 3.1) 20/02/2004.

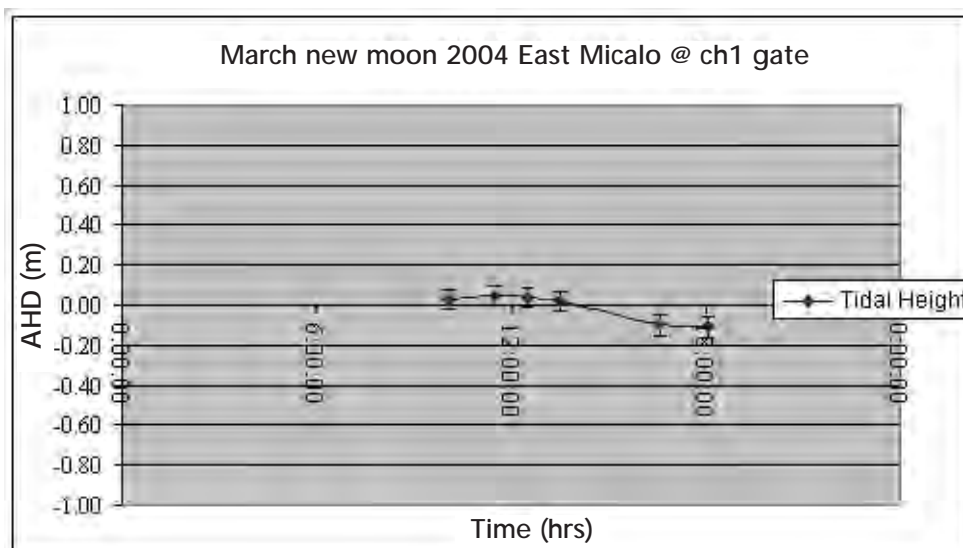
Figure 4: Spring tide height at east Micalo Island up stream side of floodgate 1 on drain 1 (site 1.1) 20/03/2004.

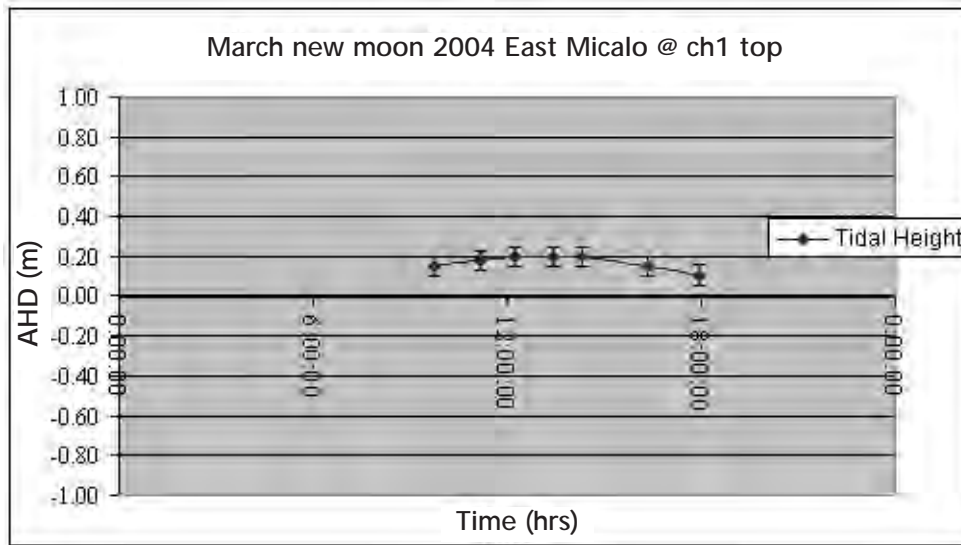
Figure 5: Spring tide height at east Micalo Island upstream on drain 1 (site 1.2) 20/03/2004.

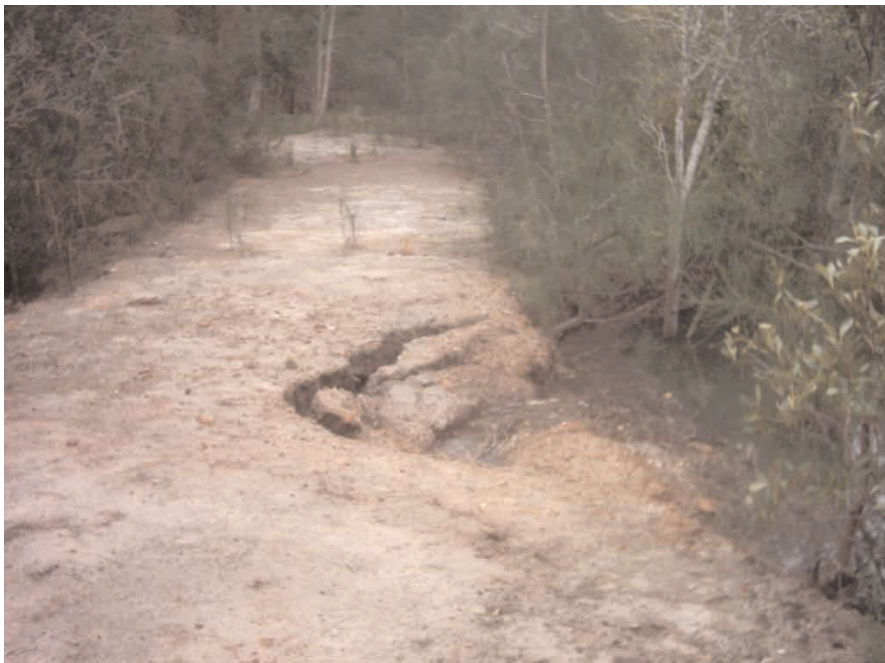
Plate 5: Spring high tide at east Micalo Island at floodgate 1 on drain 1 (site 1.1) 20/02/2004. Note subsidence of the floodgate levee and topping by spring high tide water level.

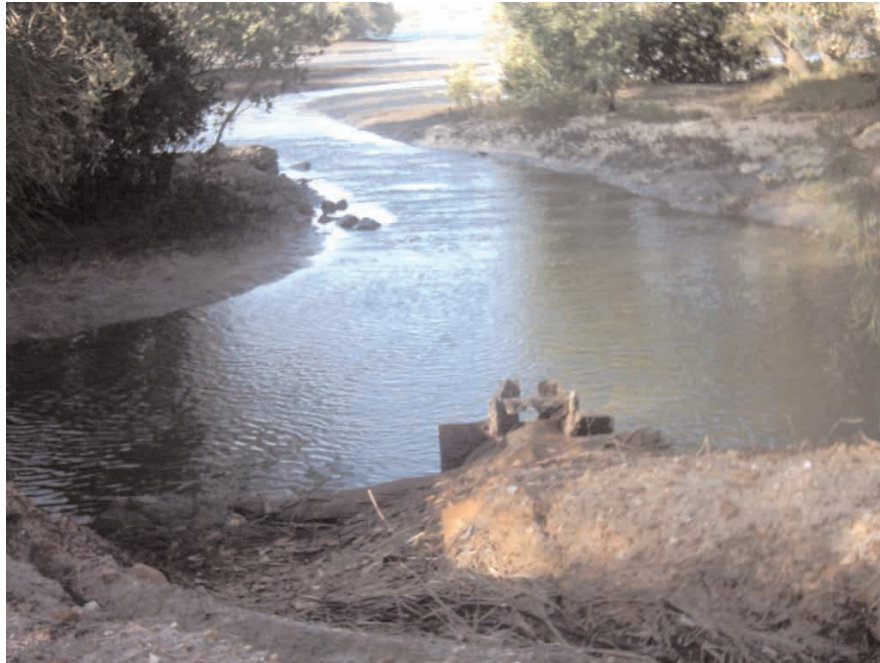
Plate 6: Spring low tide at east Micalo Island looking downstream at floodgate 1 on drain 1 (site 1.1) 20/02/2004. Note subsidence of the floodgate levee.

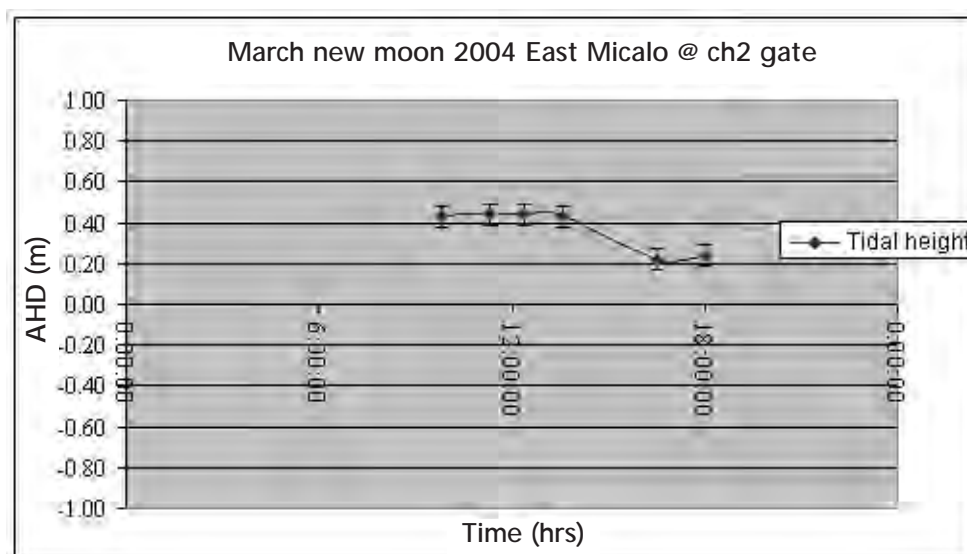
Figure 6: Spring tide height at east Micalo Island up stream side of floodgate 2 on drain 2 (site 2.1) 20/03/2004.

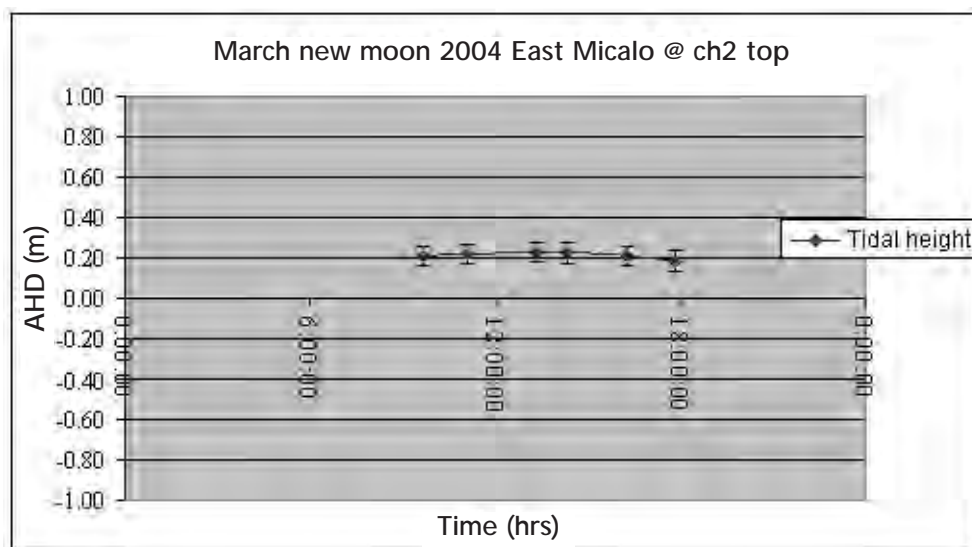
Figure 7: Spring tide height at east Micalo Island up stream on drain 2 (site 2.2) 20/03/2004.

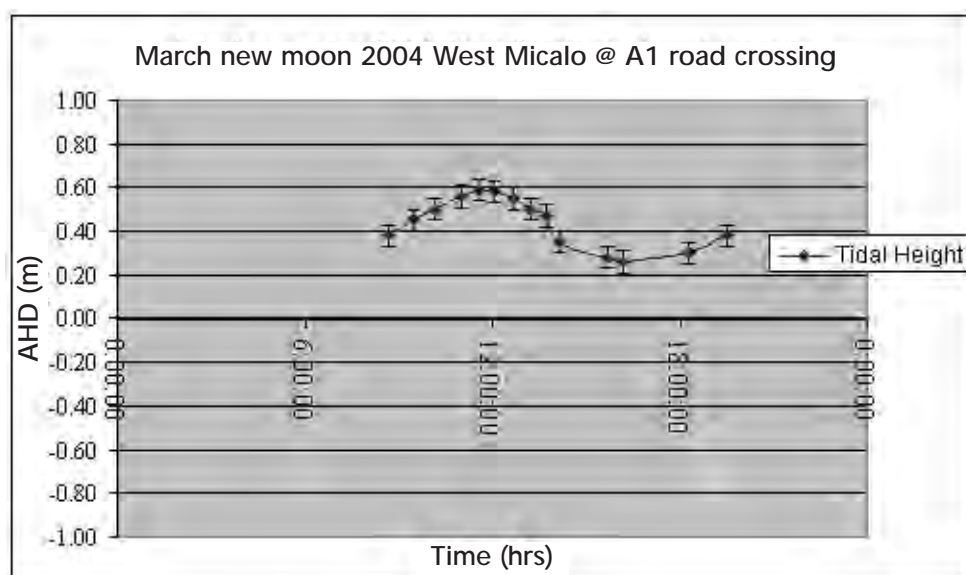
Figure 8: Spring tide height at west Micalo Island at the road crossing on the downstream end of drain 3 (site 3.1) 20/03/2004.

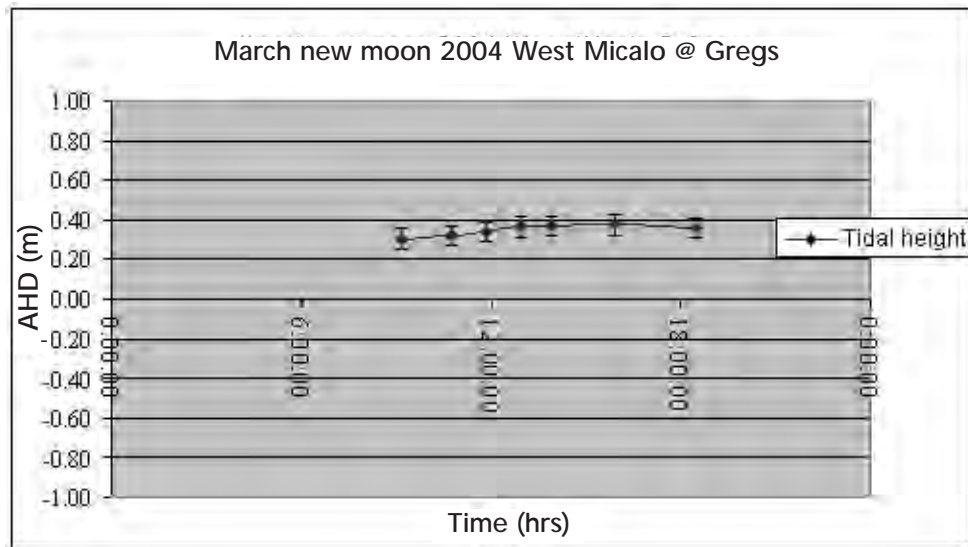
Figure 9: Spring tide height at west Micalo Island upstream point on drain 3 (site 3.2) 20/03/2004.
