Marine Aquaculture Research Lease

Annual Environmental Management Report

October 2017

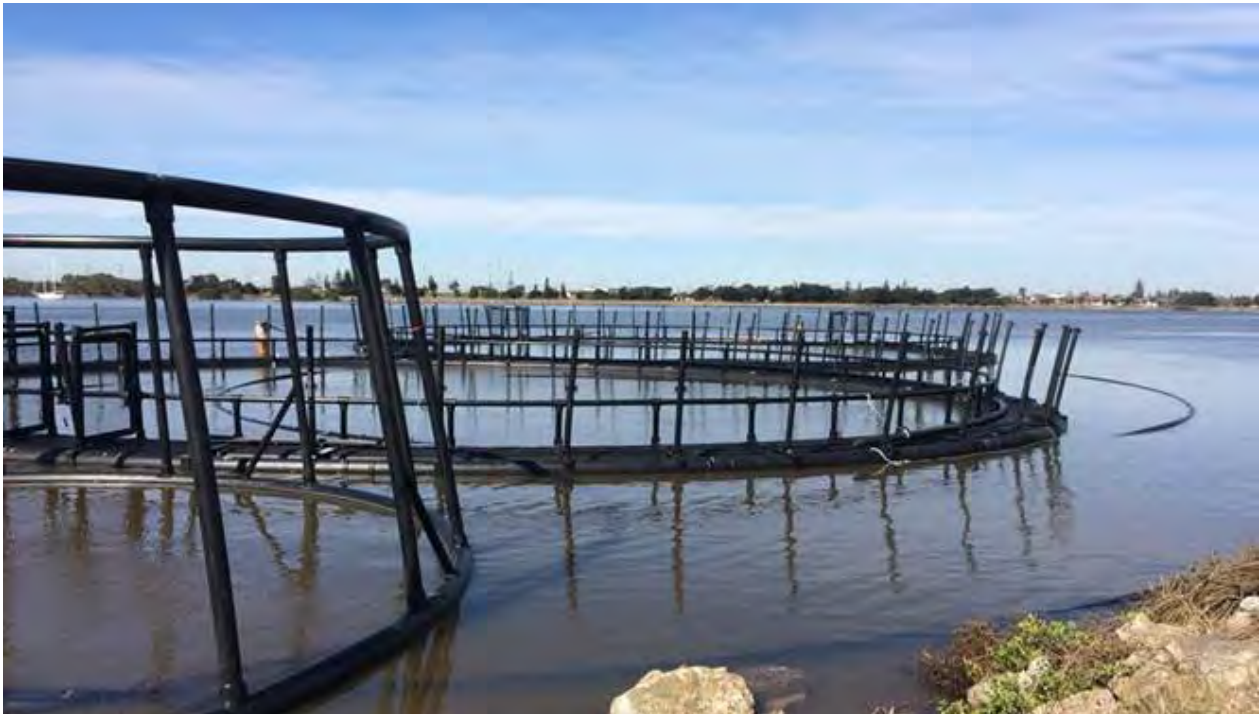
Construction activities for the MARL commenced in Newcastle during September 2016, including the fabrication of stingray anchors, two sea pens of 38 m diameter in Newcastle Harbour and mooring lines in the Koorangang Industrial Precinct (Figure 1).

Figure 1: The sea pens in Newcastle Harbour next to the Koorangang Industrial Precinct (Source: NSW DPI, 2016).

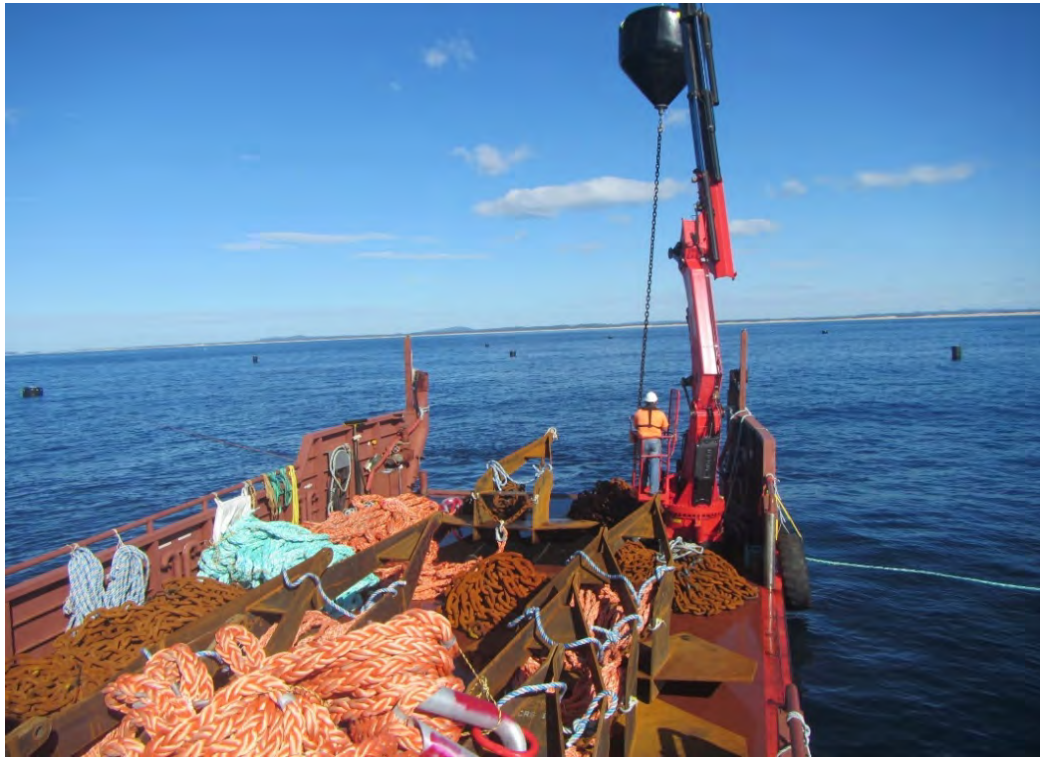
Figure 2: The deployment of anchors, anchor deployment lines and mooring lines on the MARL (Source: Huon, 2016).

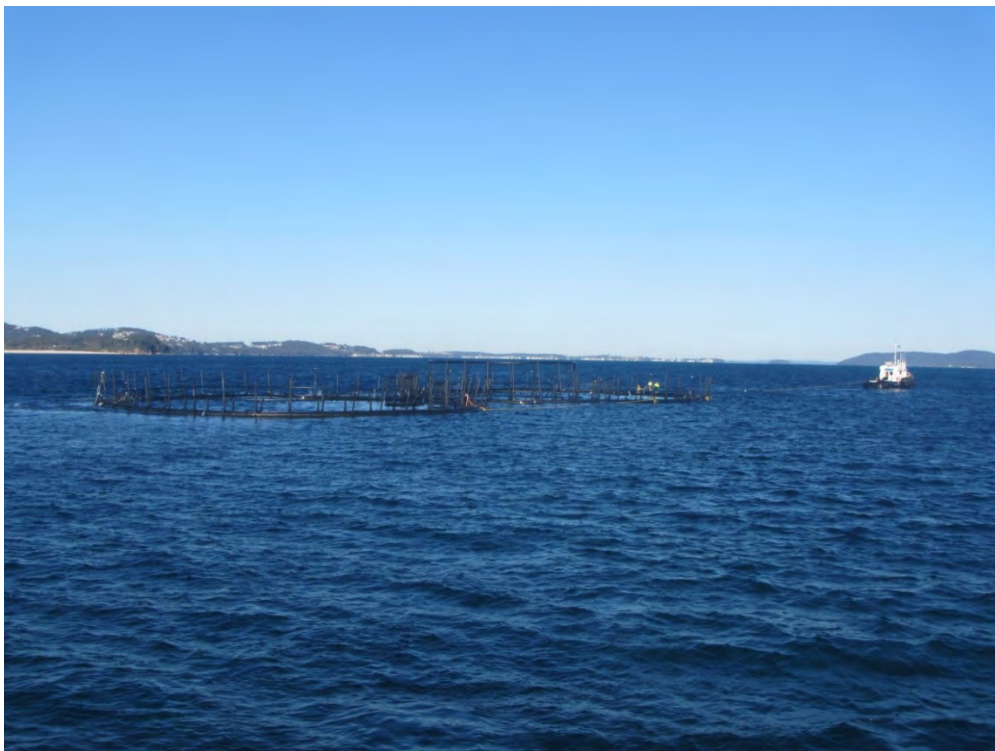
A NSW Office of Environment and Heritage (NSW OEH) approved observer monitored the installation activities, including the towing of the sea cages from Newcastle Harbour to the MARL (Figure 3), and recorded marine fauna interactions and sightings during deployment.

Figure 3: The sea pens being towed to the MARL (Source: Huon, 2016).

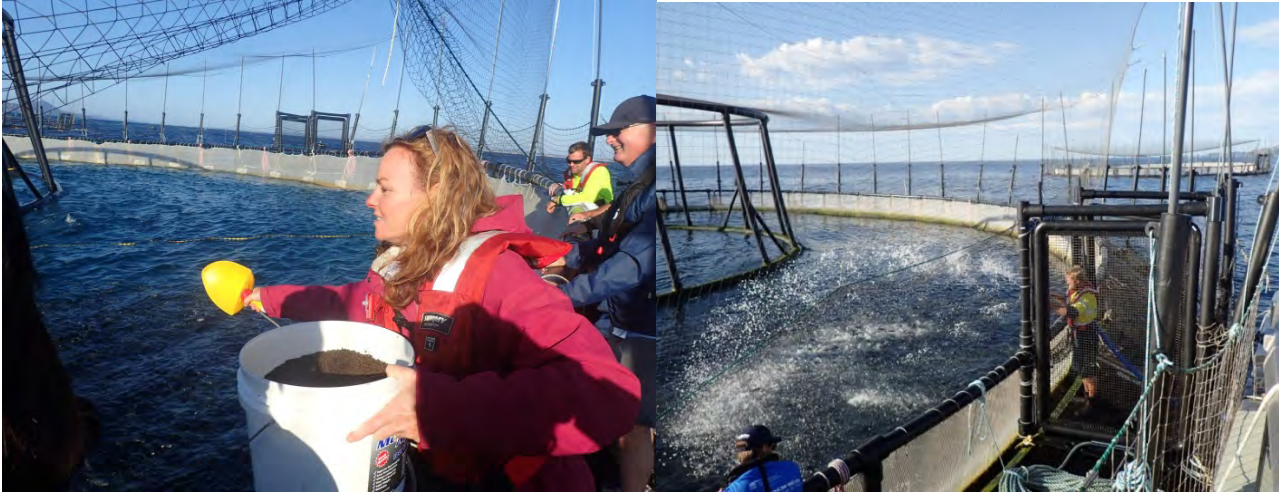
The feeding of stock commenced on 17th October 2016 when the first batch of fingerlings were transferred to the MARL. Fingerlings were initially fed daily by hand (Figure 8). Hand feeding was replaced by the use of a mechanical device in December 2016. A Feed Register has been maintained for the MARL which has recorded feed input details e.g. feed type, size and quantity.

Figure 8: The fingerlings were initially fed by hand daily and currently by a mechanical device (Source: NSW DPI, 2016).

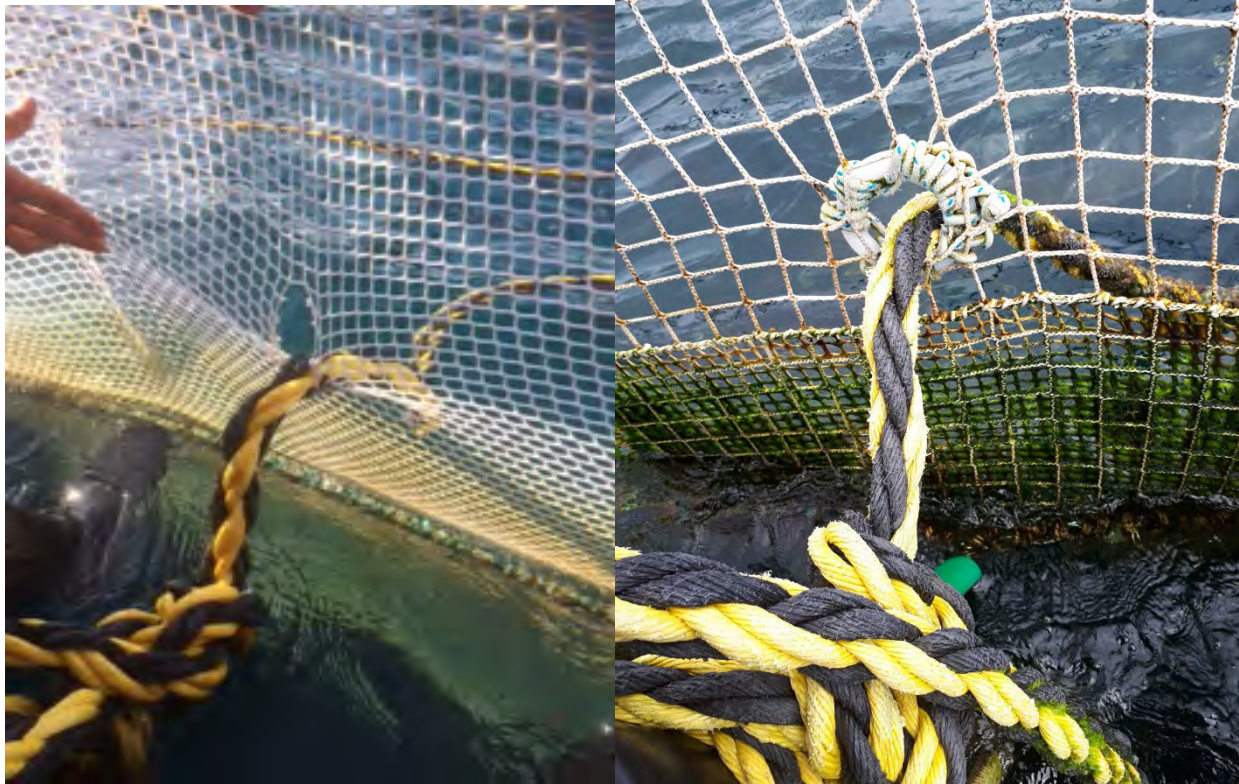
Severe sea conditions in November 2016 resulted in the bird netting support structure rope chafing a hole in the culture net close to water line (Figure 9), which was identified during routine maintenance inspections. This resulted in 50 fish escaping which were recaptured.

Figure 9: Damage caused by bird netting support structure rope chaffing a hole in the culture net and the modification undertaken to mitigate the issue. (Source: Huon, 2016 & 2017).

The corrective action undertaken to manage this future risk was to amend the tie off point and provide chafe protection to grow net. In-pen bird netting support structures are unlikely to be used again in 120 m diameter sea pens.

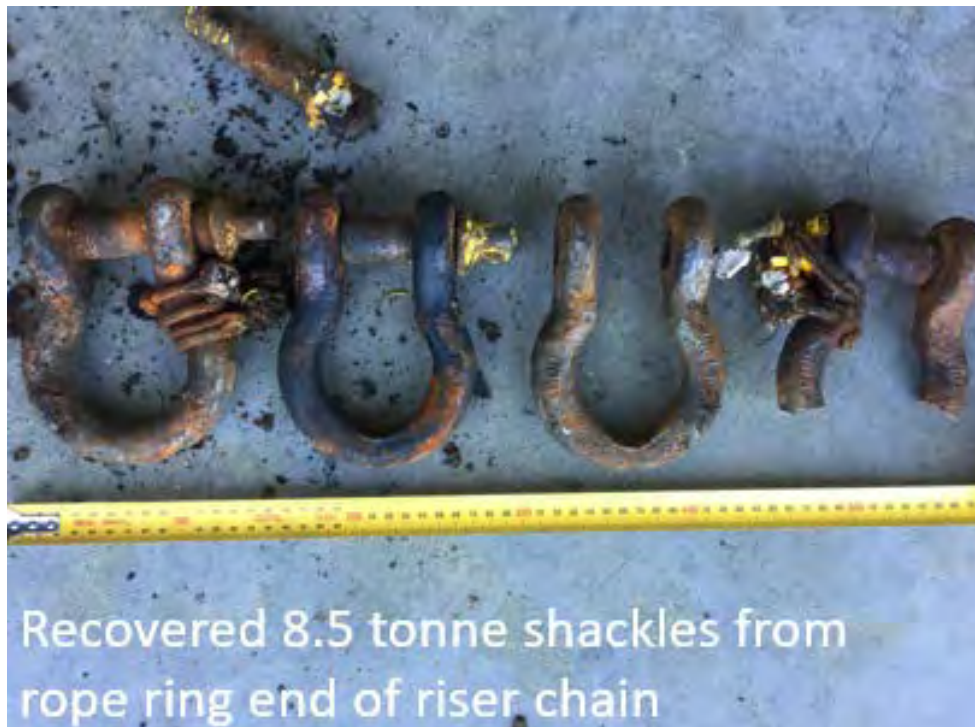
Another grid buoy became loose on 25th April 2017 when an 8.5 tonne shackle malfunctioned (Figure 10). Farm personnel were onsite when it broke free and were able to retrieve it within the boundaries of the MARL.

Figure 10: Malfunctioning 8.5 tonne shackles from grid buoys (Source: Huon, 2017).

- Investigate the malfunction with the product manufacturer;
- The ability to fit grid buoys with GPS transponders;
- Reduce hardware components associated with current mooring arrangement were possible to prevent re-occurrence; and
- Next mooring installation will have a further reduction of hardware components.

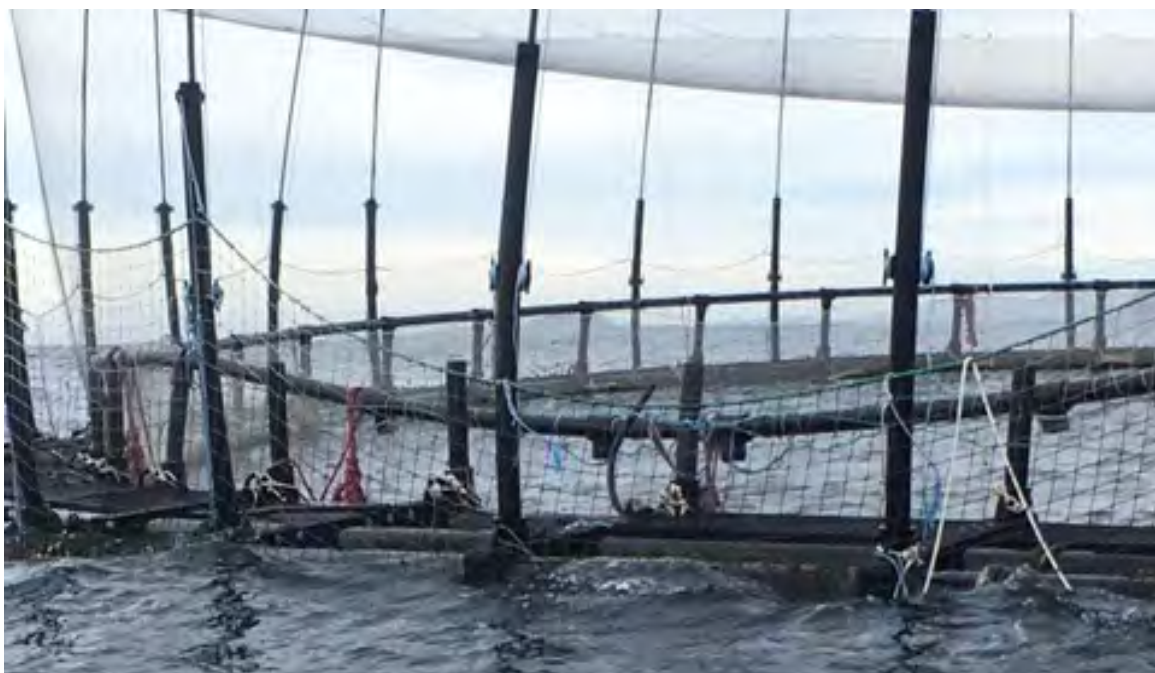
Extreme weather conditions in August 2017 resulted in the shearing of pins holding four stanchions in place on a sea pen. This caused the hand rail to drop slightly which resulted in the culture net dropping slightly (Figure 11) and permitted approximately 500 fish to escape. The size of the fish resulted in the majority of the 500 fish being contained between the culture and predator nets enabling 16 of them to be recaptured. Attempts to recapture the fish between the culture and predator nets will continue.

Figure 11: Picture showing dropped rail holding culture net which resulted from malfunctioned stanchion pins (Source: Huon, 2017).

The damage to the sea pen infrastructure has been rectified.

The corrective action undertaken to manage this future risk is to investigate the structural soundness of the malfunctioning component, adjusting the height of the culture net and modifying future pens.

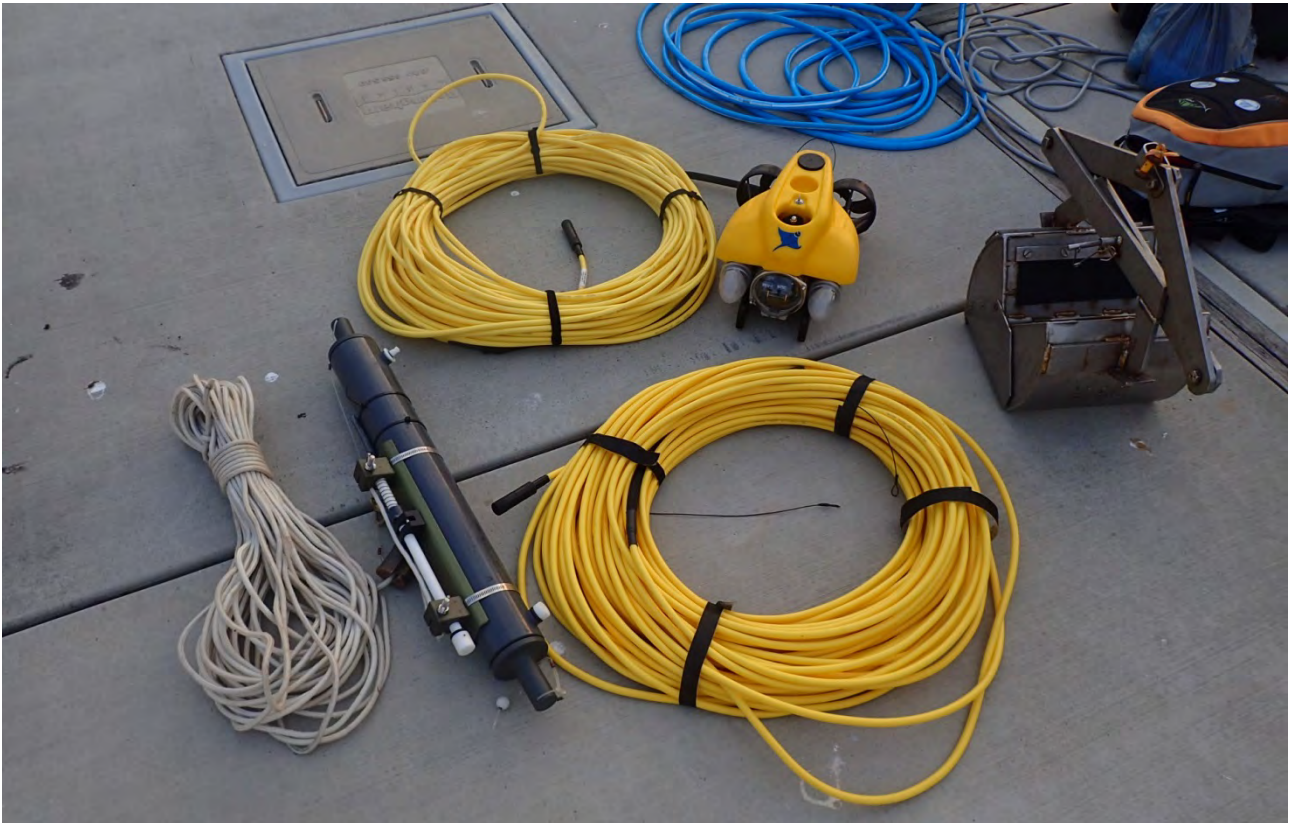
The Program includes monitoring of: water quality (temperature, salinity, oxygen, pH, Chlorophyll α and concentrations of nitrogen and phosphorus); biological changes (macrobenthic invertebrates, i.e. worms and crustaceans larger than 1 mm); chemical changes (the composition of elements in the seafloor); and physical changes (the particle size of sediment and video footage) (Figure 14).

Figure 14: Equipment used during the Water Quality and Benthic Environment Monitoring Program. (NSW DPI 2017)

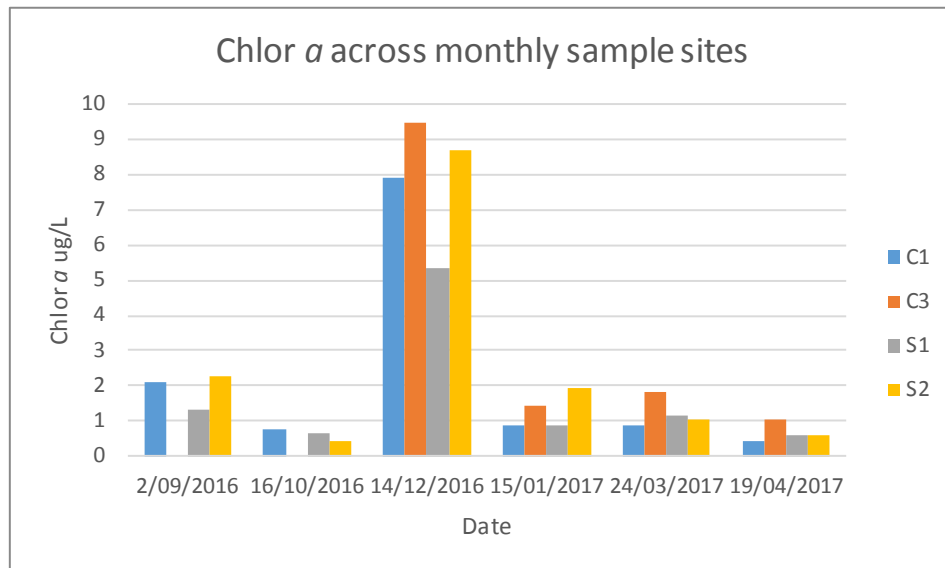
Results for surface chlorophyll α levels taken at the monthly monitoring sites show that chlorophyll α levels throughout the survey area are generally below 2µg/L, but can on occasion become elevated across all sites (i.e. December 2016) (see Figure 16). As nutrients drive plankton productivity then it is reasonable to suppose that the high dissolved nutrient levels present in the December monthly survey may be part of the reason at least for the significant increase in chlorophyll α levels at that time. The present survey and monthly results do not suggest that there is any strong trend across the survey sites, as might be expected in such an exposed area, and the pen site (S3) did not show any sign of an increase above background levels.

Figure 16: Monthly Chlorophyll α levels at sites C1, C3, S1 and S2 (Source: AMD, 2017).

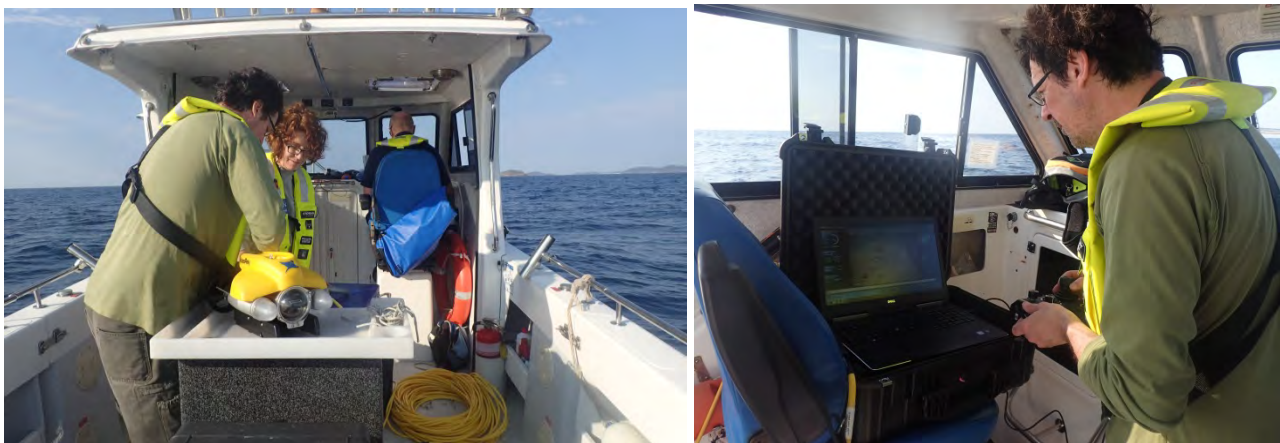
Filming of the seabed was conducted with a ROV (Figure 17) at the sea pen, compliance and control sites. The seabed was generally uniform at all sites (see Figure 18).

Figure 17: Preparation of ROV on the deck of a vessel prior to deployment and ROV operator guiding the ROV to collect footage from a sampling site. (Source: NSW DPI, 2017).

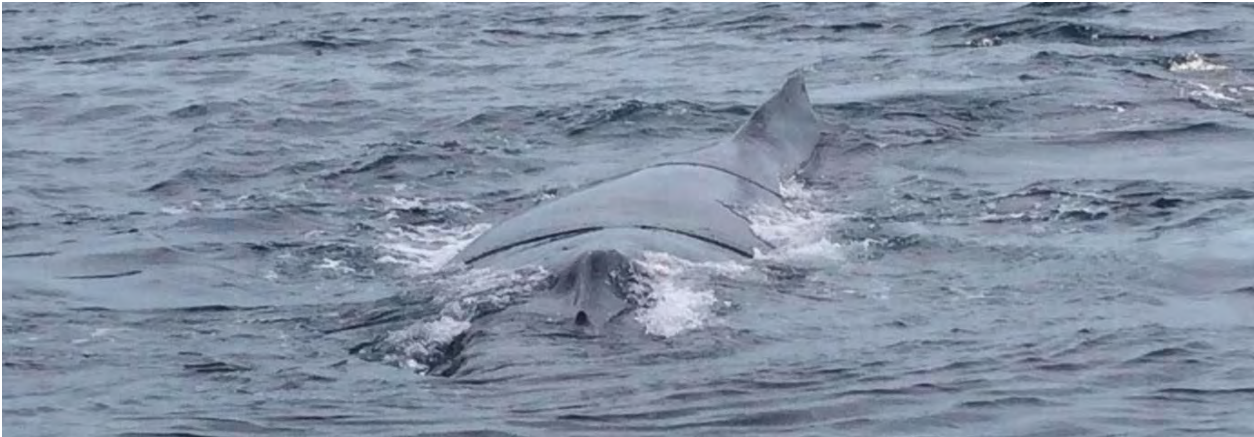
On Saturday 8th October 2016 at approximately 7:12 am two Humpback whales were observed within the MARL by a tour operator. On closer inspection it was observed that one whale had a rope of approximately 25 mm diameter around its back (Figure 26).

Figure 26: Photograph depicts a rope over the back of a Humpback whale (Source: Future, 2016).

NSW OEH, NSW DPE and Commonwealth Department of Environment and Energy were notified of this event. NSW OEH requested an incident report from the tour operator which was received on the 16th October 2016. The incident report outlined that as the tour operator approached the MARL, one of two Humpback whales in the lease area appeared to be entangled in at least one rope and that the whale was evidently distressed. It further outlined that as they ventured closer to assist and photograph the whale, it was observed rolling and managed to dislodge the rope. The two whales then stopped outside the lease area for 15-20 minutes circling the tour boat and then appeared to head south.

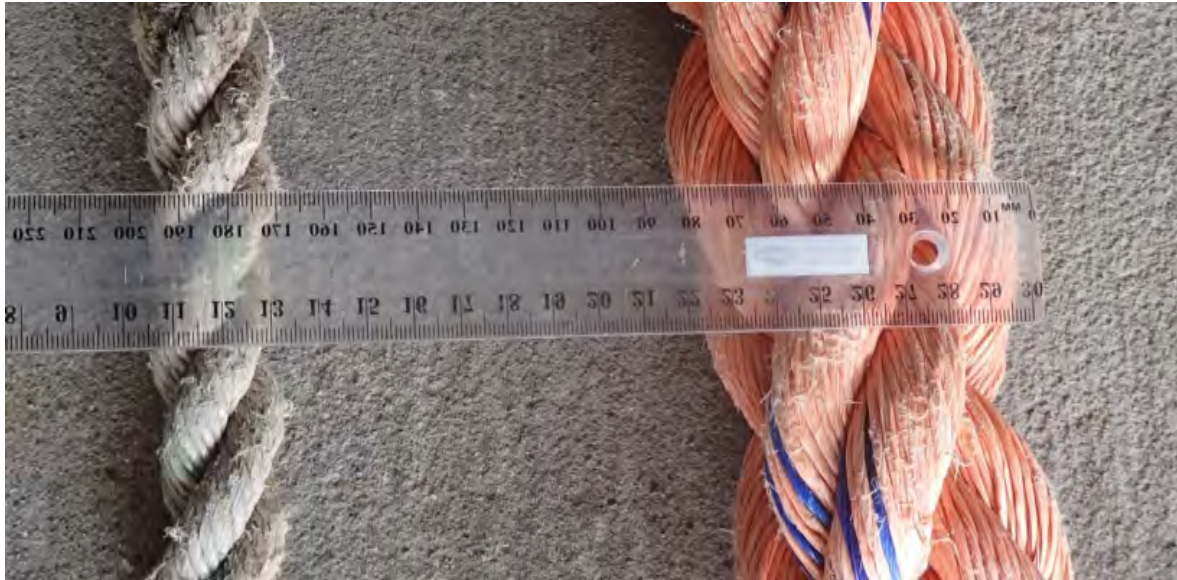
Figure 27: Comparison of a 24 mm rope and 44 mm anchor deployment line used on the MARL. Note: rope dimensions are measured with a load applied and these ropes are unloaded (Source: NSW DPI, 2016).

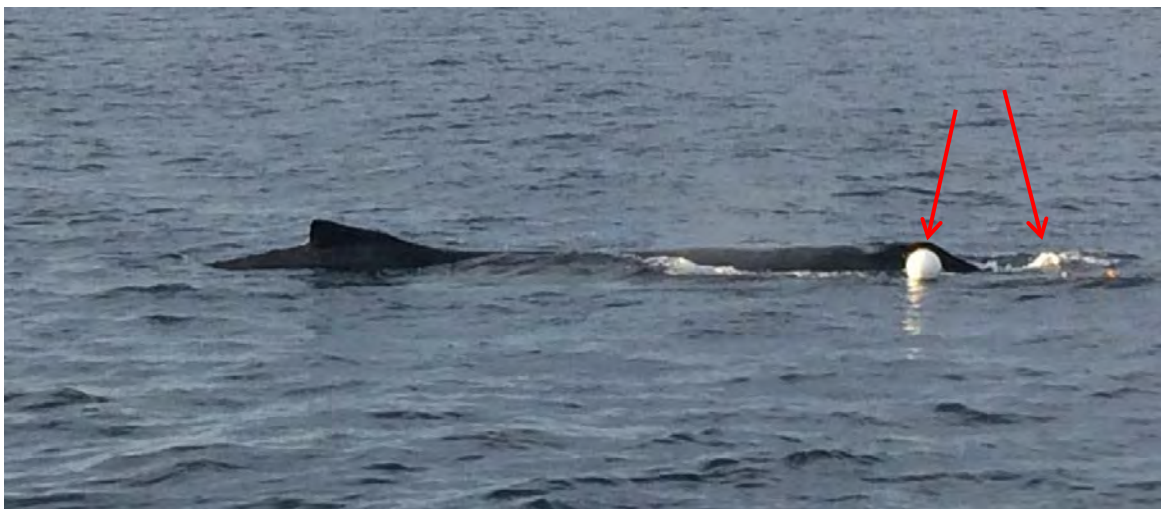
The Marine Fauna Interaction Committee, which consists of representatives from NSW OEH, Macquarie University, Port Stephens-Great Lakes Marine Park, Huon Aquaculture and NSW DPI, reviewed the incident report and photographs provided by the tour operator. The Committee also reviewed the photographs taken by the NSW OEH approved observer and consulted a Fisheries Officer who is familiar with fishing equipment. Observations indicate the presence of two small floats in many of the photographs in addition to the white buoy attached to the anchor deployment line of the MARL (Figure 28).

Figure 28: Larger anchor installation line white buoy and the two small floats (Source: Wiltshire, 2016).

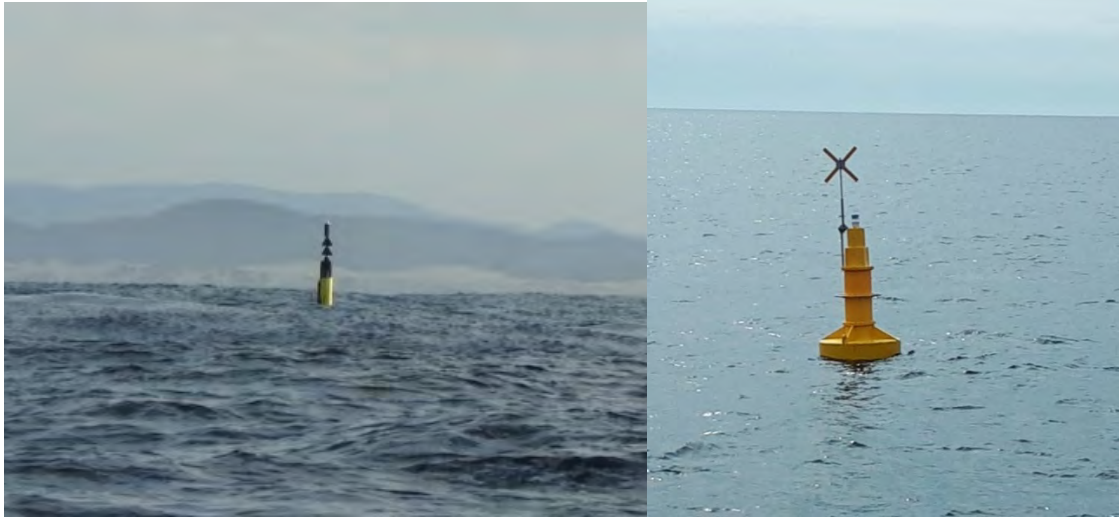
The original spar cardinal marker buoys were replaced with Sealite Poseidon buoys (Figure 30). Poseidon buoys are larger in size and have enhanced visibility compared with the previously installed spar buoys. They maintain their height above sea level in large waves and strong currents. They do tend to exhibit more lateral movement around their installed position but the improved visibility is more desirable from the feedback from the community and regulatory authority.

Figure 30: Original and new marker buoys (Source: NSW DPI, 2017; Huon, 2017).
