# The Assessment & Modification of Barriers to Fish Passage in the Namoi Catchment

NSW Department of Primary Industries (2006). *The Assessment and Modification of Barriers to Fish Passage in the Namoi Catchment*. Report to the Namoi Catchment Management Authority. Department of Primary Industries (Aquatic Habitat Rehabilitation Unit), Tamworth.

As a result of funding from the Namoi Catchment Management Authority, NSW Department of Primary Industries undertook a project entitled *“The Assessment and Modification of Barriers to Fish Passage in the Namoi Catchment”*.

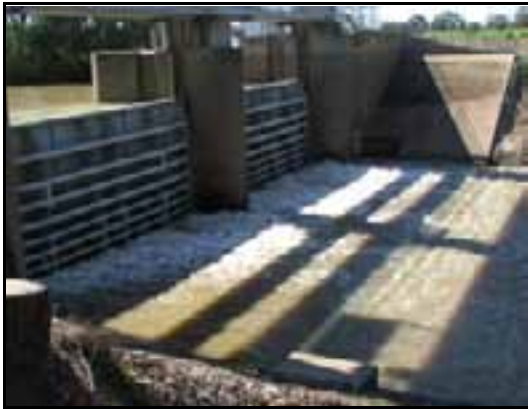
**Plate 7:** Gunidgera Weir (419/970000/B0104)

Gunidgera Weir (Plate 7) is located in the lower end of the catchment on the Namoi River, approximately 3km north of Wee Waa. The weir is approximately 5m in height and 50m across the length of the crest. Gunidgera Weir is a regulating structure that acts as a barrier to fish passage throughout the majority of flow conditions, except during high flow events. When flows are low however, the weir restricts fish passage due to excessive headloss and increased turbulence across the face of the structure. There is currently an ineffective fishway at this site.

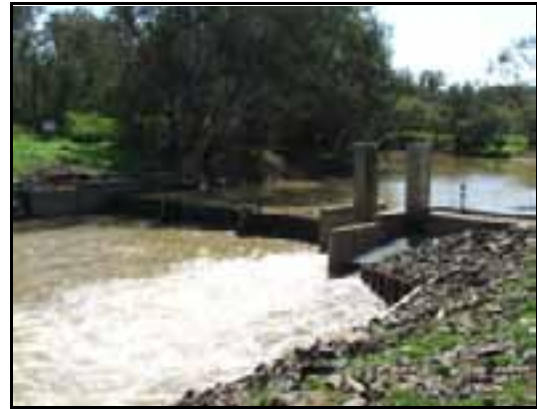
**Plate 8:** Weeta Weir (419/970000/B0106)

Weeta Weir (Plate 8) is located in the lower end of the catchment on the Namoi River, approximately 40km southwest of Wee Waa. The weir is approximately 2m in height and 45m across the length of the crest. Weeta Weir is a regulating structure that currently has an ineffective submerged orifice fishway. The weir acts as a barrier to fish passage during low flows due to excessive headloss and increased turbulence across the face of the structure.

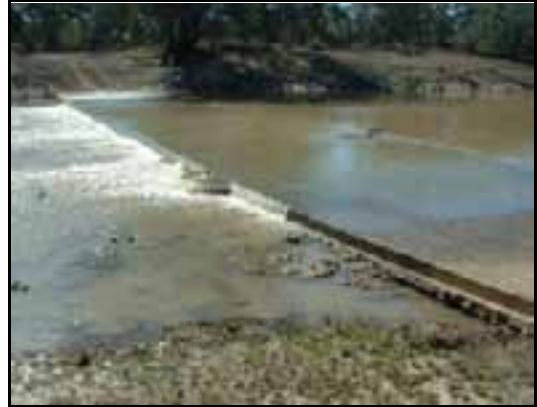
**Plate 10:** Stoney Crossing (BE21)

The Stoney Crossing (Plate 10) Causeway is located in the lower end of the catchment on the Namoi River, near the town of Pilliga. The structure is approximately 0.5m high and 30m in length and is built directly on the bed, slightly above the natural channel level. This construction has resulted in the causeway acting as a barrier to fish passage due to the excessive headloss of approximately 0.5m, as well as the associated increase in velocities over the crossing.

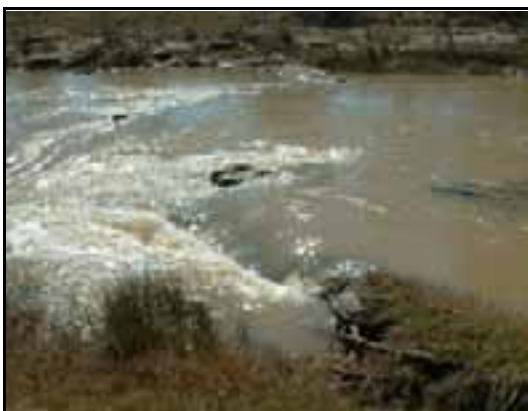
**Plate 11:** Bugilbone water gauge (WGS4)

The Bugilbone gauging structure (Plate 11) is situated on the Namoi River in the lower end of the catchment. The structure is constructed of both natural bedrock and concrete, and is approximately 15m in length across the channel. The concrete section of this structure is approximately 0.5m high and 1.5m in length. However, it is located directly in the low-flow channel of the system, creating a barrier to fish passage due to excessive headloss and increased turbulence, especially in the low-flow channel of the waterway.

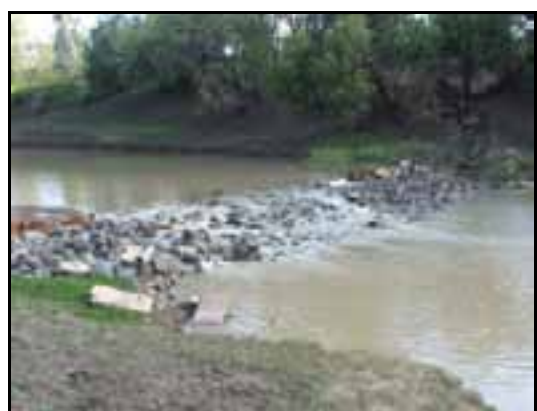
**Plate 12:** Walgett Weir (419/970000/B0068)

The Walgett Shire Council Weir (Plate 12) is located in the lower end of the Namoi catchment on the Namoi River, just within the town limits of Walgett. The weir is located 4km upstream of the Namoi River and Barwon River junction, and is approximately 1.8m in height and 30m across the length of the crest. Walgett Shire Council Weir is a fixed crest structure with no regulating infrastructure associated with it and is used for town water supply. The weir acts as a barrier to fish passage during flows less than approximately 1500 ML/day, with flows below this resulting in excessive headloss, as well as increased turbulence and velocity across the face of the structure.

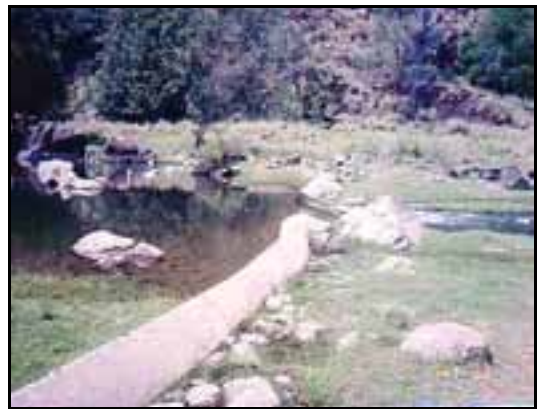
**Plate 30:** Manilla River gauge (WGS6)

The Manilla River gauging structure (Plate 30) is located immediately downstream of Split Rock Dam between the towns of Manilla and Barraba in the Tamworth Regional LGA. The fixed crest structure is constructed of concrete and is approximately 0.5m high and 30m long. The structure acts as a barrier to fish passage due to excessive headloss, as well as increased turbulence and velocity across the face of the structure.

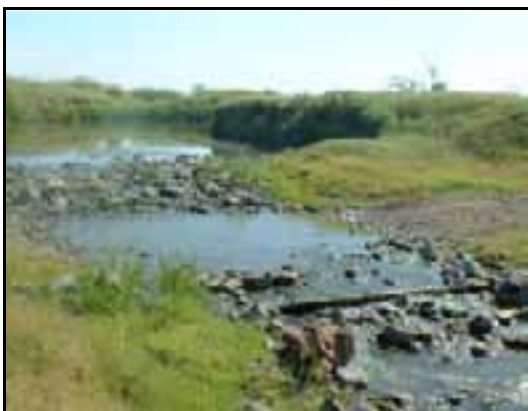
**Plate 31:** Mooki River Ford (MI10)

This private road crossing (Plate 31) is located on the Mooki River and is situated in the lower section of the catchment near the town of Breeza. The crossing is approximately 0.2m high and 5m long and uses natural river rock as its base, however the structure also incorporates the use of large rocks on both the upstream and downstream side of the crossing to pool water upstream. This aspect of the crossing has resulted in excessive headloss of approximately 0.2m, impacting on fish passage at this site.

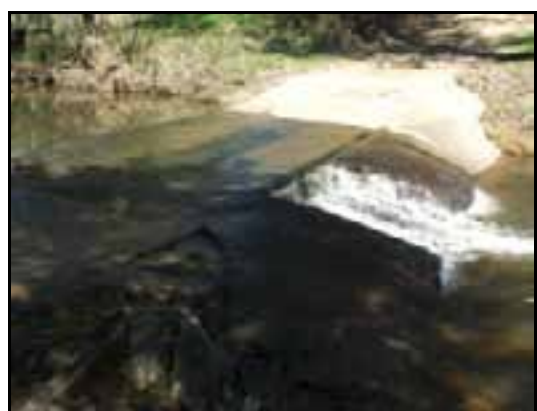
**Plate 32:** Ingalba Flat Causeway (CR56)

The concrete causeway (Plate 32) is located on Swamp Oak Creek, a major tributary of the Cockburn River, in the upper section of the catchment near the town of Weabonga. The crossing is approximately 1m in height and 12m long, with no associated low-flow infrastructure and the downstream side of the causeway experiencing erosion effects from high flows. The presence of the instream crossing significantly impacts on fish passage due to excessive headloss, as well as an associated increase in turbulence across the face of the structure.

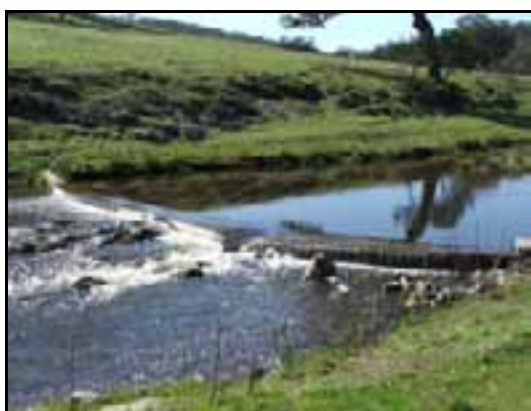
**Plate 33:** Swamp Oak Creek water gauge (WGS7)

This water gauge (Plate 33) is located on Swamp Oak Creek, a major tributary of the Cockburn River, in the middle section of the Namoi Catchment near the town of Limbri. The instream barrier is a fixed v-notch weir structure that is constructed of concrete and is approximately 0.5m in height and 22m across the length of the crest. The structure acts as a barrier to fish passage during low flows, restricting fish passage due to excessive headloss, as well as increased velocity and turbulence through the vertical flume.
