# Electrical Incident Report

## Spread the Safety Message

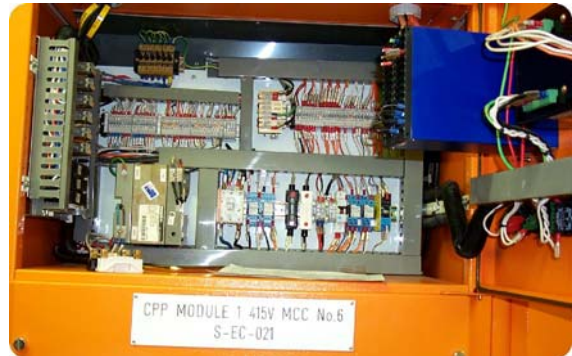
A contract electrician received an electric shock while working in a distribution board.

He thought the cubicle was isolated but had overlooked a back feed to a control wire.

- 1 Two contract electricians were working on the main distribution board in a washery substation.
- 2 The board has two supplies and is separated by a bus tie circuit breaker.
- 3 A JSA had been performed for carrying out work on No 1 side of the board.
- 4 It was decided by the men that some additional work would be carried out on No 2 side.
- 5 One of the electricians noted that No 2 supply was off and locked, so began working in the one of the cubicles.
- 6 He grabbed a spade lug on a control wire to straiten it before putting it into a relay terminal.
- 7 The spade lug was live at 240V, being fed from an alternate source from the other side of the bus tie.

- ✓ **TEST BEFORE TOUCH.**
- ✓ If the scope of work changes, check that the JSA is still relevant.
- ✓ Electrical isolation **MUST** include checking for live conductors.
- ✓ Best practice is to use two forms to prove that a circuit is de-energised.
  1. A Fit for Purpose meter (e.g/ Cat III multimeter or better.)  
Make sure it is working.  
Test the conductors you are going to touch.
  2. A non contact tester.  
Test before and after use.  
Test generally all locations in the work area.
- ✓ **MAKE SURE YOU HAVE YOUR TEST EQUIPMENT WITH YOU**
- ✓ In addition, consideration must be given to the possibility that conductors may become live during the course of the job.
