Tilligerry Creek Floodgate Assessment

Report to the Hunter-Central Rivers
Catchment Management Authority

Project number HCR07_106

January 2009

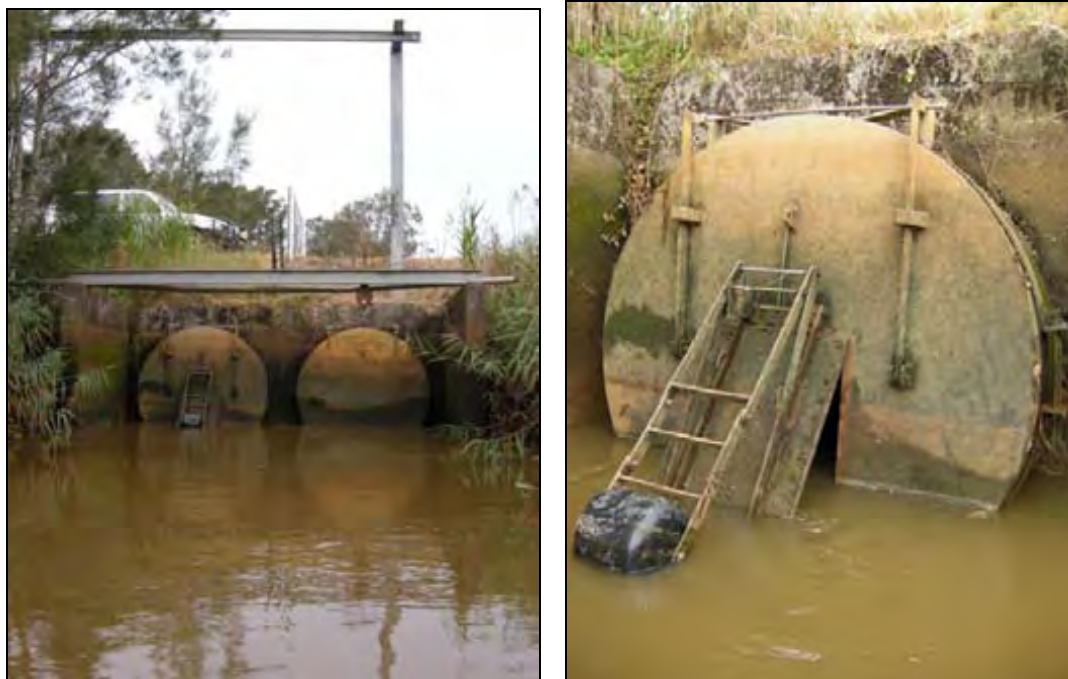
Figures 4 & 5 Auto-tidal floodgate on Windeyers Creek (Raymond Terrace) similar to the recommended management recommendation for Tilligerry Creek floodgates.

Auto-tidal floodgates (Figures 4 & 5) are commonly used to treat environmental problems on floodplains such as poor water quality, acid sulfate soils and fish passage barriers. Many projects on the NSW North Coast have demonstrated marked improvements in water quality following the installation of auto-tidal floodgates on systems similar to Tilligerry Creek.

A tidal floodgate remains open during low flows, and closes automatically when water levels reach a pre-set height (i.e. floods or king tides). The tidal gate also maintains the flood mitigation capacity of the floodgate, keeping flood waters from inundating the farms on the floodplain.

It is recommended that the maximum level of tidal water permitted to enter the drain through the auto-tidal floodgate is 0m AHD (i.e. mean sea level or medium level tide). This would allow the rising tide to enter the drain up to 0m AHD, at which level the auto-tidal gate would shut to exclude high and king tides and floodwaters.

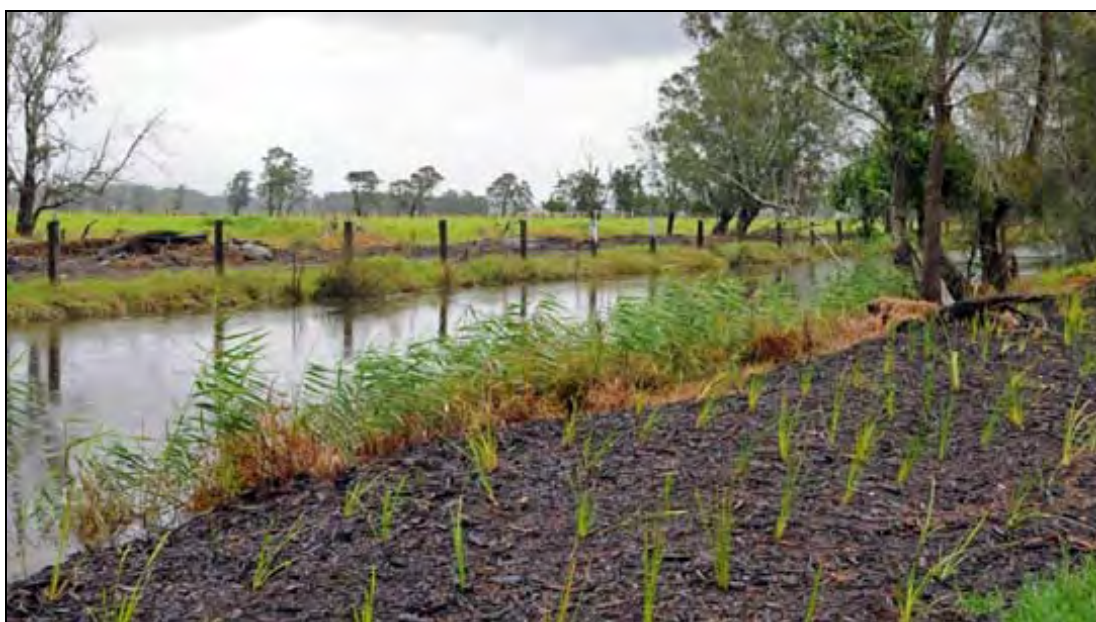
In response to this problem, in 2007 Port Stephens Council upgraded all failing septic tanks (Earth tech Engineering, 2007). More recently the Council has administered small grants to landholders for riparian rehabilitation projects, including fencing and revegetation (Figure 8). As the riparian zone establishes it will become a filter for runoff, capturing nutrients and preventing bank erosion and waterway sedimentation.

Figure 8 Tilligerry Creek fencing and revegetation site

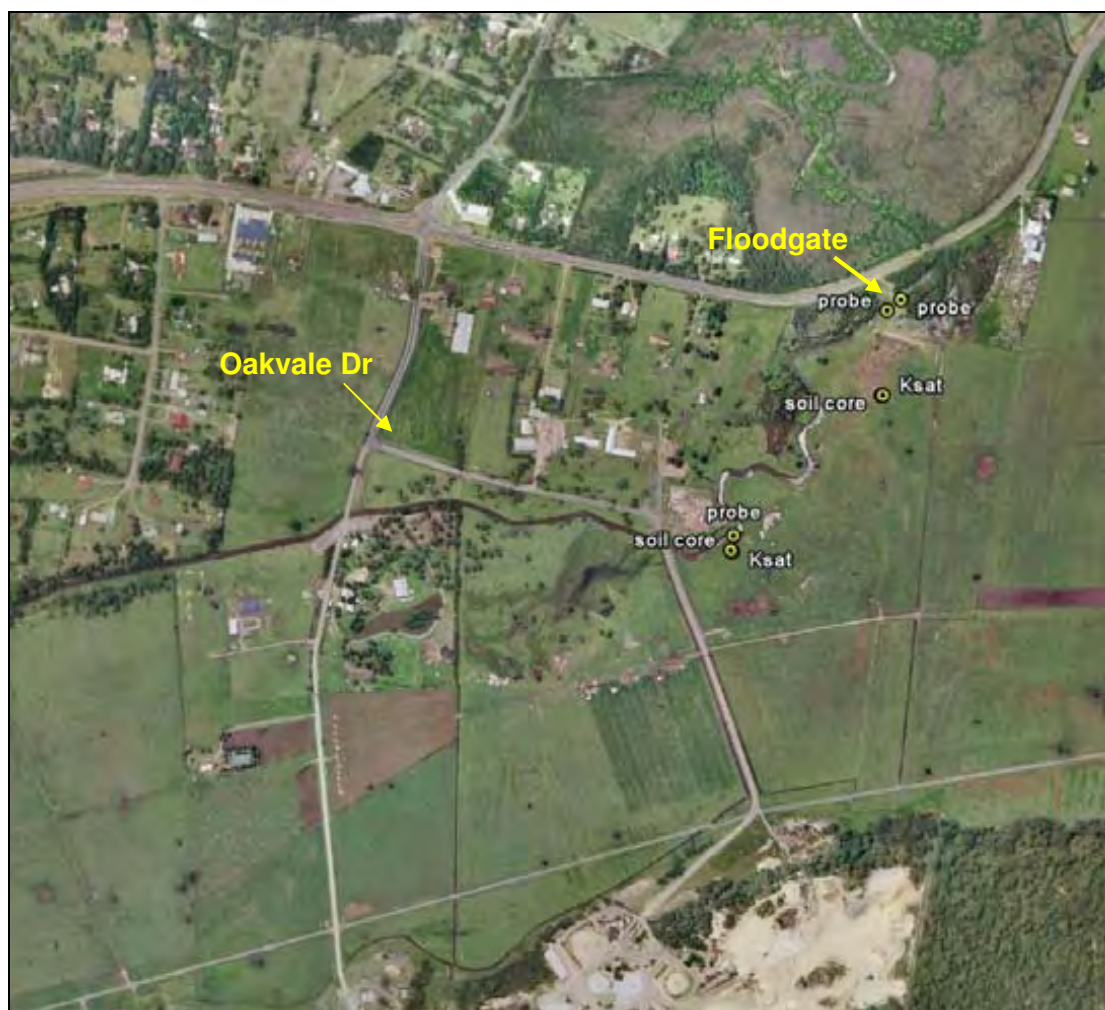
Figure 9 Locations of site assessments at the Tilligerry Creek floodgates (Imagery: Google Earth)

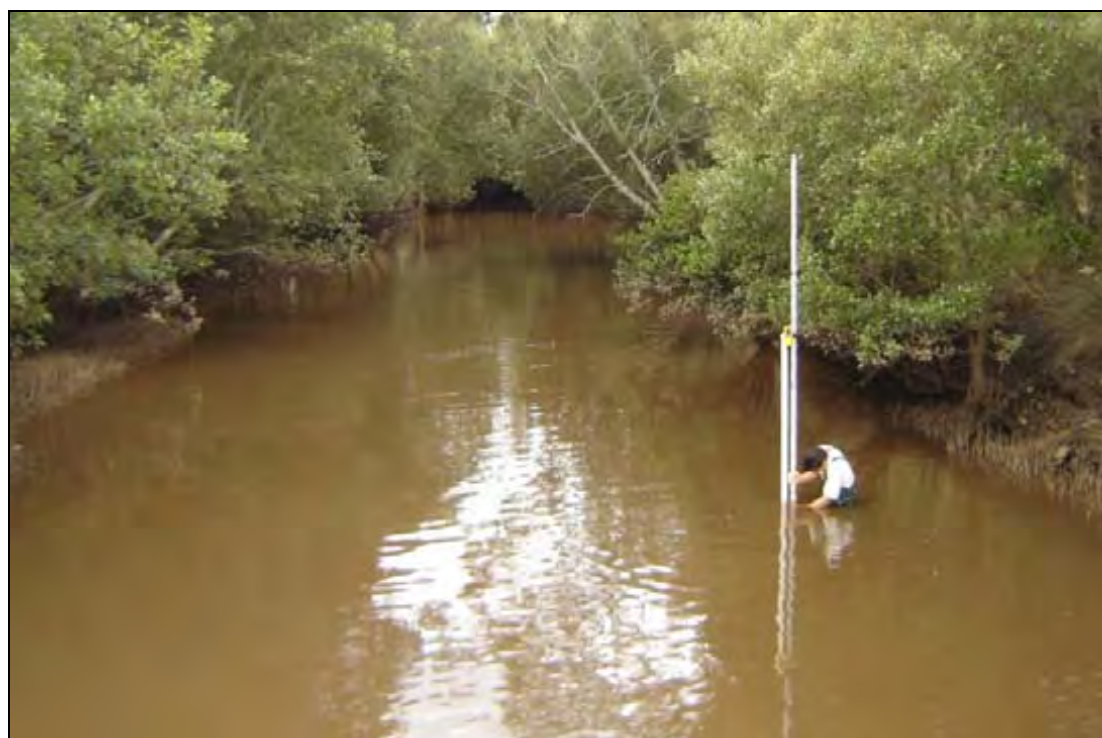
Three Odyssey capacitance water levels probes were deployed in Tilligerry Creek from 13th August - 22nd September 2008 and 24th October - 26th November 2008. The probes were located immediately upstream and downstream of the floodgates and one approximately 0.6km upstream adjacent to the lowest point of land (Figure 10). Loggers were surveyed to enable interpretation of results in relation to AHD.

The second installation was necessary due to failure of the downstream probe to record during the initial deployment. A new probe was used for the second deployment.

Figure 10 Water level probes were deployed upstream and downstream of the floodgates to record changes in water level with tide.

Figure 12 shows the tidal variations recorded by all three in-stream probes. At high tide both the upstream and low point recorders appear to show tidal influence. While the floodgates allow some leaking, this is not significant and does not reach the low point. The fluctuations in water levels observed for the upstream and low point probes occurs while the gates are forced shut during the in-coming tides. During this time, water backs up in the drain at least as far as the low point until the out-going tide allows the gates to open and the system discharges.

Immediately downstream of the floodgates, the highest tide reached 1.041m AHD and a minimum of -0.782m AHD. The highest water levels measured upstream of the gates were much less than downstream. Immediately upstream of the gates recorded a maximum of -0.054 m AHD and the low point reaching -0.082 m AHD. The lowest water levels were similar at these locations to the downstream water level, with upstream recording -0.719m AHD and the low point recording -0.752m AHD. Water levels downstream of the gates were observed overtopping the floodgate headwall during a high tide but not the levy between upstream and downstream.
