Report produced for Department of Primary Industries and Regional Development - Fisheries

Brunswick River Estuary NEAP Bank Erosion and Riparian Condition Assessment Report

18 November 2024

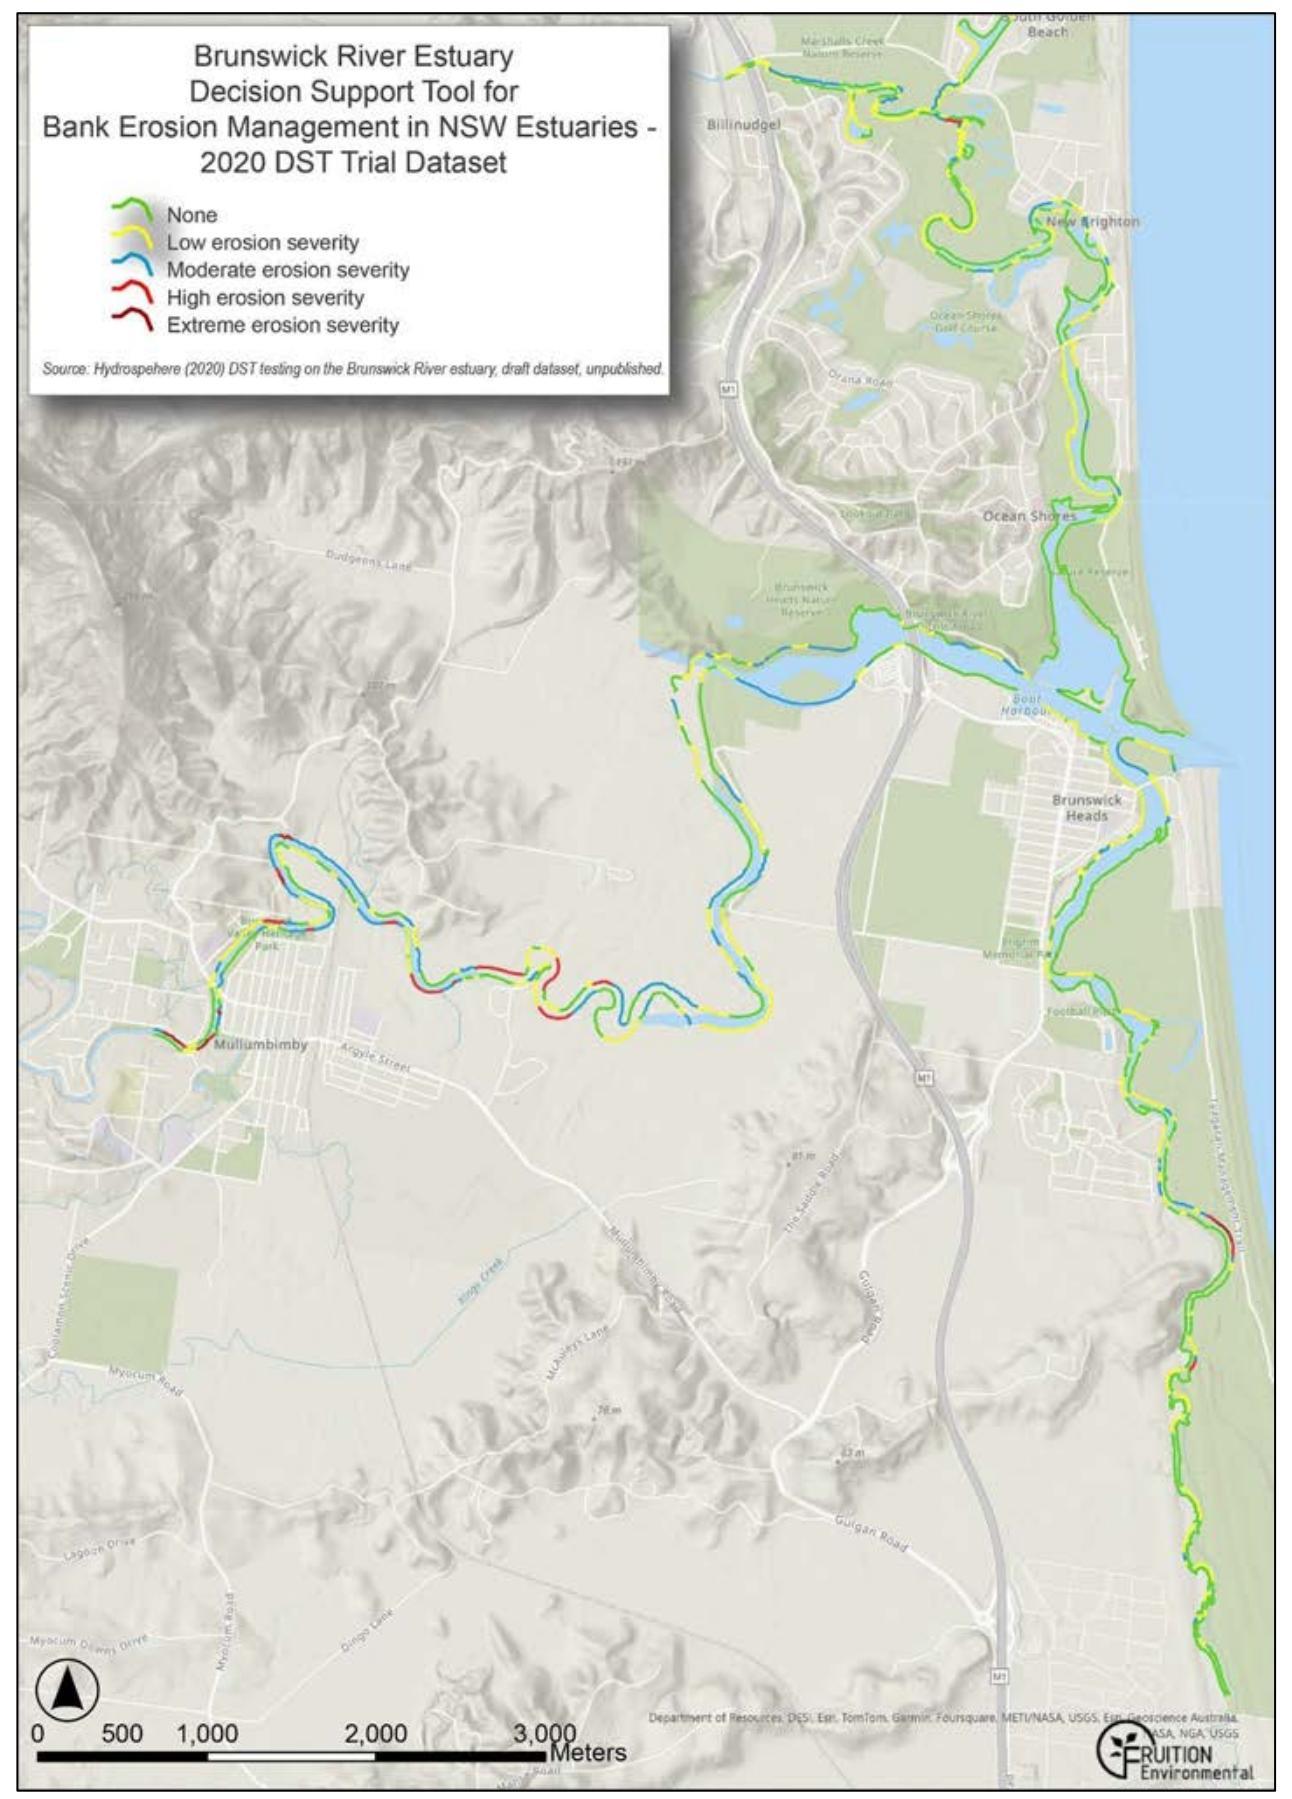
Figure 8 shows the erosion severity attributed to each survey segment in 2020.

Figure 8 Draft mapping of bank erosion severity in 2020 undertaken by Hydrosphere Consulting during field validation of the MEMS funded DST for estuary bank erosion management project (Data source: Hydrosphere, 2020, unpublished data provided by NSW DPIRD Fisheries).

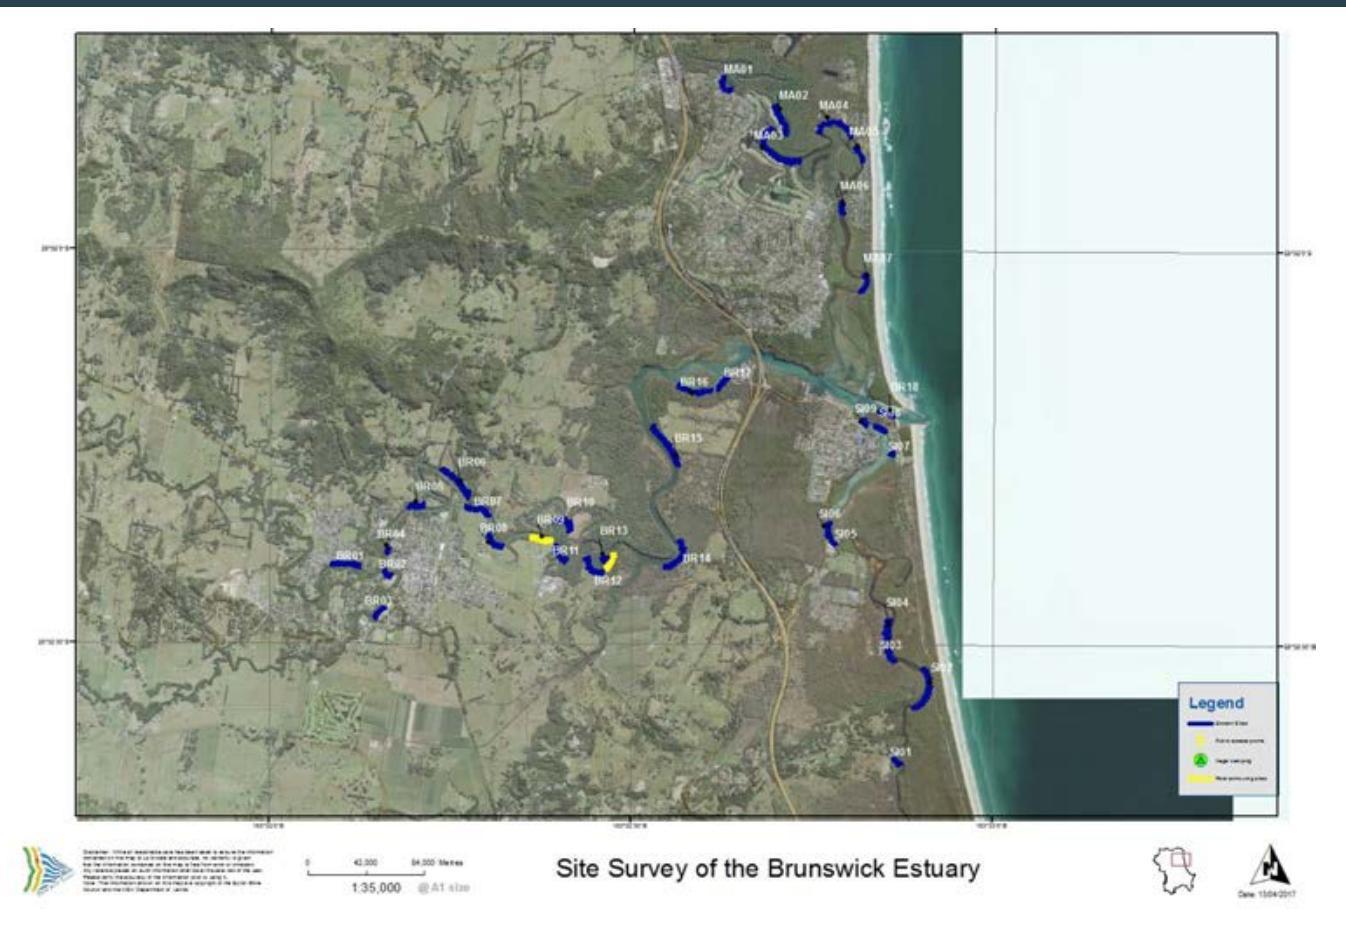
Figure 9 Locations of bank erosion (blue) and rock revetment (yellow) identified in the CZMP site survey and audit update in February 2017 (Source: BSC, 2018).

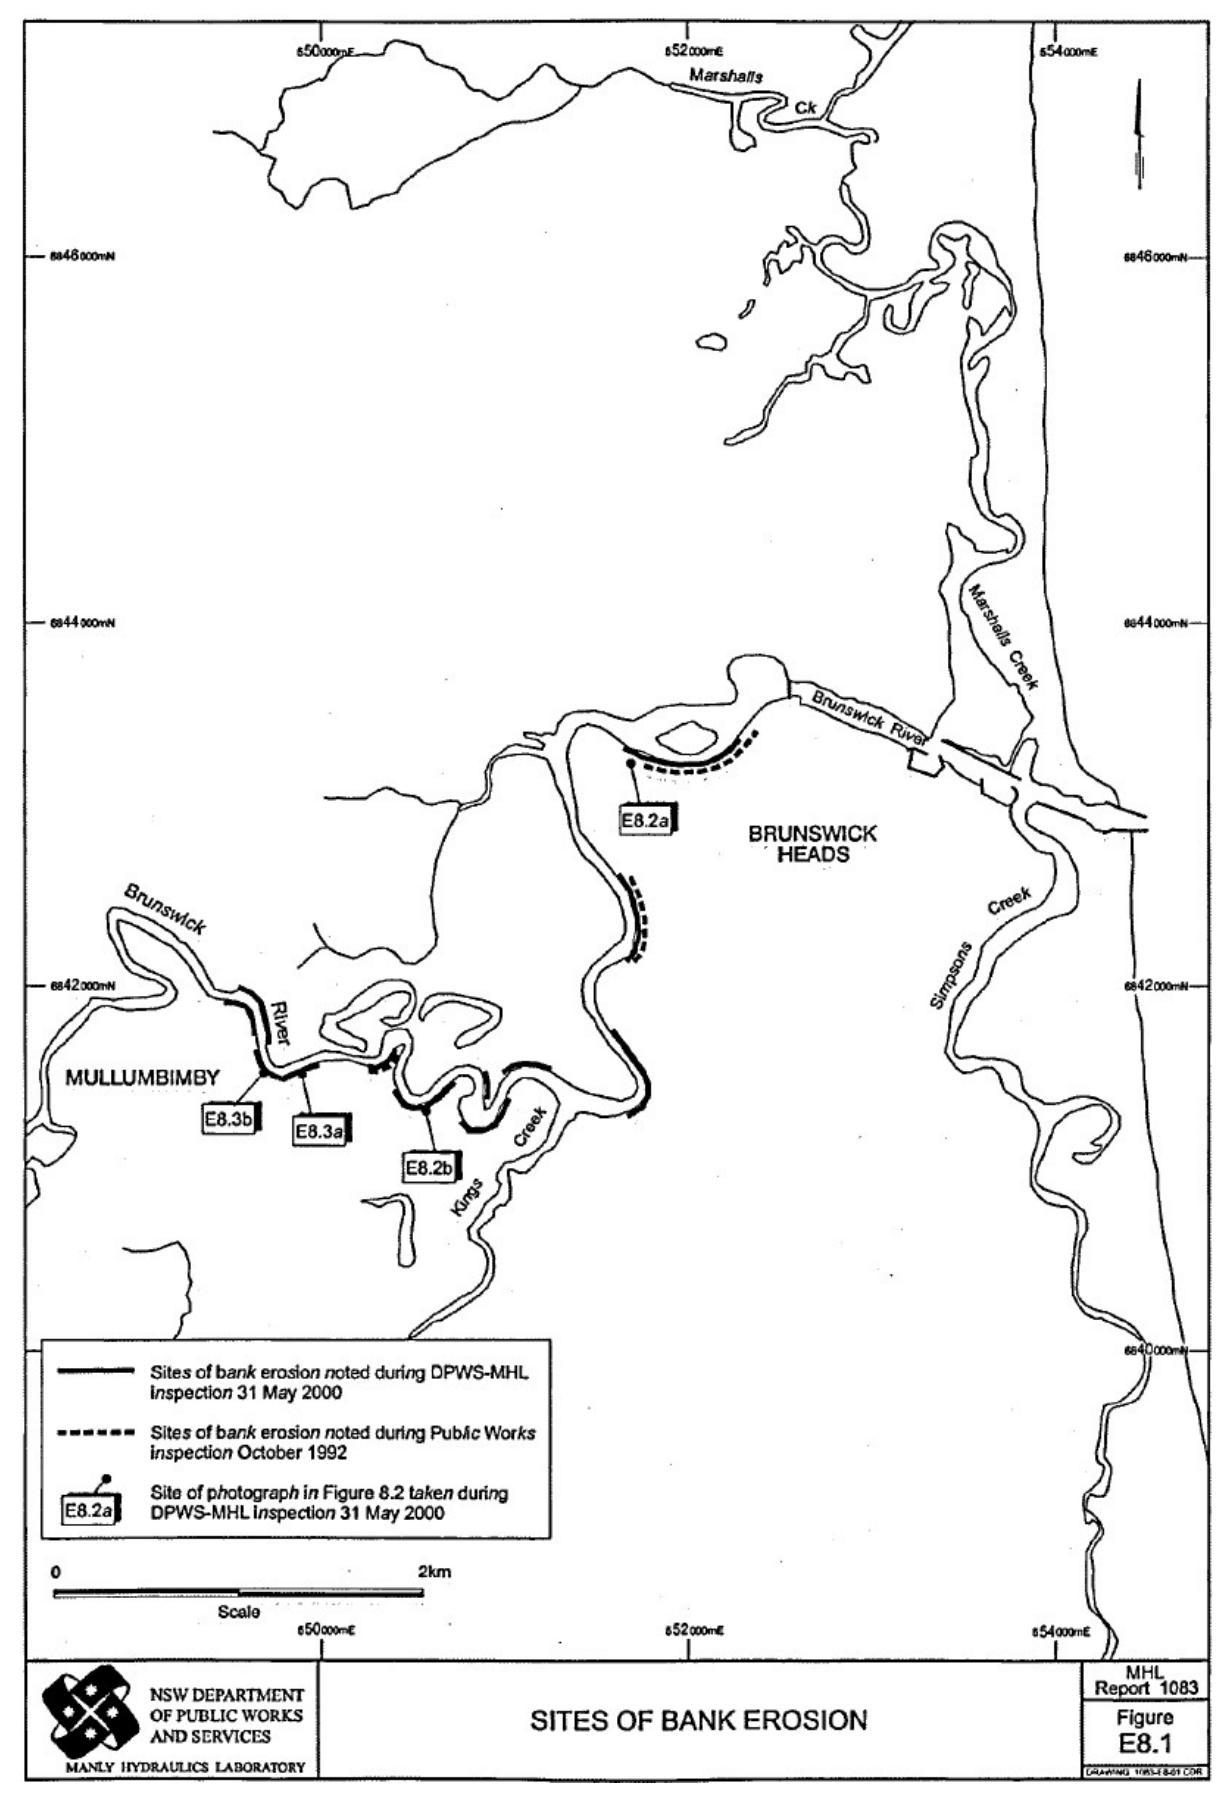
Figure 10 Sites of bank erosion recorded during the MHL bank erosion assessment (2000) and previous Public Works (1992) assessments (Source: MHL, 2002a).

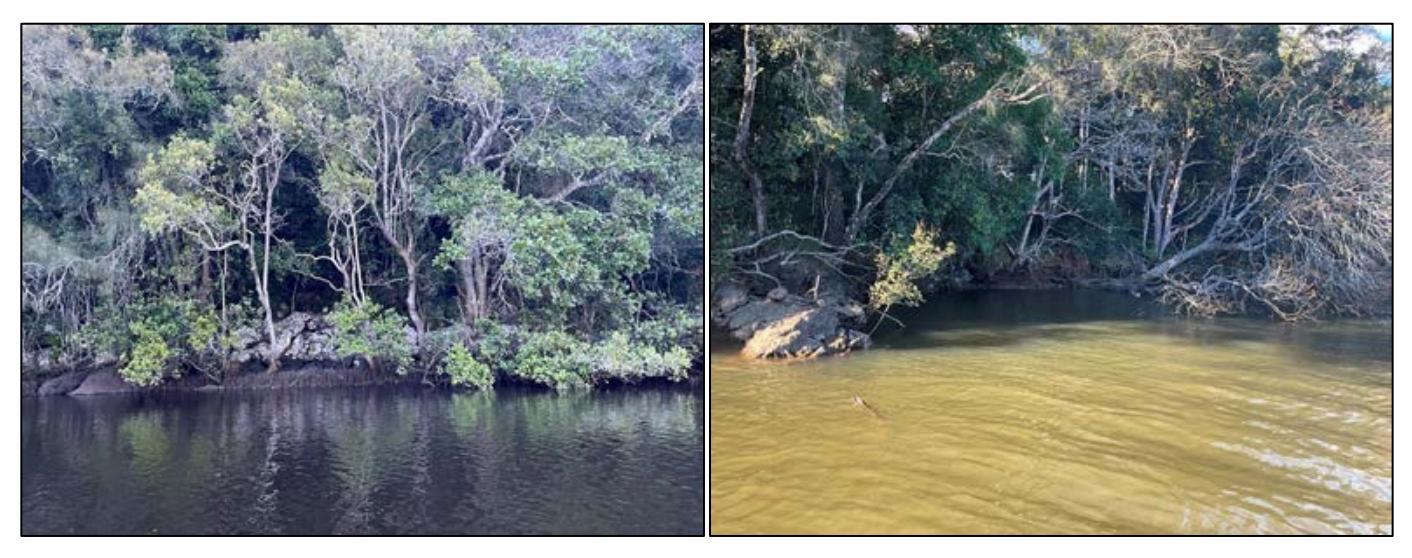
Plate 2 Bedrock outcropping is common in the Fluvial Dominated Process Zone in both Simpsons Creek (left) and the Brunswick River estuaries (right).

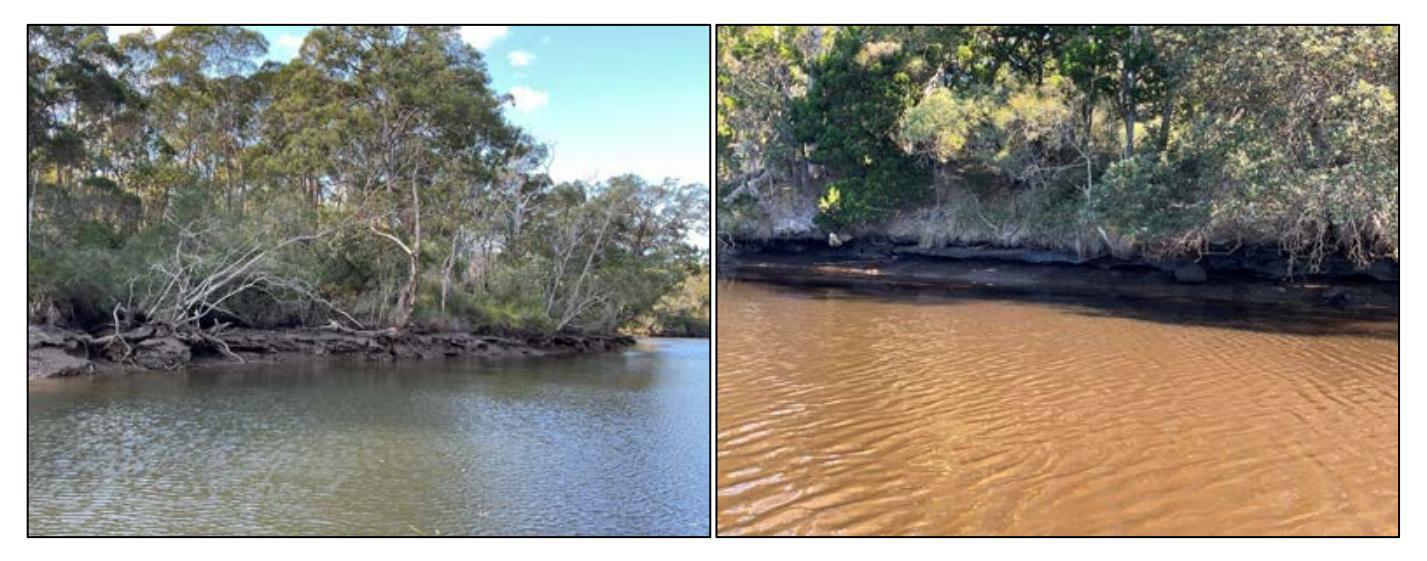
Plate 4Coffee rock (cemented indurated sands) occurs at isolated locations in the Fluvial Transition ProcessZone in both the Brunswick River (left) and the Simpsons Creek estuaries (right).

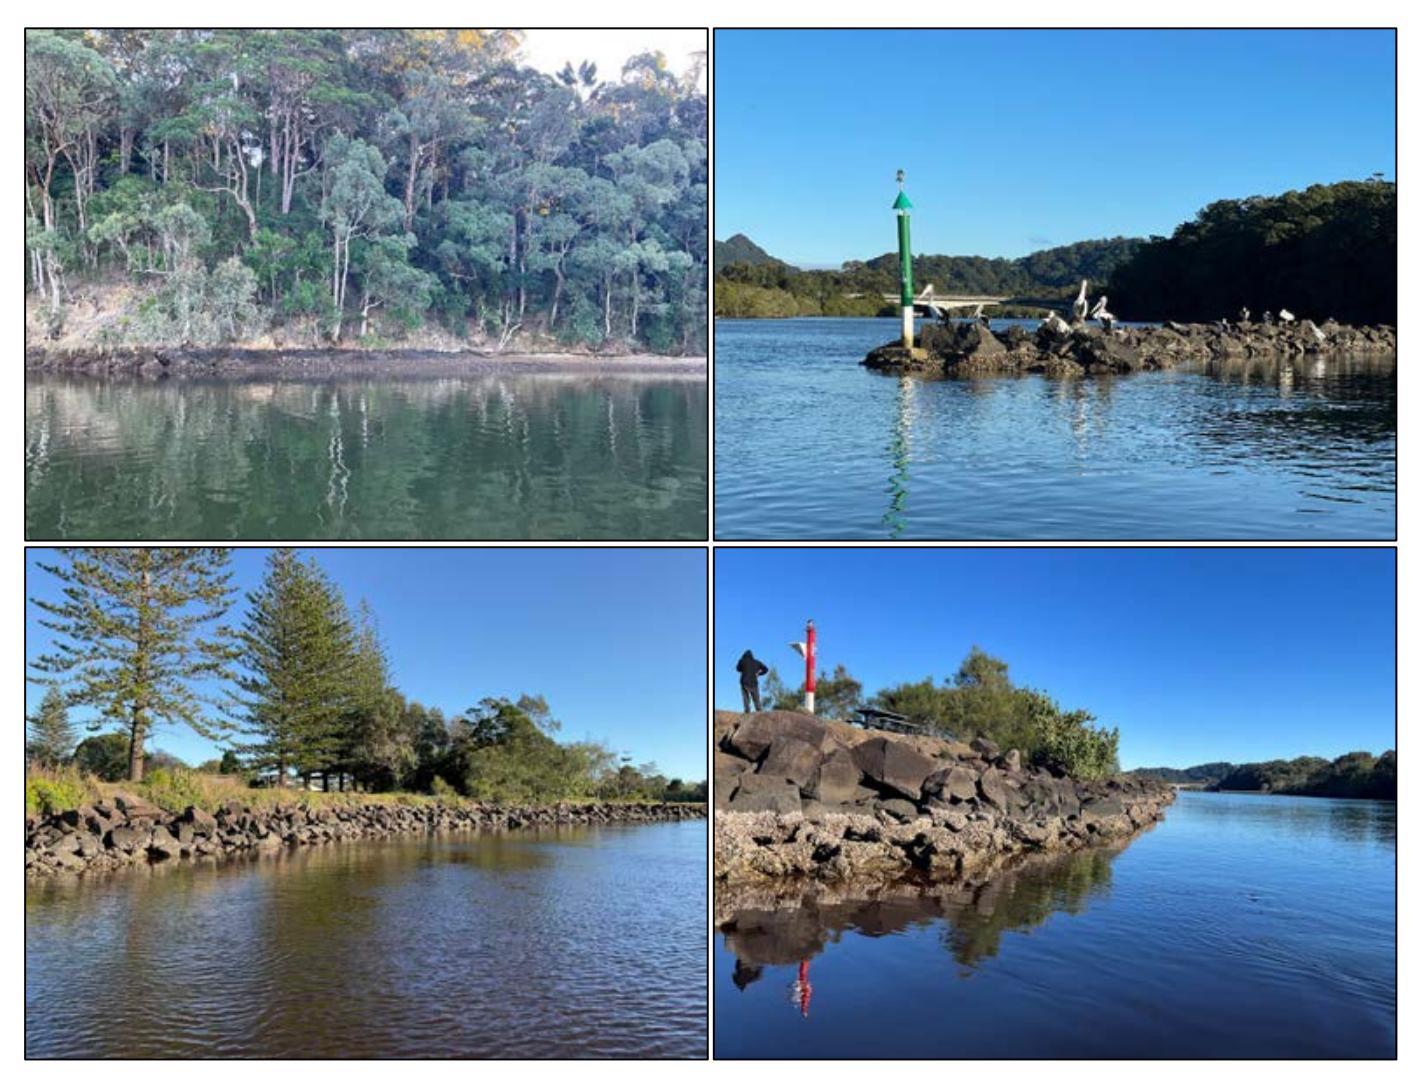
Contemporary erosion processes are predominantly current scour associated with tidal flows, scour associated with episodic floods, and wind and boat wave erosion which are somewhat tempered by the extensive bank protection works and entrance training works found throughout this zone (*Plate 6*).

Plate 6Bedrock outcropping and extensive bank protection works, entrance training walls and seawalls occur
in the Marine Tidal Delta Process Zone. For example, clockwise from top left: bedrock on the northern
bank of the lower Brunswick River adjacent to the Brunswick River Nature Reserve; entrance training
walls on lower Marshalls Creek, the lower Brunswick River, and lower Simpsons Creek.

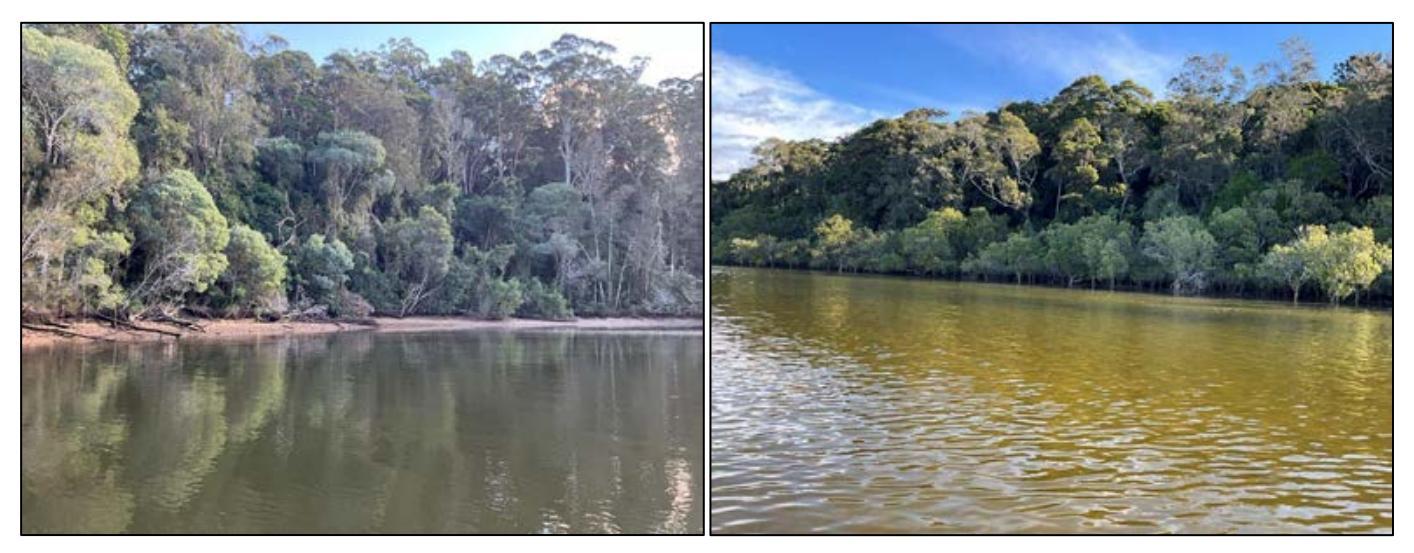
Plate 11 Examples of very good condition riparian vegetation: From left to right, Brunswick River Reach 5; Marshalls Creek Reach 344.

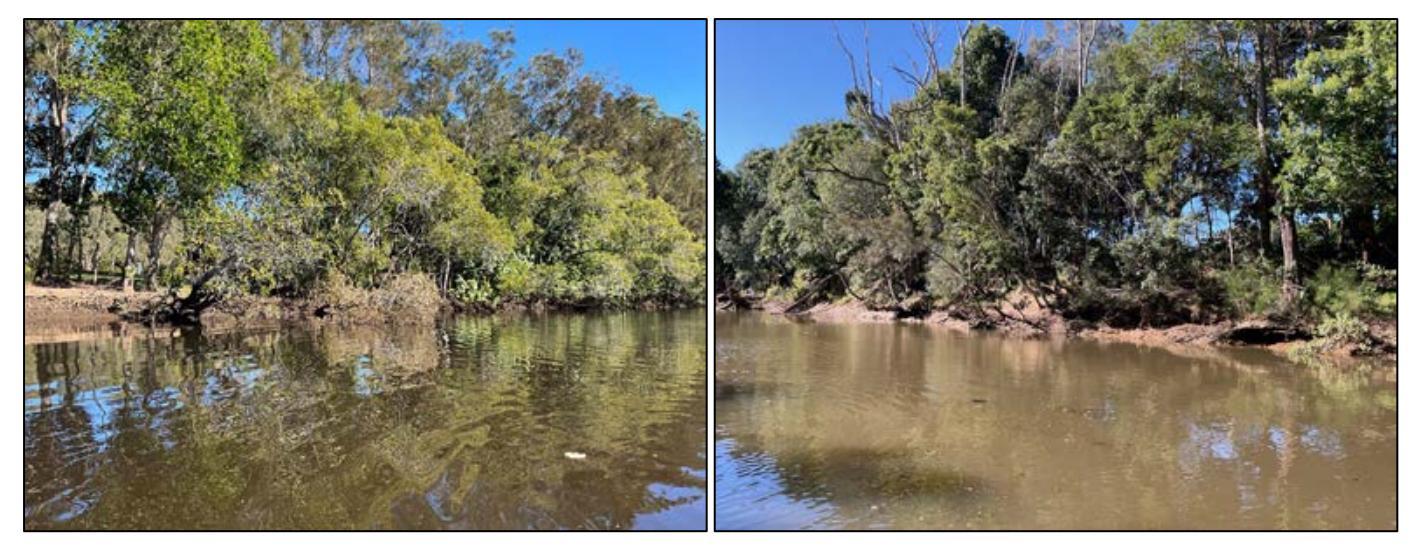
Plate 12 Examples of good condition riparian vegetation: Left to right, Marshalls Creek Reach 299, Brunswick River Reach 199.

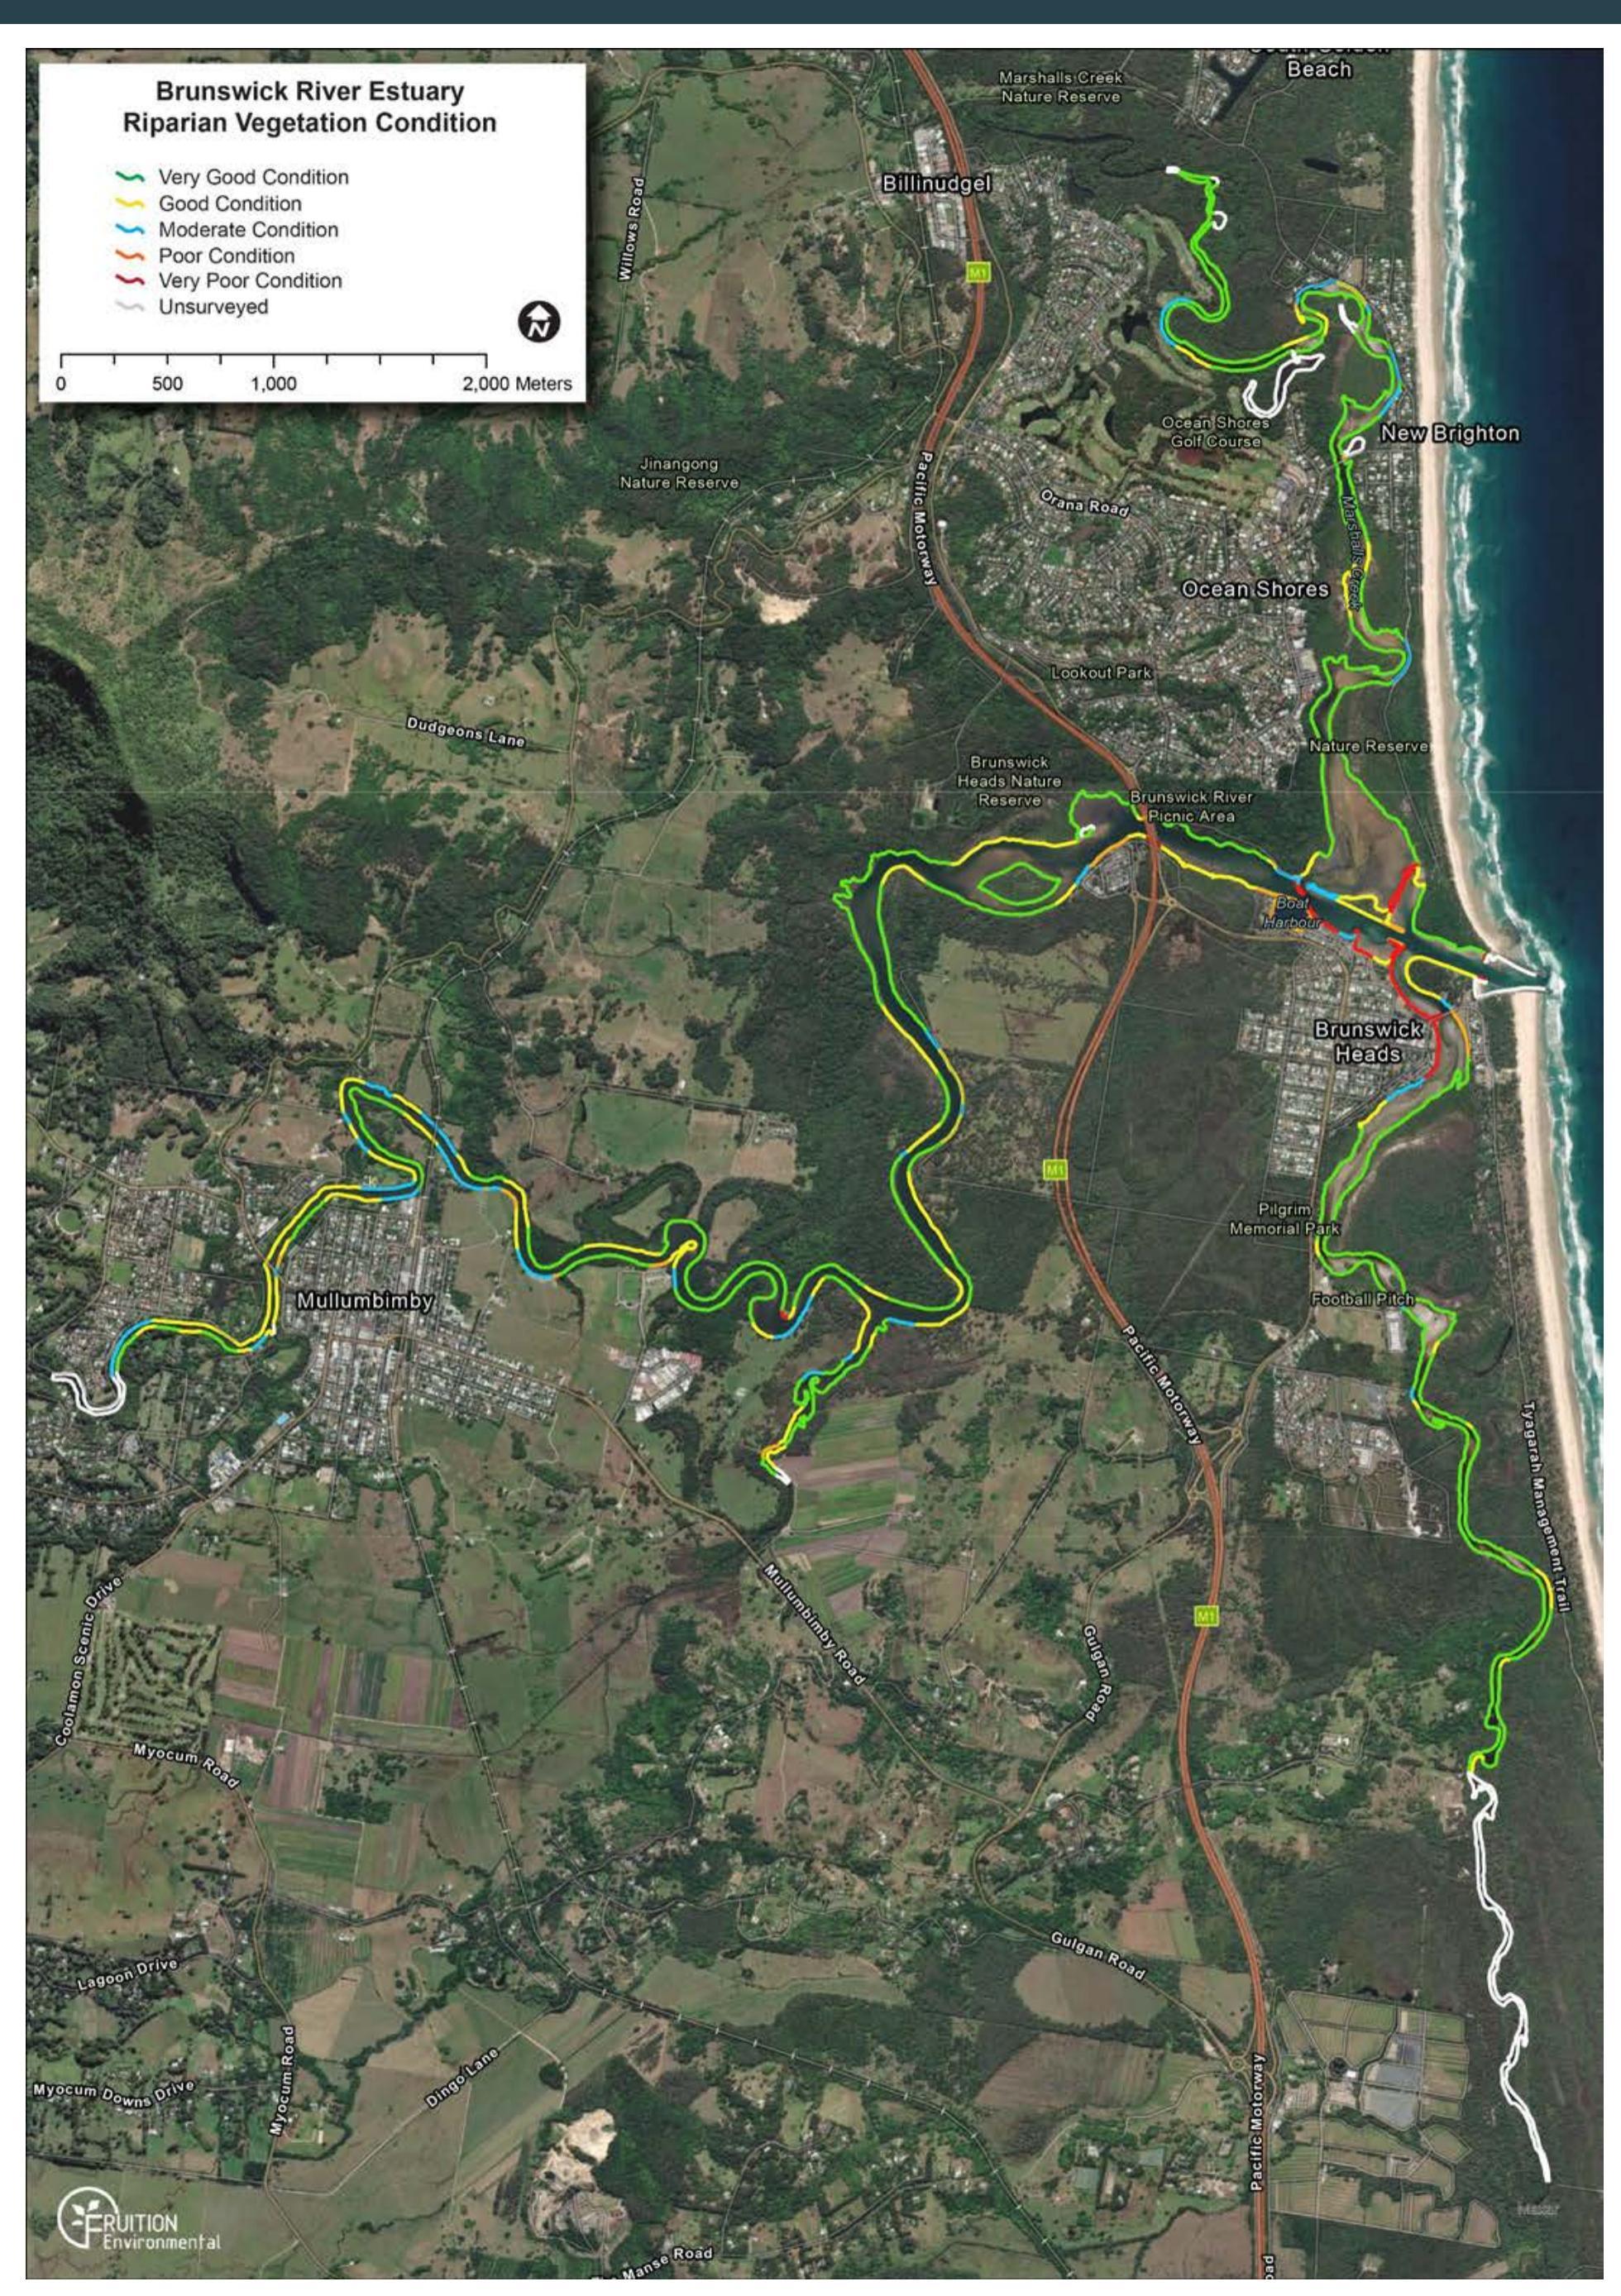
Figure 17 Distribution of riparian vegetation condition across the Brunswick River Estuary Study Area

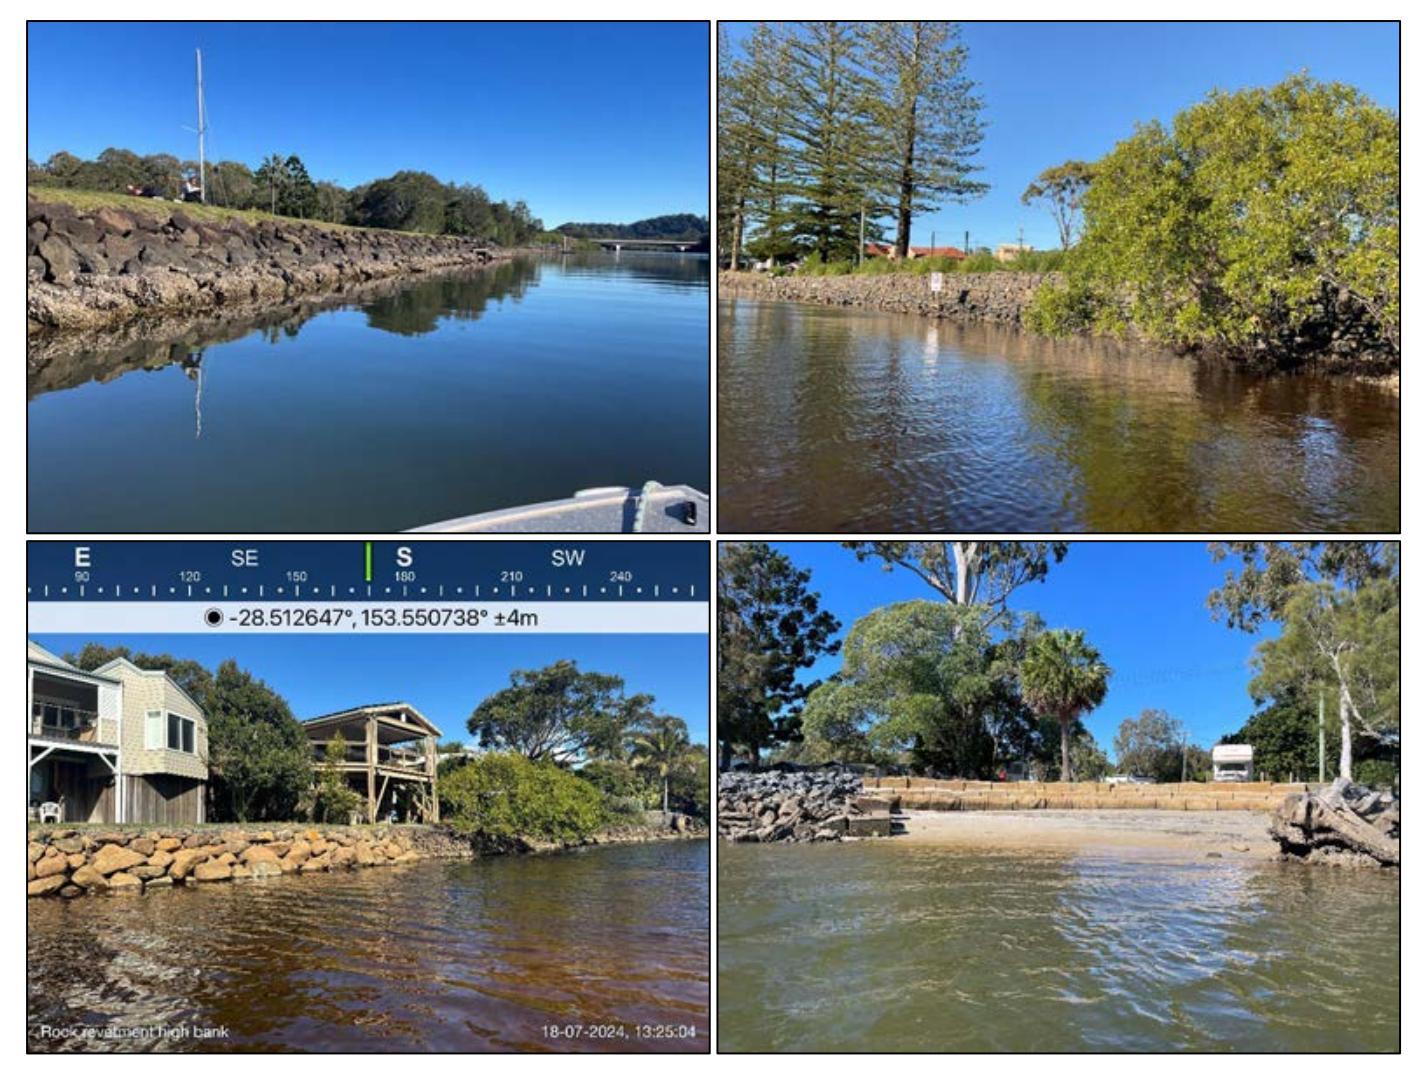
Plate 17 Examples of effective bank protection works in the Brunswick River estuary, clockwise from top left: rock revetment in the lower Brunswick; Rock armouring in lower Simpsons Creek; rock armouring and sandstone blocks on the lower Brunswick River at Reach 118; rock armouring on Marshalls Creek Reach 355.

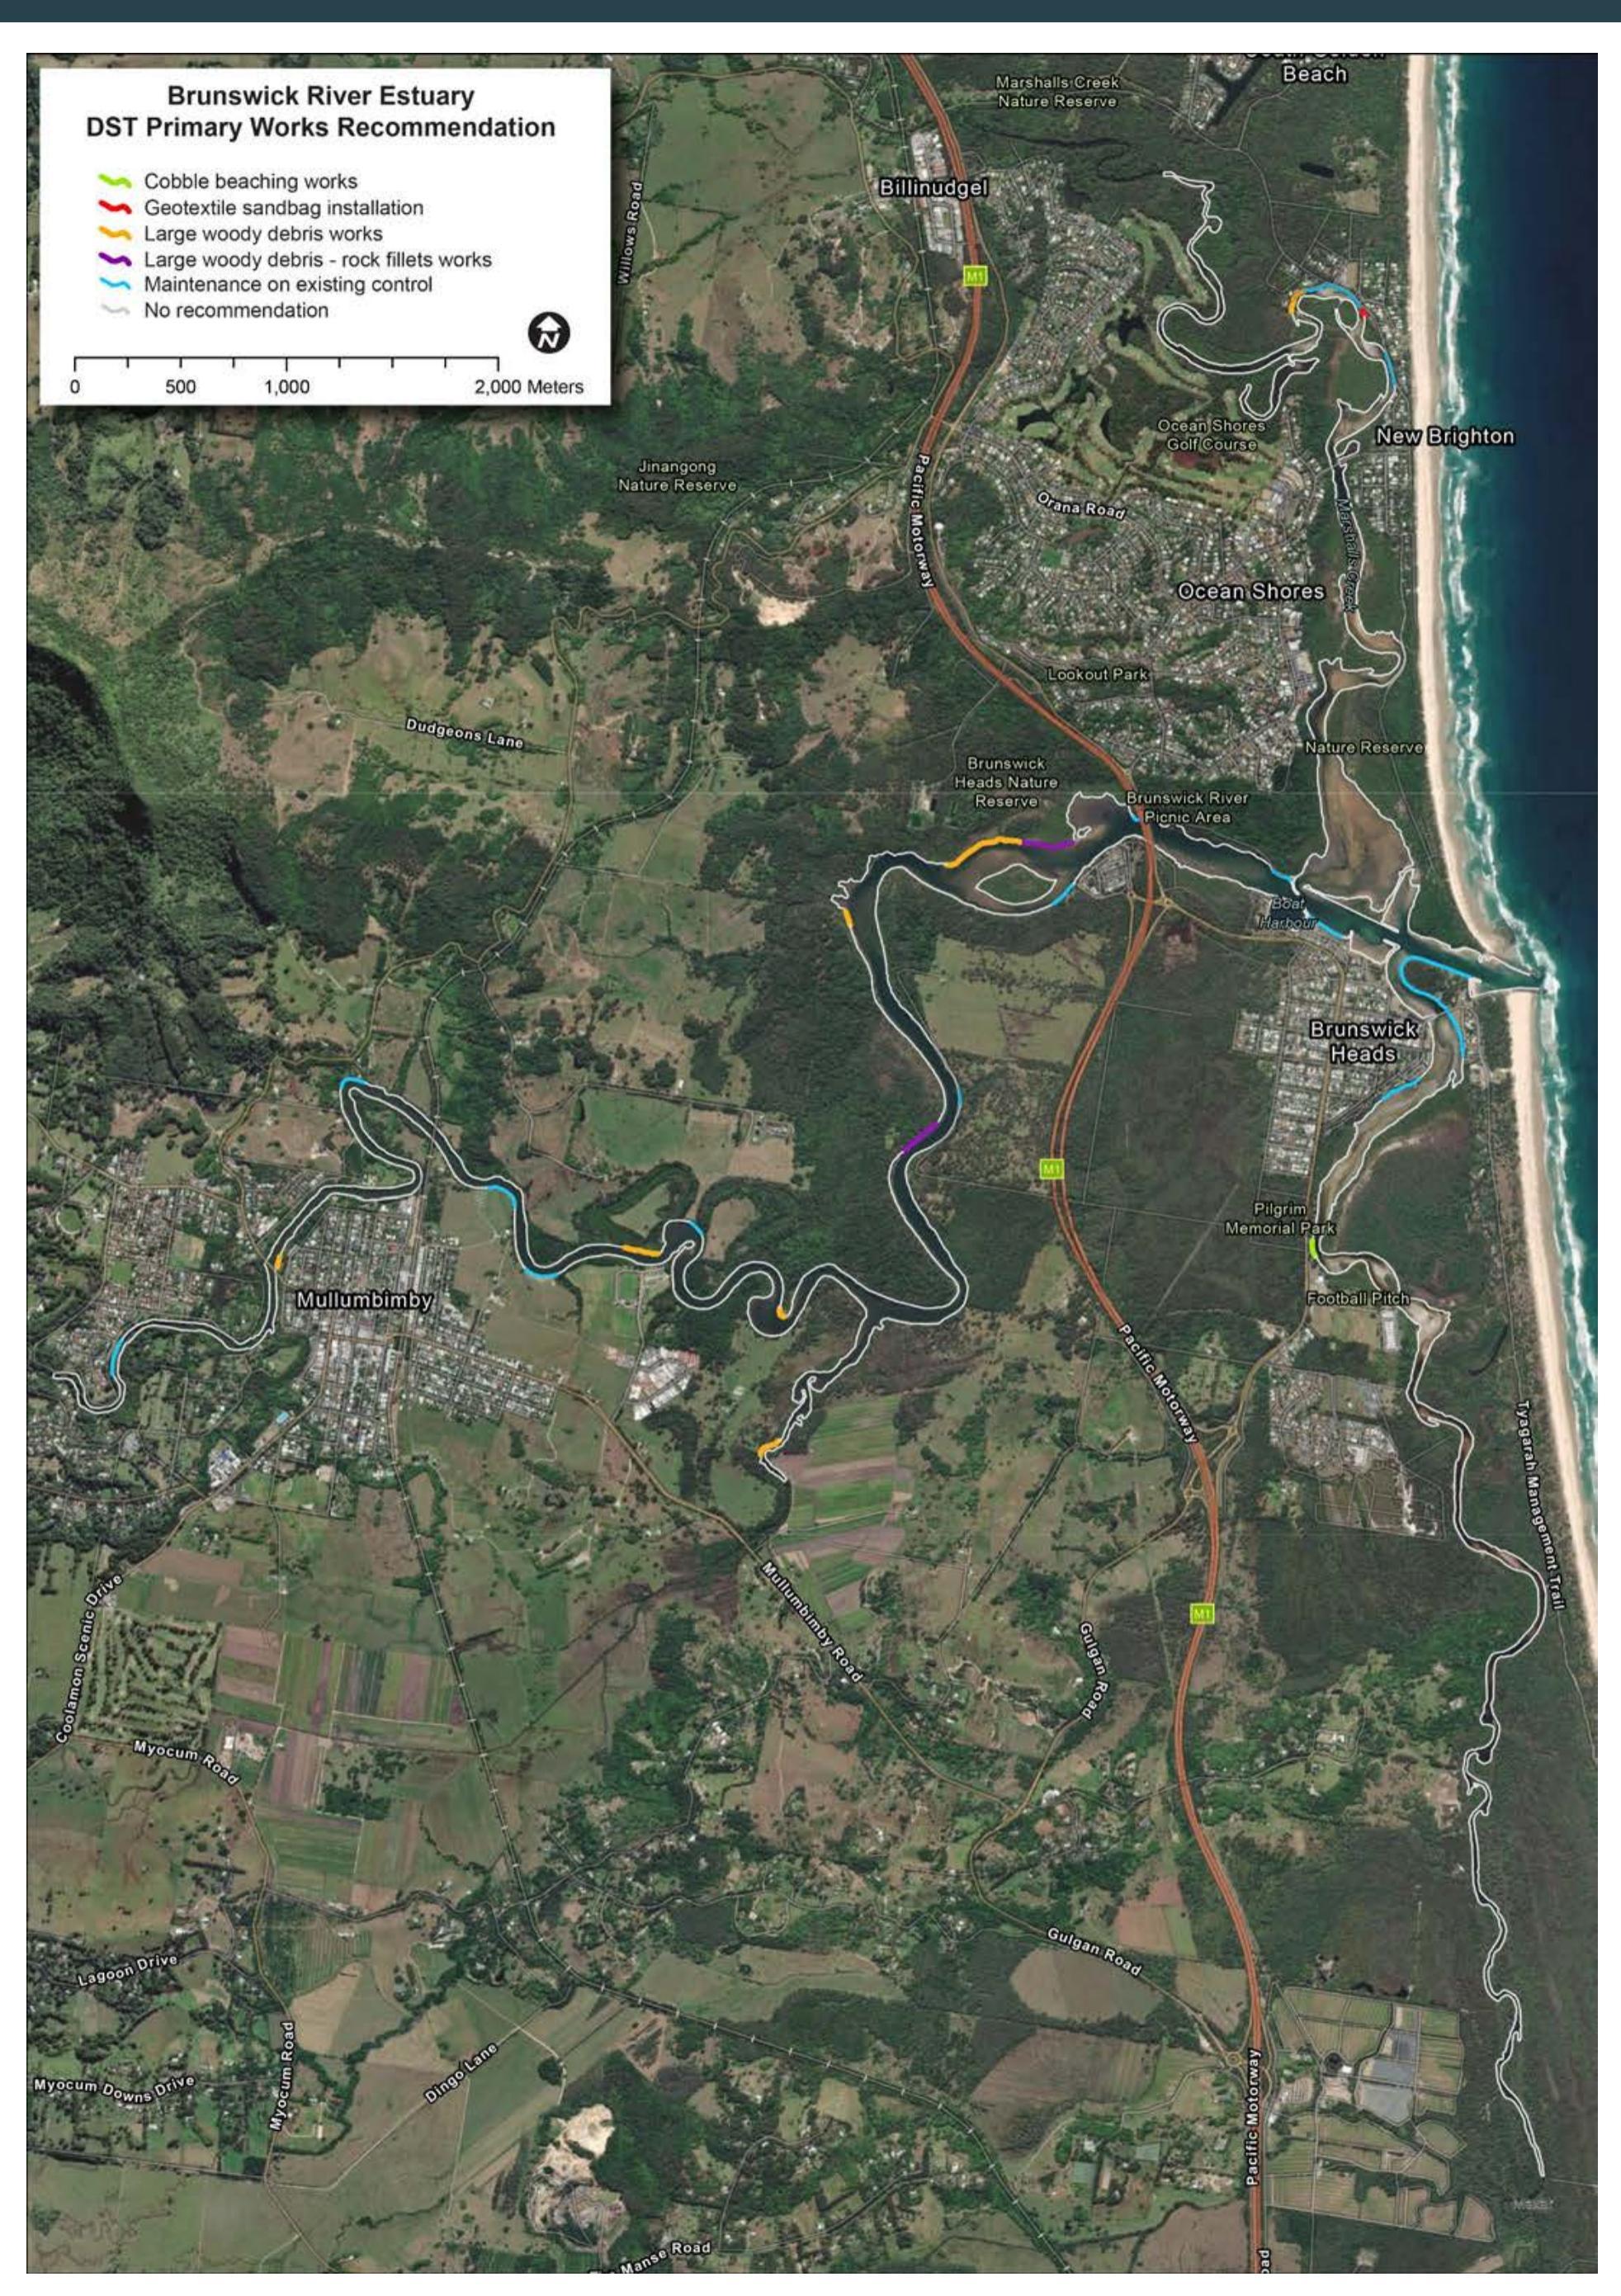
Figure 18 Distribution of DST Recommendations across the Brunswick River Estuary Study Area
