## **Case Study: Coral Avenue, Mullumbimby**

Adapted from NSW Department of Primary Industries (2005) *Reducing the impact of road crossings on aquatic habitat in coastal waterways – Northern Rivers, NSW*. Report to the Northern Rivers Catchment Management Authority. NSW Department of Primary Industries, Wollongbar, NSW.

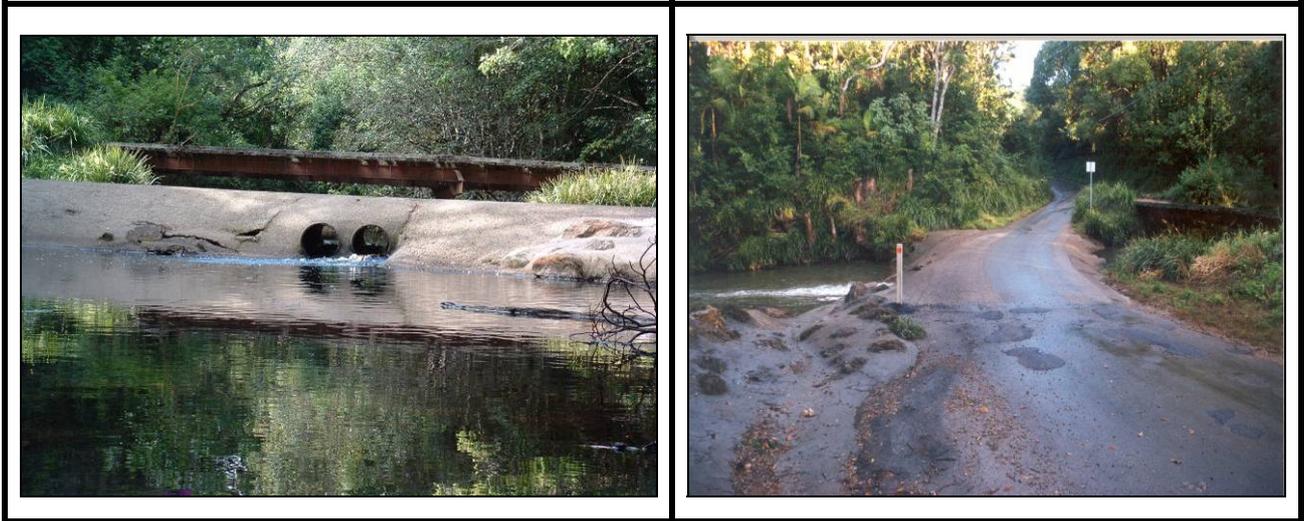
Coral Avenue crossing, which traverses the Brunswick River near Mullumbimby, was characterised by a piped causeway 19 m in length and 8 m wide with two low-flow pipes. The outlets of both low-flow pipes were raised above the bed of the waterway by approximately 800 mm, which prohibited fish from migrating upstream during low-flow conditions. During moderate to high flow events, excessive water velocity through the pipes further restricted fish passage until the structure drowned out. Prioritisation of road crossing barriers in the Northern Rivers CMA highlighted Coral Avenue as the top priority waterway structure for remediation due to the following factors:

On-ground works began in April 2005 with the removal of the dilapidated timber bridge located immediately upstream of the crossing, followed by works to prepare the road for realignment (e.g. tree lopping, adjustment of power lines). The Doolan Deck Bridge was to be positioned approximately 5 m upstream of the causeway, thus effectively maintaining vehicle access throughout the proposed works over the existing causeway. Footings for the new bridge were constructed during a three-week period in August, with the insertion of the single span bridge occurring a week later (**Plate a-b**). Two cranes were used to lift the prefabricated bridge deck into place, with works being completed over a four hour session. Following the construction of road approaches for the bridge which provided vehicle access across the waterway, the existing causeway barrier was removed.

Prior to removing the piped causeway, instream sediment control consisting of a floating silt boom was installed across the full width of the downstream channel. The causeway barrier was removed over a two-day period using an excavator fitted with a rock-hammer (**Plate c-d**). Spoil from the causeway was transported to the Council tip, with sediment fences being erected on the disturbed banks to limit bank erosion and sedimentation into the waterway. Road approaches either side of the crossing were sealed via bitumen, with rock scour protection inserted around the structure to assist in bank stability (**Plate e-f**). On-ground works were completed in 10 weeks, with revegetation of disturbed banks to occur the following Autumn (2006).
