Report produced for
Department of Primary Industries and
Regional Development - Fisheries

Bellinger-Kalang River Estuary NEAP Bank Erosion and Riparian Condition Assessment Report

20 December 2024

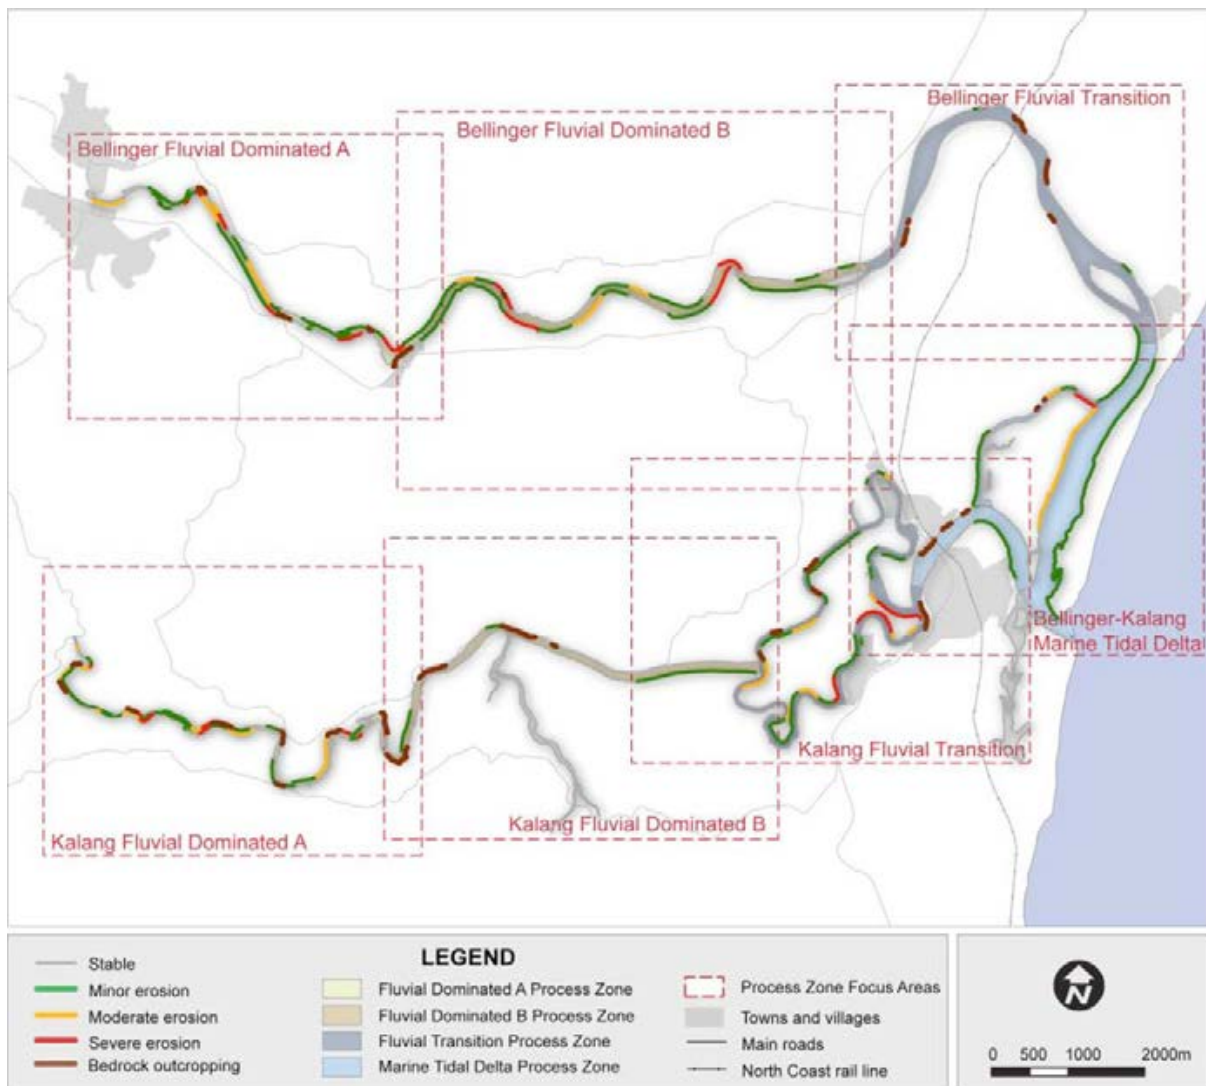
Figure 3 Bank erosion severity mapping in the Bellinger and Kalang River estuaries. 2009, undertaken by Telfer and Cohen (2010)

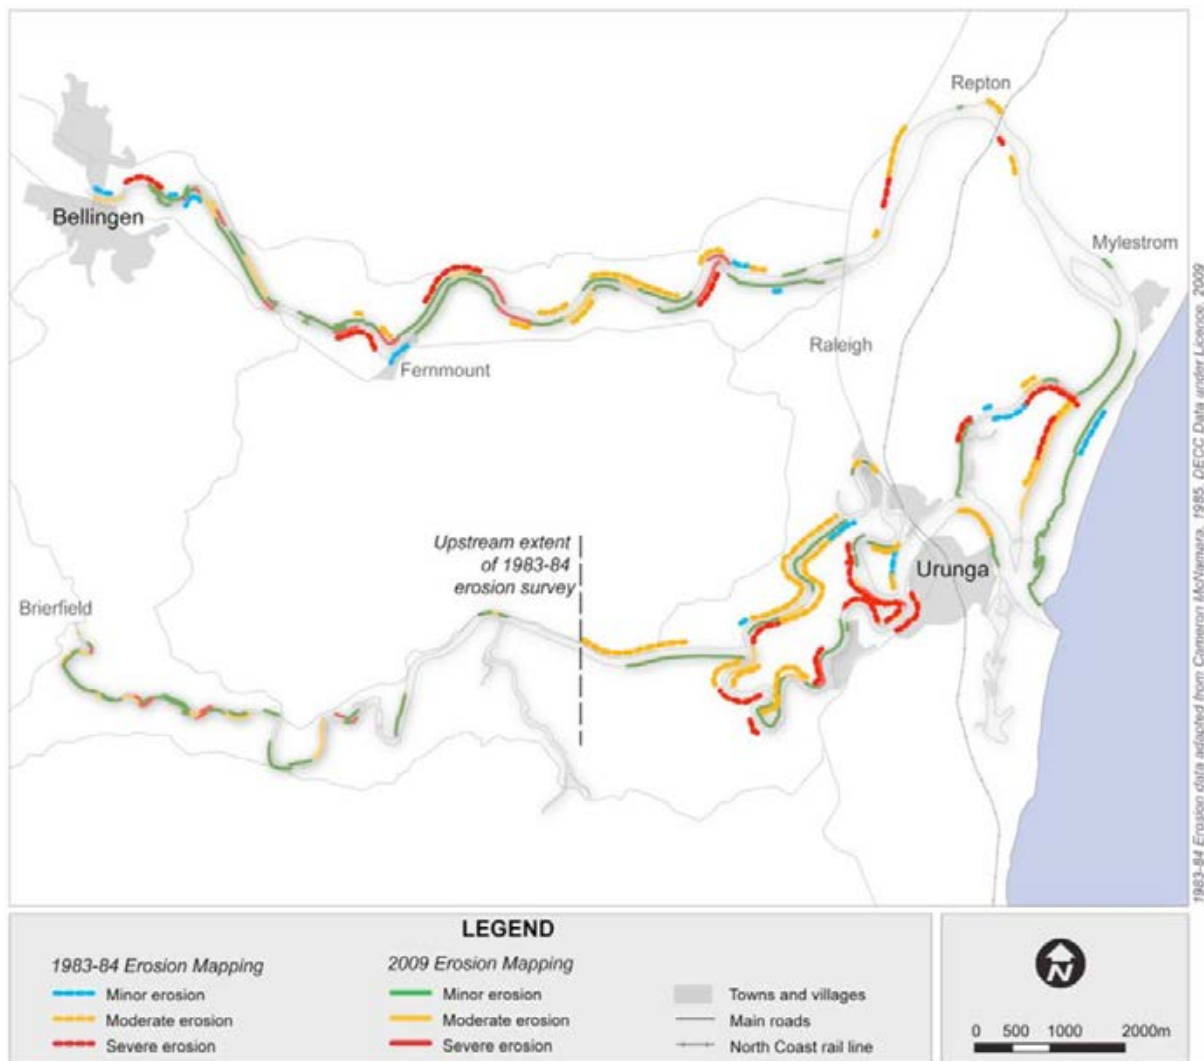
Cameron McNamara, 1985: see *Figure 4*) to determine ongoing erosion rates and volumes. The report noted that much of the erosion was the result of fluvial processes associated with flooding, but that erosion was exacerbated by clearing of riparian vegetation, as well as stock access in a number of locations.

Figure 4 Comparison of active bank erosion in 1981-84 (by Cameron McNamara, 1984) and 2009 (source: Telfer and Cohen, 2010)

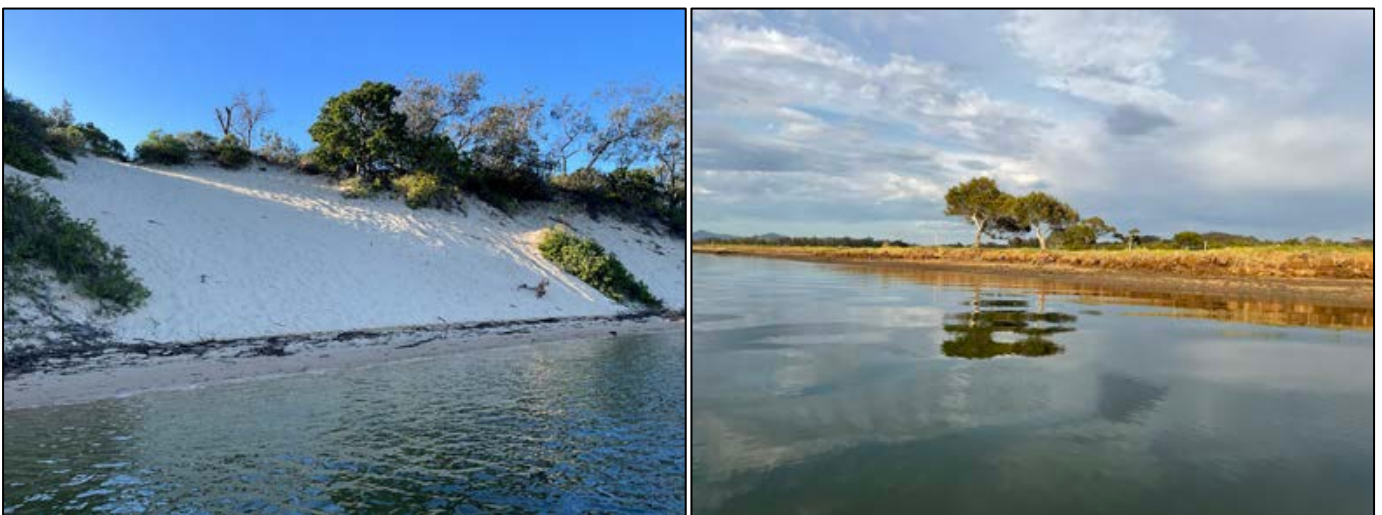
Plate 4 *The coastal barrier forms the eastern bank of the Bellinger below Mylestom (left) and low relief floodplains are generally dominated by swamp oak floodplain forest, mangroves and saltmarsh unless historically cleared (right).*

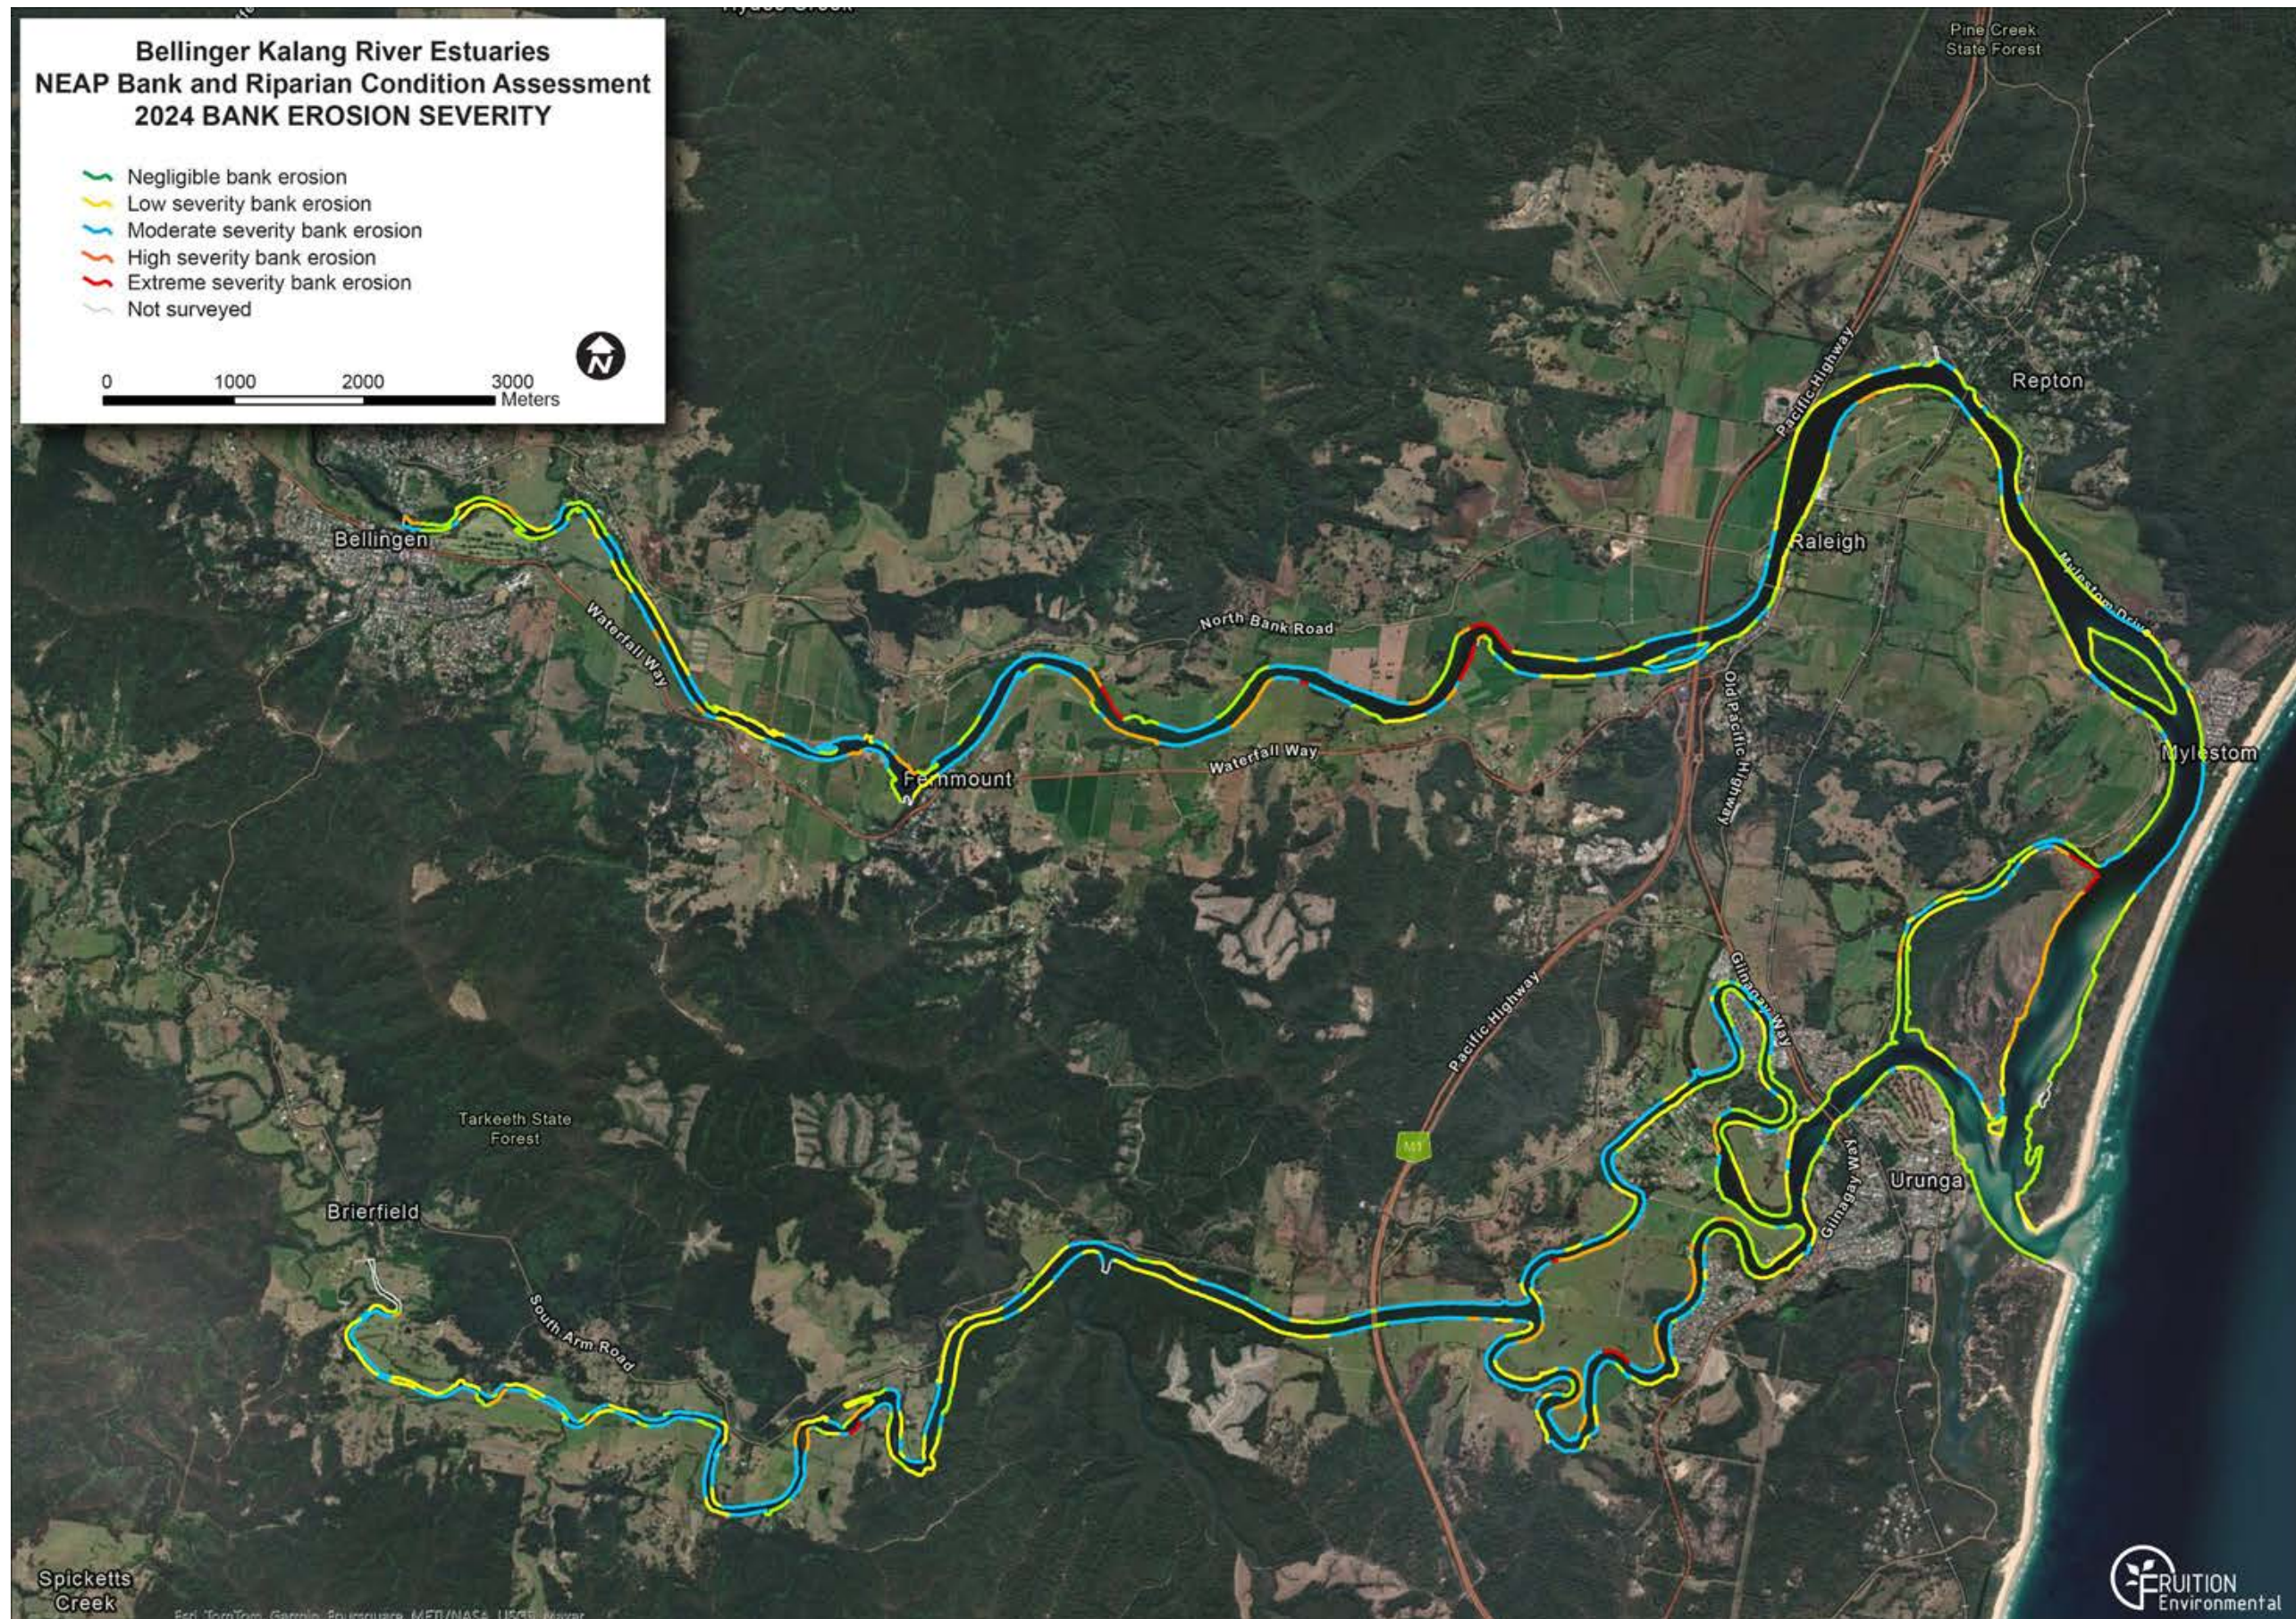
Figure 14 shows the spatial distribution of bank erosion severity within the Bellinger and Kalang River estuaries, while *Table 1* summarises the proportions of estuary bank of each category of erosion severity for the whole estuary study area (depicted graphically in *Figure 15*). This table shows that a little over half of the estuary banks in the study area have either Low or Negligible erosion (55.2%), and the remaining 44.8% of banks are experiencing erosion elevated above expected natural levels. The assessment of bank erosion severity across the estuary indicates that 1.6% (1,819 m) of the mapped banks are experiencing Extreme erosion, while 6.7% (7,759 m) show High erosion. This distribution suggests that while Moderate erosion is the most widespread erosion issue, Extreme and High erosion are less common but still significant in localised areas.

Figure 14 Distribution of mapped bank erosion severity across the Bellinger-Kalang River Estuary Study Area

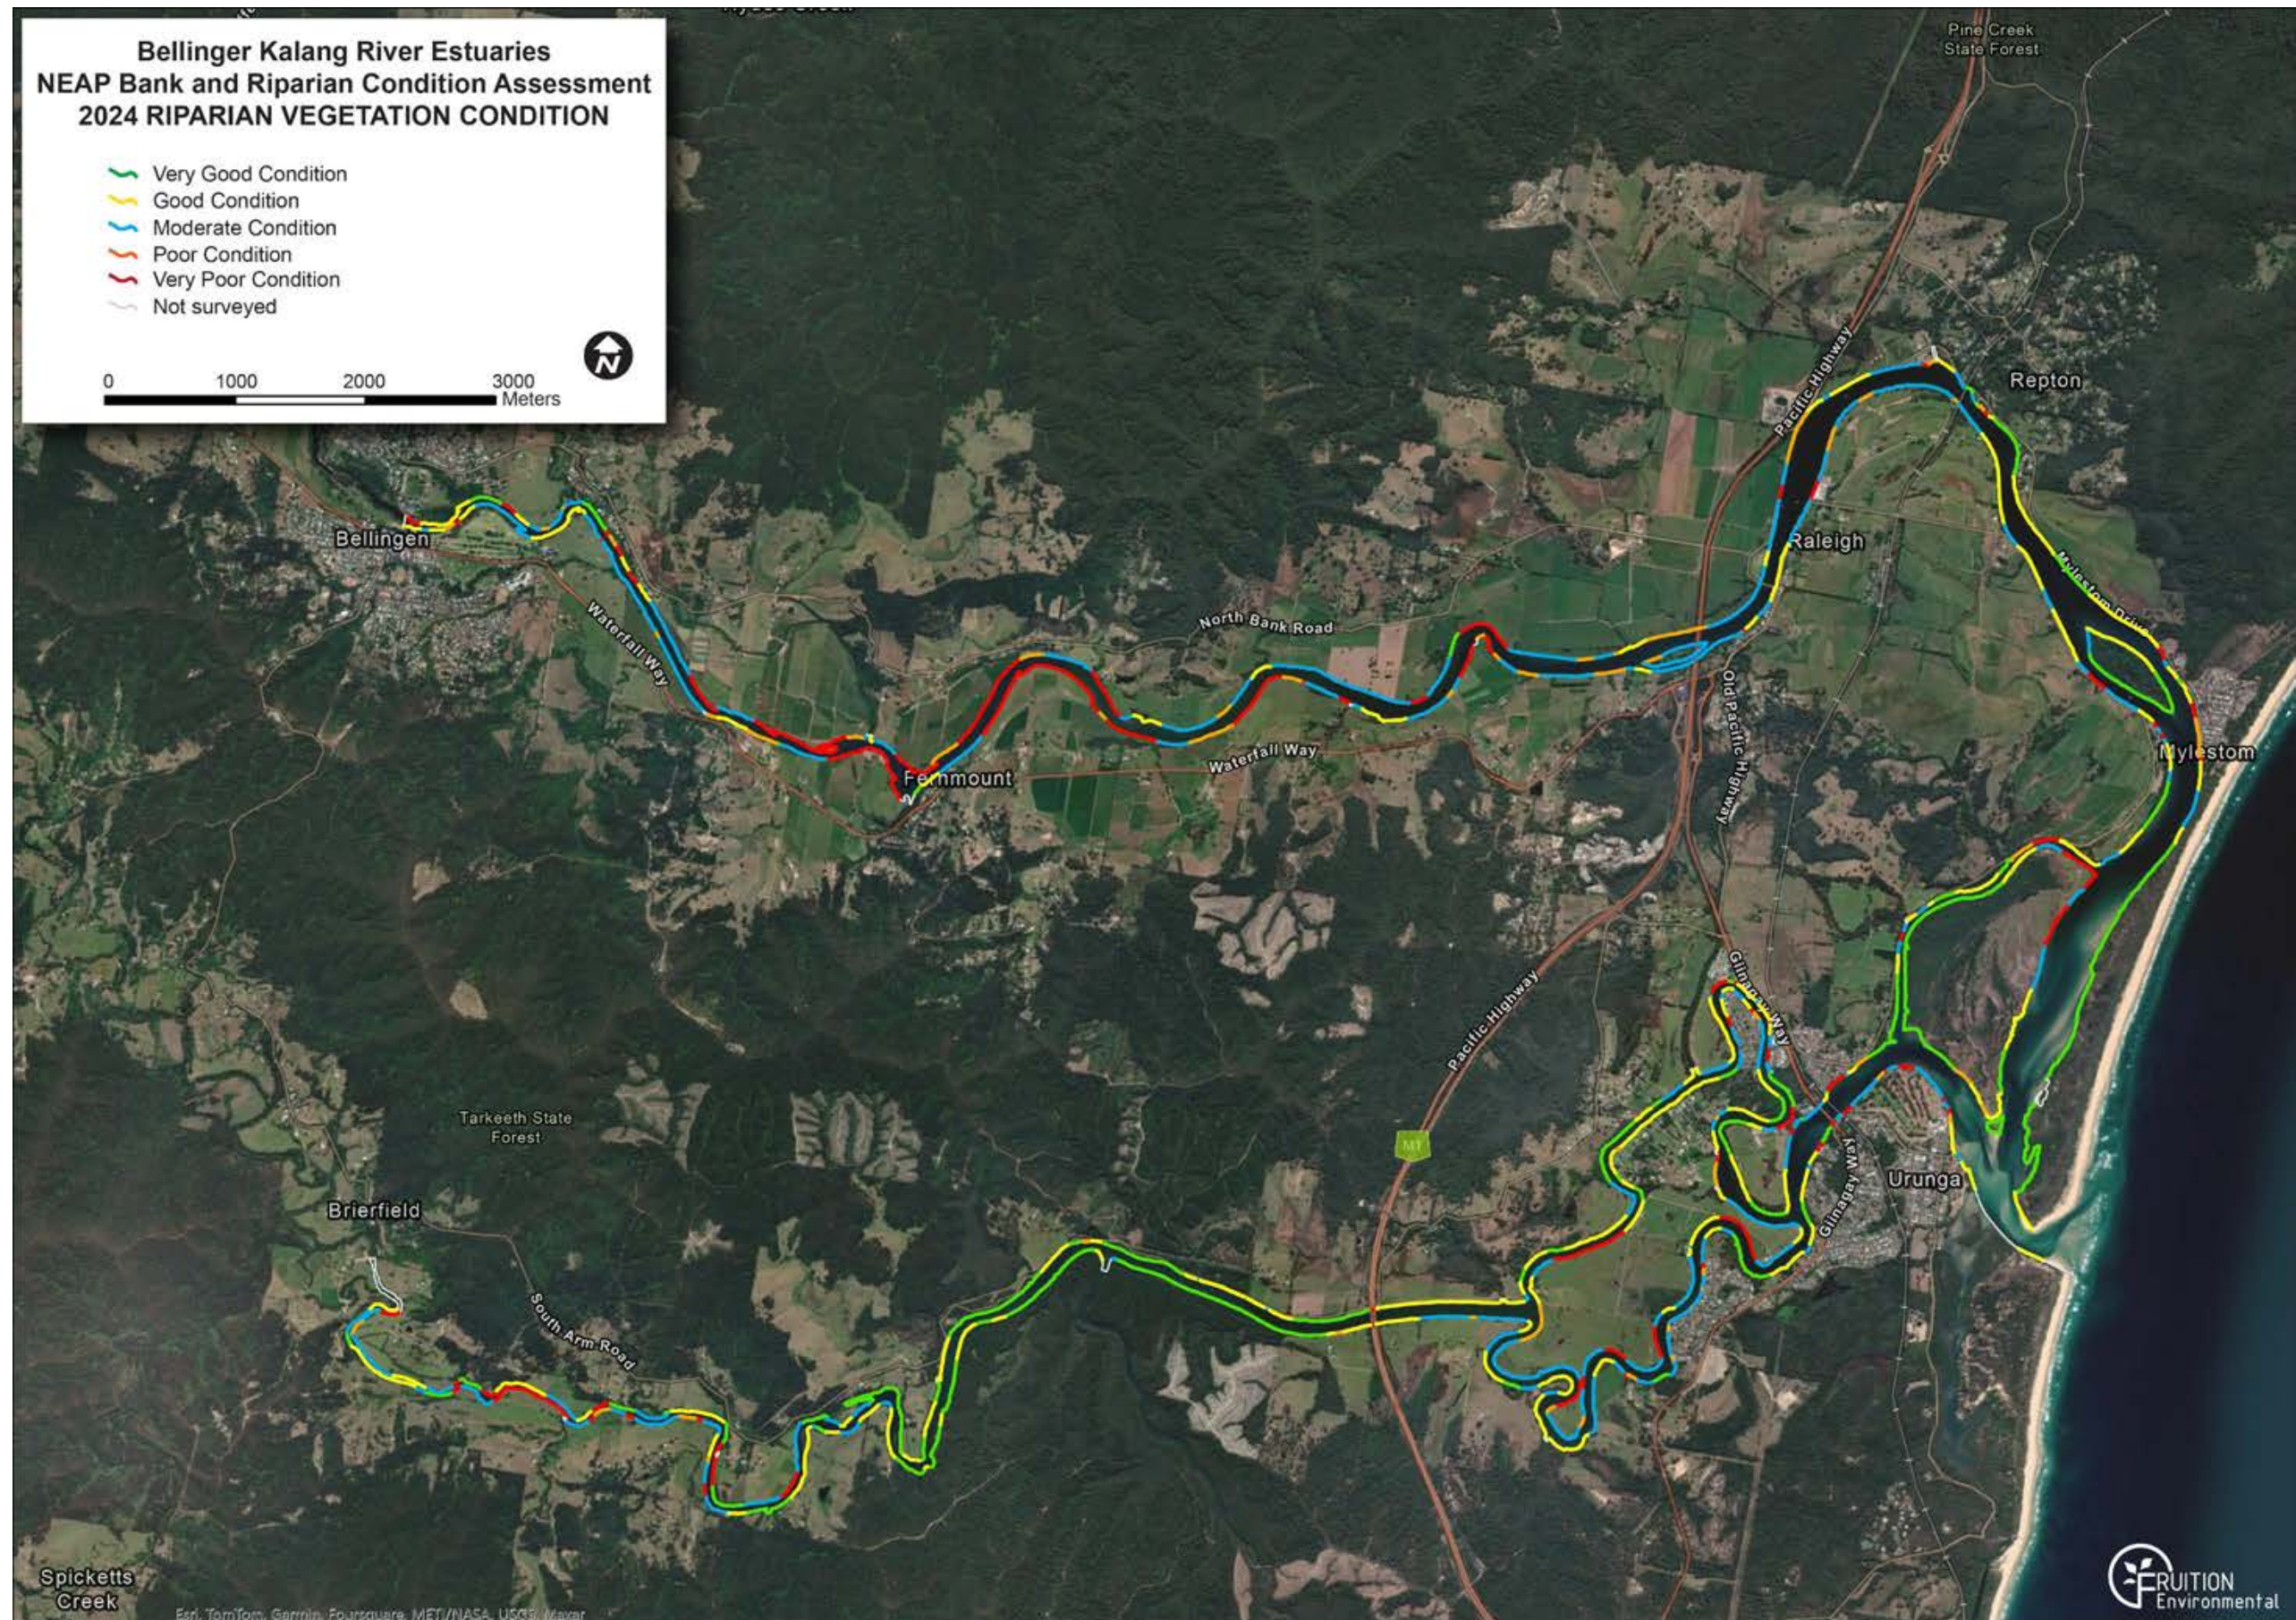
In reaches with Very Poor to Moderate condition vegetation a major factor in the rating is narrow riparian width. More than half of the surveyed estuary length (57%) having average riparian widths recorded as less than 5 m wide, almost two thirds (66%) recorded under 10 m wide.

Much of the bank length described with Poor to Very Poor riparian condition occurs in agricultural areas, along areas of residential foreshore development cleared for amenity and access such as in Urunga and Mylsetom, or are where intensive bank remediation works have been implemented in close proximity to infrastructure such as roads or entrance sea walls restricting riparian width.

Figure 15 Distribution of riparian vegetation condition across the Bellinger and Kalang River Estuaries Study Area

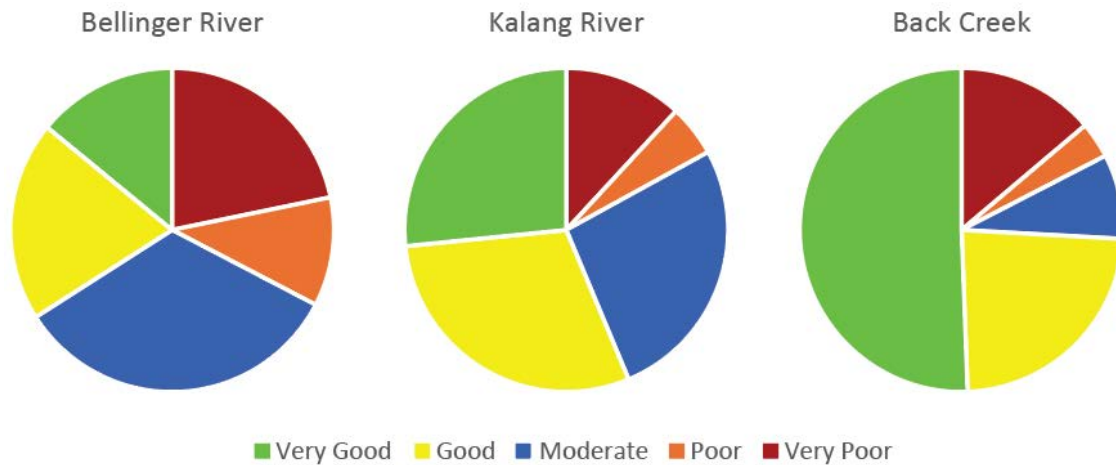
Figure 16 Proportional distribution of riparian vegetation condition within each estuary of the Bellinger-Kalang River study area.

When looking at individual estuary systems, the Bellinger River shows the highest level of riparian degradation, with 32.7% of its length in Very Poor to Poor condition, compared to 34.1% in Good to Very Good condition. In contrast, the Kalang River has 17% in the lower condition categories and 56.3% of its length in Good to Very Good condition. As with the erosion severity ratings, the higher proportion of riparian vegetation in Good to Very Good condition reflects the degree of valley confinement, reduced floodplain development, extensive mangrove forests of the lower estuary, limitations on land use that have resulted in reduced historical clearing of the riparian zone.

Back Creek shows the highest proportion of healthy vegetation (50.6% in Very Good condition) with over half its banks featuring riparian vegetation in Very Good condition. The poorer condition vegetation is generally found adjacent to Yellow Rock Road where the riparian strip is narrow or on the Northern tip of Urunga Island which has been cleared and impacted by stock for many years.

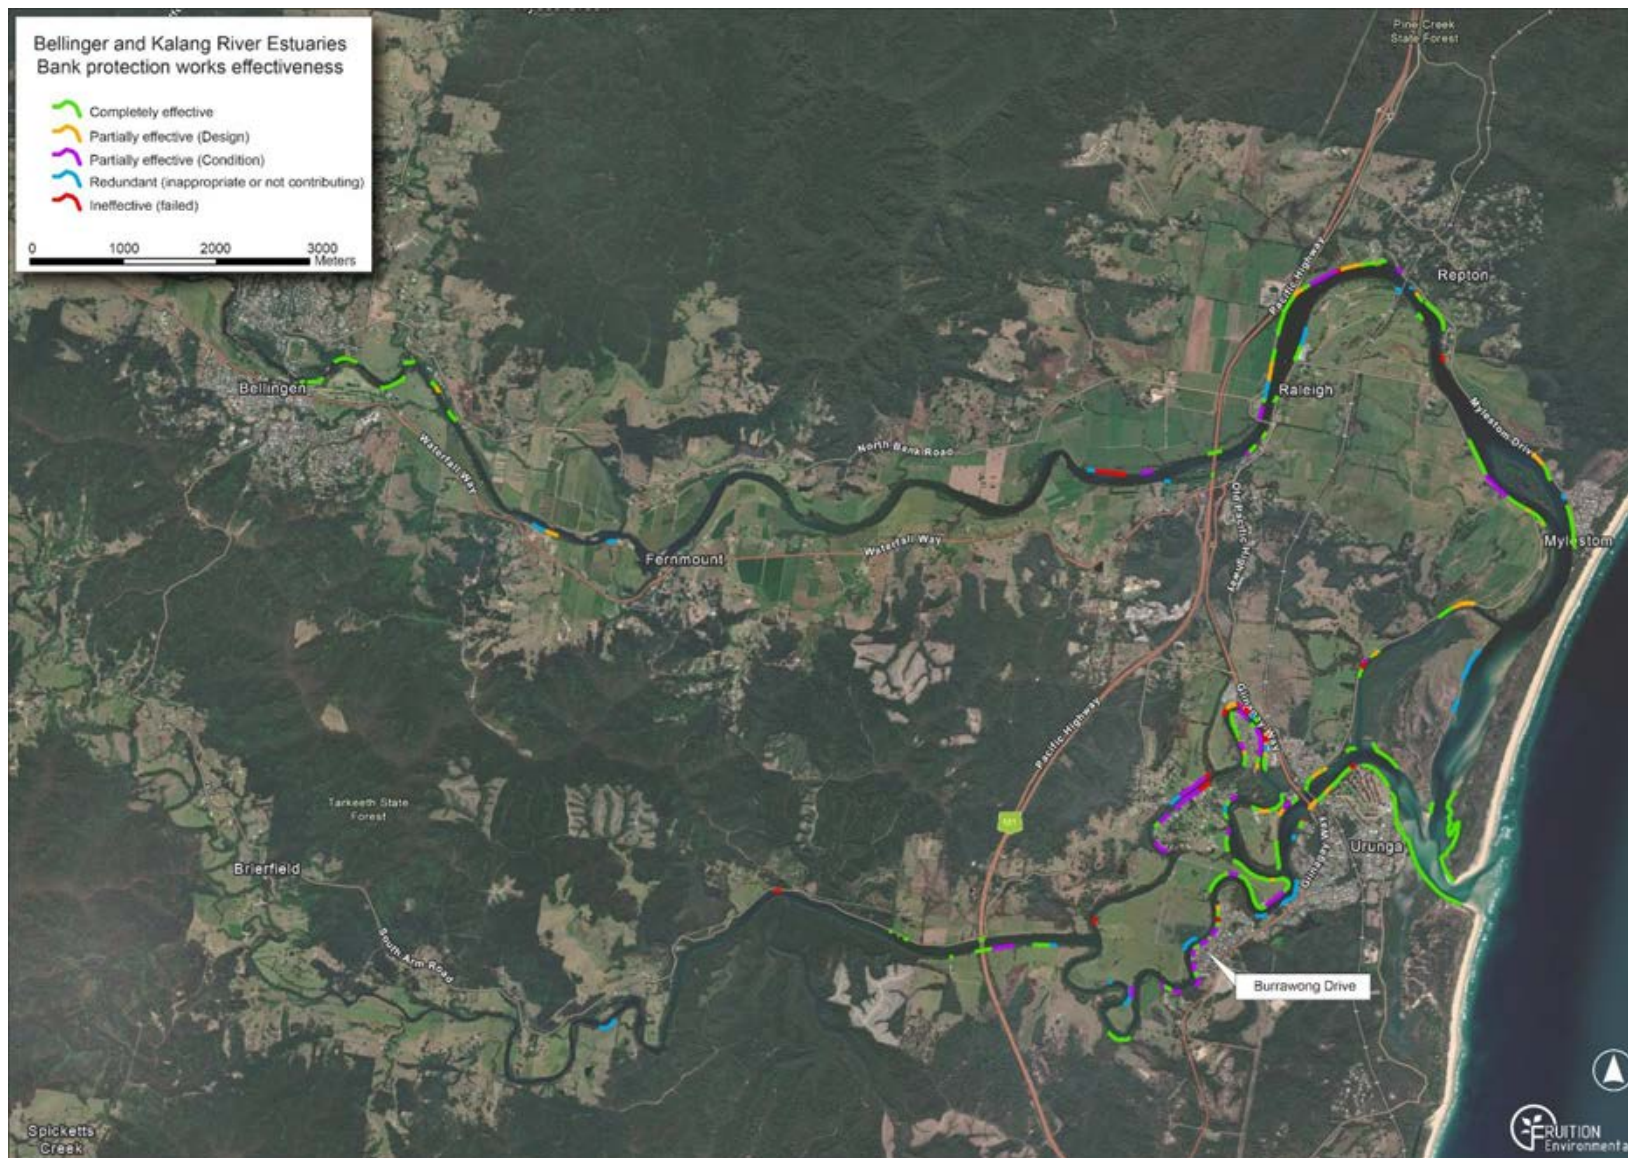
Figure 17 shows the distribution of works within the study area and the assessed effectiveness or otherwise of the structures/works types present in those reaches.

Inappropriate works generally demonstrated a high degree of failure, with 33.3% of these works (15.1% of the length) having completely failed or been ineffective at mitigating erosion, and a further 34.3% (38.3% of bank length) having partial failure. Examples of inappropriate works types are shown in *Plate 17*.

Figure 17 Distribution of bank protection works effectiveness within the Bellinger-Kalang River study area.

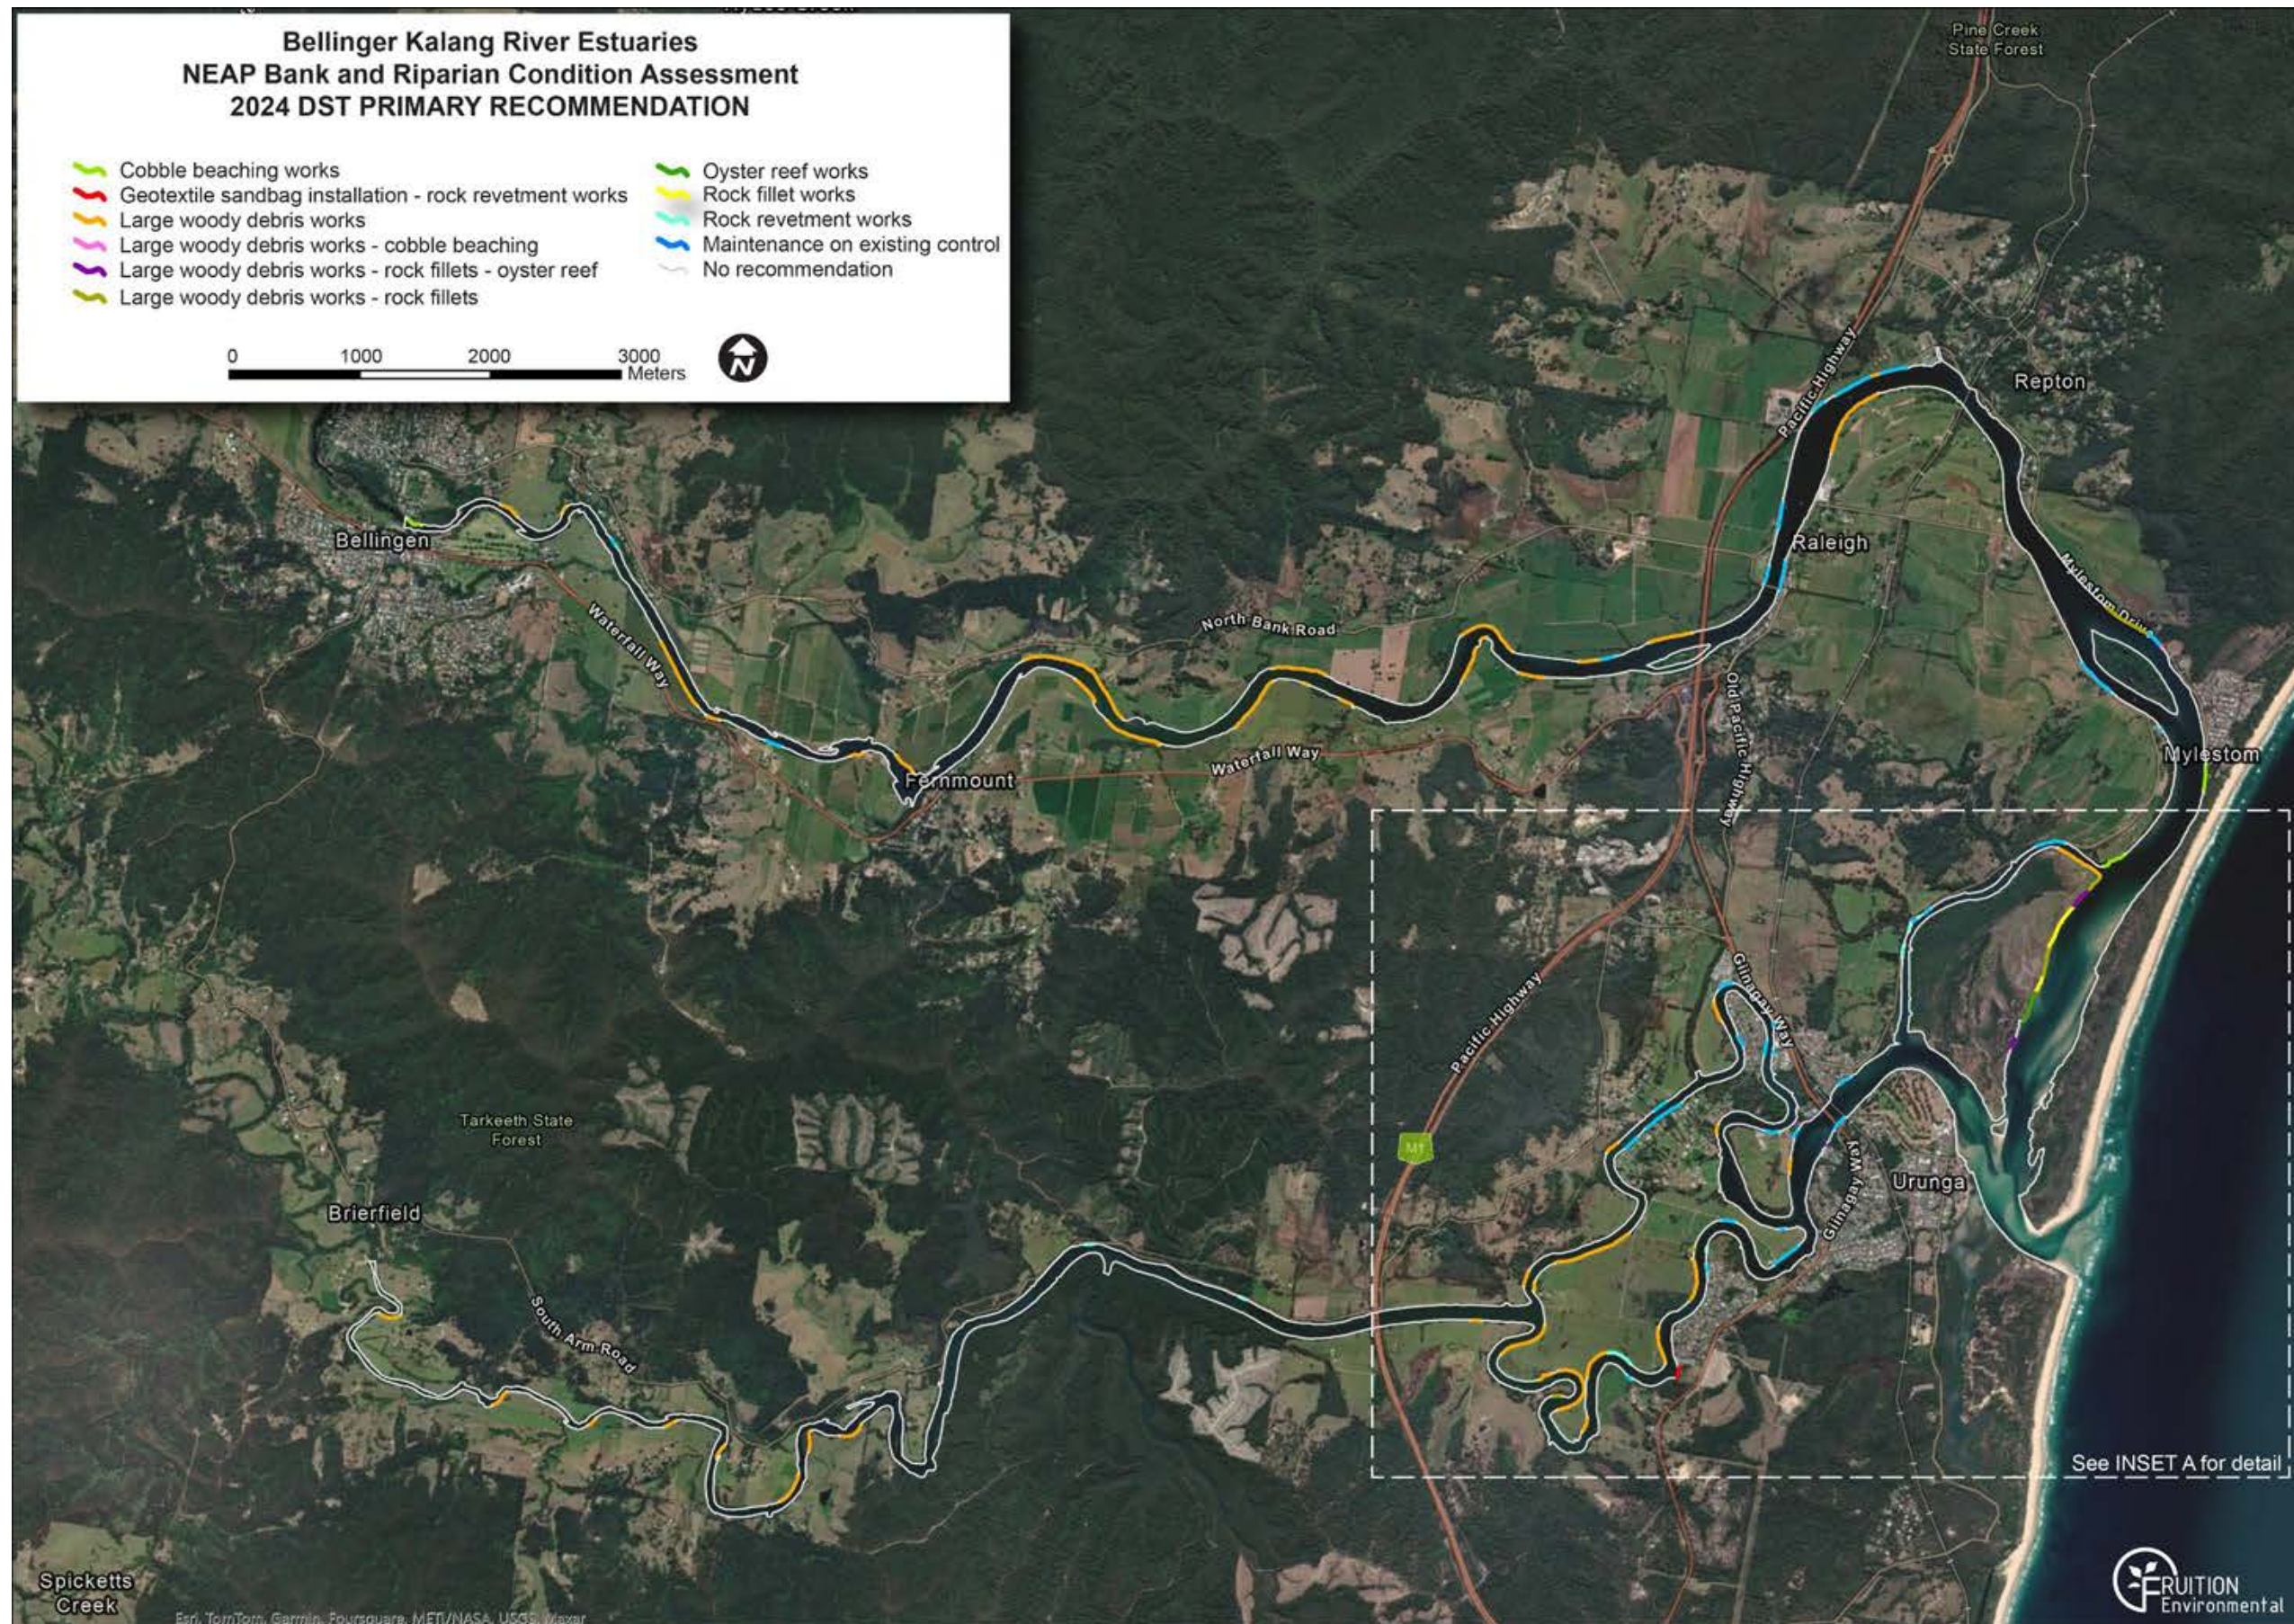
Figures 19 and 20 show the distribution of DST Primary Works Recommendations within the Bellinger-Kalang River estuary study area. The DST primary recommendation is either a main works type or a recommendation to maintain the existing controls present where appropriate. In some instances where options score equally, the DST has recommended multiple options as a primary recommendation. As bank

Figure 19 Primary DST Recommendations across the Bellinger and Kalang River Estuary Study Area

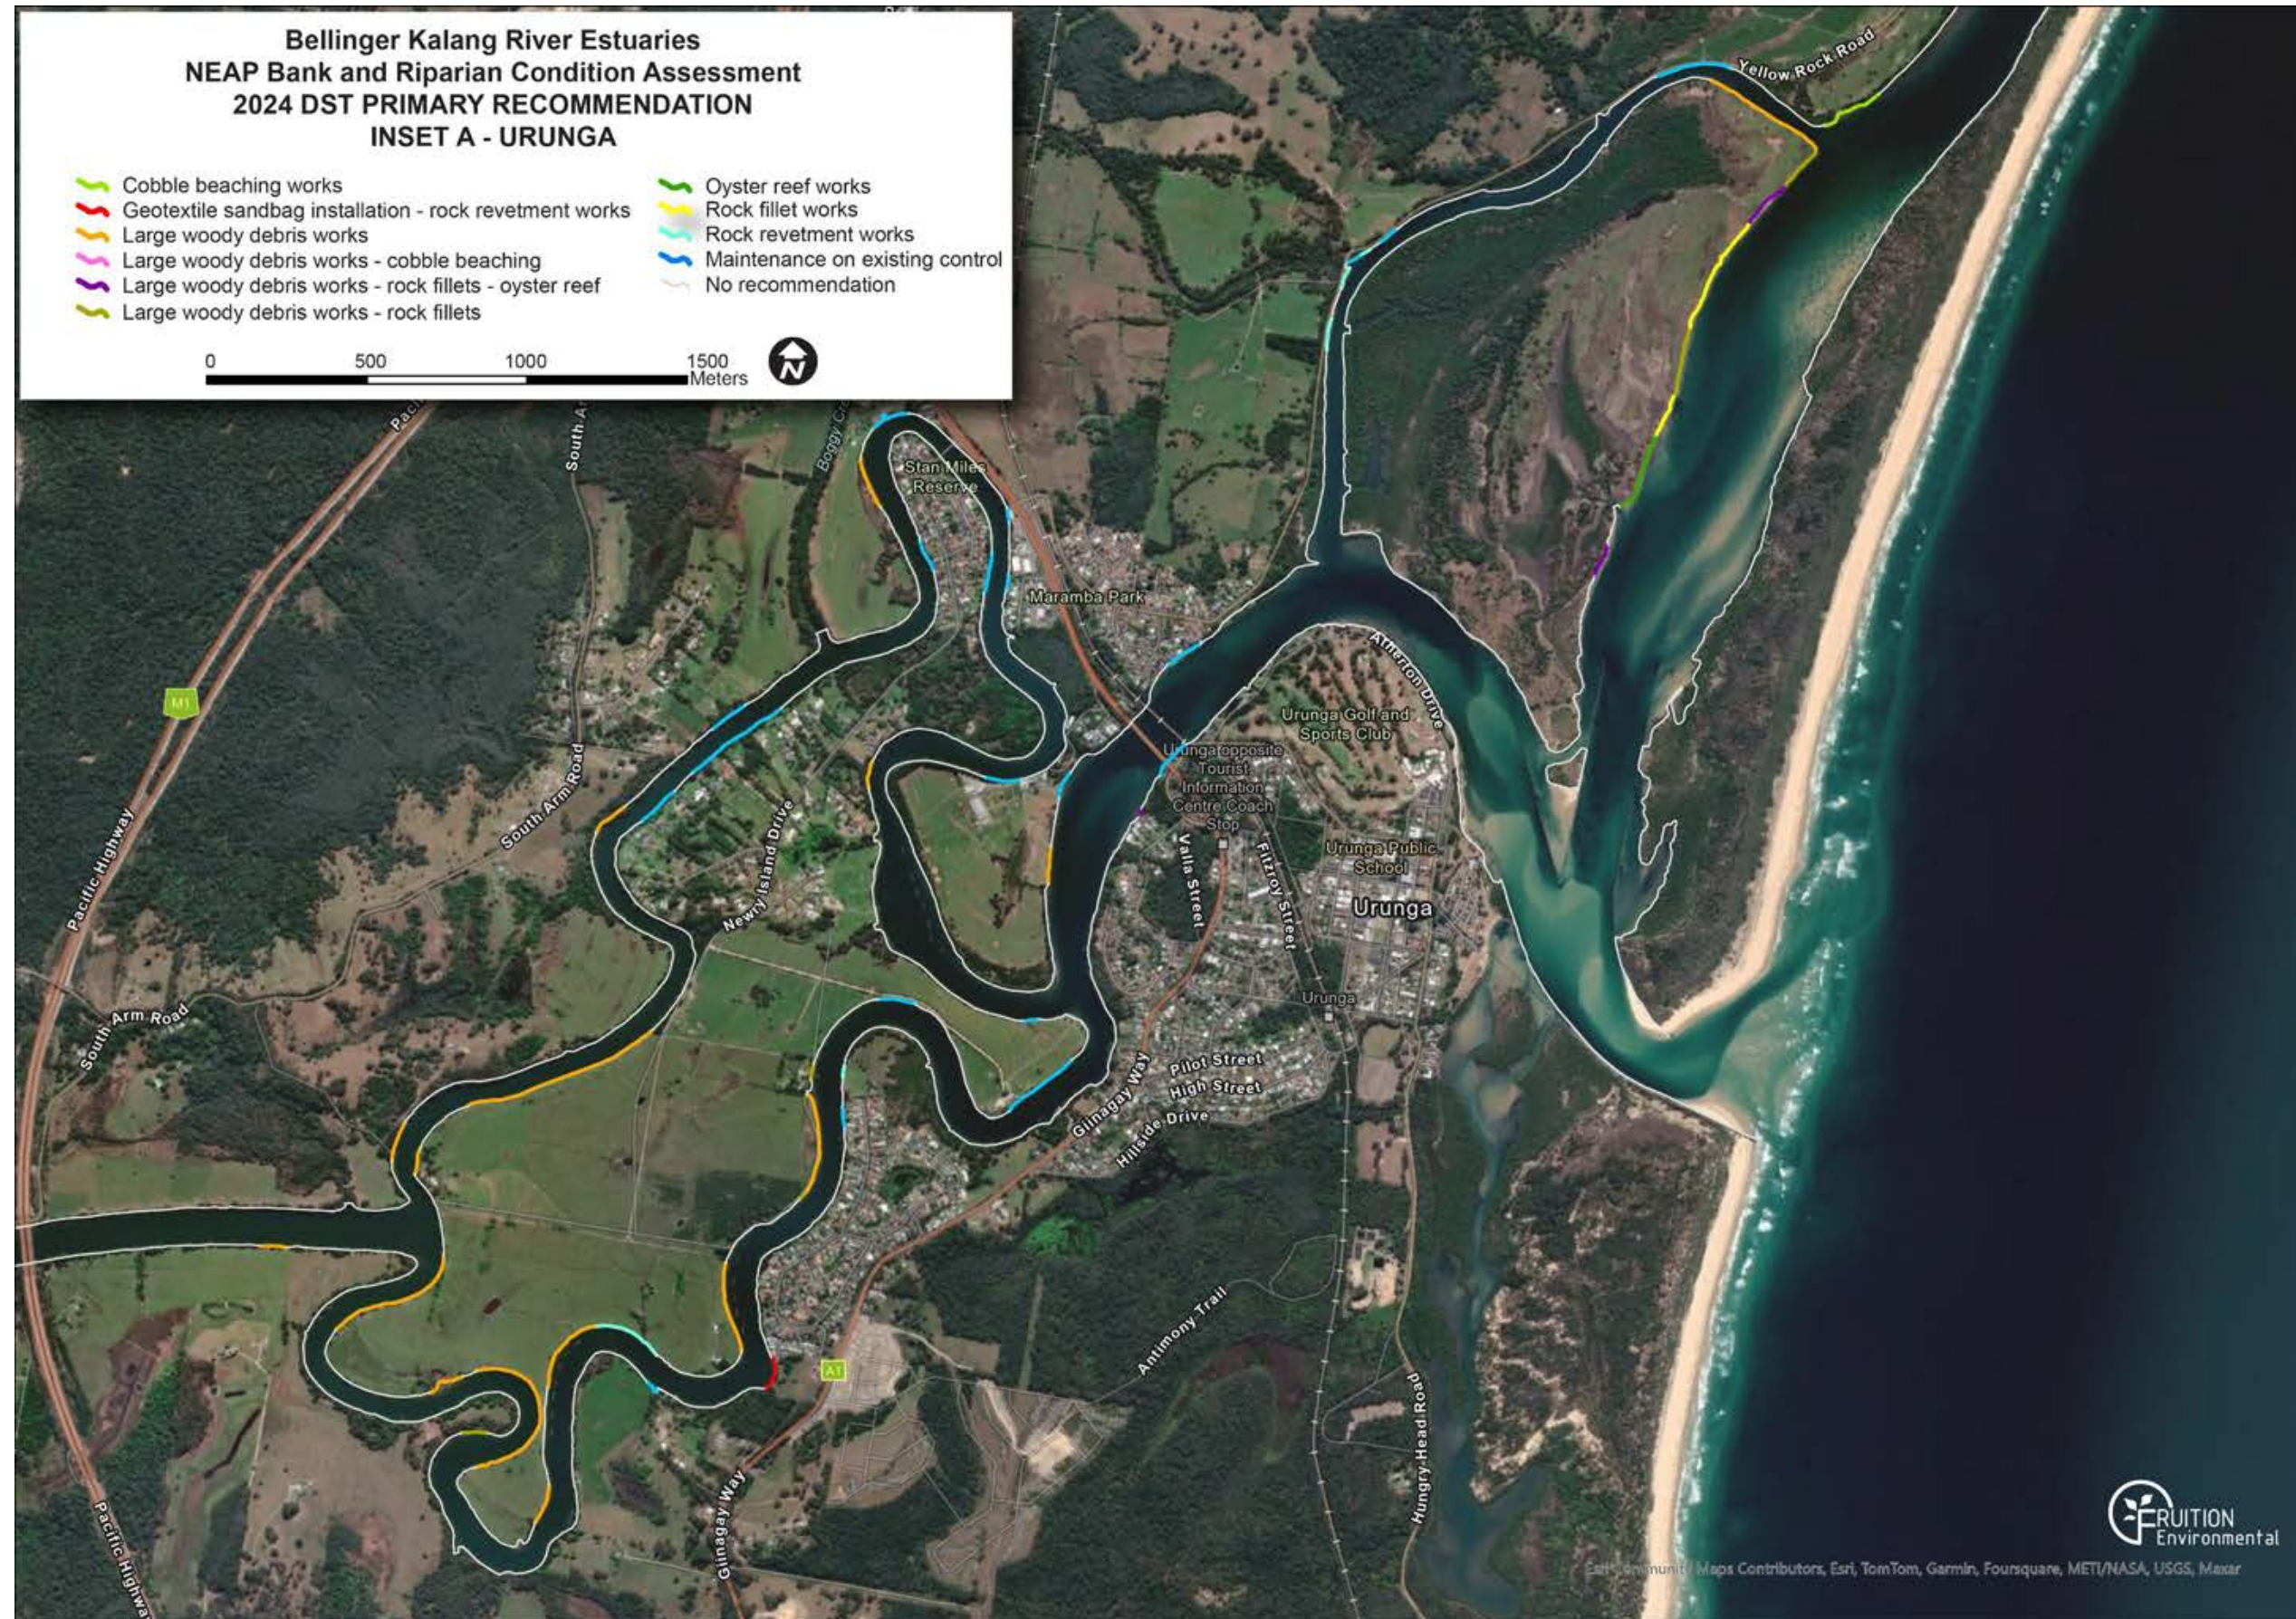
Figure 20 Primary DST Recommendations across the Bellinger and Kalang River Estuary Study Area
