Report produced for
Department of Primary Industries and
Regional Development - Fisheries

Bellinger-Kalang River Estuary NEAP Bank Erosion and Riparian Condition Assessment Report

20 December 2024

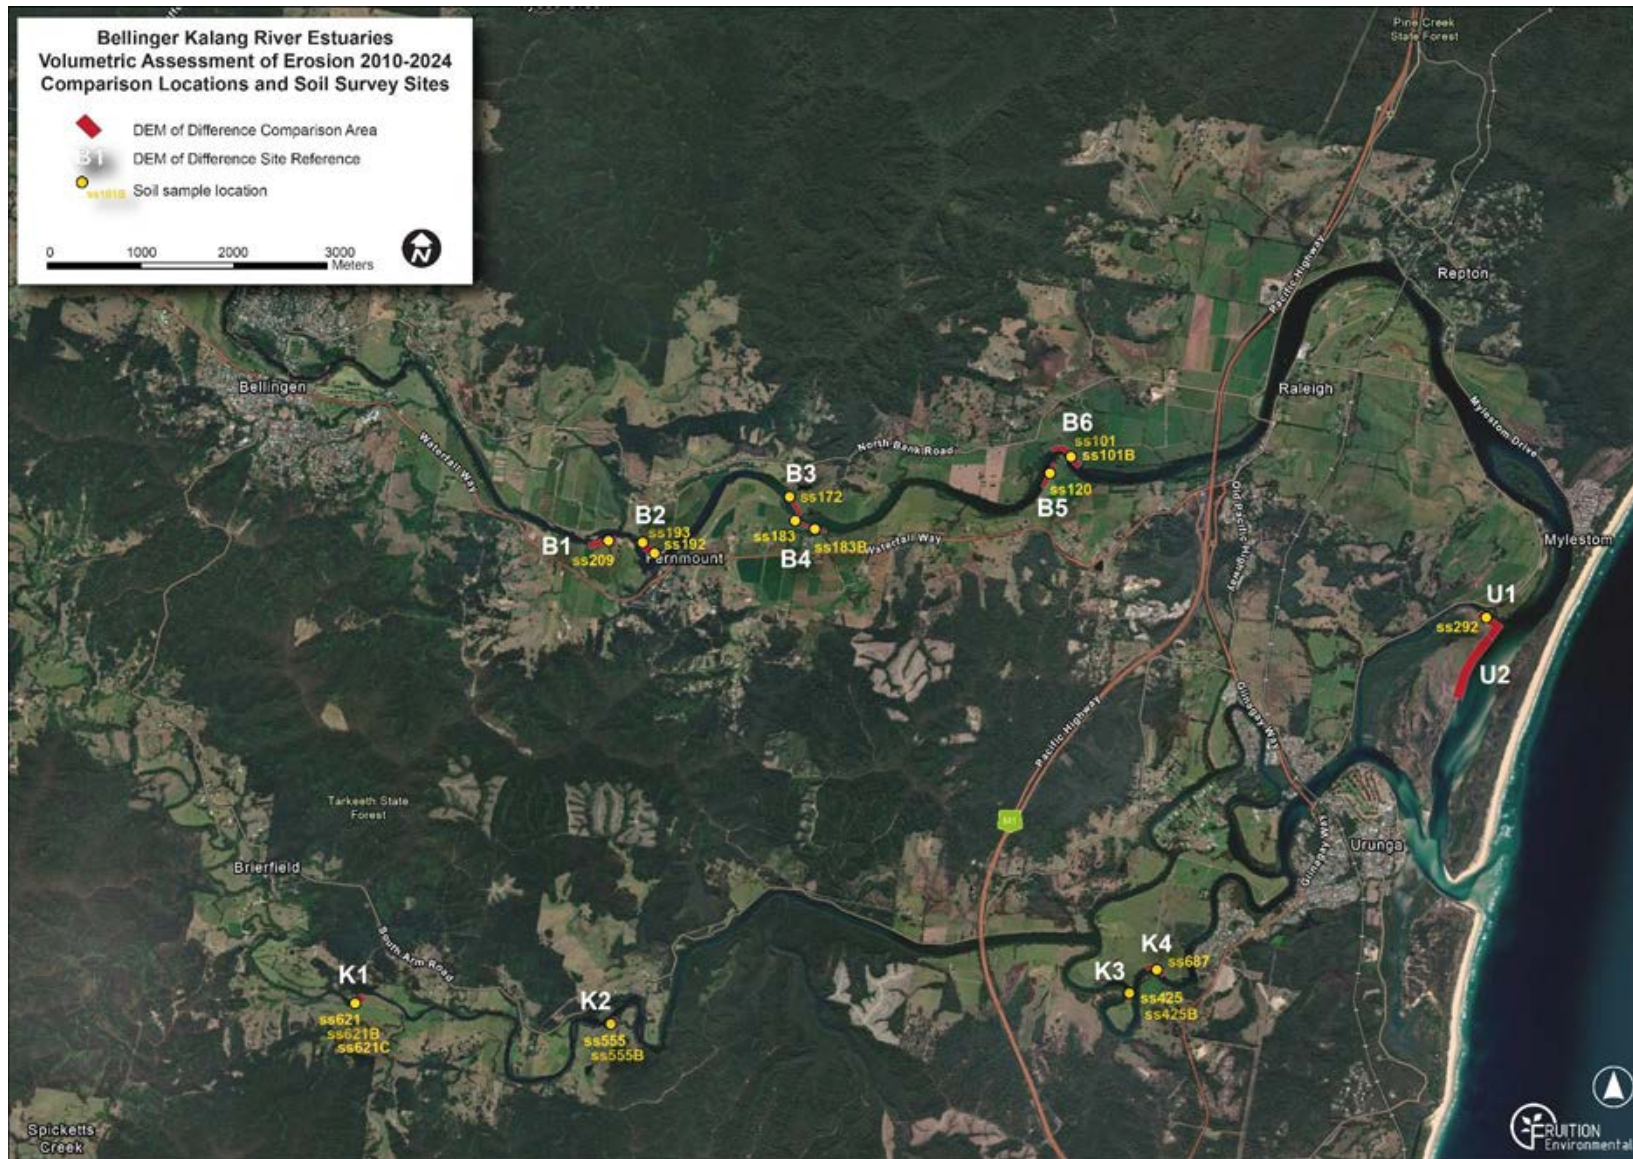
Sites were selected on the basis of the 2024 field survey of bank condition, with sites selected from the pool of 58 sites mapped as either having high or severe erosion within the Bellinger and Kalang River estuary study area. The sites selected were all from the mid to upper Bellinger River, upper Kalang River, Newry Island and Urunga Island (*Figure 21*).

Figure 21 Sites of erosion identified through field assessment in 2024 which have been analysed to determine contemporary rates of erosion and contribution to fine sediment supply within the Bellinger and Kalang River estuary study area (2010-2024).

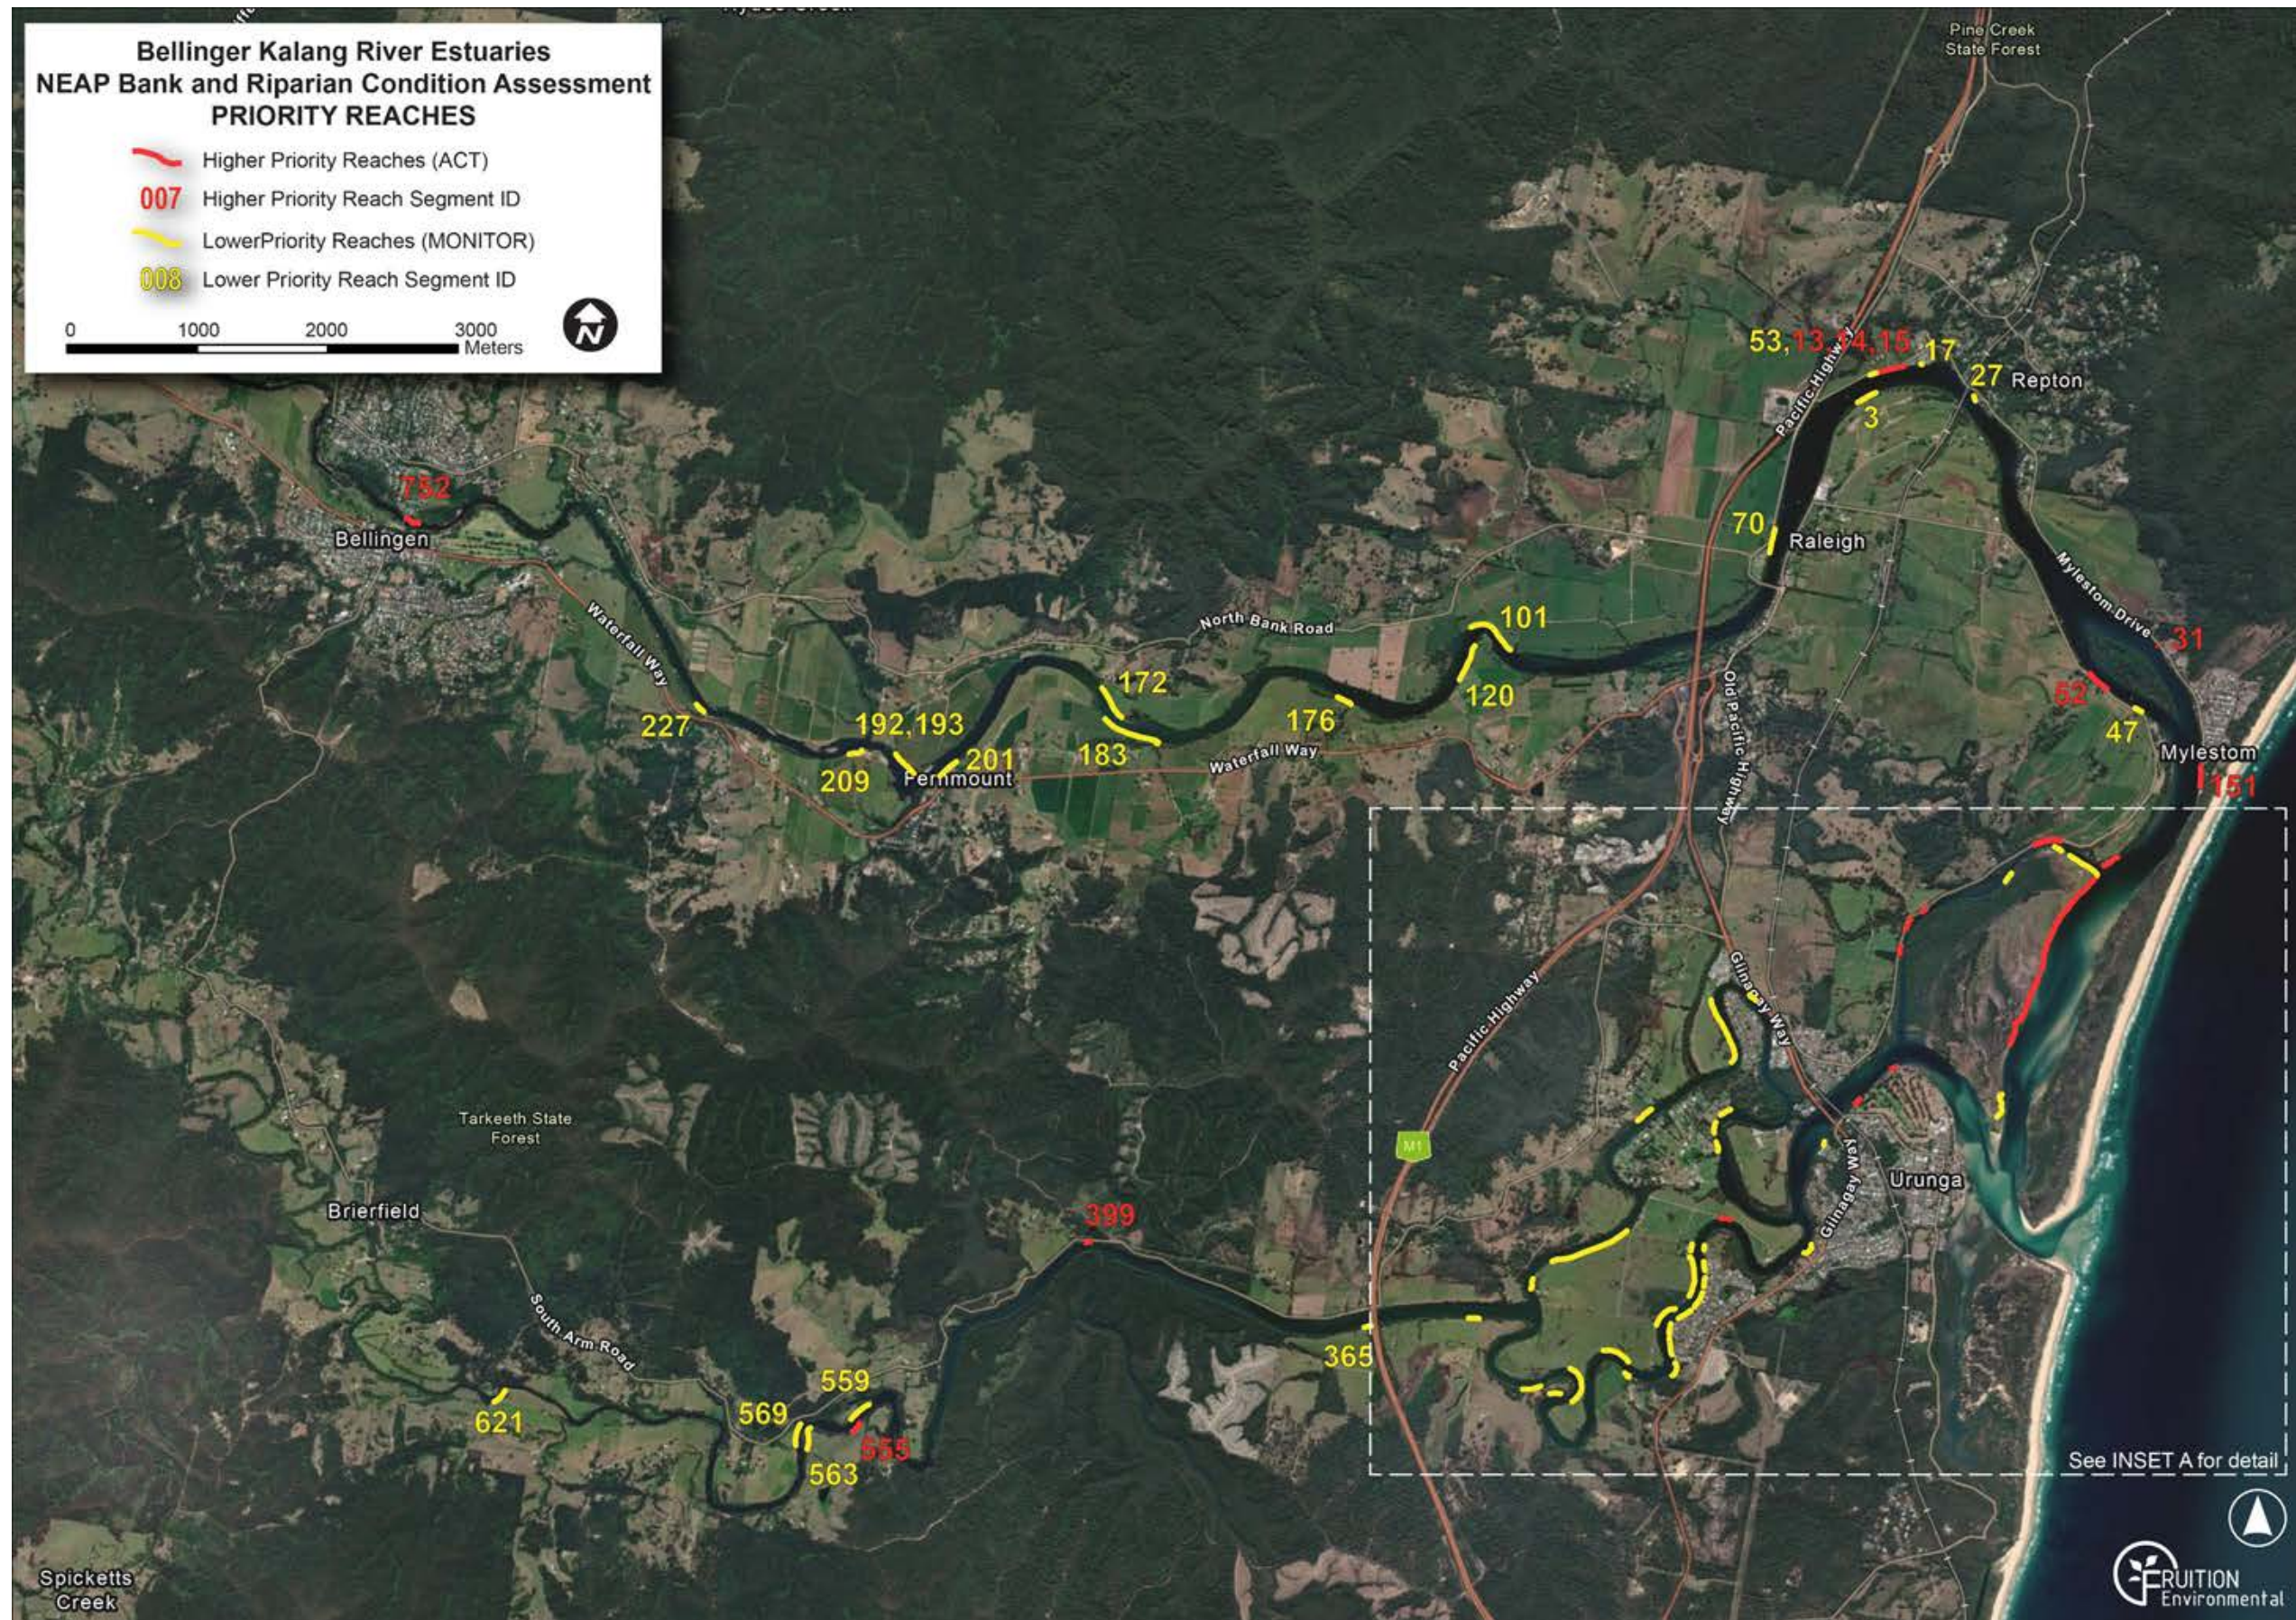
Table 20 lists the top 19 ranked reaches/focus areas within the Bellinger-Kalang River estuary study area. The main issues identified as affecting the reach and the objectives of management intervention are listed. These locations are considered higher priority for management interventions to improve flood resilience, protect public assets and infrastructure, improve water quality, improve estuary health, and protect or enhance important riparian vegetation communities. The locations of the higher priority reaches and focal areas are indicated in red in *Figures 26 and 27*.

Figure 26 Locations and Reach reference IDs for priority reaches for management intervention based on the Bellinger and Kalang River Estuaries NEAP Bank and Riparian Condition Assessment 2024 (INSET A provided in Figure 27 overleaf).

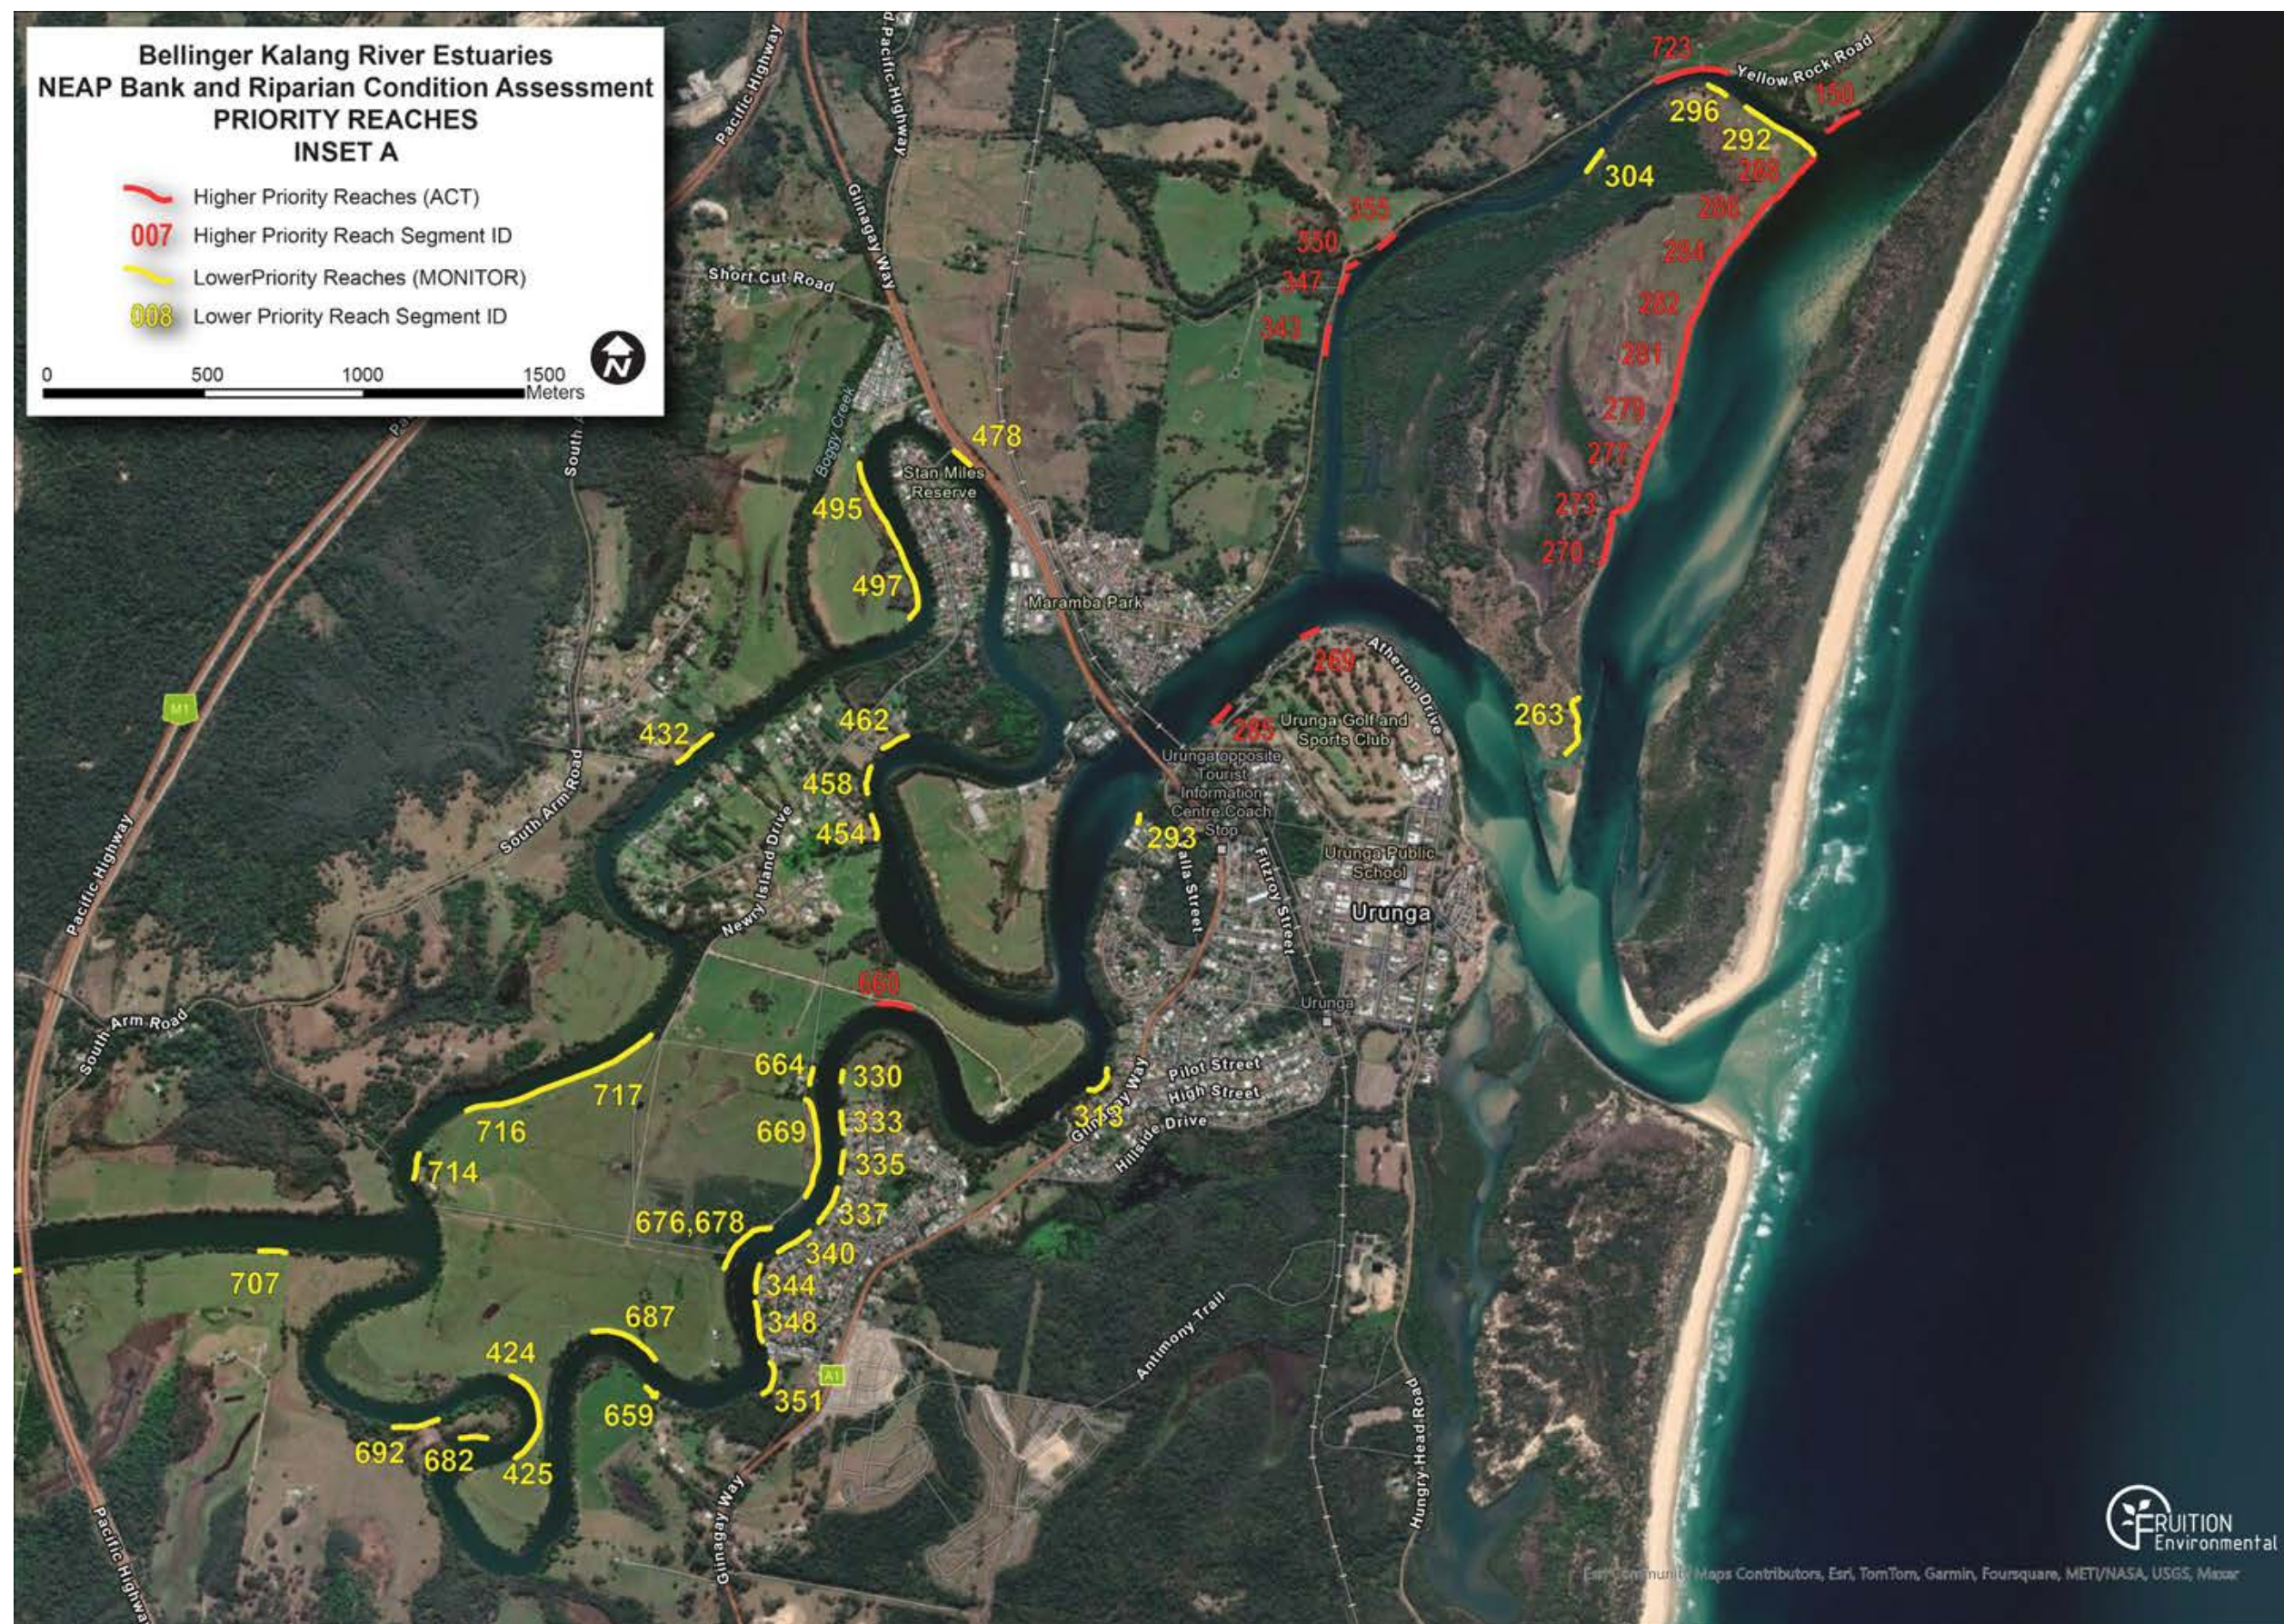
Figure 27 Locations and Reach reference IDs for priority reaches for management intervention in the Newry Island/Urunga/Back Creek area (INSET A) based on the Bellinger and Kalang River Estuaries NEAP Bank and Riparian Condition Assessment 2024
