NSW DEPARTMENT OF
PRIMARY INDUSTRIES

Plant and Equipment Mechanical Presentation

**Presented to the Mine Managers
Association NSW Coal Mines
3 May 2007**

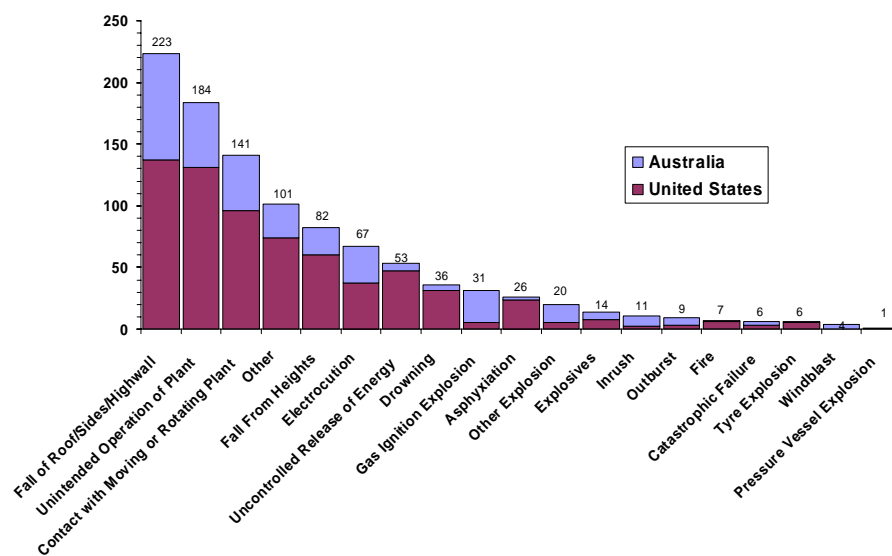
Agent of Fatality – Total 1022

It was identified that core-risk or high-risk activities were involved in less than half of the fatalities and that more than half of the fatalities were equipment related.

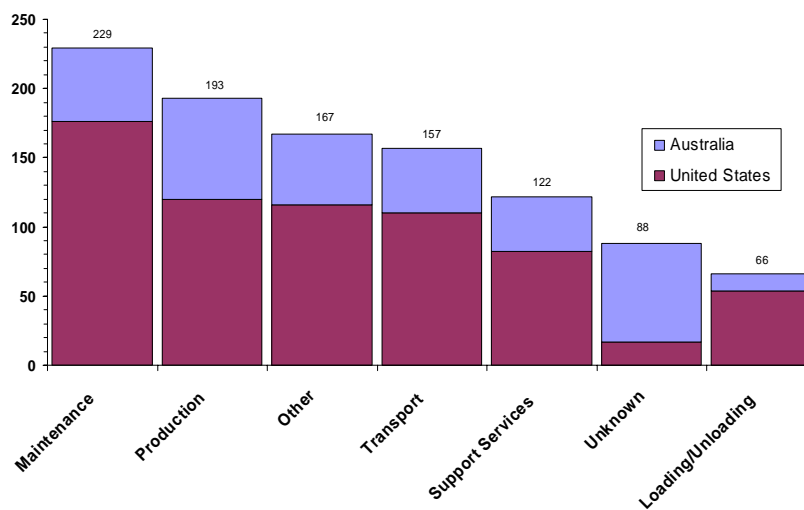
Activities at Time of Incident

The activities at the time of the fatality were also analysed.

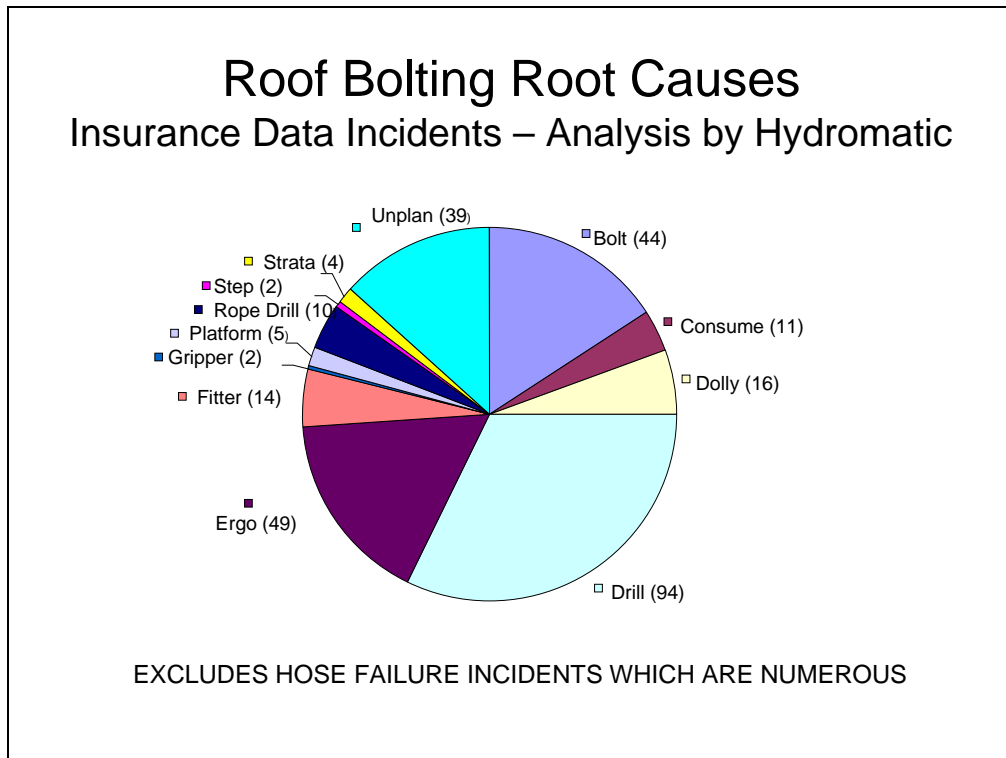
The graph below gives a broad breakdown of the root causes of roof bolting injuries.

The following information is an analysis of data supplied by Coal Services Pty Ltd on the accidents involving mobile bolting equipment used in NSW coal mines. The study covers the years from 1999 to 2004 shows:

- 292 accidents associated with operating and maintaining roof bolting equipment
- 55 accidents occurred during some part of the rib bolting process
