# TECHNICAL PUBLICATION

## VENTILATION UNDER TIMBER FLOORS

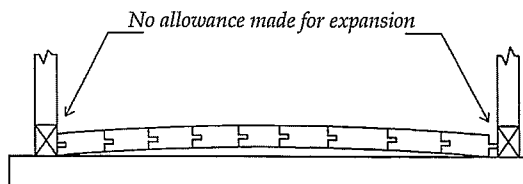
Alternatively, the floor may react to excess moisture by lifting in a continuous curve, known as doming either pulling the nails from the joists or lifting the entire floor framing off its supports. Excessive springiness of the floor, particularly towards the centre of the room is usually a fair indication of this problem. Doming may occur during periods of excessively wet weather but, providing the nails have not pulled, when the weather conditions revert to normal or the underfloor conditions are corrected, the floor will usually return to normal.

Figure 3. Doming or blown floor.

A blown floor on the other hand may be severe enough to actually force two or more boards up to form a peak or sawtooth effect. This is normally the result of insufficient expansion joints being provided in a large floor area and will often be more severe where a secret nail T&G profile

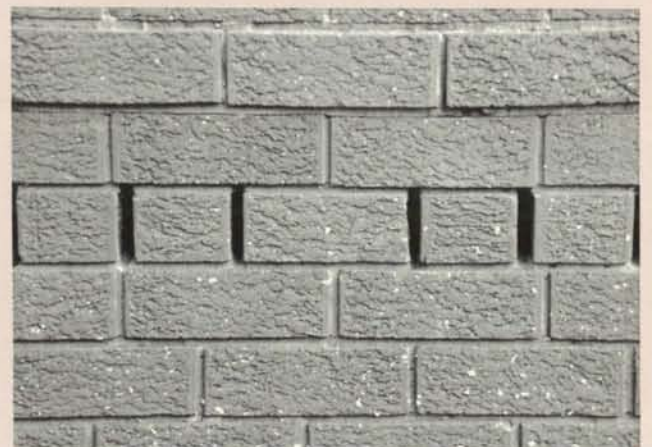
The minimum suggested requirement for 2100 mm<sup>2</sup> of ventilator space per lineal metre of external wall is approximately equivalent to a row of unmortared brick joints of normal size all the way around the house. This, while being an unobtrusive way of providing the minimum requirement, means the gaps will only be some 7-10 mm in width. If, as is usually the case, maintenance of ventilator space is neglected, the likelihood of blockages from the original mortar, spiders' webs or other foreign material will soon render the available ventilation useless. More common these days is for the aggregation of the necessary gaps into groups of three or four, 50 mm wide spaces in the bricks. While that usually makes for easier bricklaying, another and better way of ensuring good cross ventilation is to provide a continuous row of open mortar joints of around 20-25 mm.

*Figure 5. Spaced brick ventilation.*

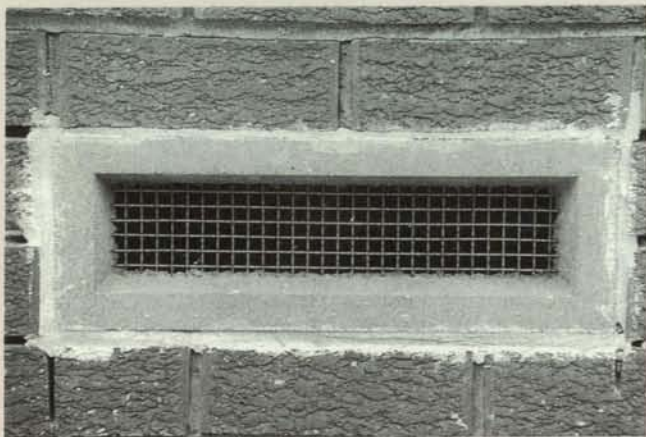
Where the foundation wall is easily accessible, the installation of additional vents in the form of cement framed bronze mesh ventilators offer a practical alternative. Available in various sizes, they are made to suit standard brick patterns and provide clear space of

up to 25,900 mm<sup>2</sup>. Where it is not practicable to provide additional natural ventilation, the installation of mechanical ventilators may solve the problem. These units are usually vented above the roof and generally work on the same principle as the wind driven roof space ventilators that are becoming increasingly popular. Because of site variations and the often substantial differences in performance of these mechanical units it is impossible to make any recommendations regarding brands, types or quantities required. The best advice would be to consult the various manufacturers or to engage a specialist in the field.

Figure 6. Bronze mesh ventilator.
