Minor bank stabilisation works

Pumpkin Point rock fillets

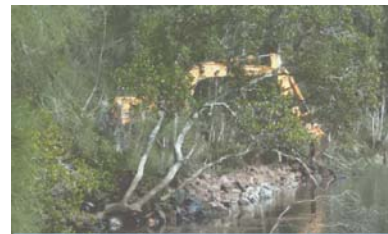
An excavator with a long arm grab was used to construct the rock fillets. Photo: D.Kirkness

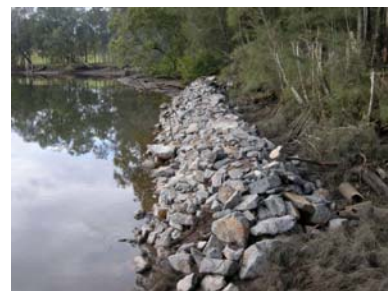
Rock fillets protect young mangroves against wave action erosion. Photo: I&I NSW

The site was identified by the Hunter Central Rivers Catchment Management Authority as an ideal location for rock fillet construction to alleviate issues from erosion. Rather than rock-lining the banks, rock fillets provide stability to river banks and protection from wave erosion to allow vegetation such as mangroves to establish in the space behind them.
