## reshaping gullies and return to pasture

<b>Landholder</b>	Keith Doherty
<b>Map reference</b>	10
<b>Land use</b>	Grazing and future cabinet timbers
<b>Soil Erosion Solutions Grant</b>	\$5,940 (hire of earthmoving equipment, purchase seed and mulch)
<b>Landholder's in-kind contribution</b>	\$5,940 (labour, tractor work)

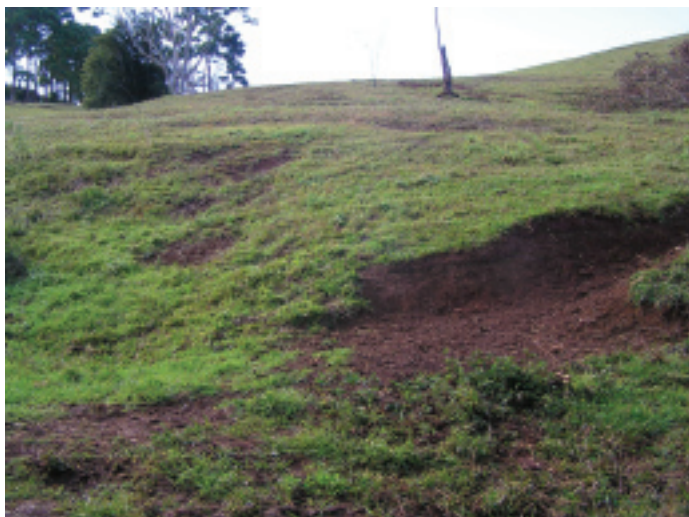
One of the sites for rehabilitation

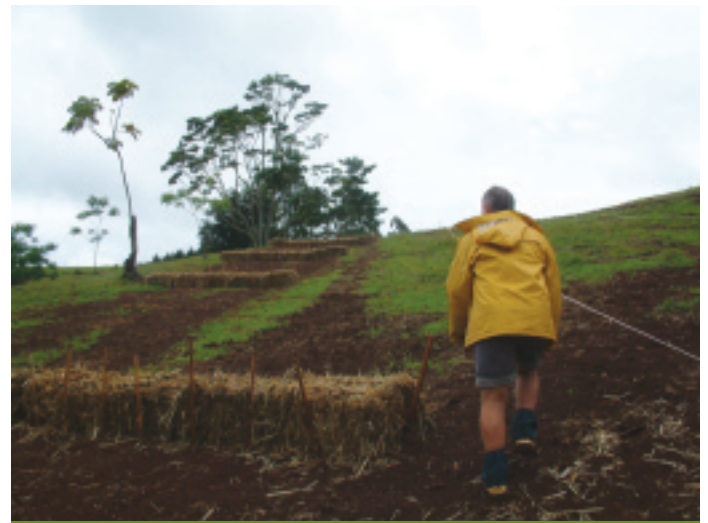
Hay bales slow down water on a steep slope

"The most difficult thing about the project was the sheer time and effort involved in manually cleaning up the surface rock following earthmoving equipment activities, and securing 800 straw bales on steep slopes to keep soil in its place and allow the newly planted grass seed to take."

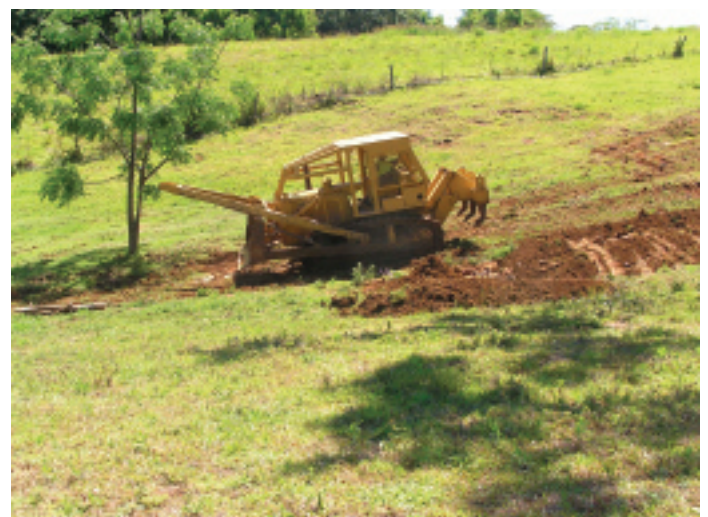
Reshaping in progress

- Cattle were temporarily excluded from the rehabilitation sites.
- Some gates and sections of fences were removed to allow access for machinery.
- Eroded sections were reshaped, lined with rock and covered with topsoil.
- One very steep slope was terraced to slow down water flow.
- Slopes were detailed to allow slashing for maintenance.
- Disturbed soil was fertilised, seeded with grasses and mulched.
- Straw bales were placed across slopes to minimise soil and seed loss.
