NSW DEPARTMENT OF
PRIMARY INDUSTRIES

SAFETY ALERT

Severe Scald From Radiator Cap Removal

Mine Safety Report No: SA06 – 03
File No: 05/5979
Comet ID: 317525602001
Prepared by: Gordon Jervis
Phone: 02 4931 6642
Date Created: 30 January 2006

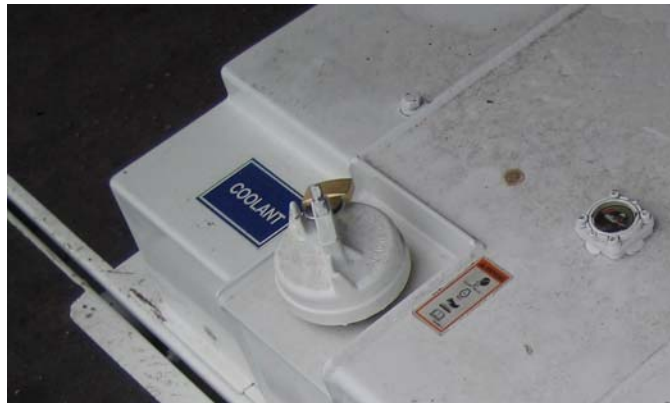
Coolant Cap on a New Truck

- Have in place a Design Standard (equipment specification) of Engineering Practice that addresses item (1) above.
- Ensure radiator caps for cooling systems are fitted with a means of safely relieving pressure to prevent burning of personnel
- Ensure there are clear and concise signs adjacent to radiator caps to warn operators of the hazards of removing hot radiator caps.
- Cover the above items in the training and competence assessment of operators
- Train tradespeople to diagnose cooling system problems and in the maintenance of engineering standards.
