SAFETY ALERT

FIELD TECHNICIANS INJURED AT DRILLING SITE

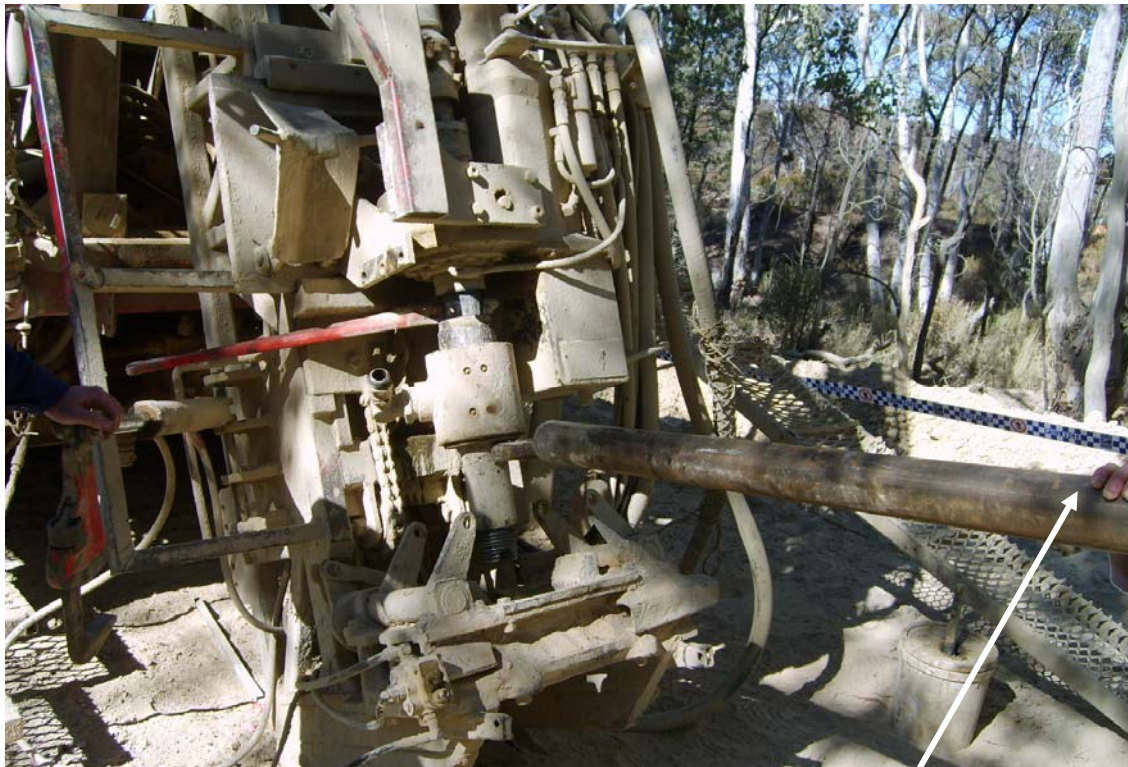
Drill Rig with Drill Rod Being Used as a Lever

The driller and his assistant had attempted to crack the thread on the air swivel without success. It was decided to use a 3 metre long drill rod as a lever to try and crack the frozen thread. Two field technicians who were working nearby were asked to assist hold the drill rod in position. The lever was positioned over a set of large stilsons below the frozen thread. Another set of large stilsons

were positioned above the frozen thread. *Refer photograph page 1.* The drill rig was started and forward rotation applied to hold the top set of stilsons in place. The forward rotation force was released resulting in the drill rod immediately moving in the reverse direction. The two field technicians were struck on the head by the drill rod, knocking them to the ground. They both sustained head injuries. The driller's assistant was also knocked to the ground by the drill rod, he was uninjured.

1. Developing and implementing effective isolation procedures to control exposure to hazardous energies
2. Providing information and training to ensure persons are competent to carry out their work activities
3. Ensuring contractors safety management plans are approved, regularly reviewed and are effectively implemented
4. Ensure equipment is fit for purpose
5. Conduct JSA or risk assessment for all non routine high risk work activities – apply the hierarchy of controls
6. Refer and review - Minerals Industry Safety Handbook Section 4.2.7 Exploration Drilling
