gully management

Landholder	Kevin & Leeanne Coonan
Map reference	2
Land use	Beef cattle grazing and dairy farming
Soil Erosion Solutions Grant	\$9,800 (earthworks)
Landholder's in-kind contribution	\$10,260 (earthworks, labour, fencing materials)
West of the Ranges Landcare Inc. (WORLI)	\$500 (trees, labour and administration support)

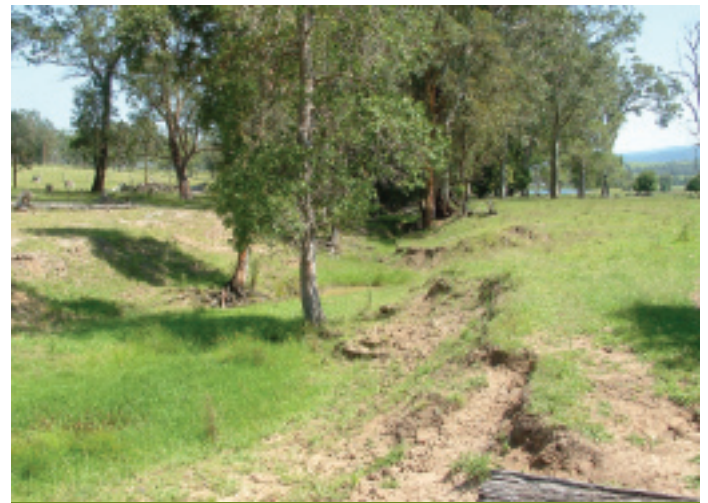
A failing dam within a gully line in remnant bushland had increased erosion. Access by cattle to the gully had contributed to the erosion and the failure of the dam.

Erosion in the gully

- The failing dam in the gully line has been decommissioned.
- An existing larger dam upstream of the gully was extended to increase water storage capacity, and so reduce water flows downstream.
- New fences were constructed and existing fencing repaired to exclude cattle from the watercourse, protecting the works area and existing remnant bushland.
- 50 local native trees were planted by the local landcare group to improve soil stability and biodiversity.
- Weeds are being managed in the rehabilitation area.

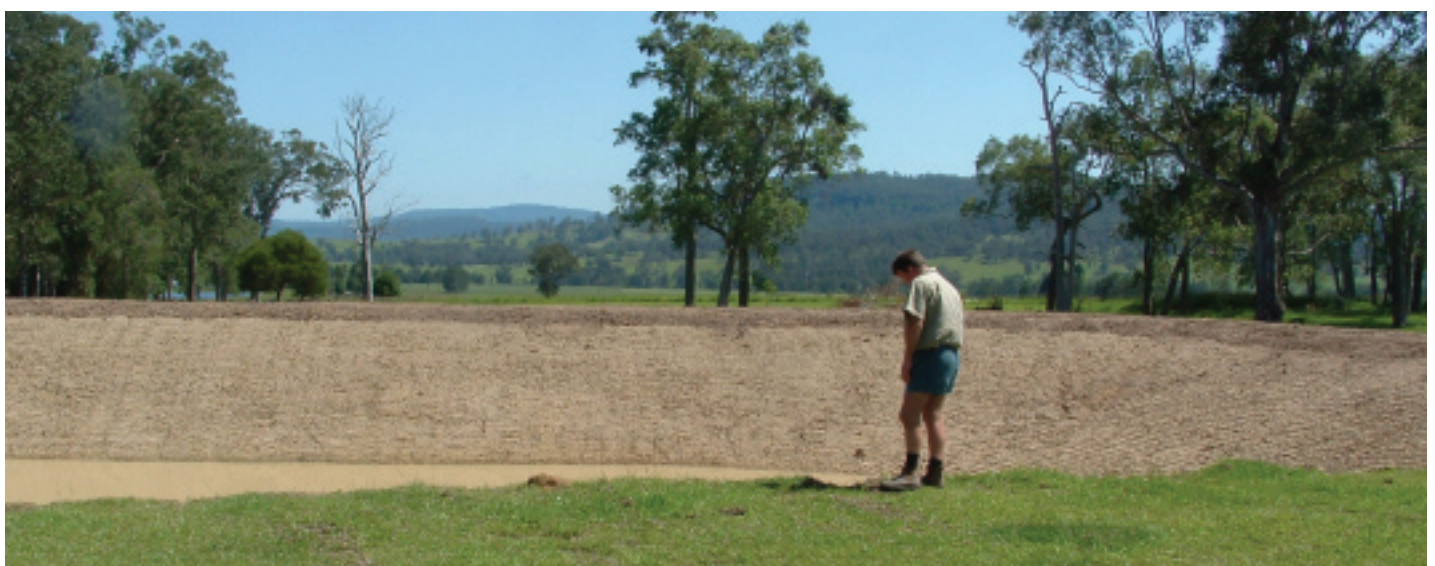
Kevin Coonan inspects the new dam
