SAFETY ALERT

SCRAPER DRIVER INJURED IN COLLISION WITH HAUL TRUCK

Report No:	SA 04 – 22
Comet ID	1131001
Date:	18/10/2004
Prepared by:	Robert jay
Phone	(02) 63926337

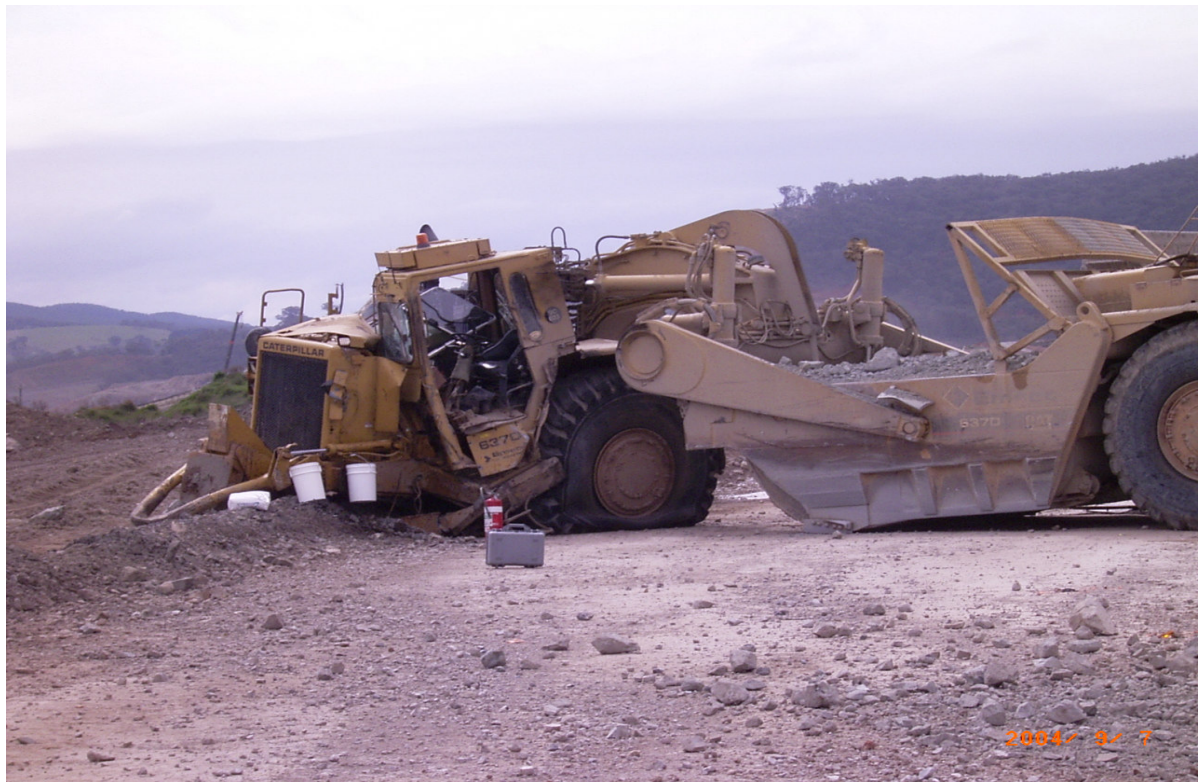
The scraper was descending an access ramp and turned onto a haul road. An empty dump truck travelling along the road came into contact with the front of the scraper. The scraper cabin was extensively damaged. The scraper was on the blind side of the dump truck. The scraper driver was wearing a seat belt at the time of the accident, which possibly saved his life.

- The scraper entered the haul road on the blind side of the truck.
- The scraper driver cannot recall details of the collision.
- The truck driver did not see the scraper enter the haul road.
- The road, weather conditions and visibility were good at the time of the accident.
- Both drivers were competent for the equipment they were operating.
- The truck and scraper were in good mechanical condition.

- Review Risk Assessments and Safe Work Procedures for the operation of ancillary mobile equipment on haul roads where large dump trucks are operating
- Review communication systems for ancillary mobile equipment
- Inform the workforce through tool box and safety meetings the hazards associated with ancillary mobile equipment entering haul roads on the blind side of large dump trucks
- Review standards of intersection design and signposting
- Conduct regular workplace inspections and task observations to ensure compliance with correct operating procedures and standards
- Investigate proximity warning devices for ancillary equipment
