## diverting water around a gully

<b>Landholder</b>	Bruce King
<b>Map reference</b>	14
<b>Land use</b>	Grazing
<b>Soil Erosion Solutions Grant</b>	\$2,200 (earthmoving, wire, seed & fertiliser)
<b>Landholder's in-kind contribution</b>	\$2,500 (labour, supply rocks, supply tractor)

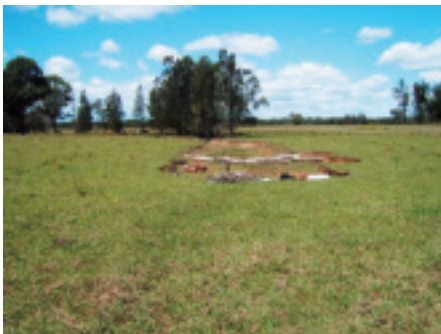
The gully before works

An active gully head had developed in a transitional area where a broad depression carried flood overflow from a wetland into a defined creek line. The open country and very gentle slope of the site allowed the creation of a preferred flow line around the gully area.

- A small rock weir was constructed in the creek to dissipate the energy of the water flow discharging from the diversion bank. This leaky weir backs up water during high flows to create a temporary pond, slowing the water and reducing its erosive power before it travels downstream.
- The gully head and walls were reshaped and grassed.
- The diversion bank, reshaped gully and part of the downstream watercourse were fenced off to exclude cattle.

- Above the gully head a back push diversion bank was constructed. This ensured the diverted water ran along undisturbed ground and dense vegetation. The diverted water runs around the gully area and is directed back into the natural creekline further downstream.

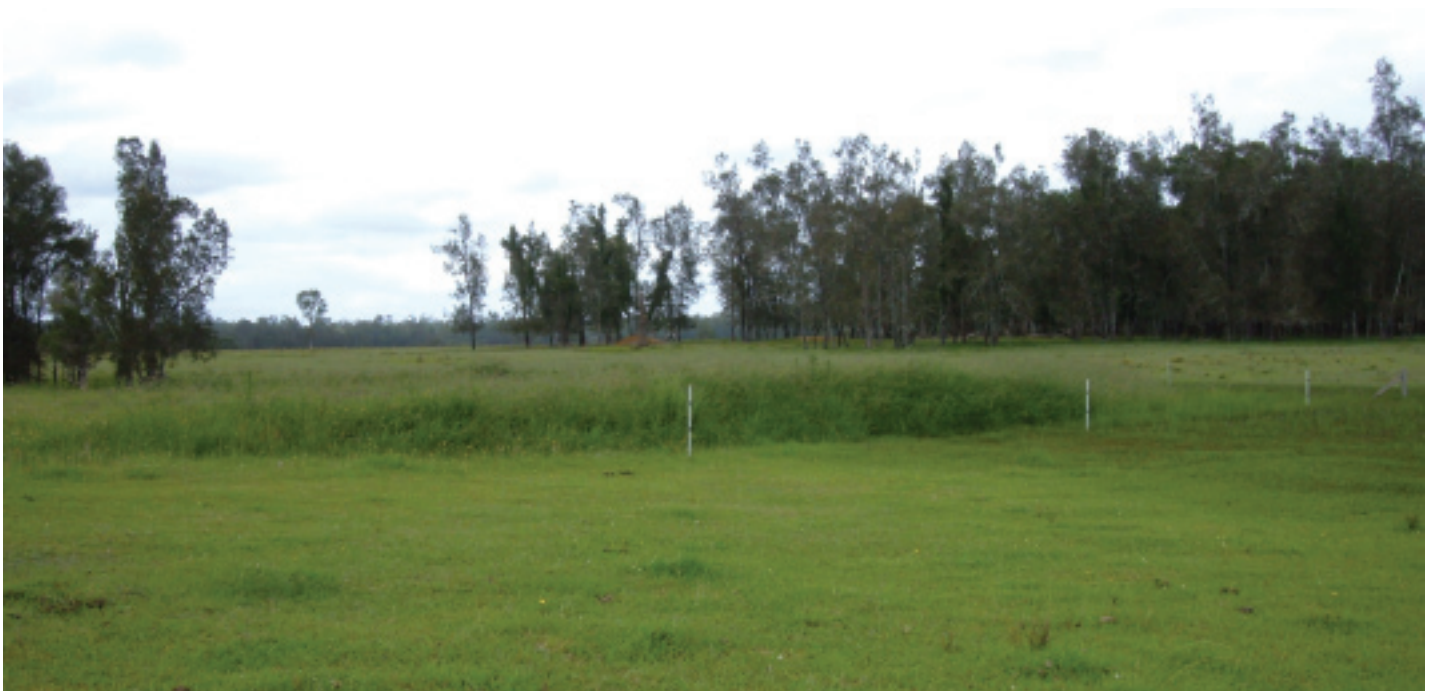
The diversion bank seen from upslope
