NSW DEPARTMENT OF  
PRIMARY INDUSTRIES

# SAFETY ALERT

## Dangerous Uncontrolled Release of Hydraulic Energy

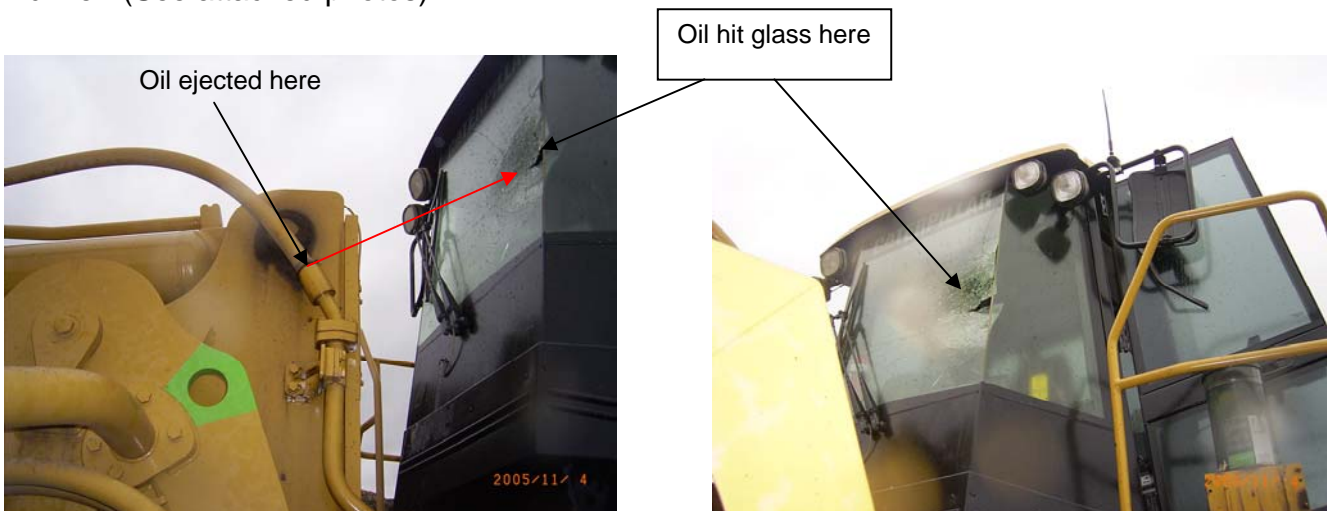
While the wheel loader was being operated a corroded hydraulic hose end released uncontrolled hydraulic fluid which ejected towards the driver's windscreen.

The energy from the uncontrolled release of hydraulic oil was sufficient for the hydraulic oil to penetrate the front windscreen of the loader, enter the driver's compartment and hit the driver. (See attached photos)

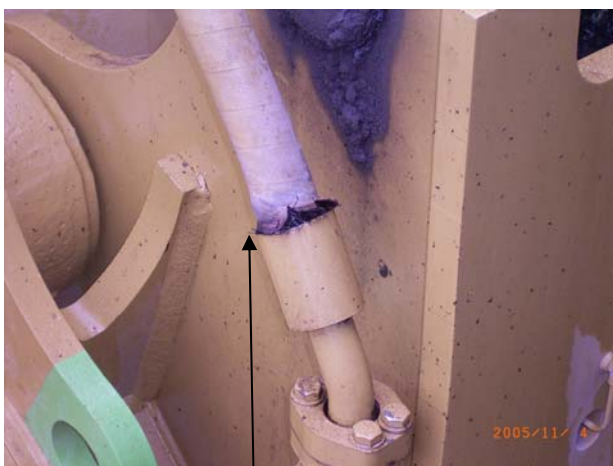
Preliminary investigation shows the hydraulic hose for the bucket tilt function failed where the hydraulic hose enters the hose fitting (hose end) which is located close to the operator's cabin.

While the hose visually appeared to be in a relatively good condition, it failed due to corrosion. The hose has an operating pressure of approximately 31.5MPa (4,500psi).

Corroded hose end

1. Inspect all high risk hydraulic hoses on equipment to ensure they are fit for purpose and free of defects.
2. Through the hierarchy of risk controls remove the exposed risk, either by relocation, guarding or other design improvements.

3. Ensure all high-risk hydraulic systems are securely protected by guards or other such devices that will diffuse the hydraulic energy and provide equivalent levels of safety.
4. Develop a hydraulic hose management system that allows hose replacement, failures and damage to be monitored and to implement predictive maintenance strategies. For example replace high risk hoses before failure.
5. Review MDG 41 Guideline for Fluid Power System Safety for Mines (Draft) for additional information.
6. Advise equipment manufacturers of safety related defects and faults from time to time.
7. Owners and operators of CAT 988G and 988H wheel loaders should contact the OEM or representative for additional information.

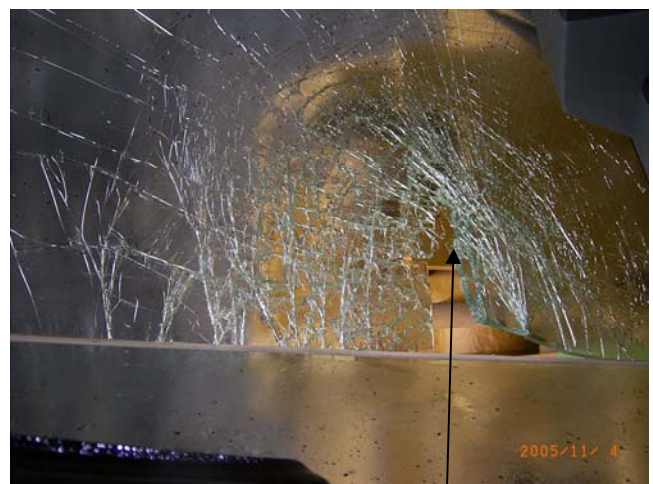
Smashed Windscreen
