SAFETY ALERT

Seatbelts Must Be Worn

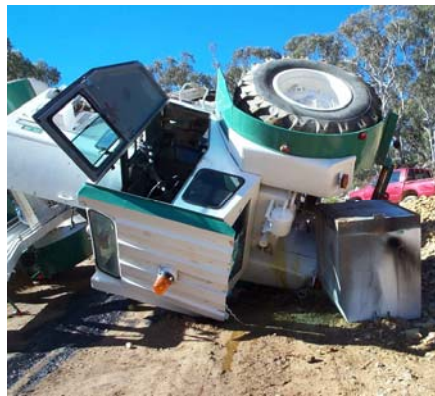
The failure to wear a seatbelt can lead to expulsion from the vehicle or severe injury from lack of restraint within the cabin.

- Review Mobile Equipment Operational Risk Assessments and Safe Work Procedures to minimise risk in the workplace
- Ensure seatbelts or appropriate restraints are fitted to the mobile equipment
- Ensure mobile equipment seatbelt and anchorage point engineering complies with Australian Standard 2664 or ISO 6683.
- Inform the workforce through tool box and safety meetings of the hazards associated with not wearing seatbelts while driving or being a passenger in mobile equipment
- Conduct regular workplace inspections and task observations to ensure compliance with the correct use of seatbelts

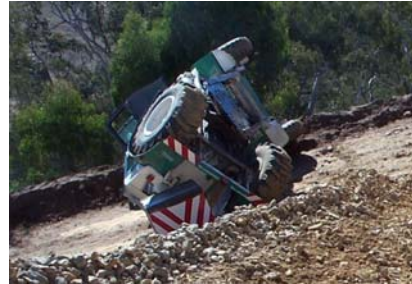
With no seatbelt, expulsion from the cabin can lead to injury and/or death through being crushed by the equipment.
