safe diversion of water

Landholder	Ian Clapham – Brooklet Farm Frank Elsworth – Figtree Plantation
Map reference	8
Land use	Macadamias
Soil Erosion Solutions Grant	\$10,000 (earthworks to construct diversion drain, matting to protect drain and grass seed)
Landholder's in-kind contribution	\$16,746 (removal of windbreak, labour)

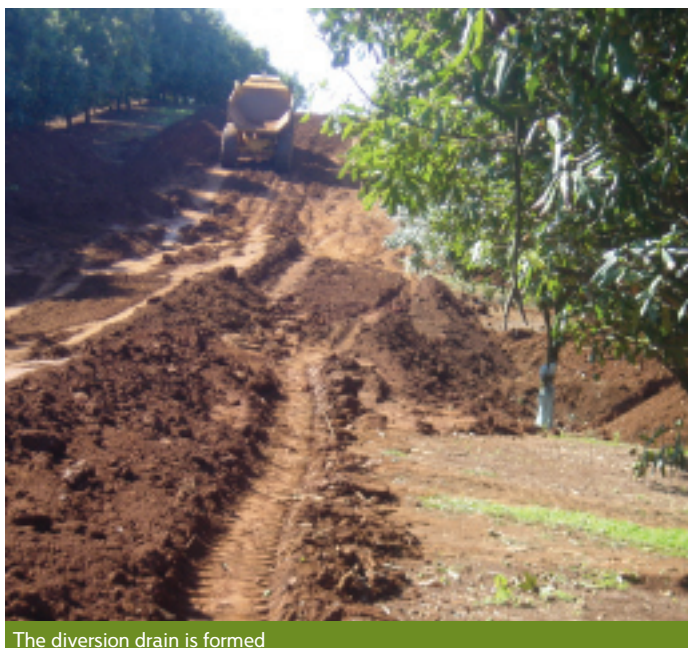
The diversion drain is formed

- The windbreak between the two properties was removed and mulched.
- A broad shallow diversion bank was constructed along the boundary to divert water to the farm dam and into a nearby stable watercourse.
- Excavated soil was used to form low profile mounds along the adjoining eroded tree rows.
- Jute erosion control matting was installed in the high flow area of the new drain to give immediate protection.
- Carpet grass and winter ryegrass were sown in all disturbed areas.

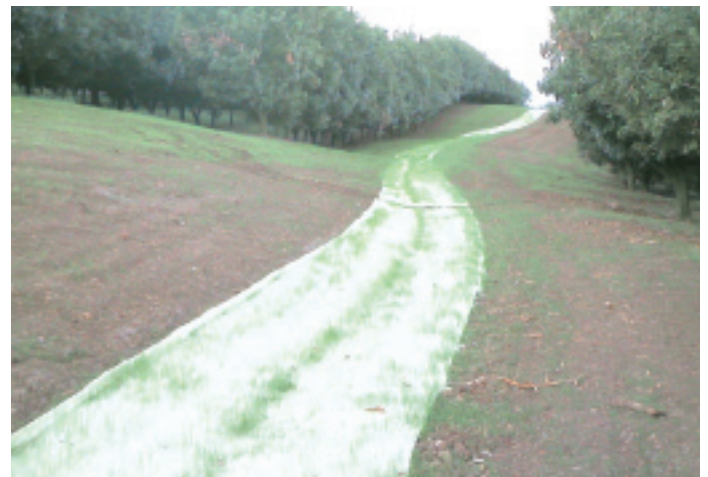
Jute erosion matting laid in the new drain's flowline

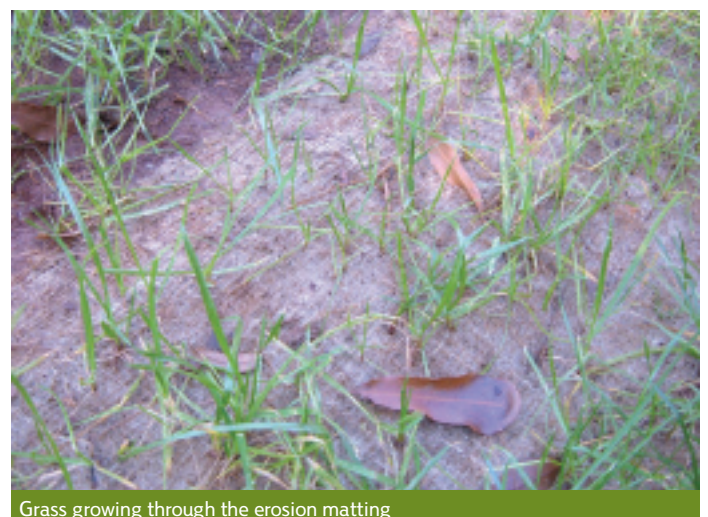
Grass growing through the erosion matting
