## soil conservation on a blueberry farm

<b>Landholder</b>	Sohan Atwal
<b>Map reference</b>	16
<b>Land use</b>	Bananas and blueberries
<b>Soil Erosion Solutions Grant</b>	\$9,300 (gabion rock, gravel, cracker dust, pipes, excavator hire, geofabric sandbags, grass seed)
<b>Landholder's in-kind contribution</b>	\$9,300 (labour, tractor work)

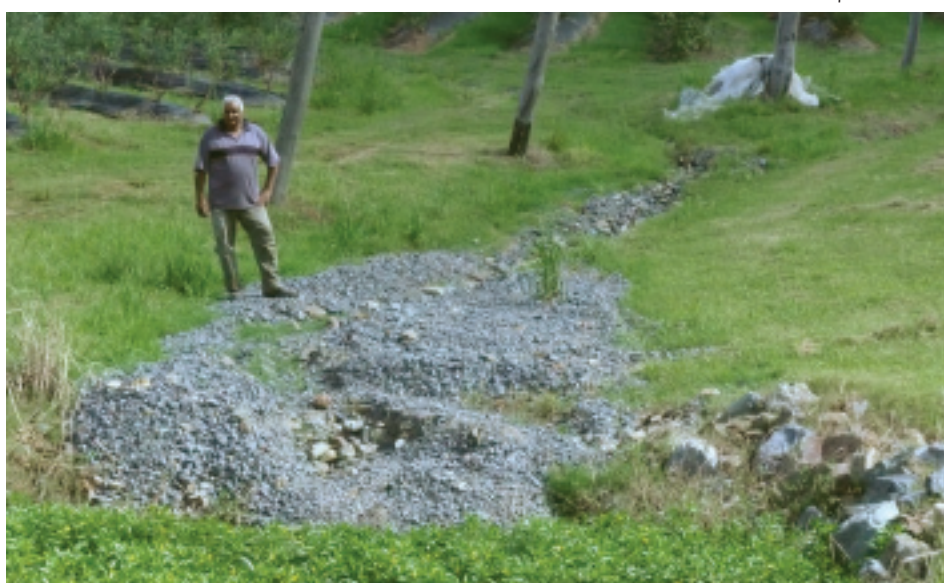
Subsurface drainage improves the central flow line

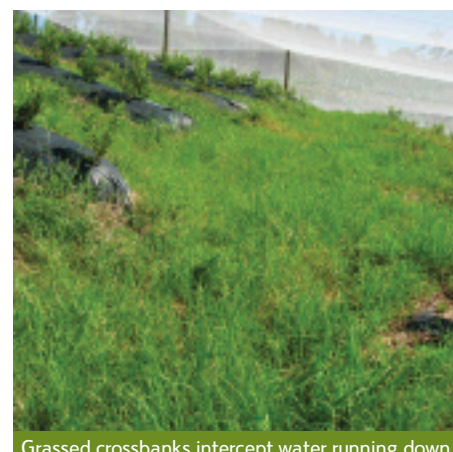
Grassed crossbanks intercept water running down the blueberry rows
