7. Water quality and assessment

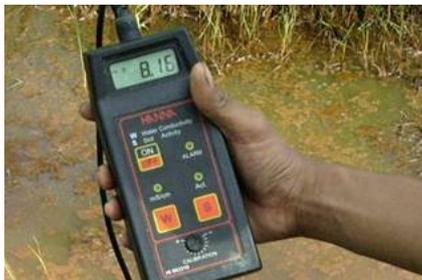
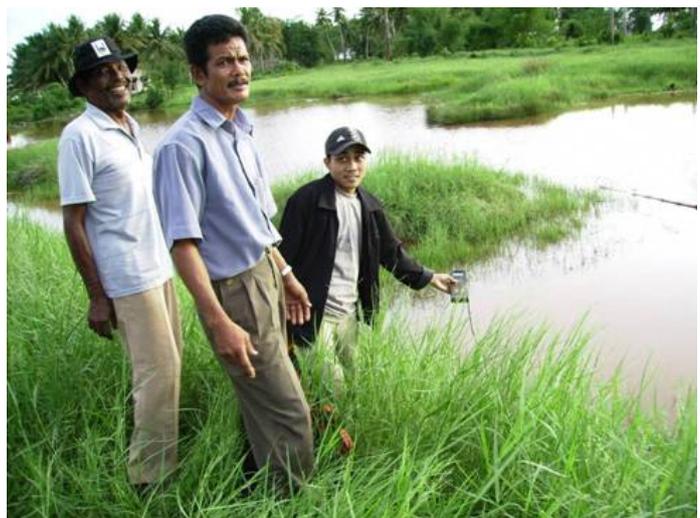
Figure 11: A portable meter helps to identify salinity of irrigation water and ensure that crops are not affected by high levels of salt

In the 2004 tsunami, seawater inundated wells and affected groundwater supplies in some areas. In dry seasons farmers need to use well water, so saline groundwater may affect vegetable production. It is important to assess water salinity levels to identify water too saline for crop production, and prevent crop failures. For instance, in the district of Bireuen, irrigated rice experienced more problems than dryland rice possibly due to salt in the river water used for irrigation. As a general rule the use of irrigation water with $EC_e > 1.5$ dS/m should be avoided, Water with an EC greater than 3 dS/m may cause crop damage.

How to test water salinity
