APPENDIX 6. WETLAND MANAGEMENT STORIES

IAN McCOLL - 'HILLCREST'

Where	30km south-west of Cowra, NSW
Enterprise	Mixed cropping & livestock production
Size	640 hectares
Wetland area	0.8 hectares (2 acres)

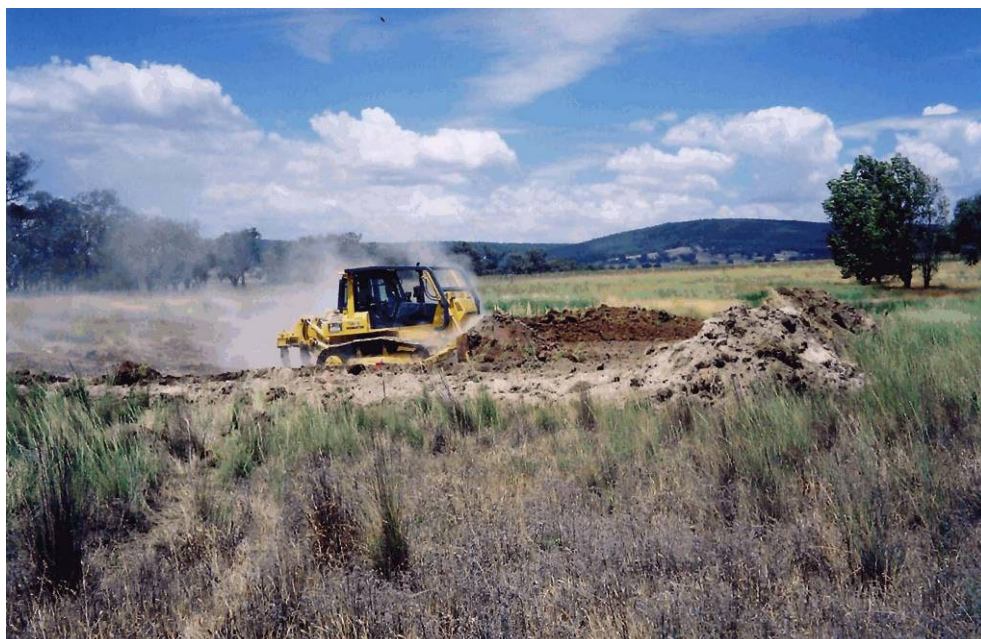
Image 37: Work commences on Ian McColl's constructed wetland (February 2003). Essentially a modified farm dam, the wetland incorporates an island and was built to provide areas with differing water depths. A 100mm spillway by-pass pipe was also installed through the dam wall which carries the base flows, keeping the spillway dry.

The design brief was a simple one; the wetland was to be constructed in a similar manner to a normal farm dam, but with an island and benches installed. The latter were included so that once the dam filled there would be areas of shallow and medium depth water, as well as deeper areas near the centre. The island was built to create a predator-free refuge for water birds, while the differing water levels were included to provide variation in habitat types, both for aquatic plants and birds. Ian recalls that coming up with the design was not that easy because most of the available designs for constructed wetlands were complex, large scale and would have been very expensive to install. In addition to this, finding a local contractor with experience in farm-scale wetland construction proved very difficult. *'There was a bit of a communication breakdown at the beginning'* Ian recalls, with the eventual alignment being slightly different to what he felt had been initially agreed. Once completed however, Ian was happy with the result.
